Article

Experimental Studies into the Analysis Required for the Durability Assessment of 7075 and 6061 Cold Spray Repairs to Military Aircraft

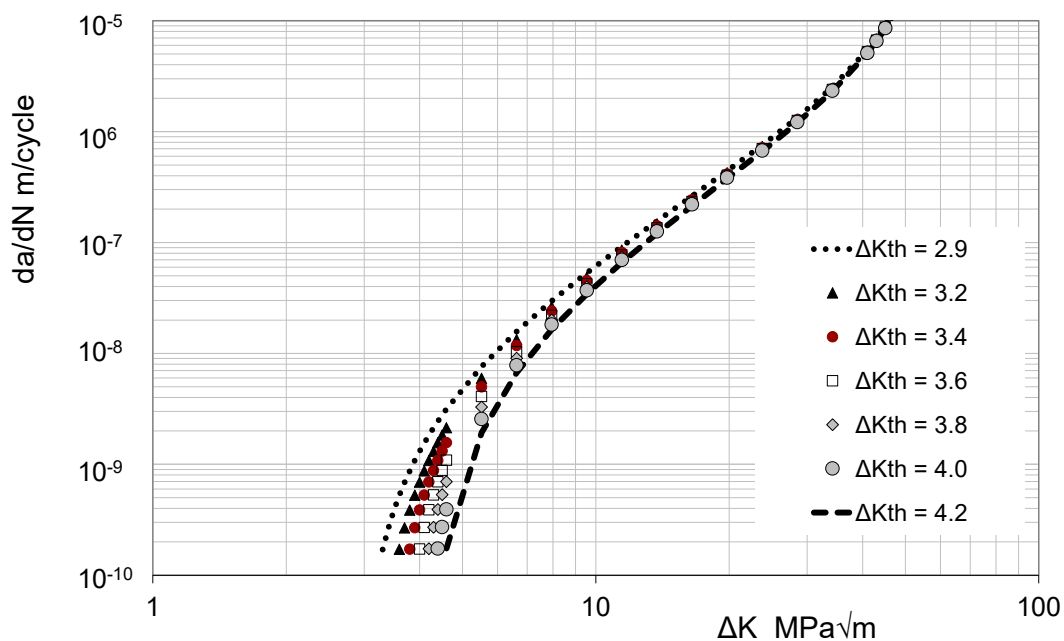
Figure 1. The scatter seen in the family of da/dN versus ΔK curves corresponding to the Virkler, Hillberry and Goel crack growth data.

Structures Bulletin EZ-19-01 [23] stresses the importance of analysis in the durability/economic life assessment of AM and AM repairs, such as cold spray (SPD) and laser-assisted deposition, and mandates the use of a minimum equivalent initial damage size (EIDS) of 0.254 mm. This size EIDS is taken from JSSG2006 [25]. A problem faced in the durability analysis needed for the certification of cold spray repairs is how can the necessary small crack da/dN versus ΔK curve be determined. It is tempting to use the approach proposed in [17], whereby a small sub mm notch is cut into a specimen. Unfortunately, there are numerous problems with this approach. In this context, it should be noted that the paper by Virkler and Hillbery [45] is acknowledged as the seminal paper that established the degree of scatter seen in da/dN versus ΔK tests performed to the fatigue test standard ASTM E647-13a [46]—see

Figure 1. Other examples of this non-uniqueness, i.e., the variability in the da/dN versus ΔK curves for a conventionally manufactured material, are given in [47,48].

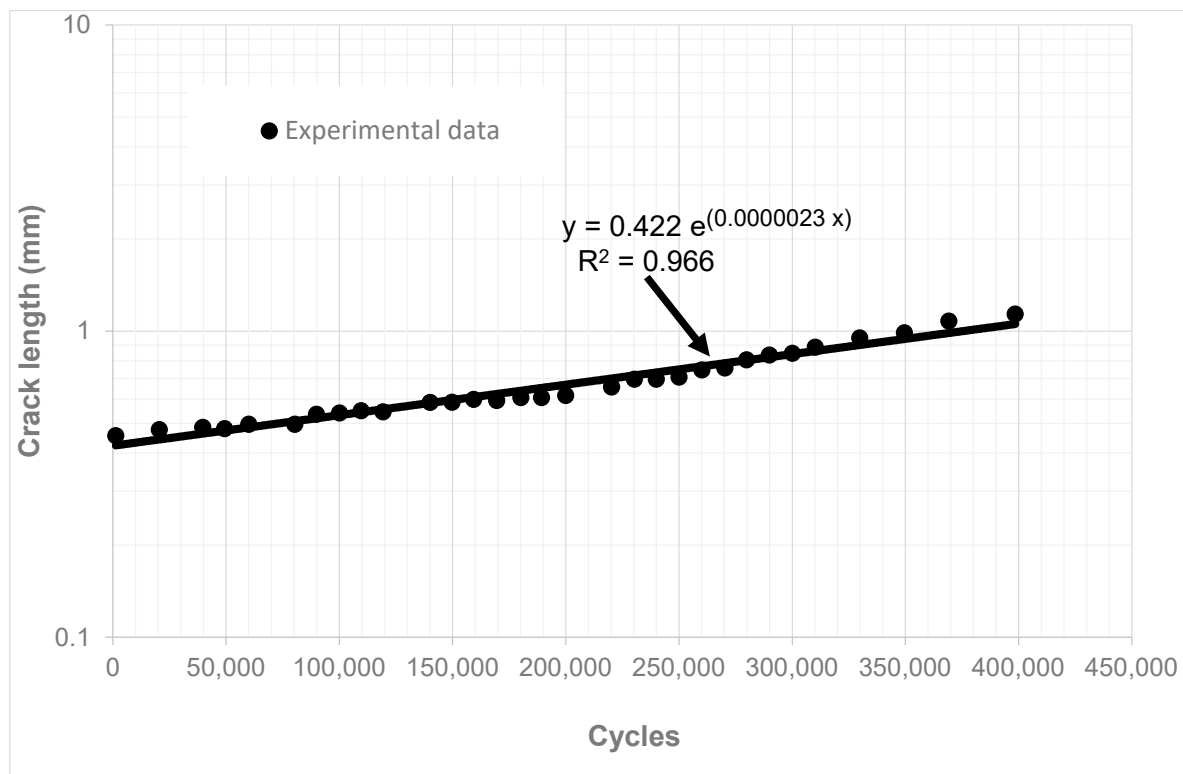
Figure 2. The crack growth history associated with the fastest small crack in tests on 6061-T6511.

To illustrate the (potential) scatter associated with the growth of small/short cracks in conventionally manufactured 6061, it is pertinent to note the crack growth histories reported in [53,54]. Whereas [53] specifically stated that the crack growth was exponential, and that the crack rate da/dN was proportional to the crack length, a similar statement was not made in [54]. However, on plotting the crack growth history associated with the fastest crack reported in [54], it can be seen that crack growth was essentially exponential—see Figure 2. Hence, as a first approximation, the crack growth rate was essentially proportional to the crack length. As such, it follows that for these tests, the crack growth rate da/dN should be able to be approximated by a simple Paris-like power law with a low fatigue threshold and, as per [26,36,55,56], an exponent of (approximately) 2. As such, unlike the crack growth curves given in [17], the 6061 small/short crack growth data presented in [53,54] is consistent with the USAF Durability Design Handbook [34] and the USAF approach to assessing the economic life of military aircraft [35].

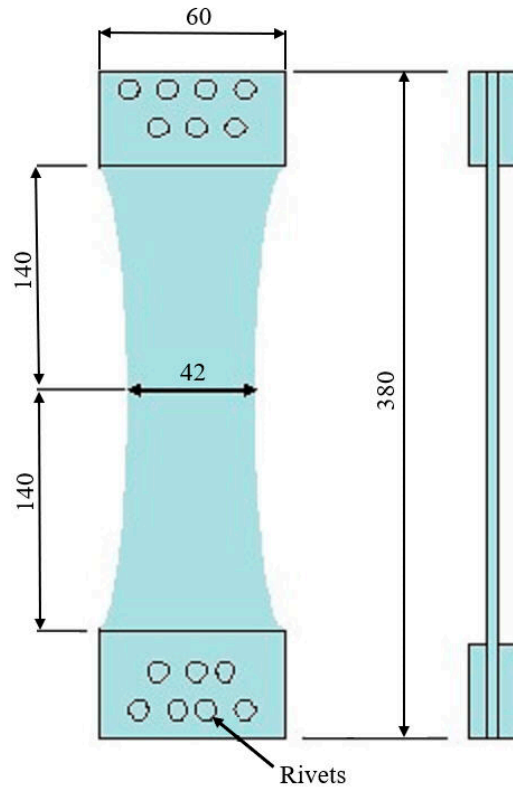
Figure 3. Geometry of the dogbone test specimens.

A series of constant amplitude fatigue tests, at a load ratio of $R = 0.1$, were performed on 3.175 mm thick 2024-T3 dogbone specimens, with a geometry as shown in Figure 3. The tests were performed in an MTS 100 kN servo-hydraulic machine in accordance with the American Society Testing and Materials (ASTM) tests standard E 739-80 [57]. The effect of two different coating thicknesses, namely 0.1 and 0.5 mm, was evaluated and tests at a number of load levels were performed. The resultant stress life curve is shown in Figure 4 together with data obtained from tests on panels without a cold spray coating, and for one specimen that was not coated, which was grit blasted prior to testing at a stress in the working section of 225 MPa, which corresponds to a load of approximately 30.00 kN. The grit blasting (surface preparation) process used was the same as that used for all cold spray applications to Royal Australian Air Force aircraft [16], and the application parameters are as outlined in [11]. Indeed, this combination of surface treatment and application parameters is used in all of the

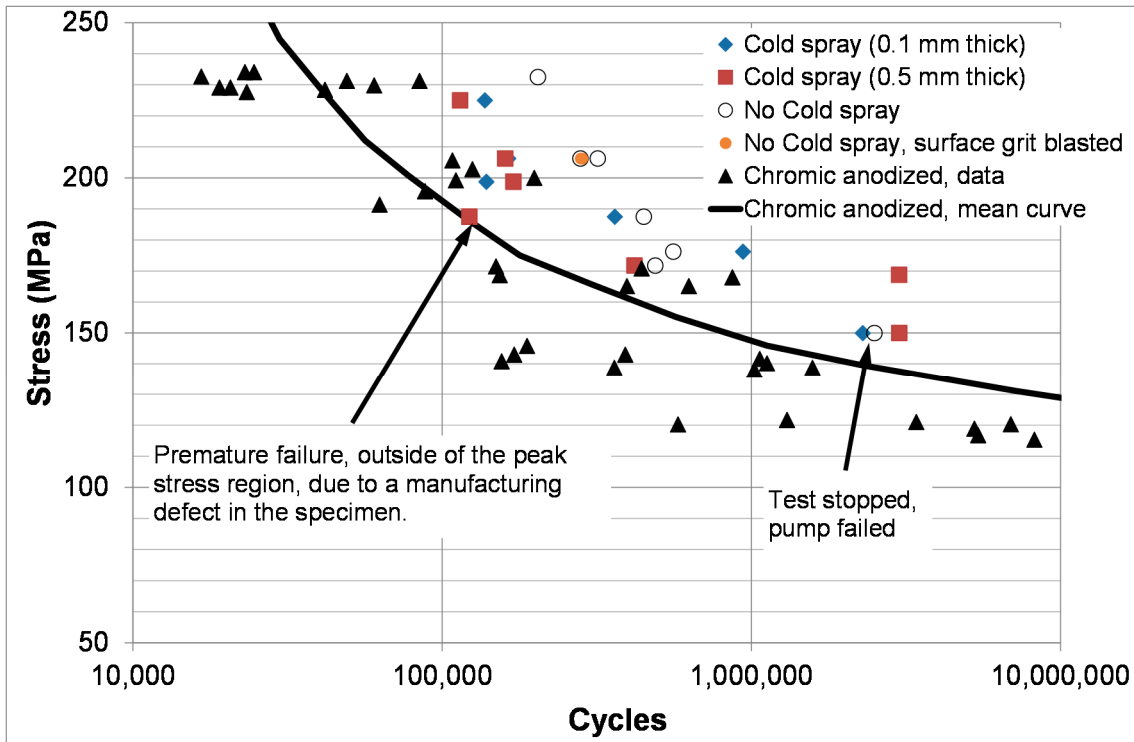
Figure 4. The stress life data associated with the tests on a 2024-T3 skin with a 7075 powder coating.

cold spray examples discussed in this paper. Since it is common practice for aerospace skins to be surface treated so as to minimise the effect of corrosion, Figure 4 also presents the stress life curves given in [58] for tests on chromic anodized 2024-T3.

A key point to be noted in Figure 4 is that below a stress of approximately 150 MPa, there was no failure. There was also no cracking in the 7075 coating, or delamination of the coating from the 2024-T3 substrate. To illustrate this, Figure 5 presents a picture of the stress range of the bulk stresses field ($\Delta\sigma_1 + \Delta\sigma_2 + \Delta\sigma_3$), which is the first invariant of the stress tensor, obtained using infra-red thermography, in a 7075 coating of a specimen that was tested at a stress corresponding to approximately 150 MPa, that did not fail after more than 3,000,000 cycles. Here, $\Delta\sigma_1$, $\Delta\sigma_2$, and $\Delta\sigma_3$ are the ranges of the three principal stresses, namely σ_1 , σ_2 , and σ_3 , in a cycle. (The test was stopped after approximately 3,000,000 cycles.) This picture reveals that there was no cracking in the coating.

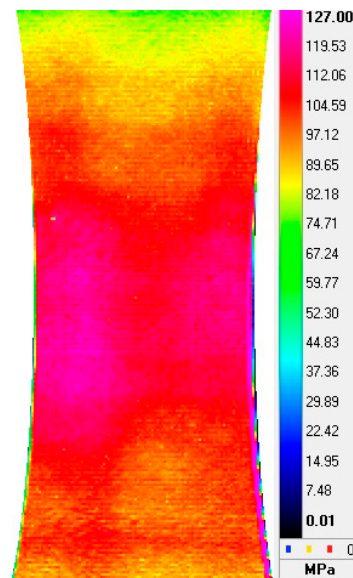
Figure 5. The bulk stress field in the 7075 coating at 3,011,000 cycles.

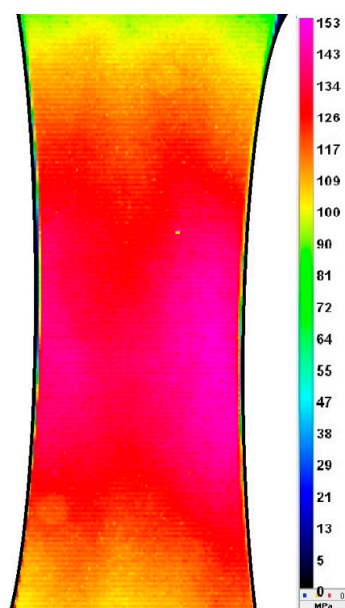
Figure 6. Bulk stress field in the coating at 2,293,500 cycles.

To further illustrate this, Figure 6 presents a picture of the bulk stress field at 2,293,500 cycles in a specimen tested at a stress of approximately 169 MPa. This test was terminated shortly thereafter due to failure of the pump. This picture also reveals that there was no cracking in coating.

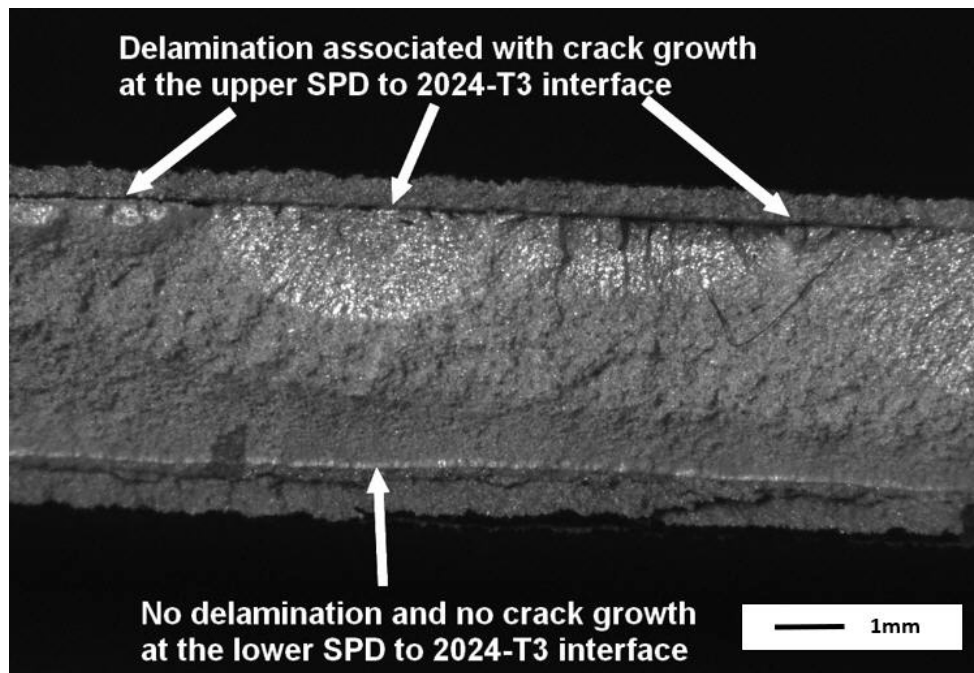
Figure 7. Note the delamination is associated with crack growth on the upper interface and the intact nature of the interface on the opposing (uncracked) surface.

Figures 7 and 8 show the failure surface associated with specimen number S24, which had a 0.5 mm thick 7075 coating and which failed at 114,344 cycles, and specimen S22 which failed at 122,521 cycles. In both cases, we see that cracks in the 2024-T3 nucleated at multiple locations at the intersection between the 7075 coating and the 2024-T3 substructure. The growth of these (multiple) cracks subsequently led to delamination of the coating from the 2024-T3. Also note the intact nature of the interface on the opposing (uncracked) surface. This phenomenon, i.e., failure due to the nucleation and growth of multiple cracks in the 2024-T3 at the interface between the 2024-T3 and the coating, was seen in all cases.

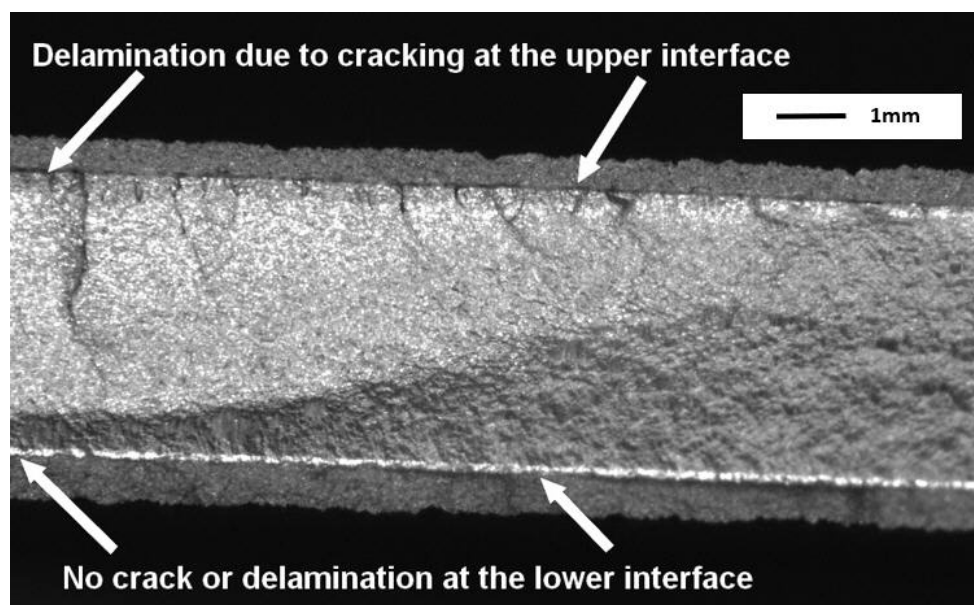
Figure 8. Note the delamination is associated with crack growth and the intact nature of the interface on the opposing (uncracked) surface.

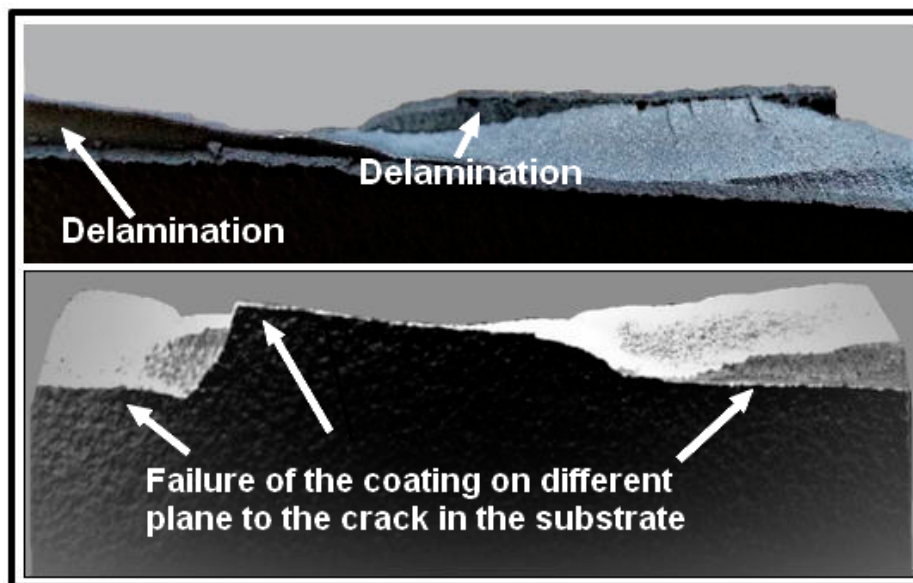
Figure 9. Delamination of specimen S40, which had a 0.5 mm thick 7075 coating, was tested at 25 kN which corresponds to a stress of 187.5 MPa, and failed at approximately 124,000 cycles. Note how the failure of the coating is on a different plane to that of the crack in the 2024-T3.

This phenomenon was also seen in the current fatigue test program—see Figures 9 and 10, where we see both delamination of the 7075 coating from the 2024-T3—which arose as a result of failure in the 2024-T3 substrate, and the fact that the failure of the coating was frequently associated with a different plane to that of the cracking in the 2024-T3 substrate.

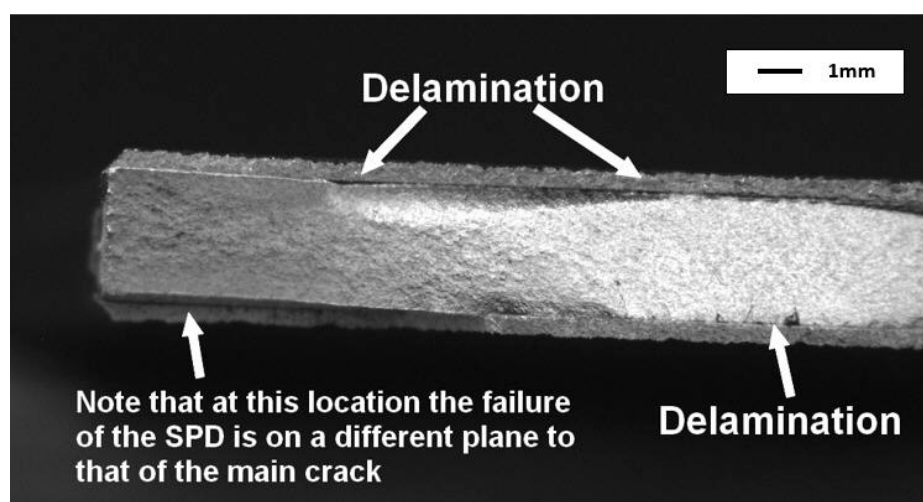
Figure 10. Delamination of specimen S40, which had a 0.5 mm thick 7075 coating, was tested at 25 kN and failed at approximately 124,000 cycles. Note how the failure of the coating is on a different plane to that of the crack in the 2024-T3.

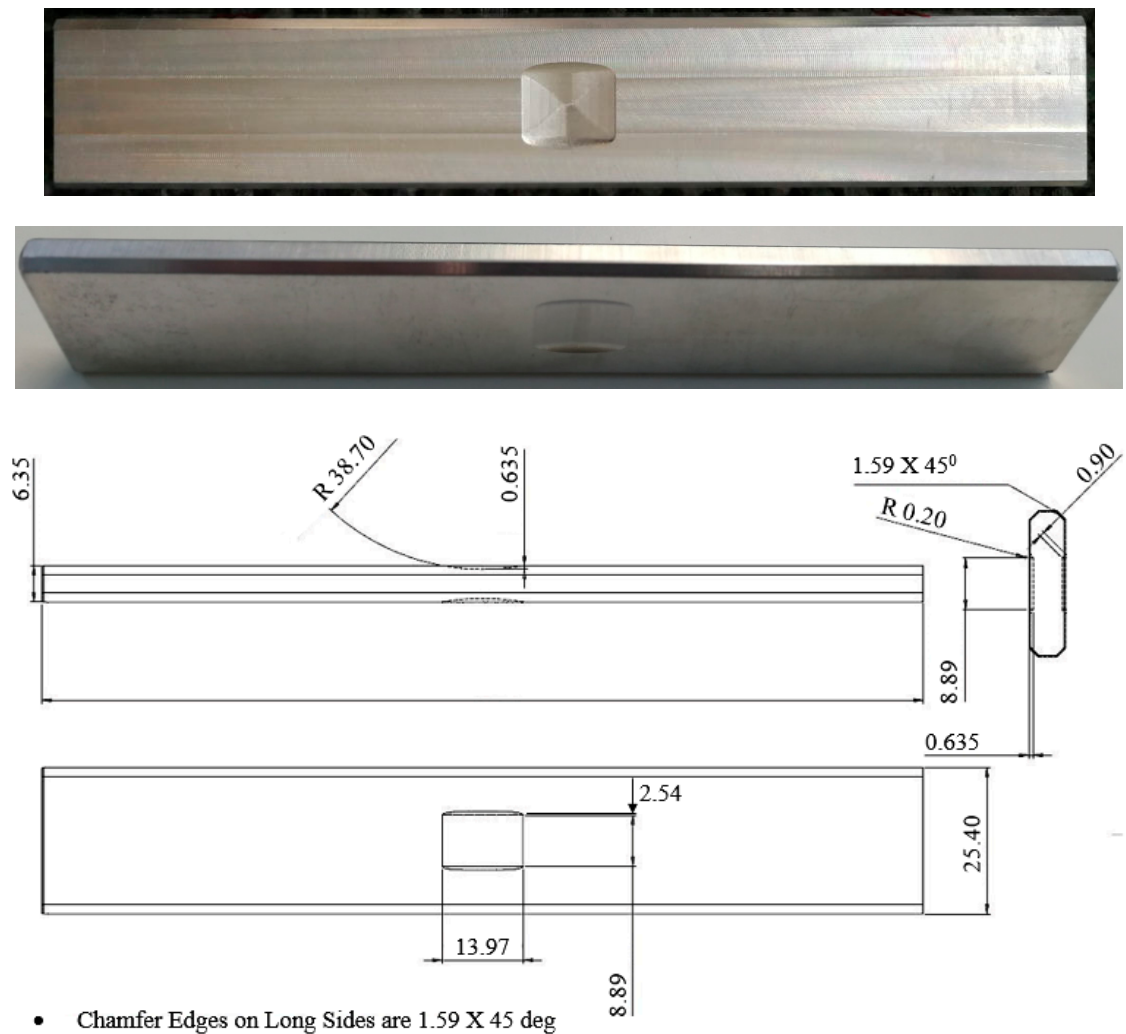
Figure 11. Geometry of the unrepaired (baseline) specimen—units are in mm.

To continue this study, we tested SPD (cold spray) repairs to a simulated corrosion rework in a 7075-T7351 skin. The geometry of the test specimen is as shown in Figure 11, and a typical repaired specimen is shown in Figure 12. A total of 16 specimens were tested—see Table 1. The tests were performed at a maximum load of 38.1 kN and $R = 0.1$. This corresponds to a maximum remote stress of approximately 240 MPa. The cold spray coatings evaluated in this study were 7075, 6061, and ceramic particles in a 6061 aluminium matrix, which in this study is referred to as AMC.

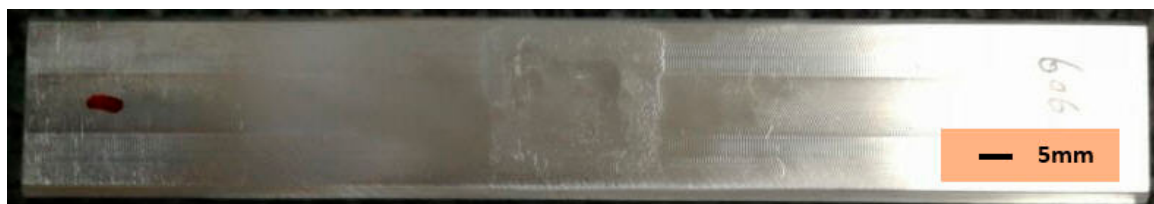
Figure 12. A specimen repaired with a 6061 powder coating.

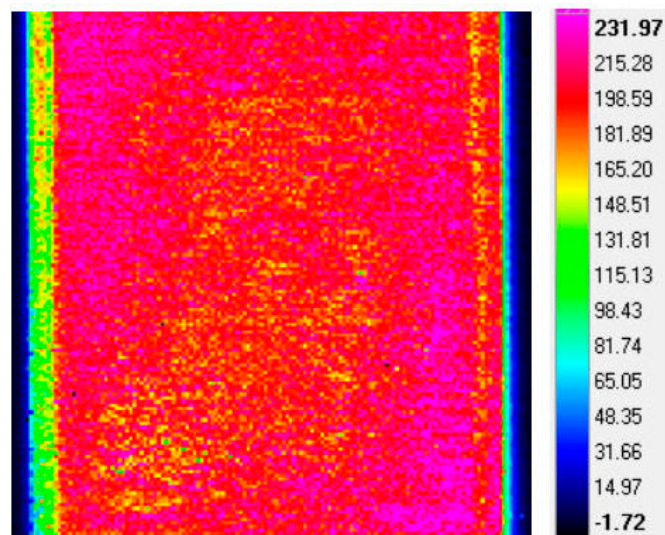
Figure 13. The bulk stress field at a load of 38.1kN and R = 0.1 for a specimen repaired with a 6061 powder coating.

Prior to fatigue testing, lock-in thermography (infra-red) stress pictures were taken both for the unrepaired specimens and for the specimens with 7075, 6061 and AMC SPD coatings. A typical infra-red bulk stress picture is shown in Figure 13. These figures revealed that the application of the coatings resulted in the specimens having a near uniform stress field. In other words, the coating had (essentially) removed the stress concentration due to the simulated corrosion cut.

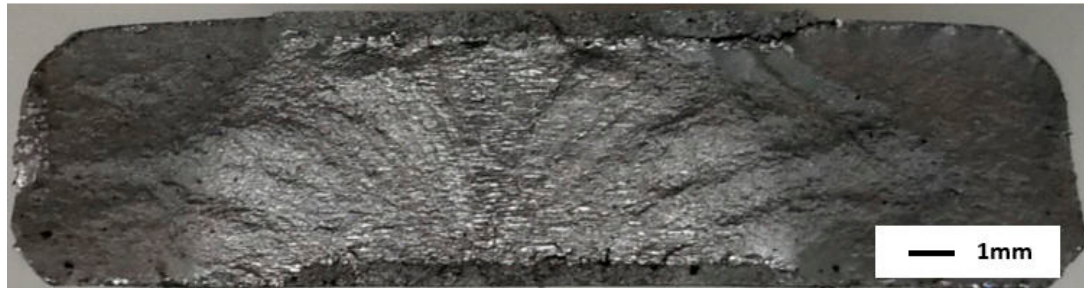
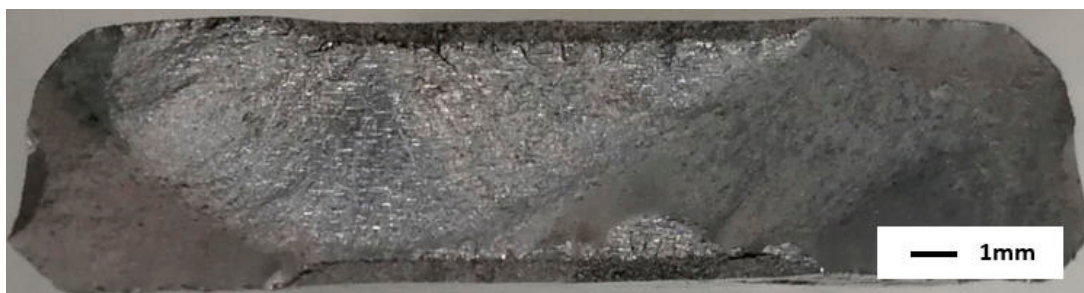
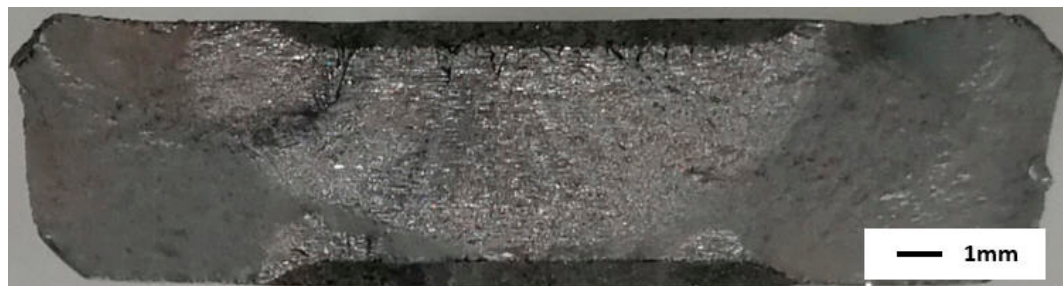
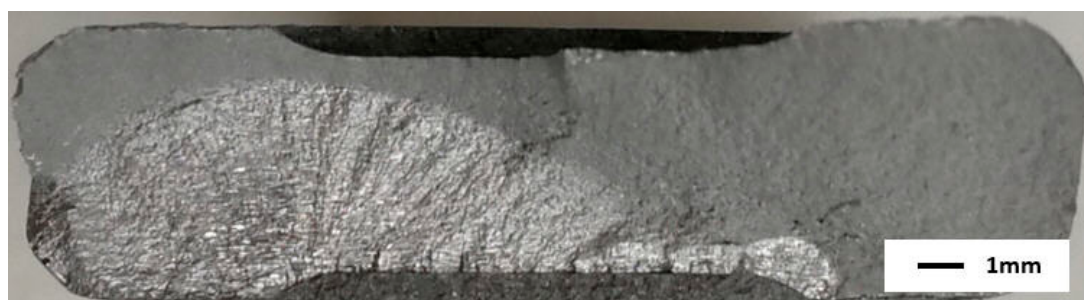
Figure 14. Failure surface associated with specimen 6061_F_2, failed at 87,958 cycles.

Figure 15. Failure surface associated with specimen 7075_F_3, failed at 83,590 cycles.

Figure 16. Failure surface associated with specimen AMC_F_1, failed at 38,677 cycles.

Figure 17. Failure surface associated with AMC LT-NGB 1, failed at 54,801 cycles.

Figure 18. Failure surface associated with specimen 7075HT_F_1, failed at 36,284 cycles.

The test lives associated with these specimens are listed in Table 1. Table 1 reveals that the baseline specimens had the longest test lives. Of the repaired specimens, the non-heat-treated 6061 doubler specimens had the longest fatigue lives. The mean fatigue lives of specimens with non-heat-treated 7075 coatings, heat-treated 7075HT, AMC and AMC LT-NGB were approximately 77.6%, 38%, 43.3%, and 60% of that seen by specimens with a non-heat-treated 6061 SPD coating (doubler). Heat treatment of the 7075 coating significantly reduced the fatigue life. Typical failure surfaces are shown in Figures 14–18.

All of the specimens failed as a result of the nucleation of multiple cracks in the 7075-T7351 substrate at the intersection between the coating and the substrate. This failure mechanism is identical to that seen in the previous studies.

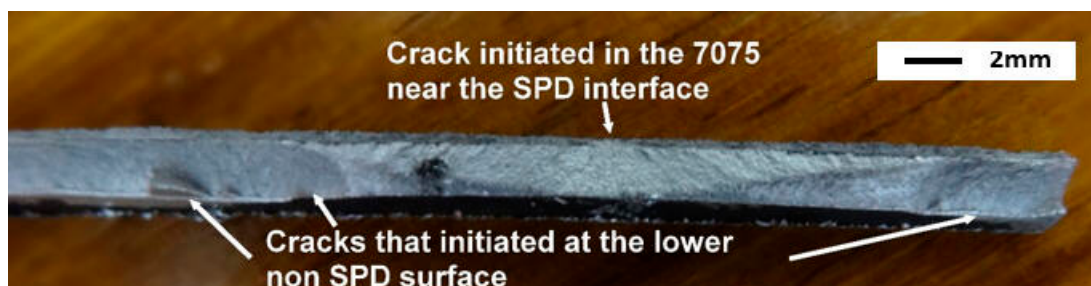
Figure 20. Multiple initiation sites both on the repaired (coated) side, in the 7075-T6 near the interface with the coating, and on the opposing face that did not have a coating.

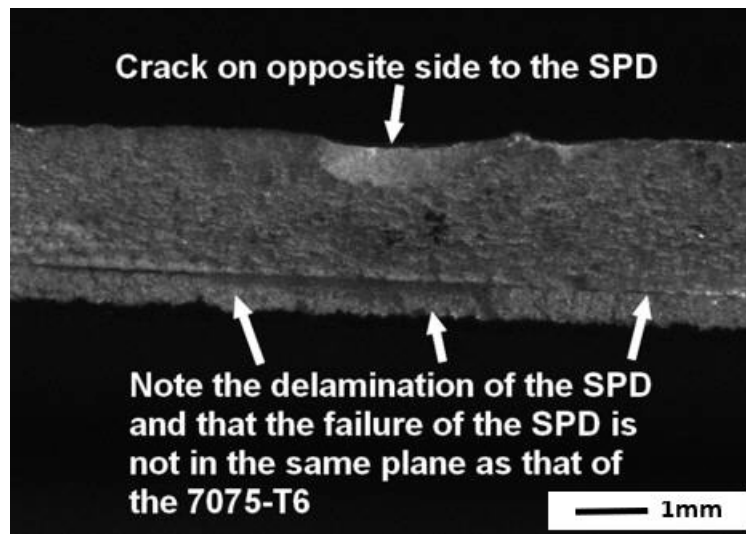
Figure 21. Close-up view of cracking on the side opposite to the repair/coating, and subsequent delamination both between the coating and the 7075-T6 substrate.

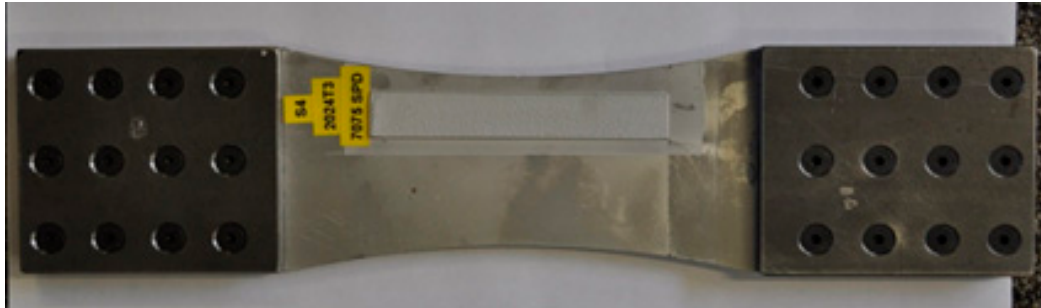
Figure 22. Location of the 7075 SPD strip on the 2024-T3 specimen.

The damage tolerance of an appropriately designed and applied coating, specifically its ability to resist cracking and delamination, was further illustrated in [11] that studied the ability of a 10 mm wide and 1 mm thick 7075 SPD strip, with a triangular cross section, to retard the growth of a 3.2 mm long edge crack in a 1.27 mm thick 2024-T3 aluminum alloy specimen—see Figure 22. The 7075 strip was deposited a distance of 5 mm from the edge of the specimen—see [11] for more details. The specimen was subjected to a cyclic stress, in the working section, of approximately 53 MPa and $R = 0.1$ —see [11]. The stress images given in [11] revealed that the stresses in the 7075 strip were significantly less than 150 MPa, i.e., less than the endurance level of the 7075 coating. Furthermore, despite the crack continuing to grow beneath the 7075 strip, there was no evidence of cracking or delamination of the

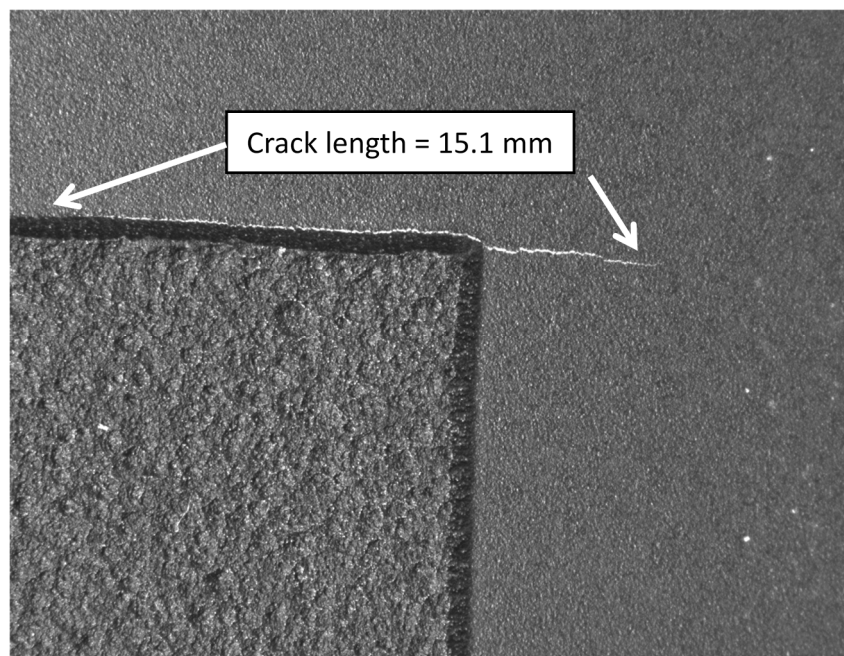
Figure 23. View of the failure location in 2024-T3 specimen.

7075 strip and failure initiated in the 2024-T3 at the ends of the strip—see Figure 23. This indicated that the 7075 deposition was more damage tolerant than the baseline 2024-T3 material. This test program was the first to highlight that the durability assessment of cold spray repairs needs to consider cracking in the substrate adjacent to a repair that can arise due to a cold spray deposition.
