Article

Surrounding Rock Control Technology of Thick Hard Roof and Hard Coal Seam Roadway under Tectonic Stress

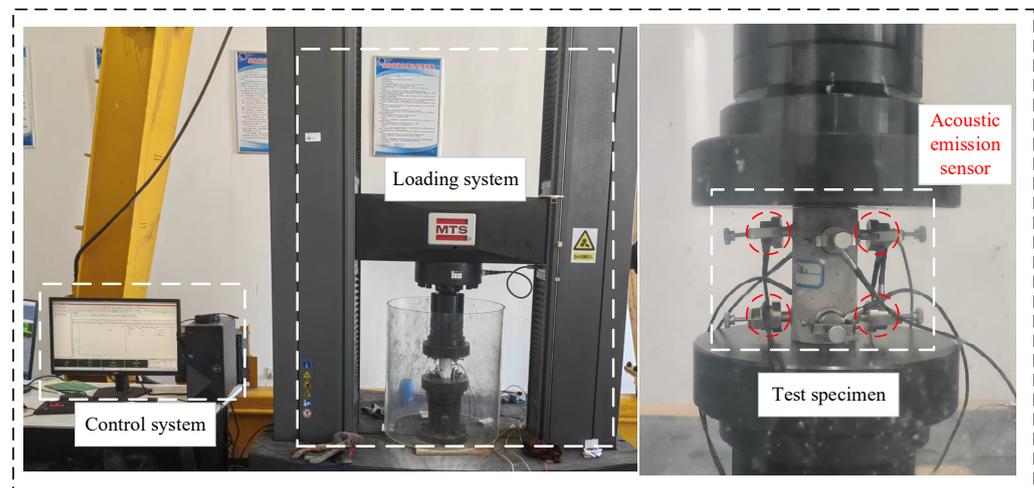
The coal and rock samples of roof, coal, and floor were prepared according to the International Society of Rock Mechanics (ISRM) test standard. The samples used in this test were three groups of roof, coal, and floor, and each group had three samples to ensure the stability of the test data. Figure 3 is the E45.605 mine rock mechanical property test system selected for this test equipment.

Figure 3. E45.605 mine rock mechanical properties test system.

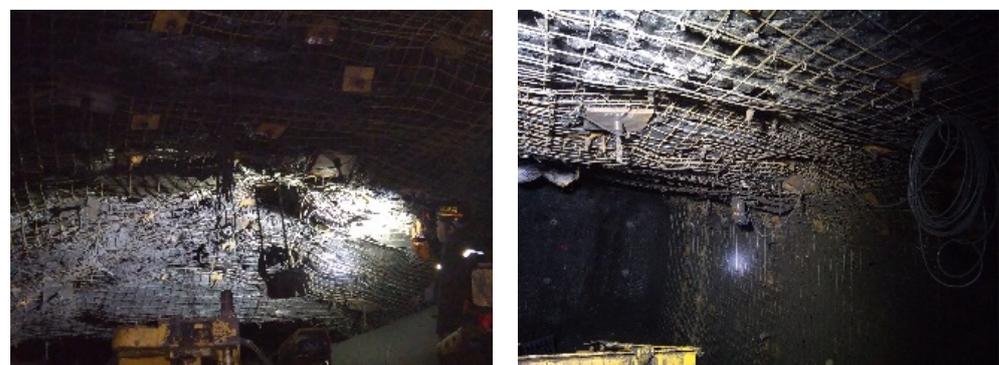
After the excavation of the roadway, the displacement of the roadway surface first increases sharply, then increases slowly, and finally enters the stage of basically unchanged displacement about 40 days after the excavation of the roadway, indicating that the surrounding rock of the roadway has been stable. According to the observation results, the surface displacement within two weeks of roadway excavation accounts for nearly 75% of the total displacement. In the early stage of roadway excavation, the displacement of the left side of the roadway is the largest, and the roof subsidence is larger than the deformation of the left side, the floor heave, and the displacement of the right side of the roadway. The main reason is that the stress of the surrounding rock of the roadway will be redistributed after the excavation of the roadway. After excavation, the disturbance to the surrounding rock of the roadway is the largest, and the deformation is 10 mm/d~33 mm/d every day according to the monitoring results. When the stress is balanced, the surface displacement velocity of each part of the roadway is reduced. When observed on the 10th day, the displacement velocity is reduced to 7 mm/d~15 mm/d. When observed on the 30th day, the average displacement is 5 mm/d. It shows that the deformation of the surrounding rock of the roadway began to stabilize, and the surface displacement velocity has decreased greatly; especially on the 40th day, the surrounding rock of the roadway has been reduced. Such as on-site support effect comparison is shown in Figure 13.

Figure 13. Comparison of supporting effect of 110,505 roadway before and after taking measures.

In summary, the roadway-surrounding rock control technology of an ‘asymmetric anchor cable + pressure relief hole’ has achieved a good control effect of roadway-surrounding rock.
