Article

# Effect of Dry-Wet Cycling on the Mechanical Properties of Rocks: A Laboratory-Scale Experimental Study

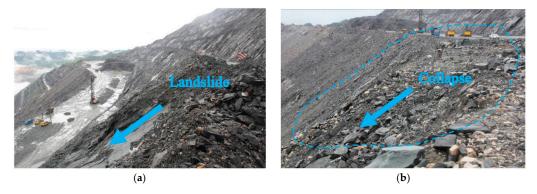
Figure 1. Landslides and collapses caused by rainfall. (a) local landslide; and (b) overall collapse

with weak development of layering, characteristics that make it easy for geological disasters such as collapse and landsliding to occur. A huge amount of rock stripping and mining is carried out in this mine every year. Due to the characteristics of the terrain and the comprehensive influence of mining, many large-scale landslides have formed on the downdip part of the lower slope, threatening safe production in the mining area. On 3 August 2012, Nanfen open-pit iron mine was hit by heavy rain from typhoon "Dawei", which resulted in large-scale cracks, collapses, and landslides on the slope, as shown in Figure 1a,b. A large area that could potentially slide has been created, which seriously threatens the normal safe production of the mine.

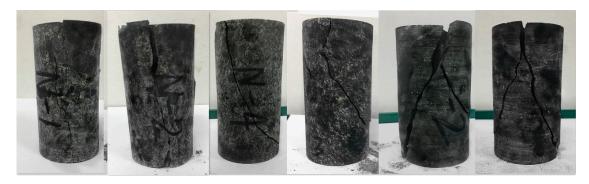
Figure 8. Images of failure in rock samples after different numbers of dry-wet cycles.

Thus, the uniaxial compressive strength and elastic modulus of the rock decreases with an increase in the number of dry-wet cycles, which shows that dry-wet cycling has a substantial damaging effect on the rock's mechanical strength. The characteristics of the rock itself and the influence of different environments and stress conditions lead to different rock masses showing different failure modes. Figure 8 presents images of chlorite samples from Nanfen destroyed by uniaxial compression tests after different numbers of dry-wet cycles. From left to right, the rock samples in the images were subjected to 0, 1, 3, 6, 10, and 15 dry-wet cycles.

Rock failure characteristics are affected by numerous factors such as mineral composition, distribution of structural planes, and the loading and stress conditions in the experimental process. It was clearly seen during the uniaxial compression tests that the post-loading failure surfaces of rocks in dry state and after one dry-wet cycle ran through the entire longitudinal axis of the rock sample. The failures were accompanied by ringing noise characteristics of brittle, tensional failure. With an increase in the number of dry-wet cycles, the characteristics of the brittle failure transitioned from strong to weak. Fissures developed that ran through the weak surfaces of the rock, and friction-induced pulverization appeared at the failure surface, a characteristic of weak surface shear failure. The sound emitted by rock failure became more complex and quieter. The failure characteristics of rocks gradually changed from brittle failure to shear failure with an increase in the number of dry-wet cycles, indicating that dry-wet cycles have a significant impact on the failure characteristics of chlorites.
