Article

Innovative Road Maintenance: Leveraging Smart Technologies for Local Infrastructure

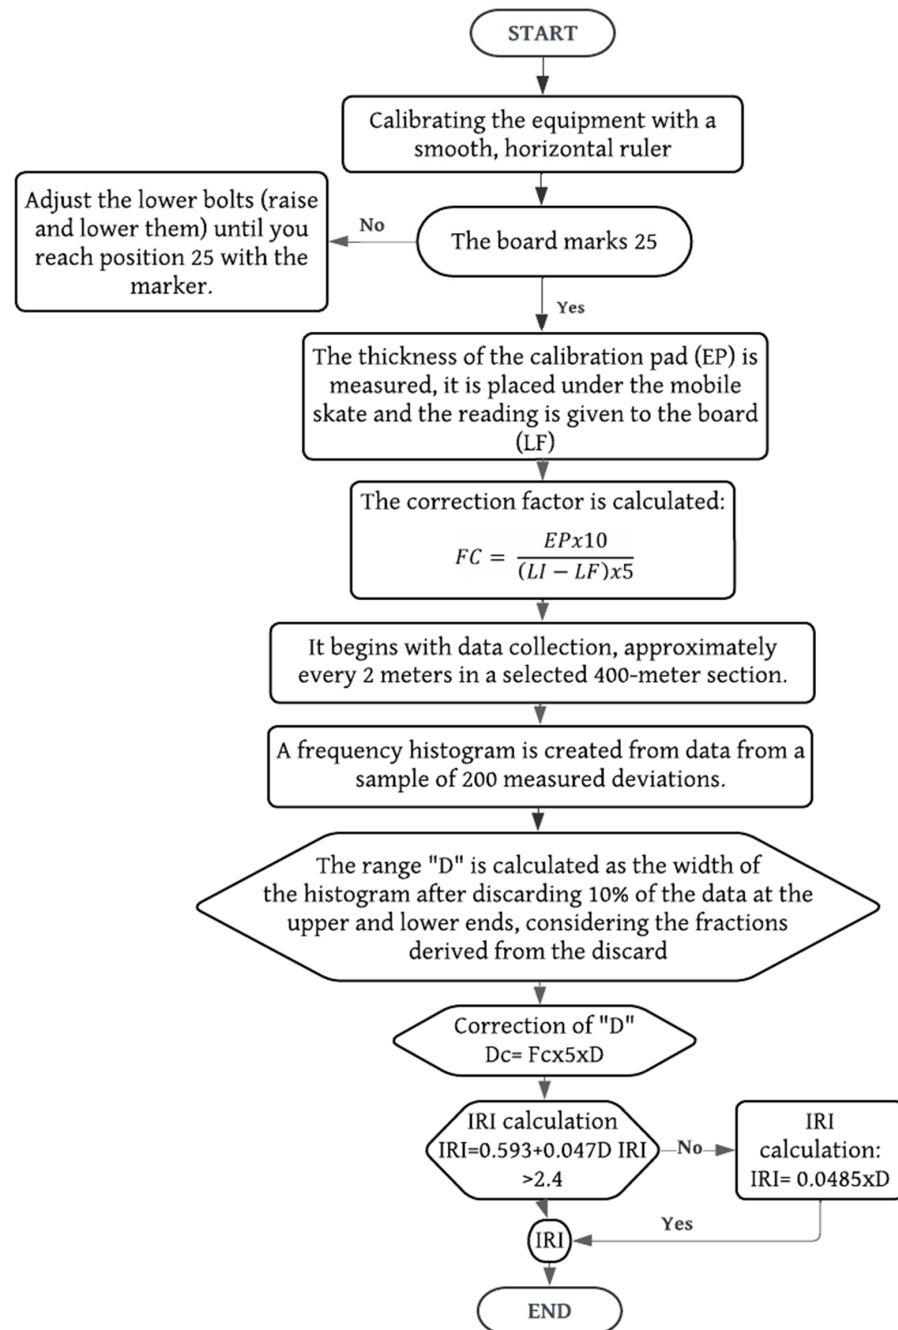
Figure 1. Flowchart of the Rugosimeter Merlin Equipment method for determining the IRI.

Figure 1, corresponding to the first flowchart, summarizes the methodology for determining the IRI (International Roughness Index) using the Merlin Roughness Meter. The procedure begins with calibrating the equipment by placing it on a horizontal surface and adjusting its support points until the pointer indicates 25. If it doesn't, the lower bolts are adjusted until this is achieved. Then, two readings are taken: an initial one (Li) and another

with a calibration block under the movable foot (Lf) to determine the correction factor. Three people are required: an operator, an assistant to record the readings and a spotter. The operator moves the equipment until the wheel completes one rotation (1.98 m), places it on its three support points, and records the pointer's position in a field form, repeating the process until 200 consecutive readings are completed. The recording form has 20 rows and 10 columns, filled from top to bottom and left to right.

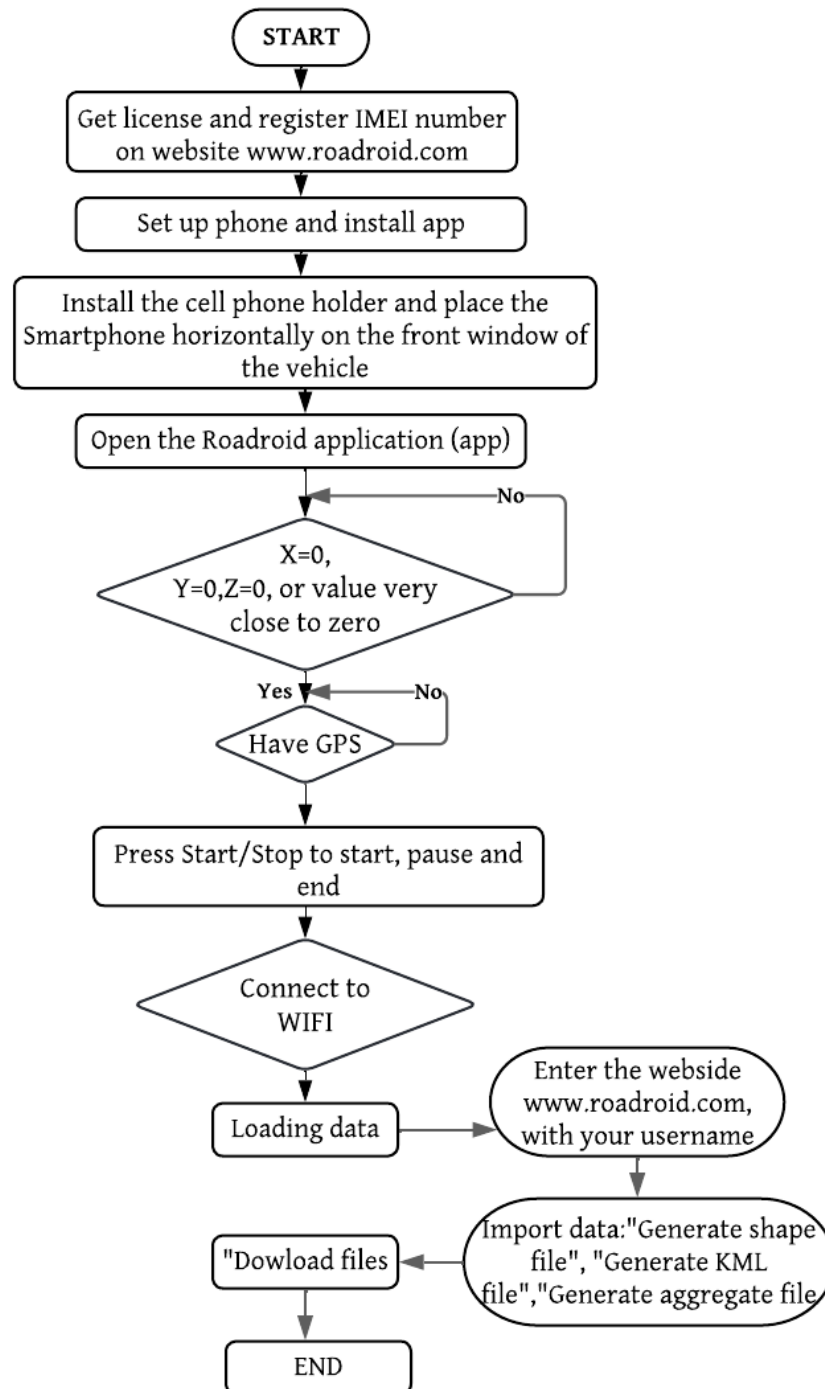
Figure 2. Flowchart of the Roadroid method for determining the IRI.

Figure 2, corresponding to the second flowchart, summarizes the methodology for determining the IRI (International Roughness Index) using the Roadroid application. The procedure begins by creating an account on the Roadroid website, where personal data and the phone's IMEI are registered. The license can be free for educational purposes or purchased on the site. After registration, the phone is calibrated to ensure no data is lost. A mount for the phone must be installed on the vehicle's windshield, ensuring a

horizontal position without obstructions. To perform the IRI (International Roughness Index) diagnosis, the GPS and Wi-Fi or mobile data are activated. The app settings, such as vehicle type, are adjusted, and the phone is calibrated. Once calibrated, the diagnostic process begins by pressing the camera button, and the vehicle should move at 50 km/h. The data is uploaded to the Roadroid system using Wi-Fi. These can be viewed on a virtual map after 15–20 min, and reports can be generated and downloaded in formats like KML or TXT for analysis in programs like ArcGIS or Excel [22].

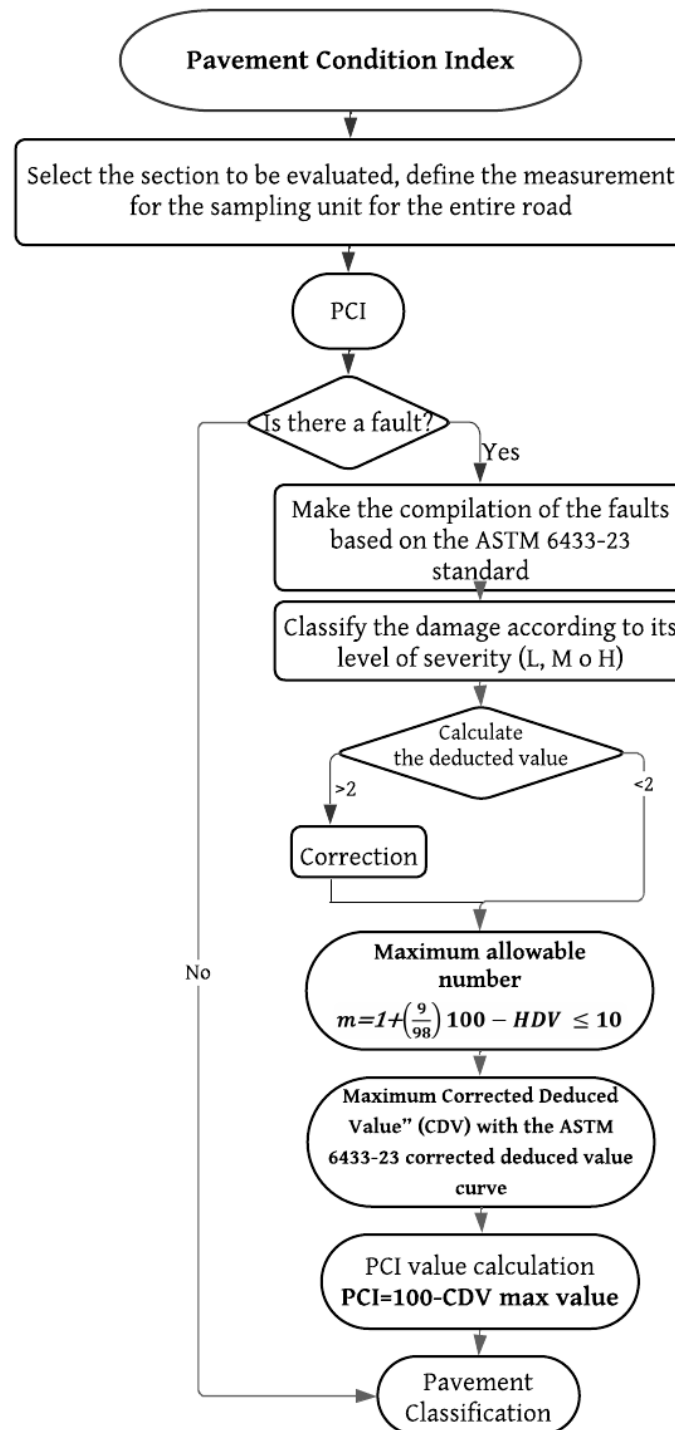
Figure 3. Procedure for measuring PCI (Pavement Condition Index) by visual inspection [23].

Figure 3, corresponding to the third flow chart, summarizes the procedure for measuring the PCI (Pavement Condition Index) through visual inspection. To calculate it, the failure data obtained during the on-site inspection according to the 19 specified failures is

required. These values are then subjected to the following steps: the Deduct Value (DV) is calculated by recording the sum of each type of failure according to its severity and quantity. The density of the failures is then used to determine the deducted value for each type of damage. Next, the maximum allowable deducted values (m) are calculated using an equation that considers the maximum deducted value for each sampling unit. The total deducted value is adjusted using a correction curve, thus obtaining the maximum Corrected Deduct Value (CDV). Finally, the PCI is calculated by subtracting the maximum CDV from 100, which indicates the pavement’s condition. The PCI is classified according to various failures such as deformations, cracks, and erosion in the pavement [23].

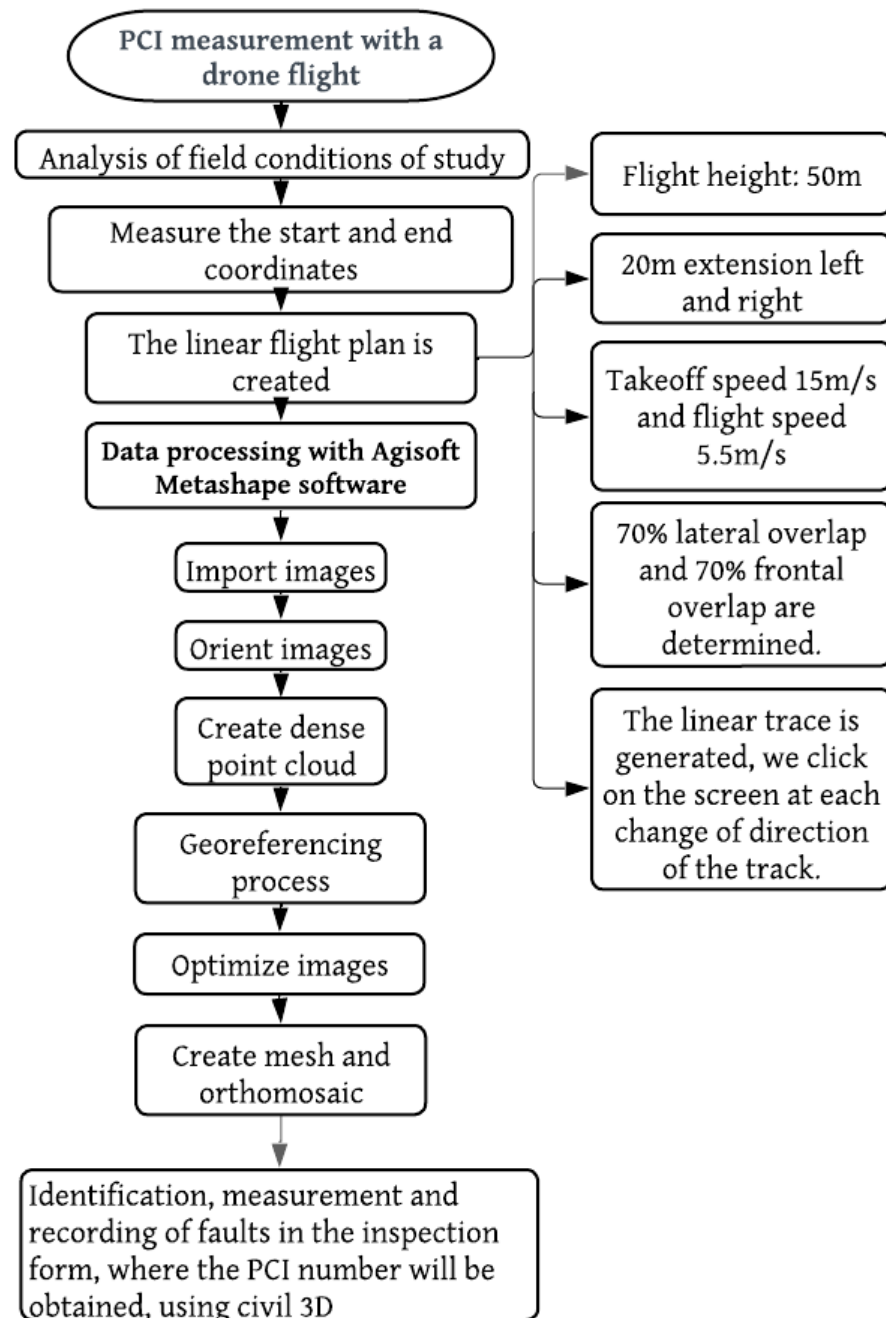
Figure 4. PCI (Pavement Condition Index) evaluation by flying the DJI Mavic 2 pro Drone.

Figure 4, corresponding to the fourth flow chart, summarizes the procedure for measuring the PCI (Pavement Condition Index) using the DJI Mavic 2 Pro drone, programmed via a mobile phone with the DJI PILOT app. The flight was conducted at 11 a.m. at an altitude of 50 m to capture high-resolution images, taking photos every 2 s with a 70% overlap. A linear flight plan was generated, and the flight parameters, such as takeoff speed (15 m/s) and flight speed (5.5 m/s), were configured. The drone followed the programmed route, returning to the takeoff point for battery replacement three times. All information was stored in the drone’s memory and then processed using Agisoft Metashape 2.1.3 software, where the images were imported, oriented in high quality, and a dense point cloud was created for the final analysis.

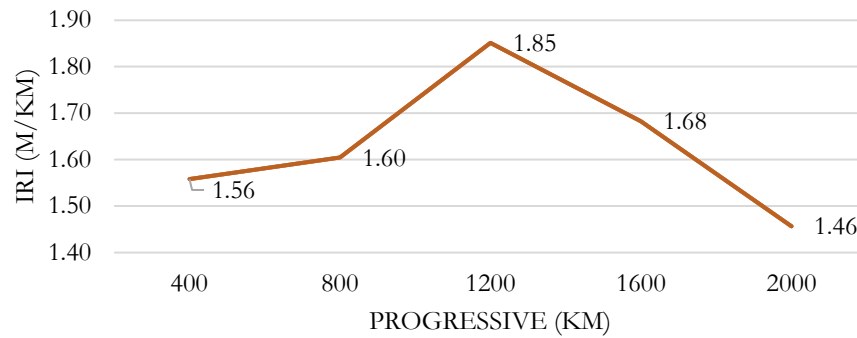
Figure 5. IRI right lane with Merlin Roughness tester.

Figure 5 shows the results for the IRI for the right lane evaluated using the Merlin Roughness Meter Series 696, Model TM171, Manufacturer Tamiequipos, Bogota, Colombia. The highest IRI value, 1.85, occurs in the section from 0+800 to 1+200.

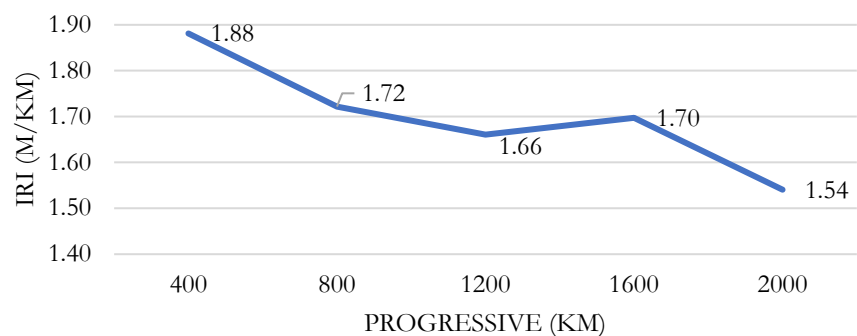
Figure 6. IRI left lane with Merlin roughness tester.

Figure 6 shows the results for the IRI for the left lane evaluated using the Merlin Roughness Meter. The highest IRI value, 1.88, occurs in the section from 0+000 to 0+400.

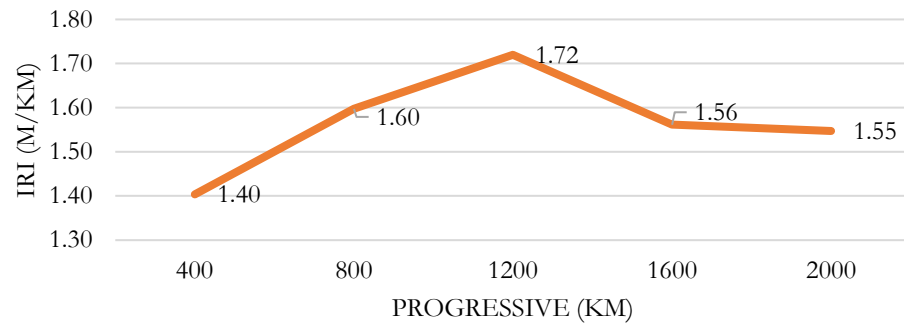
Figure 7. IRI right lane using Roadroid.

Figure 7 shows the results for the IRI for the right lane evaluated using the Roadroid app. The highest IRI value, 1.72, occurs in the section from 0+800 to 1+200.

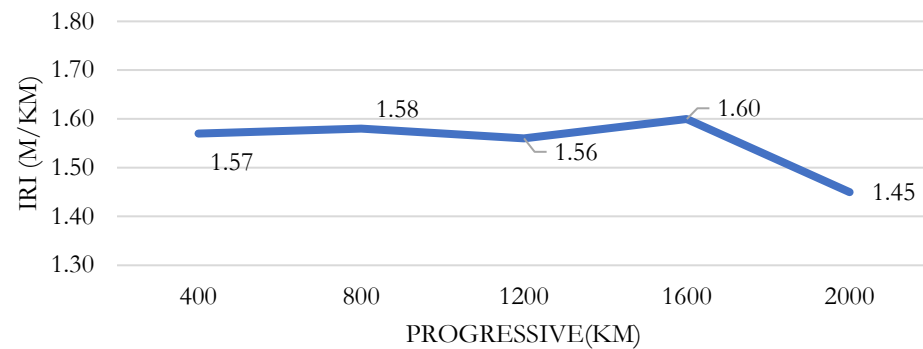
Figure 8. IRI left lane using Roadroid.

Figure 8 shows the results for the IRI for the left lane evaluated using the Roadroid app. The highest IRI value, 1.60, occurs in the section from 0+800 to 1+200.

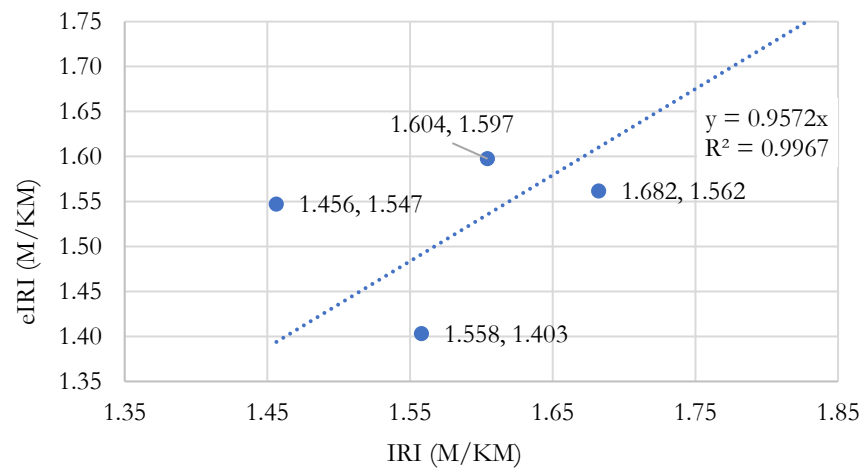
Figure 9. IRI vs. eIRI dispersion table—Right Lane.

Additionally, Figure 9 shows the scatter plot of IRI vs. eIRI for the right lane data. The best-fit line to the point cloud with the origin point (0,0) is displayed, with the IRI with

Merlin values on the “x” axis and eIRI with Roadroid values on the “y” axis. A coefficient of determination (R^2) of 0.9967 is obtained, indicating a high correlation (Figure 3).

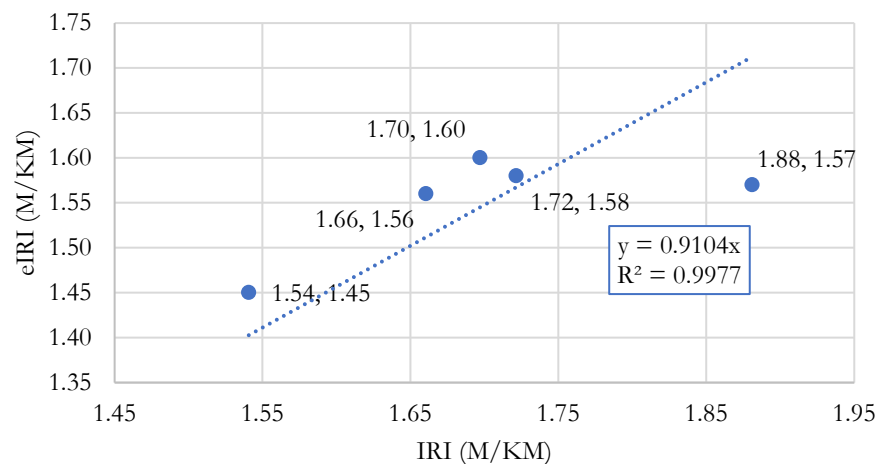
Figure 10. IRI vs. eIRI dispersion table—Left Lane.

Figure 10 shows a linear regression for the left lane data. The best-fit line to the point cloud with the origin point (0,0) is displayed, with the IRI values on the “x” axis and eIRI values on the “y” axis. A coefficient of determination (R^2) of 0.998 is obtained, also indicating a high correlation.

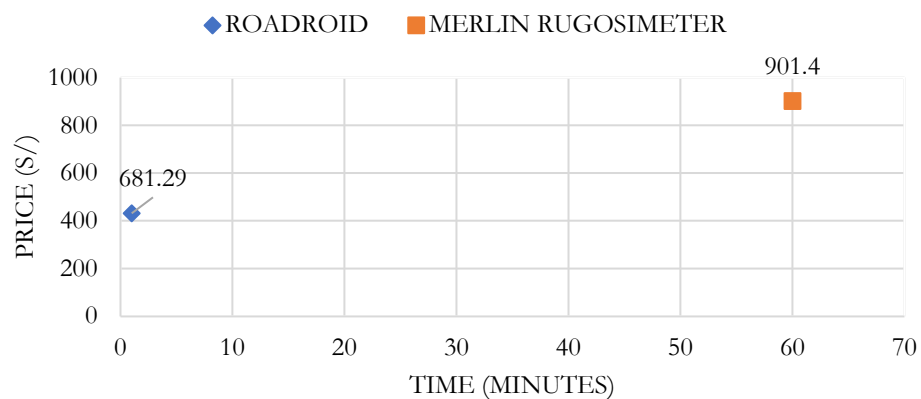
Figure 11. Cost Benefit in time between the Merlin test and Roadroid.

Figure 11 shows the Cost-Benefit analysis between these two methods, indicating that the Roadroid application is more efficient in terms of time and cost for measuring IRI over 1 km of road, with a time of 1 min and a cost of 681.29 peruvian soles per km (USD \$179.29), compared to 60 min and a cost of 901.4 soles per km (USD \$237.21) using the Merlin Roughness Meter.

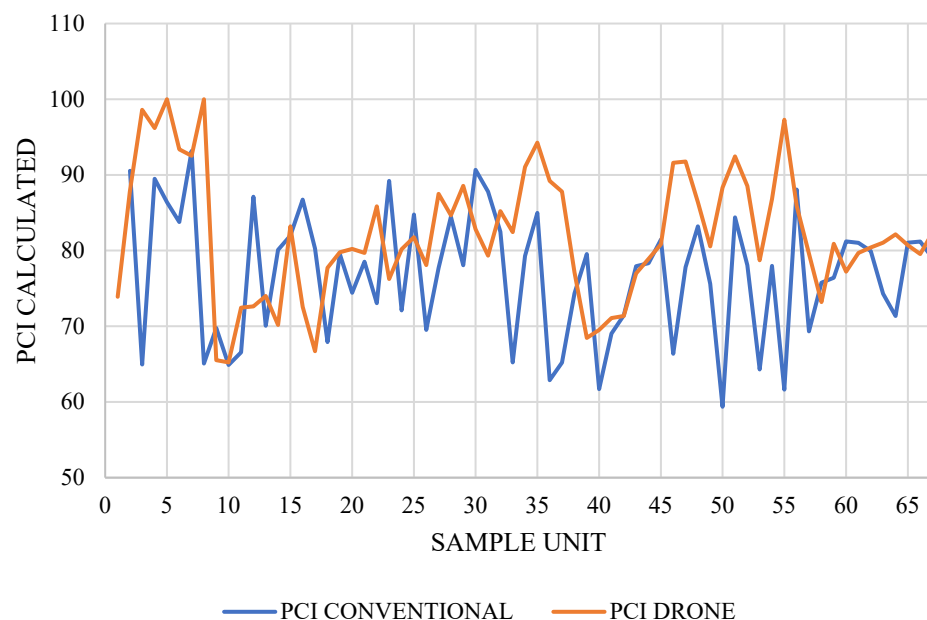
Figure 12. PCI values calculated for both methodologies.

Figure 12 shows the PCI data for each 30 m sampling unit using both methodologies.

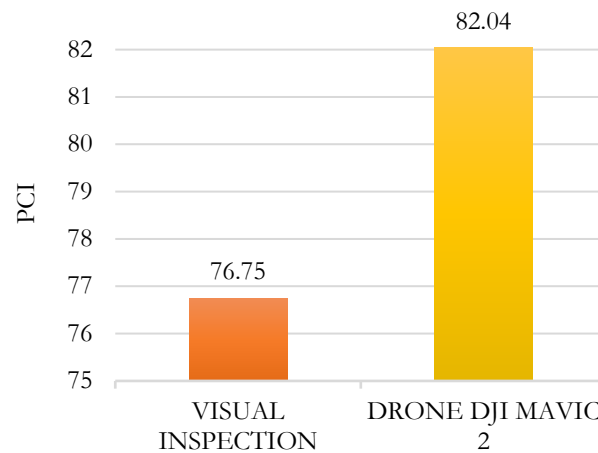
Figure 13. PCI values calculated for both methodologies.

In response to the values presented in the comparison of the intervention range between both methodologies—through the conventional method of visual inspection of failures and via drone flight (DJI Mavic 2 Pro)—for the AR-780 road, the PCI of the AR-780 local road was determined through conventional failure inspection, obtaining 50 sample units that require maintenance and 17 units that require rehabilitation (2, 7, 9, 10, 12, 17, 25, 32, 35, 36, 39, 40, 45, 49, 52, 54, and 56). Meanwhile, using the drone method for PCI, 62 sample units were found to require maintenance and 5 units to require rehabilitation

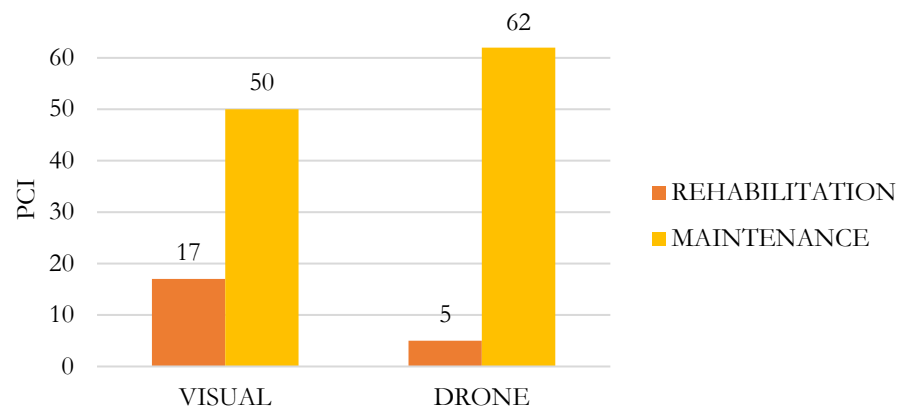
Figure 14. PCI for both types of evaluation and their respective classification.

(Figure 14). It is notable that both methods coincide with 5 sample units requiring rehabilitation intervention: UM-09, 10, 17, 39, and 40; and 50 sample units suggested maintenance intervention, with 12 sample units differing in their intervention range.

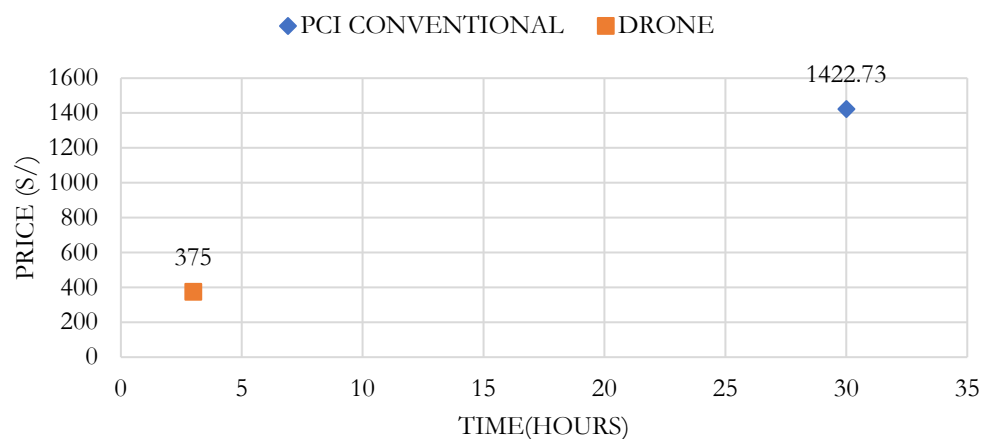
Figure 15. Cost-benefit analysis between the traditional system and the method using drones.

In Figure 15, a cost-benefit analysis between the traditional system and the method using a drone is observed, obtaining lower costs and time using a drone, which is 375 soles (\$98.68 dollars) and 3 h, compared to the traditional method, which is 1422.73 soles (\$374.40 dollars) and 30 h.
