Review

Review of Nondestructive Testing (NDT) Techniques for Timber Structures

Citation: Azzi, Z.; Al Sayegh, H.; Metwally, O.; Eissa, M. Review of Nondestructive Testing (NDT) Techniques for Timber Structures. *Infrastructures* **2025**, *10*, 28. <https://doi.org/10.3390/infrastructures10020028>

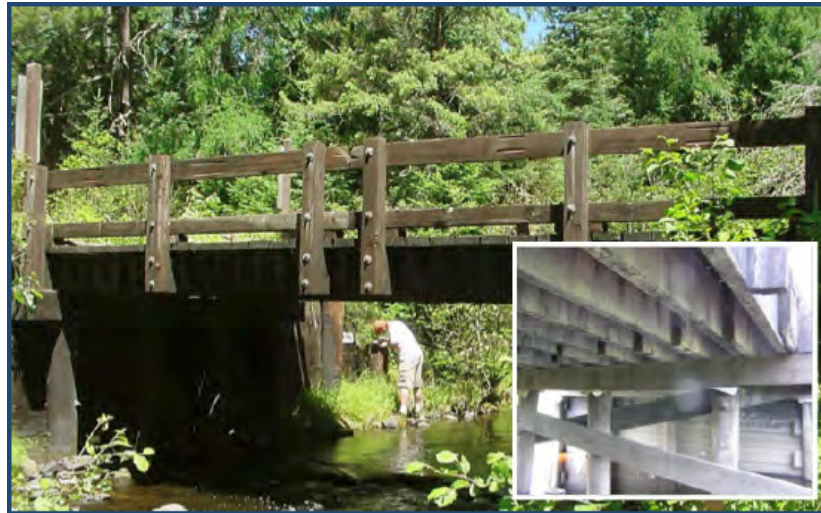
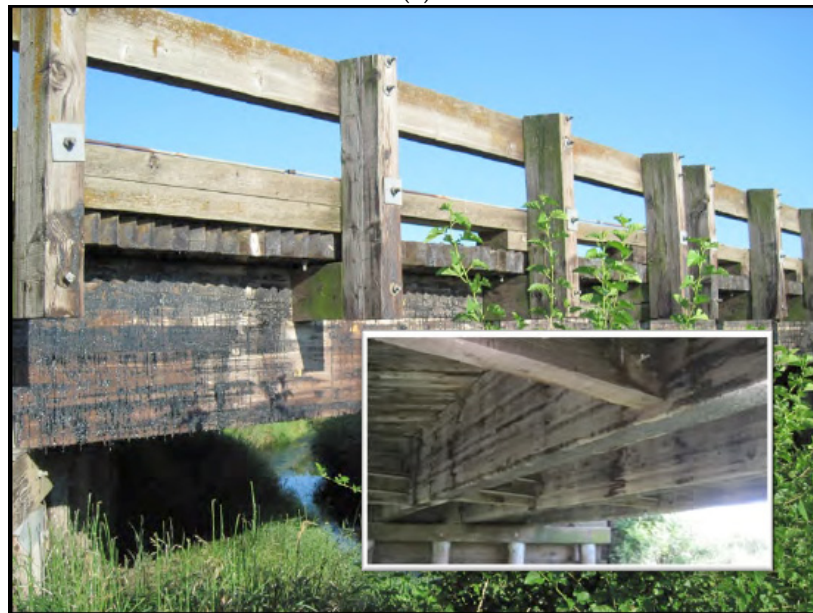
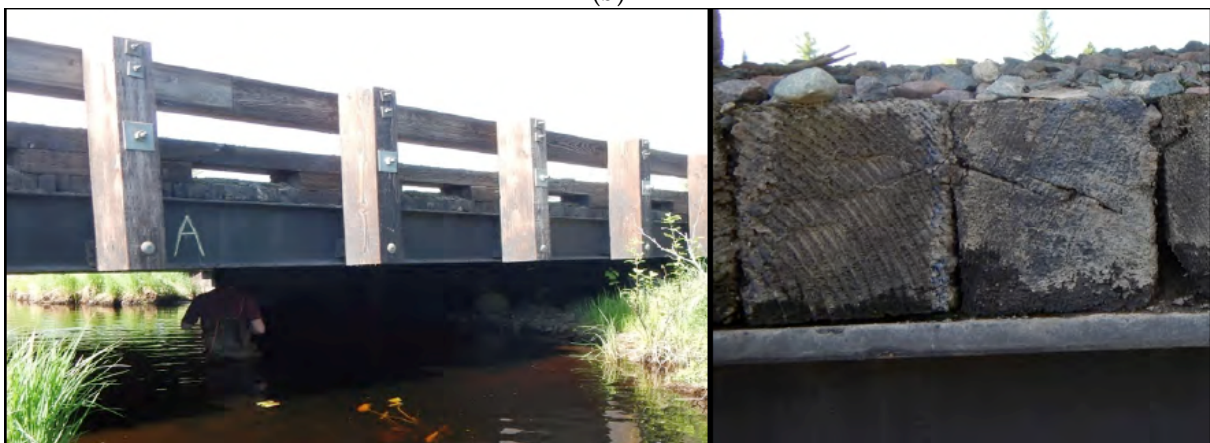
Figure 2. Examples of timber bridges constructed with (a) sawn lumber, (b) glulam timber, and (c) steel/wood composite section (Courtesy of Brashaw et al. [5]).

Additionally, wood has been a widely used material in bridge construction, particularly for bridges built during the 1950s and 1960s [3]. The Federal Highway Administration (FHWA) national bridge inventory indicates that there are over 576,000 bridges in the United States with spans of 6 m (20 feet) or more. Among these, 41,740 timber bridges exceed this span length and are still in use today. Additionally, another 42,100 bridges feature timber decks supported by steel stringers, categorizing them as steel bridges. Due to their relatively younger age compared to steel and concrete bridges, many timber bridges require repair or replacement due to identified or suspected deterioration [4]. Therefore, accurately assessing the current condition of a bridge is crucial for determining the appropriate load rating and making informed decisions regarding rehabilitation, repair, or replacement. Proper knowledge of a bridge's condition can result in cost savings by reducing the need for extensive labor and materials while extending its service life. As such, the safe and efficient functioning of the U.S. transportation system heavily relies on the performance and upkeep of vehicular bridges. Figure 2 illustrates examples of timber bridges constructed with sawn lumber, glulam, and steel/wood composite sections.

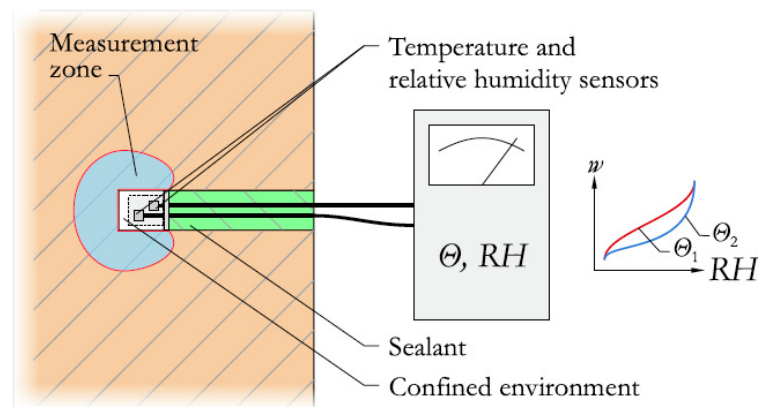
Figure 6. The hygrometric method (Courtesy of Palma & Steiger [13]).

The hygrometric method estimates the MC by measuring the relative humidity (RH) of the air surrounding the wood. This is performed by placing wood samples in airtight containers or creating small boreholes in the timber, then measuring the RH and the temperature with hygrometers and thermometers until equilibrium is reached. Installation of the measurement sensors can be difficult due to the size of the sensors. Additionally, the boreholes must be sealed to limit exchange of MC between wood and air in the borehole. The MC is calculated using standard conversion charts, with adjustments made for environmental conditions and wood species. While this method is somewhat invasive and less accurate compared to direct measurement techniques, it provides a rapid MC estimation and is particularly effective for wood with high levels of extractives or soluble salts. Additionally, this method is suitable for pressure-treated wood, which exhibits high levels of electrical resistance. The main disadvantage is that the placement of the sensors can be difficult, and can affect the measured MC due to the size of sensors and transfer of MC between wood and air. A comparison between results of several wood moisture meters operating on different principles of measurement can be found in [33]. Figure 6 shows the apparatus required to conduct the hygrometric method and obtain the temperature and relative humidity of the test specimen.

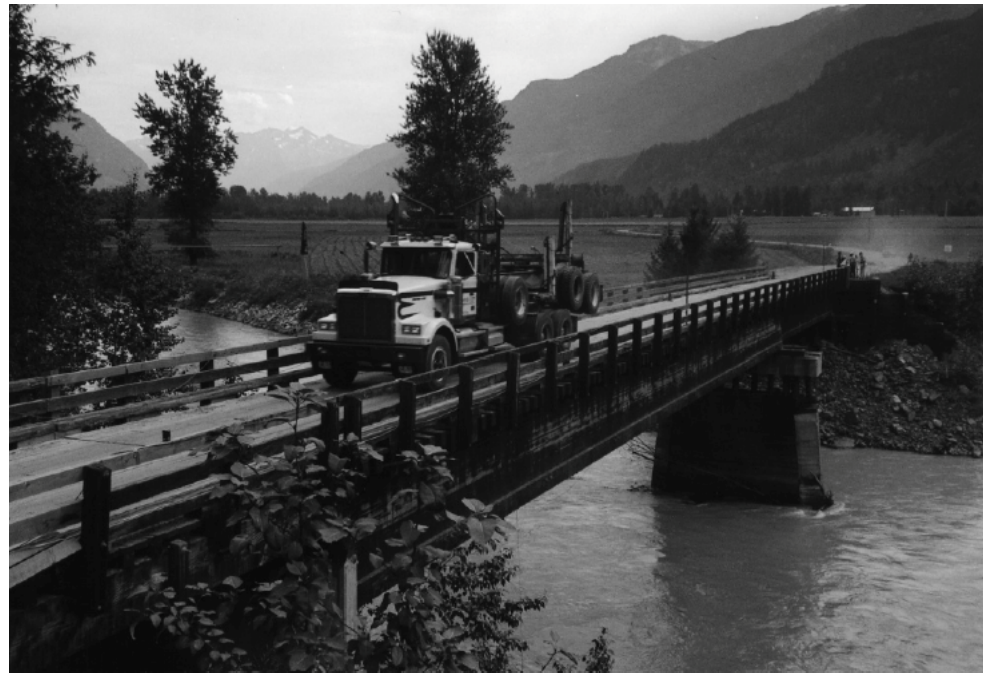
Figure 8. Forced vibration testing with truck passing over long span bridge (Courtesy of Horyna et al. [35]).

Another important use of the ambient vibration NDT technique is in bridge testing and inspections, where the purpose is to determine the dynamic properties such as frequencies and modes of the bridge using low amplitude ambient vibrations, produced by wind, or micro-tremors. Subsequently, the obtained parameters could be compared to those acquired from conducting forced vibration testing on the same bridge using a passing vehicle, such as a truck, at different speeds [35]. Figure 8 shows an example of a forced vibration test with a truck passing over a long-span bridge. Despite not requiring any actuators to excite the structure, the measured signal is usually contaminated by noise and requires special treatment to extract the modal characteristics. Additionally, this method requires a large number of sensors to accurately characterize the condition of the structure.

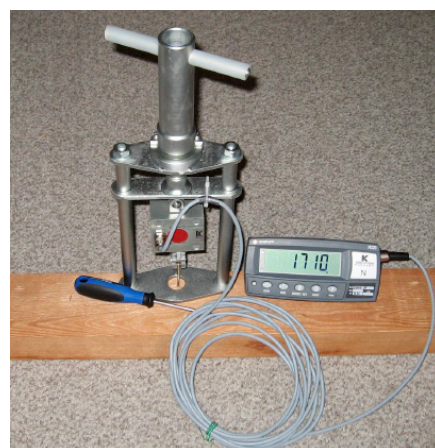
Figure 13. Screw withdrawal force meter (Designed by Fakopp Enterprise Bt., Hungary).

The screw withdrawal testing method for wood involves measuring the force required to withdraw a screw from the wood, providing an indirect assessment of the wood’s density, strength, and overall condition. This technique is particularly useful for evaluating the integrity of wooden structures without causing significant damage. By analyzing the resistance encountered during screw withdrawal, it is possible to infer the quality of the wood, including the presence of decay, moisture content, or other defects that might compromise its structural performance. The method is simple, practical, and straightforward, making it a valuable tool for inspectors for in situ assessments of timber, especially in applications where preserving the original structure is crucial. To that end, the density of the timber can be correlated to the withdrawal force [43]. Figure 13 shows an illustration of the use of the screw withdrawal testing.

Although this technique is both straightforward and cost-effective, it primarily yields localized data and may cause minor damage to the material. The results are significantly

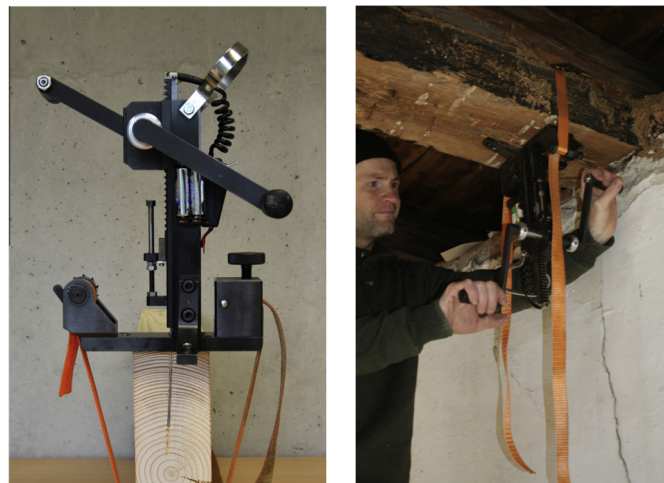
Figure 14. The pin-pushing device used for in situ testing (Courtesy of Kloiber et al. [44]).

The pin-pushing nondestructive technique involves measuring the resistance encountered when a pin or small probe is pushed into the wood. This method provides insights into the wood's density, hardness, and overall structural condition. The resistance to pin pushing is closely related to the wood's density and moisture content; denser, drier wood offers greater resistance, while softer, decayed, or moisture-laden wood allows easier penetration. Pin pushing is especially useful in assessing the condition of timber in situ, as it enables the detection of internal decay or degradation with minimal impact on the wood's integrity. This technique is often used in the evaluation of historical structures, where preserving the material is critical, as well as in industrial settings where rapid assessment is needed [44]. Figure 14 portrays the use of the pin-pushing device for in situ testing and inspections. Several external factors would affect results, such as operator skill, environmental conditions, and material variability, emphasizing the need for standardized procedures and proper interpretation.

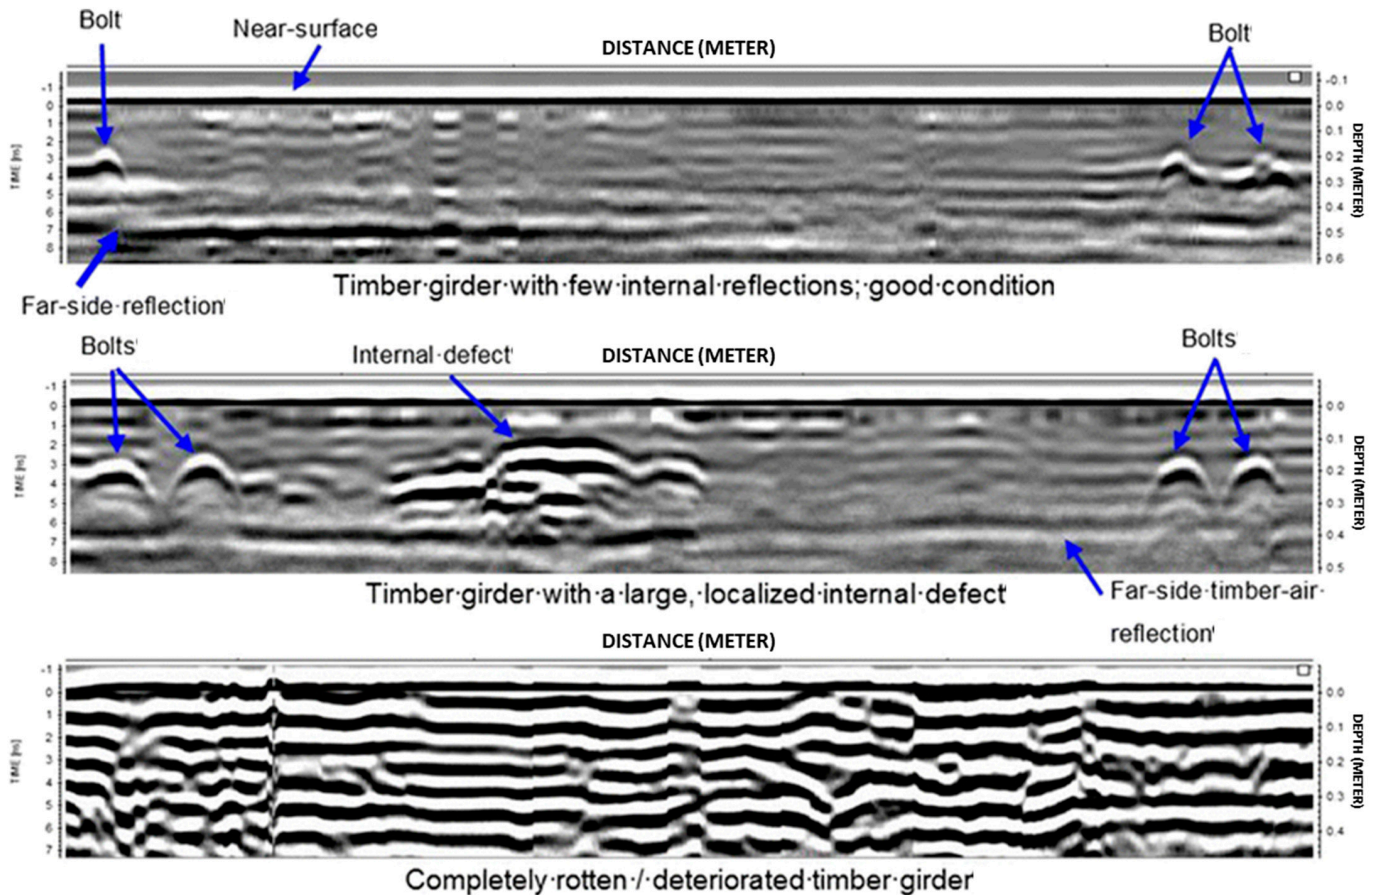
Figure 16. Example of GPR data (Courtesy of Riggio et al. [32]).

The Ground Penetrating Radar (GPR) is a technique used to detect defects and measure the dielectric properties of structural timber by emitting electromagnetic waves into the wood and capturing reflections from internal features such as voids, decay, or metal inclusions. Portable GPR systems can be fitted with high-frequency antennas (1.5–2.5 GHz) for high resolution with limited penetration depth or low-frequency antennas (900 MHz–1.0 GHz) for greater penetration depth with lower resolution, making them suitable for examining thick timber elements. The process involves placing the antenna on the timber surface, moving it along its length, and recording the reflections, with calibration based on known depths or using multi-offset methods. GPR is employed to identify internal defects and areas of excessive moisture content. The location of defects or intrusions is determined by calculating the wave velocity and the time measured between the emission and reception of the wave. Although GPR offers rapid and non-invasive assessment, it requires skilled interpretation for accurate data analysis and is less effective at detecting fine cracks. For a detailed explanation of the theory and application of the GPR method, please refer to [46]. An example of the interpretation of the GPR data showing several internal conditions is presented in Figure 16.

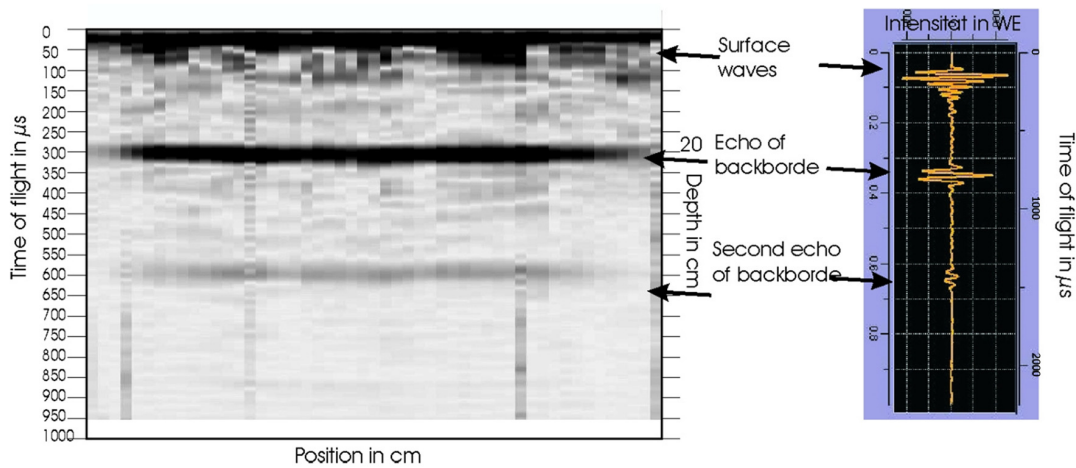
Figure 19. Results of an ultrasonic echo scan on a specimen (Courtesy of Hasenstab et al. [49]).

The ultrasonic echo method evaluates the internal condition of timber elements by examining the reflections of ultrasonic stress waves, both longitudinal and transverse. These waves reflect off surfaces where there are changes in material, such as the back surface of the wood or any internal defects. Due to natural wood’s low density, high-intensity, low-frequency probes (in the range of 50 kHz to 200 kHz) are typically used, with low-frequency shear waves being particularly effective because they experience minimal signal attenuation, even though their larger wavelength limits the size of detectable defects. The sensor head, often equipped with multiple sensors, is placed on just one side of the timber being inspected, and the waves are reflected back to these sensors. Internal defects are indicated by alterations in the reflected echo signal. The results are displayed as A-scans, which show the reflected energy over time, and B-scans, which combine A-scans to provide a two-dimensional cross-sectional view. By combining B-scans, C-scans can be produced, offering three-dimensional structural information. While this technique allows for the direct detection of changes like back walls or internal damage, precisely locating the exact position of damage within the specimen can be challenging. The method shows promise for in situ timber assessments but requires expertise due to the complexity of influencing factors, and accurately defining internal defects based solely on the reflected wave results remains difficult. Additionally, highly attenuating or very thick materials can reduce signal clarity and penetration, and advanced ultrasonic equipment (like phased-array systems) can be expensive. A sample scan on a wooden specimen using the ultrasonic echo method is portrayed in Figure 19. More details about this technique can be found in [49].
