17-Year-Long Sewage Sludge Ash Concrete Exposure Test

Koichi Kobayashi * and Wataru Koyanagi

Department of Civil Engineering, Gifu University, Gifu 5011193, Japan; wkyng@wind.sannet.ne.jp

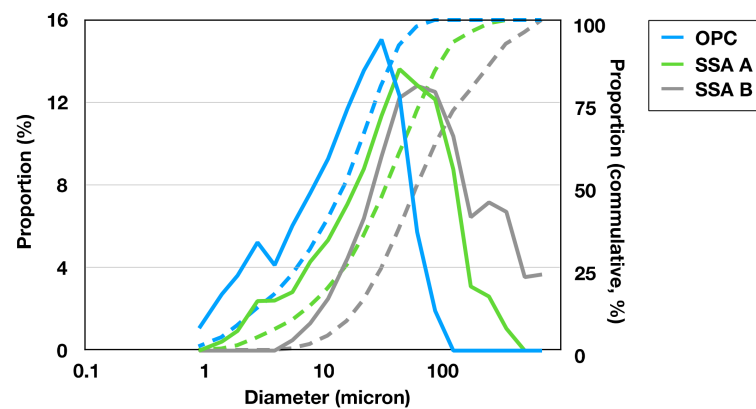
Figure 3. Particle size distributions of ordinary Portland cement and SSAs [11].

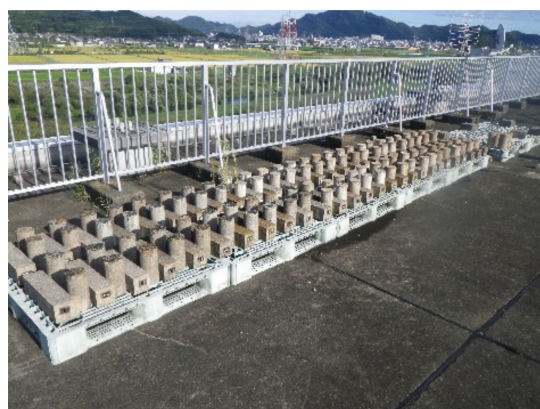
After being cured in water at 20 °C for 28 days, the specimens were left exposed outdoors at two locations, one in Gifu city located in a temperate plain (35°0027'52.47004" N, 136°44'22.69007" E), and the other in Takayama city situated in a cold mountainous basin (36°10'9.32604" N, 137°14'35.70015" E). The latter was chosen for its freezing weather during winter that is suitable for the investigation of the SSA concrete resistance to frost attack. Examples of the weather conditions of these two cities during the 17-year exposure period, from November 2015 to March 2016 and August 2016, are shown in Tables 7 and 8 [15].

Figure 4. Exposure site in the temperate plain.

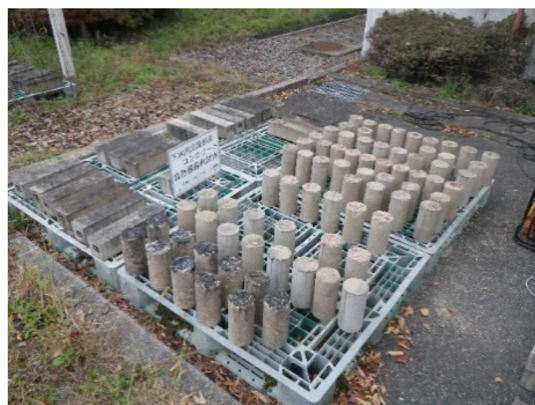
Figure 5. Exposure site in the cold mountainous basin.

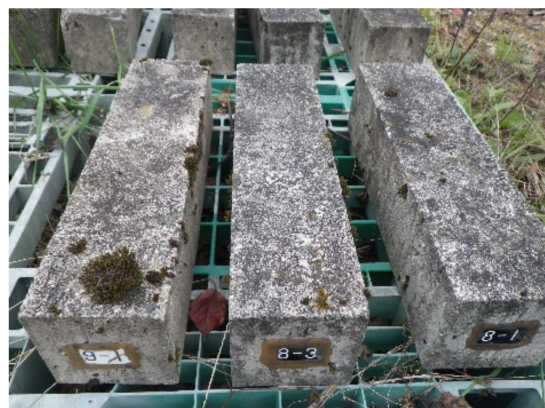
Figure 6. N24-5B and N24-10A exposed in the cold mountainous basin.

The highest and the lowest temperatures in the mountainous basin were 2 to 5 and 4 to 8 °C lower than in the temperate plain, respectively, from autumn to spring. In January and February, it snowed almost every day in the mountainous basin, with the temperature not reaching 0 °C in half of these months, while there was only one day when the temperature was below 0 °C in the temperate plain region. Figures 4 and 5 show the two exposure sites. The specimens were left uncovered there for 17 years. Figure 6 shows the appearance of N24-5B and N24-10A left exposed for 17 years in the cold mountainous basin.

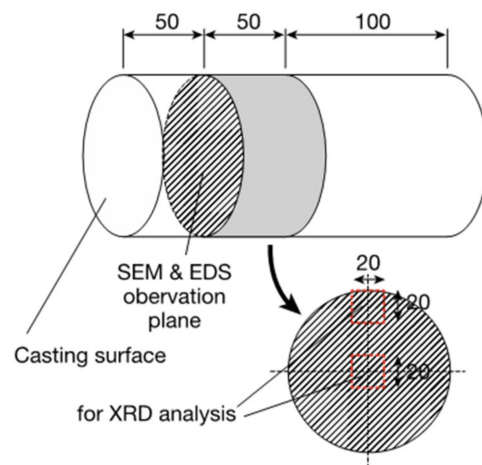
Specimens N24-0 and N24-10A left exposed in the temperate plain for 204 months were observed with SEM and EPMA. Furthermore, the compositions of the hardened cement near the surface and in the center of the specimens N24-0, N24-10A, N60-0, and N60-10A exposed in the temperate plain for 204 months were analyzed by powder X-ray diffraction (XRD). Figure 7 illustrates the SEM and EPMA observation plane and the sampling points for the XRD analysis. For the XRD analysis, the concrete sample pieces of $20 \times 20 \times 50$ mm were coarsely ground after being dried at 40 degree Celsius for 24 h, sieved with a $105 \mu\text{m}$ sieve to remove aggregates as much as possible, and pulverized. The X-ray output was 15 mA and 40 kV.

Figure 7. SEM and EPMA observation plane and sampling points for XRD analysis.

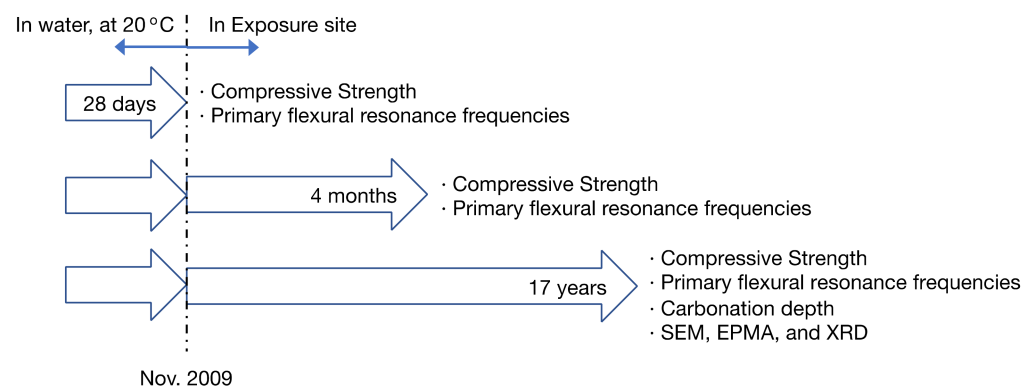
Figure 8 illustrates the schedule for this study.

Figure 8. Schedule for this study.

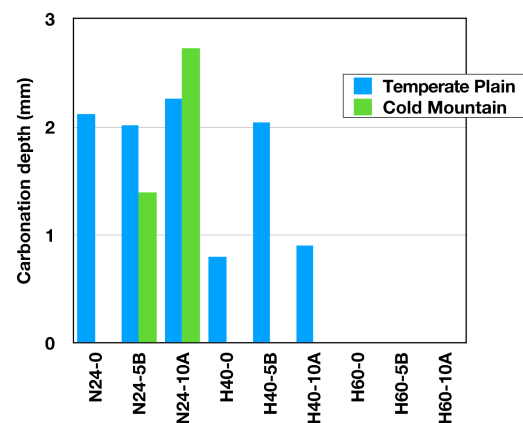
Figure 11 shows the results of carbonation depth measurements. Contrary to the concern that the pozzolanic reaction in SSA might have intensified carbonation, the carbonation depth was small in all mixtures. There was a general tendency of the specimens in the cold mountain region to have a smaller carbonation depth than the specimens in the temperate plain region. This is attributable to prolonged periods of high humidity, because of the cold climate of the mountain basin with heavy snowfall and short periods of clear sky.

Figure 11. Carbonation depth (after 17 years of exposure).

Table 9 shows the carbonation rate coefficients a of all the mixtures calculated from the measured carbonation depths using Equation (1) in comparison with predicted values a_p calculated from the respective water–cement ratios of the mixtures using Equation (2). Following the rule that fly ash is not regarded as cement in application of Equation (2), the water–cement ratios were computed without including the amounts of SSA.

According to Equation (2), no carbonation would occur in concrete with a water–cement ratio of 40% or less. As expected, Series H60 with a very low water–cement ratio was free of carbonation. All the other specimens showed a smaller carbonation rate coefficient than the expected value. This allows us to conclude that the use of SSA does not have the effect of accelerating carbonation in concrete.

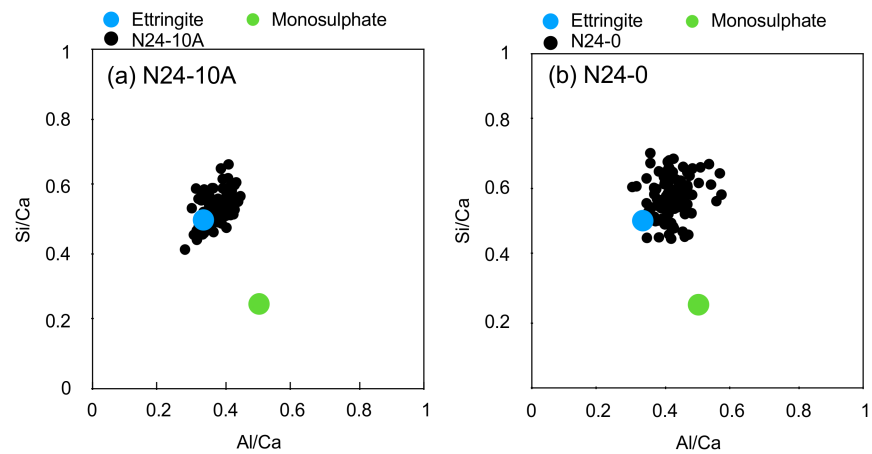
Figure 13. Compositions of crystals in air voids ((a) N24-10A, (b) N24-0).

Figure 12 shows examples of SEM images of N24-10A. No signs of deterioration such as cracks in the aggregate with a gelatinous substance and gaps around the aggregates due to cement paste expansion were discernible in the observed planes. The possibility of delayed ettringite formation (DEF) was anticipated because of the alumina richness of SSA, as shown in Table 1; indeed some needle-like crystals were visible in air voids and other cavities. An EPMA analysis indicated the ratios of Al/Ca = 1/3 and S/Ca = 1/2 (Figure 13), which confirmed that the crystals were ettringite. However, no signs of deterioration starting from these crystals were observed.
