Article

Impact of the Height of Buildings on the Maintainability of Natural Stone Claddings

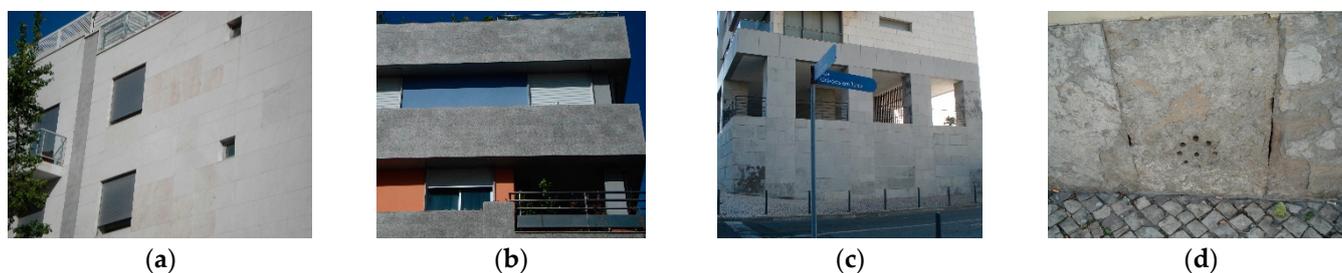
Figure 2. General appearance of NSC in the different degradation conditions: (a) condition A ($S_w \leq 1\%$); (b) condition B ($1 < S_w \leq 8\%$); (c) condition C ($8 < S_w \leq 20\%$); (d) condition D ($20 < S_w \leq 45\%$). No example is provided for condition E because there is no NSC in this condition in the database.

Figure 2 illustrates the relationship between the severity of degradation, S_w , and the degradation condition, C , with some examples. Condition A ($S_w \leq 1\%$) represents a NSC with no visible degradation; in condition B ($1 < S_w \leq 8\%$), the NSC begins to present some visual anomalies (superficial dirt and stains) and some signs of loss of integrity (material degradation and cracking); condition C ($8 < S_w \leq 20\%$) corresponds to a NSC with slight degradation, with anomalies related to joints and substrate degradation and loss of integrity (open joint, scaling of the edges, and fracture); condition D ($20 < S_w \leq 45\%$) corresponds to a NSC with moderate degradation (there is an evolution on the condition C anomalies); and condition E ($S_w > 45\%$) represents a NSC with generalised degradation and severe defects.

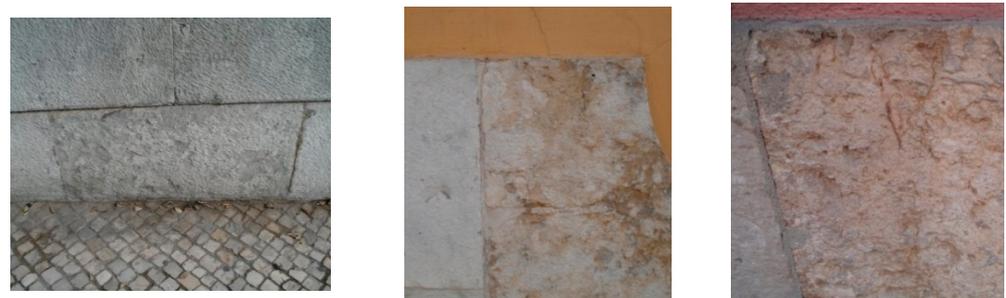
Figure 6. Illustrative examples of the loss of integrity anomalies observed in NSC located at the bottom wall of NSC façades.
