Article

Evaluation of Fissures and Cracks in Bridges by Applying Digital Image Capture Techniques Using an Unmanned Aerial Vehicle

Keywords: bridge; fissures; cracks; grayscale-based image processing; edge detection; Unmanned Aerial Vehicle

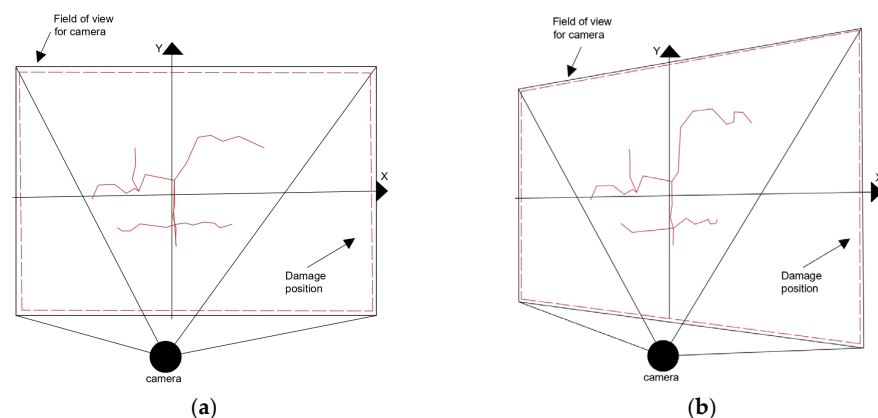
Figure 1. Perspective distortion effect. (a) Camera aligned with the defect, (b) a camera placed at the side of the damage (Adapted from Seo et al. [14]).

Figure 1 shows the perspective distortion effect caused by camera position and how it affects the perception of the actual measurements [14,16]. For this reason, photographs aligned to the damage are required to decrease the perspective distortion effect.

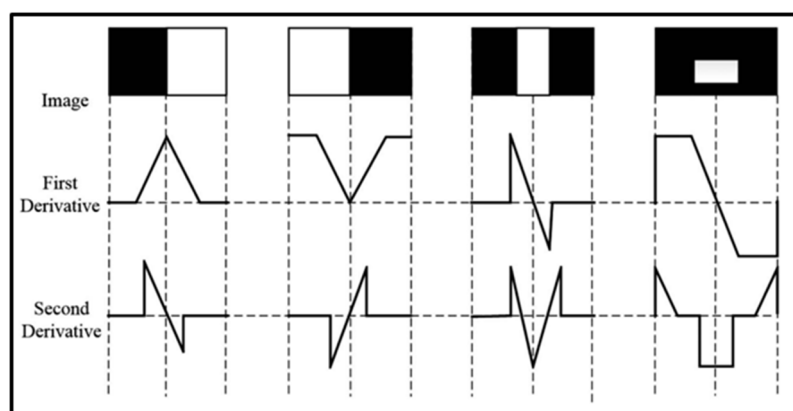
Figure 2. Detection of edge changes with first and second derivatives (adapted from Lei et al. [21]).

This technique uses grayscale conversion to detect and highlight sharp intensity changes in the image [11]. It is based on mathematical sciences using convolution kernels composed of matrices to generate vertical and horizontal derivatives of a function $f(x)$, where the first derivative allows finding the maximum and minimum points, and the second derivative finds the points where the functions become zero [17,18]. Edge detection algorithms are divided into Gradient-based and Laplacian methods [19,20], where to detect edges, the first one uses the first derivative, while the Laplacian method uses the second derivative [21]. Figure 2 shows the edge changes identified in an image converted to grayscale with the first and second derivatives.

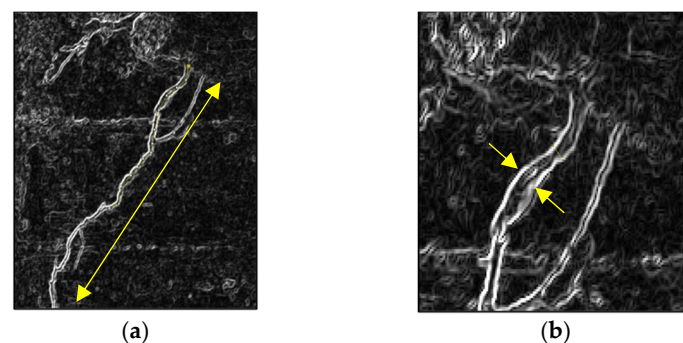
Figure 3. Measurements taken with ImageJ. (a) Yellow line shows the length of the crack or fissure, (b) Yellow lines show the width of the crack or fissure.

Once the images were processed in the ImageJ software, the fissures and cracks were delimited manually to differentiate them from other lines that exist within the image. To do so, fissures and cracks were defined, creating paths that exceeded the image, using the zoom and rule tools that the program has. In terms of dimensions, to measure the fissures and cracks (in millimeters), a known measure within the image was used as a pattern, for example, any known dimension of some structural element (coming from the structural drawings), such as the height of a beam or the width of a column, and based on this information then scale the complete image and thus obtain precise measures of fissures and cracks. Consequently, Figure 3 describes graphically how these measurements were taken after edge detection was applied to the image. The maximum thickness defined whether the damage corresponded to a crack or a fissure, its structural incidence, the possible cause of the damage, and its severity.

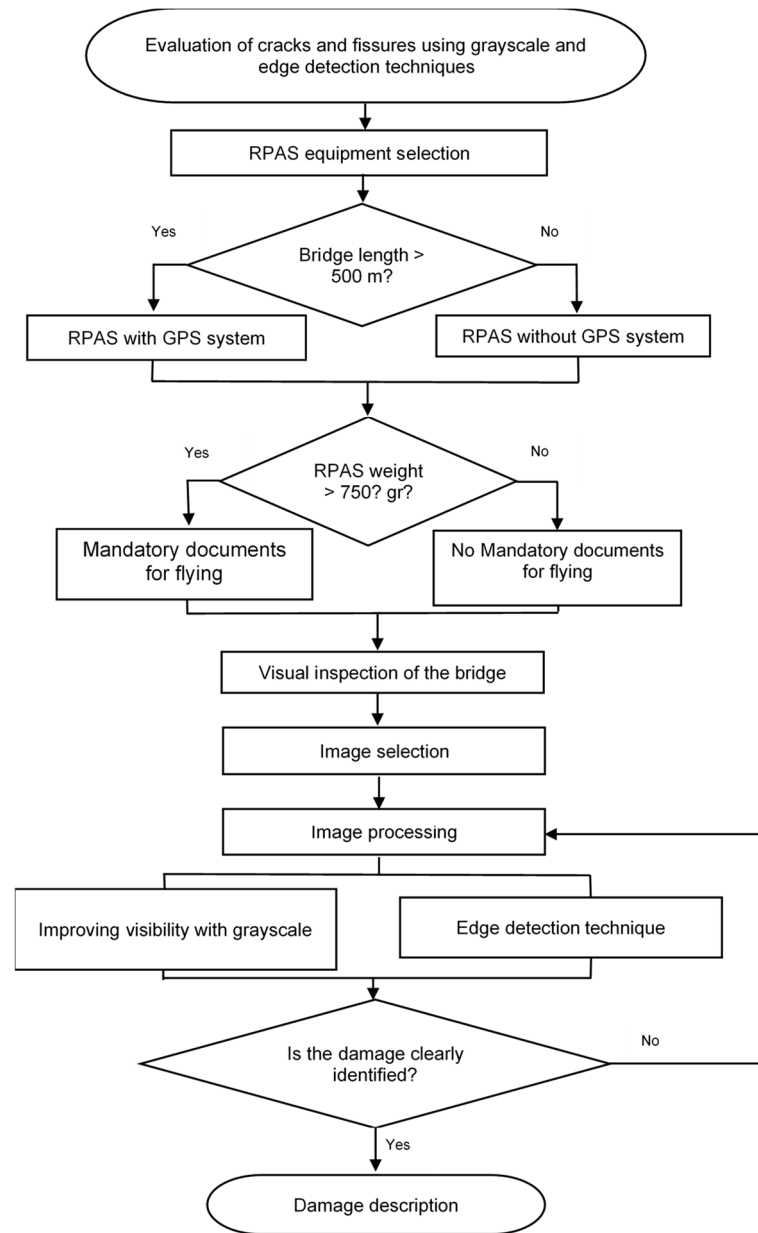
Figure 4. Flow diagram with the methodology used in this research.

In summary, Figure 4 shows a flow diagram of the methodology used to acquire the information needed to evaluate the fissures and cracks in bridges by applying digital image capture techniques with a UAV.

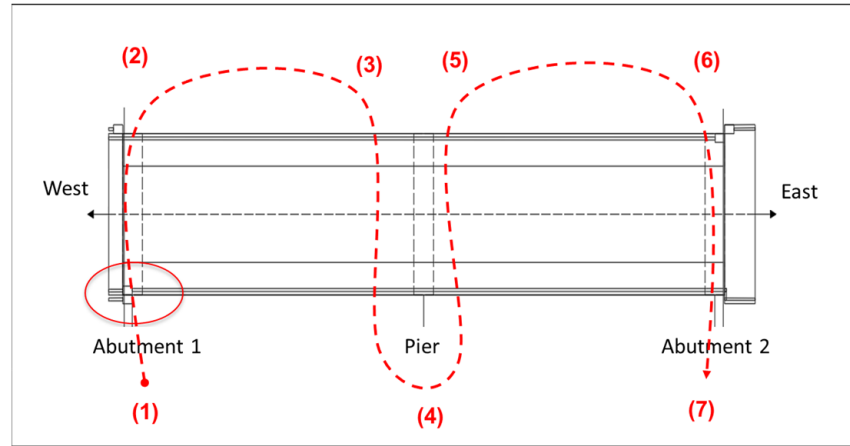
Figure 5. Small bridge damage inspection flight path (the dash line shows the flight path of the drone, the numbers show the corresponding changes in the direction where the photographs were taken, and the red circle shows the exact location to be analyzed for cracks or fissures).

The flight route is detailed in Figure 5, consisting of a flight over the roadway starting at the side of the bridge. The flight started upstream and flew over the bridge in a downstream

direction, where the UAV was introduced in both spans to return to the starting point upstream of the bridge. The height of the deck allowed the aircraft to stay stable during the flight and away from the estuary channel. As the inspection progressed, some complexities were encountered. In one of the spans, plant material was found obstructing the passage, as well as facility cables and a pipe that crossed the stream at the height of the deck.

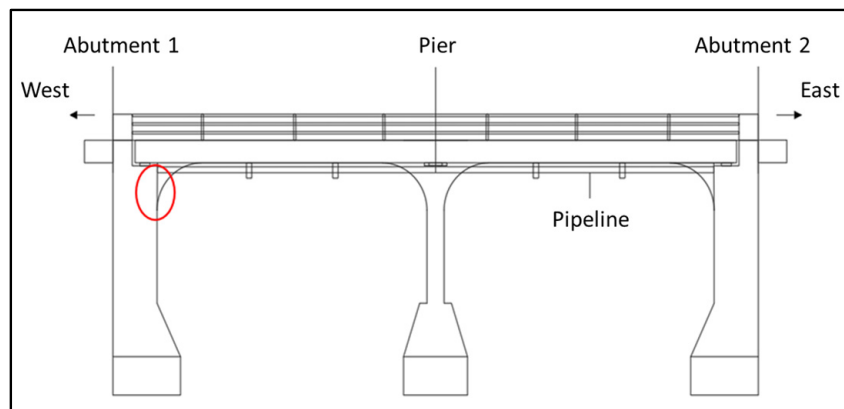
Figure 6. Location in elevation of the analyzed crack in the small bridge (the red circle shows the exact location to be analyzed for cracks or fissures).

The entire structure was inspected with a full battery charge in an estimated time of 30 min, obtaining a total of 45 photographs. Figure 6 is a sketch of the bridge identifying the location of the potential cracks.

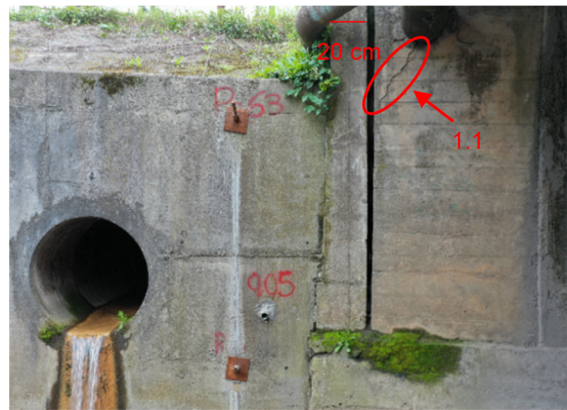
Figure 7. Identification of Crack 1.1 at the small bridge.

A crack at abutment 1 of the bridge originated from the junction with a steel pipe that crosses the estuary was identified, which failure (crack or fissure) is shown in Figure 7. As only one failure was found, it was assigned with the number 1.1 (Figure 7). The measurement of the wing wall's top was used, corresponding to 20 cm, as shown in Figure 7. Within the photograph, 20 cm was equivalent to 272 pixels, resulting in a scale of 1.36 pixels/mm.

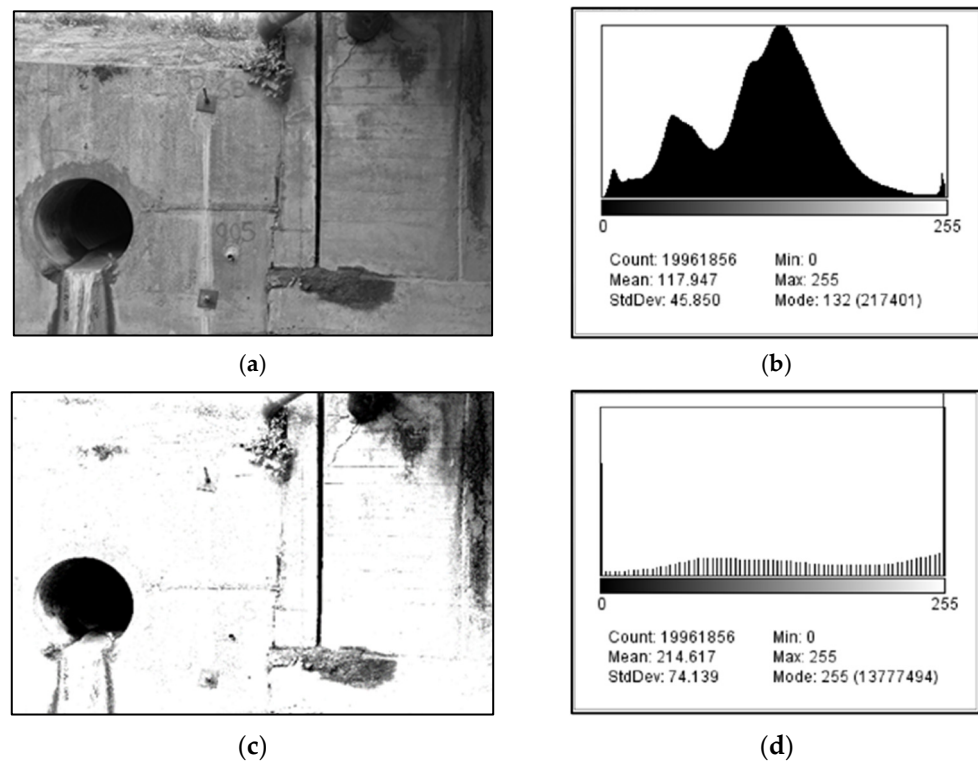
Figure 8. Image Crack 1.1 of the small bridge processed with ImageJ. (a) Grayscale application, (b) Grayscale histogram, (c) Image quality enhancement, (d) Enhanced image histogram.

The image quality was improved by modifying the brightness and contrast levels in ImageJ by applying the grayscale tool. Figure 8 shows the process that was carried out on the image. In (a) and (b), the image is shown with grayscale applied with its respective gray histogram, where the brightness and contrast have not yet been modified. Then, in (c) and (d), the image is shown with the adjusted brightness and contrast.

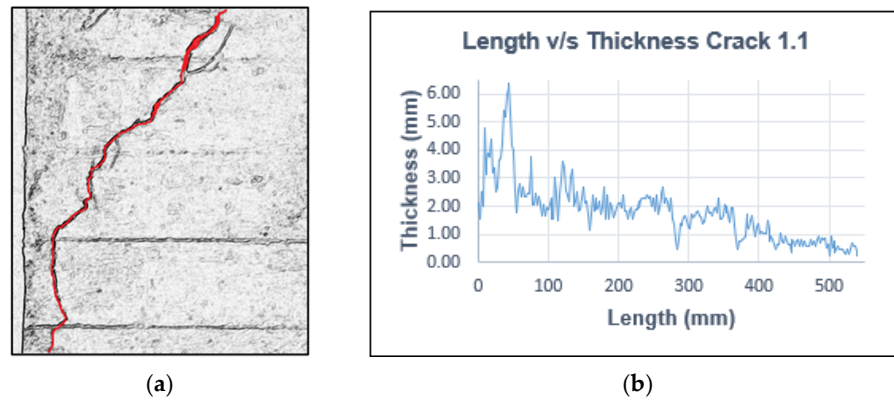
Figure 10. (a) Representation of crack 1.1 as seen in ImageJ (red line); (b) Thickness vs. Length graph of crack 1.1.

The results of the measurements along the crack are shown in Figure 10. Measurements started from the crack origin at the upper right end and progressed to the crack end at the lower left end. A total of 257 measurements were taken at a distance of approximately 2.1 mm each.

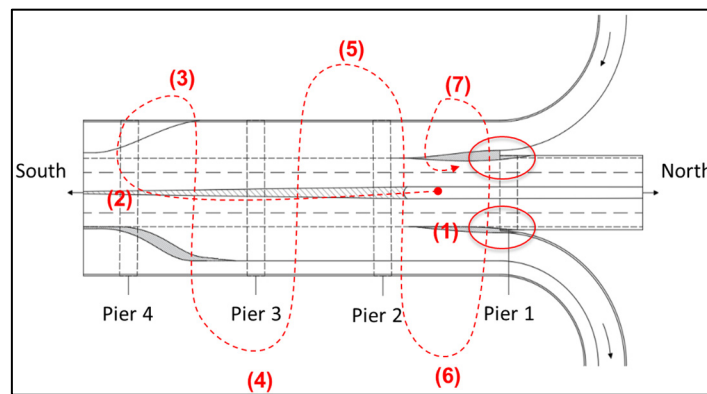
Figure 11. Large bridge damage inspection flight path (the dash line shows the flight path of the drone, the numbers show the corresponding changes in the direction where the photographs were taken, and the red circle shows the exact location to be analyzed for cracks or fissures).

Due to the large size of this structure and dense traffic, only the northern sector of the bridge, covering four piers, was inspected. The flight path detailed in Figure 11 was traced starting at Pier 2 and proceeding to Pier 4, where each span was inspected until arriving at Pier 1, where the elevations were inspected too.

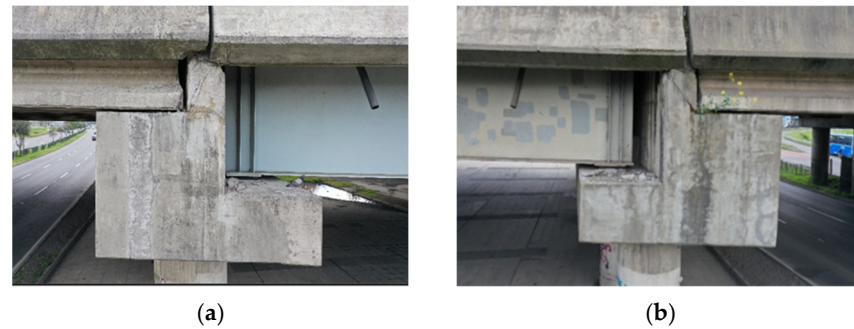
Figure 12. Images selected for crack analysis in the large bridge: (a) Header east view, (b) Header west view.

A full charge of the batteries was used to inspect the four piers of the bridge in approximately 30 min, taking 38 photographs. To analyze the identified cracks, the images shown in Figure 12 were selected. In section (a), the east view containing the crack network is shown, and in section (b), the west view containing a crack is shown. On the other hand, Figure 13 schematically shows the damage analyzed in ImageJ at the large bridge.

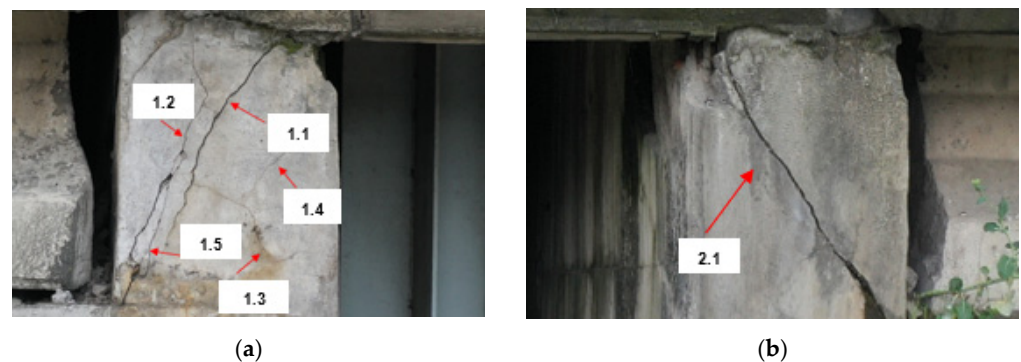
Figure 14. Cracks resulting from shear stress in the head of pier 1. (a) East view, (b) West view.

The crack numbering for the header east view was 1.1, 1.2, 1.3, 1.4, and 1.5, while for the header west view, it was 2.1, as shown in Figure 14.

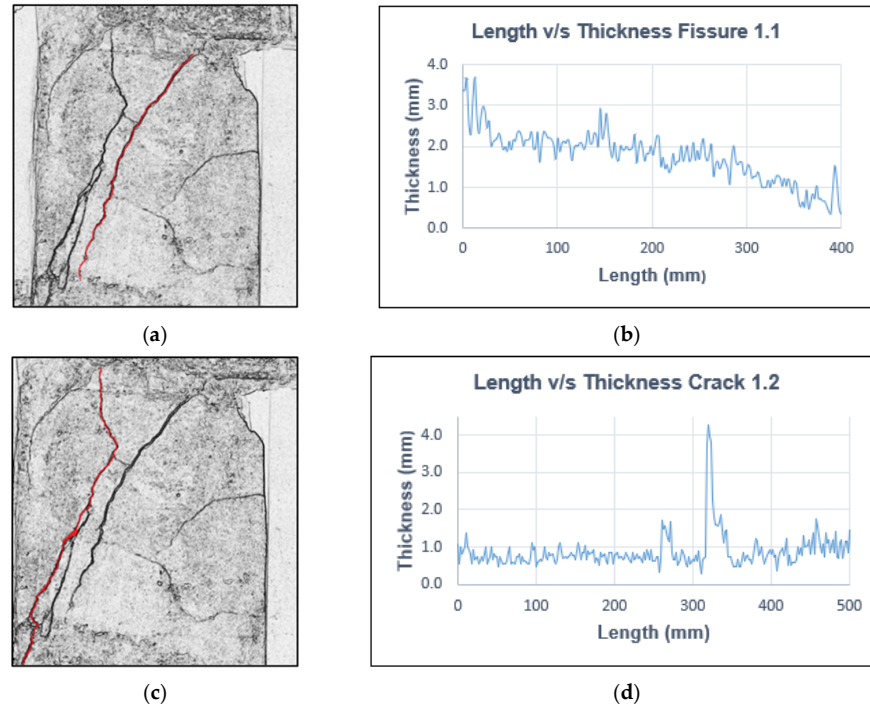
Figure 19. Crack Network Analysis east view of the large bridge. (a) Crack 1.1 Processed in ImageJ (red line); (b) Crack 1.1 Thickness v/s Length graph; (c) Crack 1.2 Processed in ImageJ (red line); (d) Crack 1.2 Thickness v/s Length graph.

The measurements obtained from ImageJ were exported to Excel to construct a “Length v/s Thickness” graph to analyze the behavior of the failures. The fissures turned out to have a little predictable behavior; the section losses produced the thickness in certain zones to be greater than the trend, causing the graphs to have an irregular behavior. Figures 19 and 20 show the graphs of the five fissures in the east view, and Figure 21 shows the graph of the fissures identified in the west view.

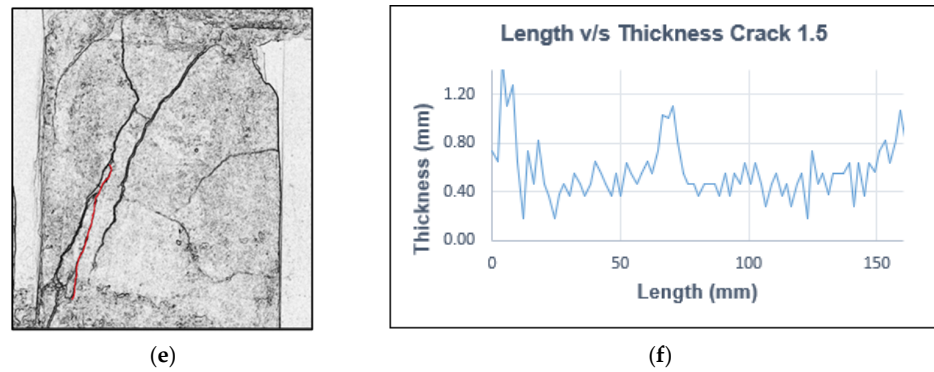
Figure 20. Cont.

Figure 20. Crack Network Analysis east view of the large bridge. (a) Crack 1.3 Processed in ImageJ (red line); (b) Crack 1.3 Thickness v/s Length graph, (c) Crack 1.4 Processed in ImageJ (red line); (d) Crack 1.4 Thickness v/s Length graph; (e) Crack 1.5 Processed in ImageJ (red line); (f) Crack 1.5 Thickness v/s Length graph.

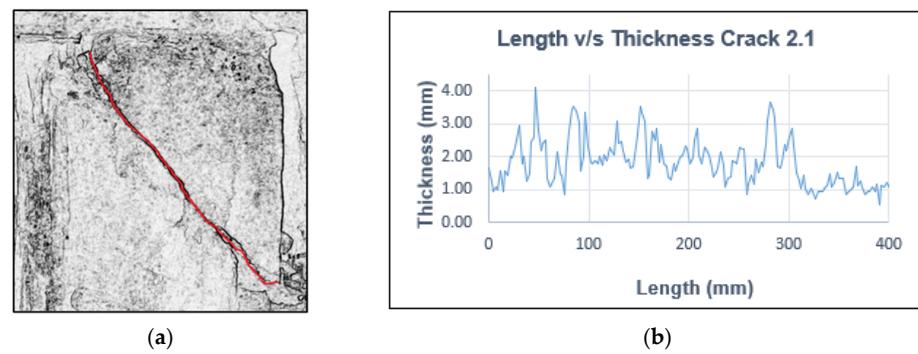
Figure 21. Analysis of Crack 2.1 of the large bridge west view (a) Crack 2.1 processed in ImageJ (red line); (b) Thickness v/s length graph of crack 2.1.
