Article

The Influence of Aggressive Environmental Conditions on the Adhesion of Applied Crystalline Materials

Martin Mottl * , Pavel Reiterman and Jiří Pazderka

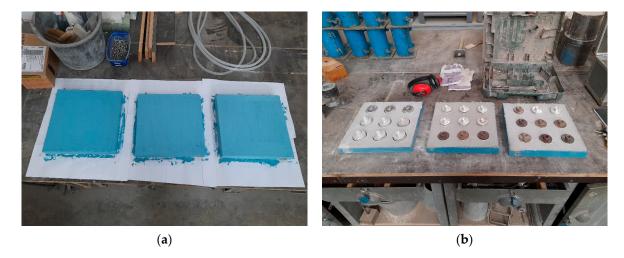
Figure 4. Tested samples: (a) preparation of test samples before CO_2 exposure; (b) test samples ready for pull-off tests after CO_2 exposure.

The third group of test samples was subjected to an accelerated carbonation process. The test procedure was based on the test standard applied for remedial mortars according to CSN EN 13295 [25]. The exposure regime prescribes an environment in the testing chamber with a concentration of 1% CO₂ and 75–80% RH for 56 days. After the prescribed time period, the depth of the carbonation front was monitored. The concrete samples were coated on the bottom and sides with an impermeable one-component polymer dispersion-based waterproofing screed to ensure ingress only through the applied mortar. Thus, only the tested surfaces of the samples were exposed to the aggressive environment.

After being exposed to the environmental conditions, the pull-off tests were carried out on every sample. Nine pull-off tests were performed on each specimen with a given remediation mortar (see Figure 4).

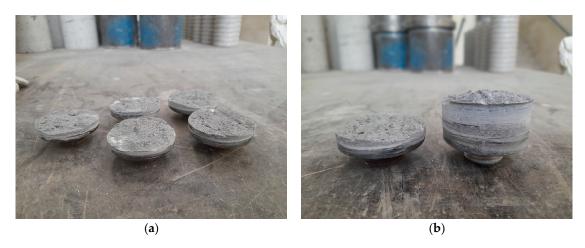
Figure 7. Rupture of samples after pull-off tests: (a) in mortar; (b) in mortar and concrete.

This decrease in strength was evident even from the nature of the failure—2/3 of all samples failed in the mortar. The form of the specimens after pull-off tests can be seen in Figure 7. The strength of samples without crystalline admixture decreased minimally. The highest number of failures in the mortar itself occurred in samples with 1% of crystalline admixture.
