Article

Integrating Non-Destructive Testing, Laser Scanning, and Numerical Modeling for Damage Assessment: The Room of the Elements

study of a wall in the Room of the Elements in Palazzo Vecchio in Florence, Italy. A qualitative crack map of the existing damages was made using a combination of documentation methods. Subsequently, a three-dimensional model was generated for numerical simulation. Additionally, whereas Carpinteri et al. (2005) uses a single, known input load [15], this work, given the existing crack pattern, evaluates several load combinations and yields the most probable loading scenario which caused the existing damage. Using finite-district element modeling, the wall was simulated under a variety of loading conditions including dead load and settlement. The results of the simulations were directly compared to the existing crack patterns to understand how they could have originated. By understanding the extent and origins of the damage, a more comprehensive assessment of a structure's health can be made. Additionally, a second study was carried out examining the impacts of different materials used as infill. This investigation into how different initial assumption

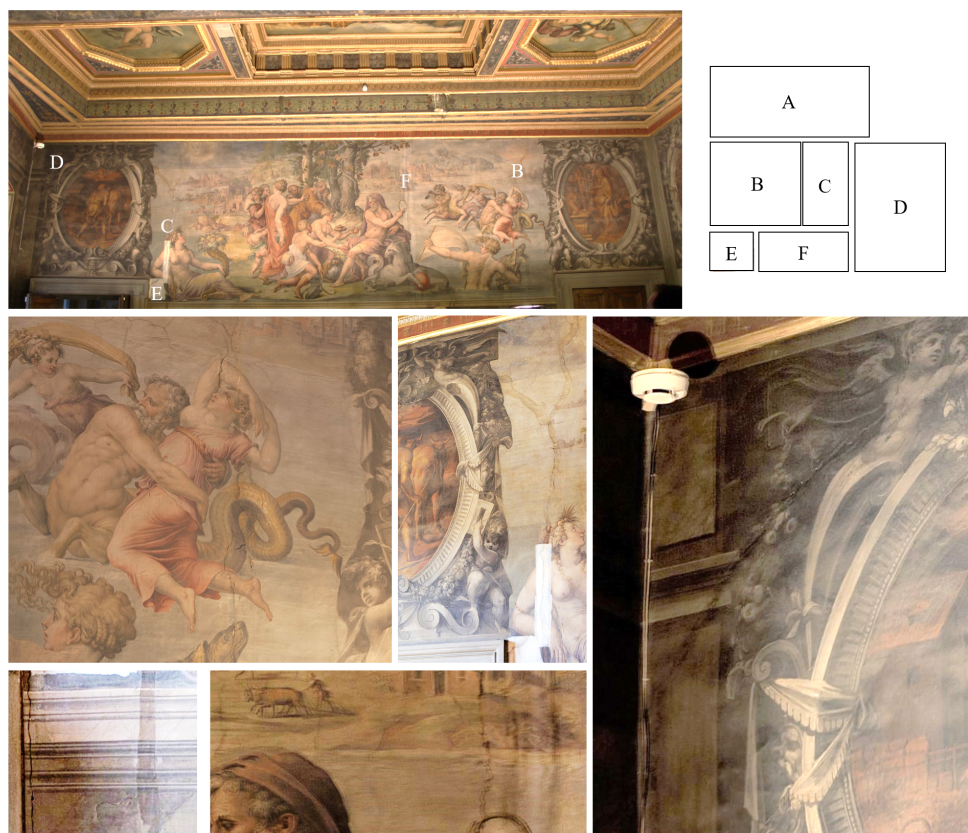
Figure 2. High resolution images of cracks in the Room of the Elements: (A) full illustration of western wall, (B–F) images of specific cracks on the western wall.

This imaging augments the data from TLS which was not always able to capture the locations of these fine cracks. Figure 2A depicts the entirety of the western wall with specific cracks (Figure 2B–F) labeled on it. Figure 2B shows cracking which goes through the woman’s arm, face, and right leg as well as through the serpent. Figure 2C illustrates cracking where sections have been recently intervened on (white rectangle); this crack starts in two parts on the ceiling, joins above the woman’s head, continues through her right shoulder and then splits in two cracks near the door which can be seen in Figure 2E. Figure 2D shows a diagonal crack on the top left corner of the west wall. Figure 2F shows cracking in the middle of the western wall. As stated above however, these methods only provide information about the surface of the fresco.

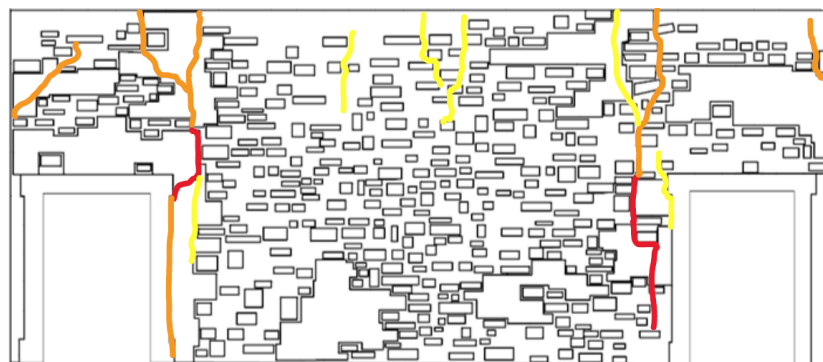
Figure 5. Map of existing cracks on the foundation wall. Red indicates cracking over 1 cm; yellow indicates cracking on the order of 1 mm; orange indicates cracking in between these two limits.

Using a combination of information from laser scanning, photogrammetry, thermography, as well as previous crack maps, a new map of the existing cracks and their relative sizes can be found in Figure 5. Since the cracks are not all visible with line-of-sight methods, the magnitudes of the cracks are approximate. In this plot, red lines denote cracks with the width on the order of 1 cm or larger, yellow denotes those on the scale of 1 mm, and orange denotes those between these limits. As can be seen in Figure 5, the widest cracks on the wall occur in the vicinity of the door jams. The widest cracks originate there and then reduce in magnitude as they continue to propagate through the wall's height. Smaller cracks can be seen at the corners of the room as well as some in the top-middle section of the wall.

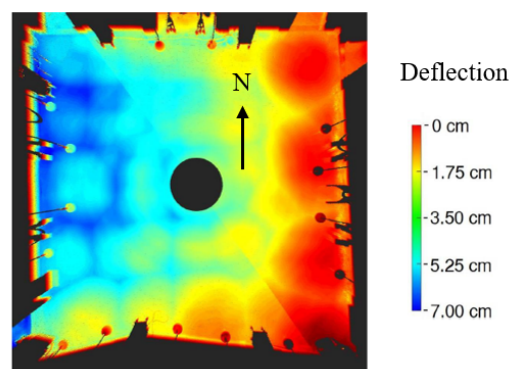
Figure 7. Settlement of the floor in the Room of the Elements; the west wall was analyzed in this work due to cracking.

The wall of the Room of the Elements was simulated under several loading combinations, the first of which was the dead load (self-weight) of the superstructure. Additionally, settlement loading was considered due to apparent floor deformations. Figure 7 was generated by comparing the laser scan data with a flat reference plane and illustrates these deformations. The wall with a high degree of cracking being considered in the present study is the west wall.

Three different settlement types with different magnitudes were considered. They are called “L”, “R” and “M” standing for settlement of the left side of the wall as described by the base in Figure 6B, right side as described by the inverse of the base in Figure 6B, and middle as described by the base in Figure 6A respectively. These three were chosen as they represent comprehensively the span of the possible settlement space in a computationally efficient way (i.e., there are infinite combinations of settlement). L and R represent possible types of settlement on each side of the room, whereas M represents possible settlements between those extremes. 0.05 m was selected for the settlement depth as it was within the middle range of values found in Figure 7. During analysis stages, it became apparent that middle settlement was the most probable cause of existing damage. Thus, 0.1 m settlement was also included to understand how variations in the magnitude of settlement depth could alter the magnitudes and locations of resulting cracks.

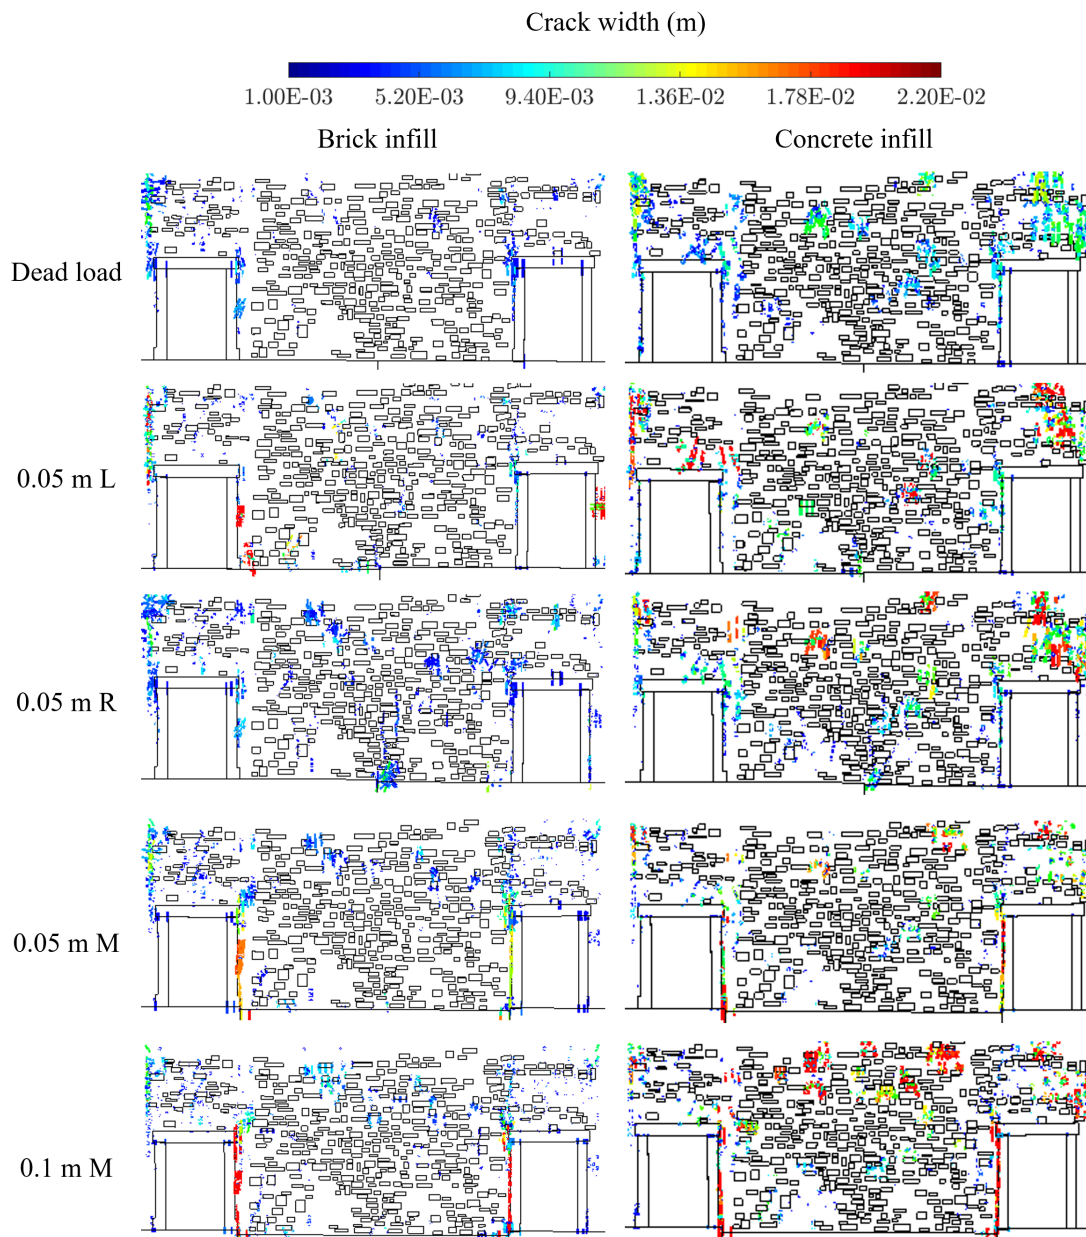
Figure 9. Crack widths of the existing geometry under combinations of dead load and settlement for brick infill and concrete infill; text value (m) indicates magnitude of settlement, while L, R, and M indicate settlement of left, right, and middle part of the wall, respectively.

Figure 9 is a plot of the crack widths incurred in the different loading simulations for both the wall with brick infill and the wall with concrete infill. A crack is defined at the interface as relative displacement between two blocks during the simulation. Similar to above, the text to the left of the figures indicates the loading condition imposed to generate the results, the number indicates the depth of settlement, and the letter refers to the section which is settled. Again, the results of simulation for both the brick and the concrete infill for each loading condition are displayed. The red lines indicate cracking magnitudes larger than 2 cm while the blue lines indicate cracking magnitudes below 1 mm.

Considering just the simulations where the infill is brick, cracking can be seen to occur consistently along the joint with the door frame. This cracking pattern is similar with the qualitative plot of cracks in Figure 5. Aside from the case where there is 0.05 m of settlement of the right side, overall the results are similar in terms of location but very different in terms of magnitude. For instance, in the simulation where there is only dead load versus where there is settlement at the middle 0.1 m, the magnitude of the cracking on the doorway changes from 0.009 m to 0.02 m. Therefore, there is enough difference to qualitatively understand which load cases could have caused the existing crack patterns and which load cases could not have. Comparing the cases where the wall has bricks for infill against the crack map in Figure 5, it can be seen that the simulation with only dead load does not produce cracking of the correct magnitude along the door jams; additionally, the case where there is 0.05 m of settlement on the right side produces too many cracks in the center of the wall's base which is not evident on the existing wall. Lastly, the cracks in the middle settlement cases match the cracks more than the case where there is settlement of the left side; in the case of the left settlement, cracking does not occur on the right door frame. Therefore, qualitatively considering only the cases where there is brick infill, settlement at the middle of the wall is the most likely reason for the cracks.

As can be seen from Figure 9, the magnitude and the location of the cracking vary not only with settlement type and magnitude, but also with the material of the infill. Despite the fact that the plots of displacement magnitude were did not show stark differences between the types of infill, it can be seen that the plots of the cracks are sensitive enough to pick that up. The magnitude of the cracking increases with the change in infill material from brick to concrete. One example of this is the case with 0.1 m of settlement in the middle of the wall. With the concrete infill, there is much larger cracking occurring in the middle of the wall's top section (on the order of 2 cm). On the wall with the brick infill, this cracking was only seen to raise to the order of 0.009 m and additionally on the existing wall, these cracks are very minor. The cracks are able to propagate through the concrete infill much easier than the brick because of the difference in energy required to cause the crack to open. Considering

both sets of simulations and the map of existing cracks, it can be qualitatively deduced that the infill material is brick and that the cause of the cracking is settlement of the middle section. An overlay of the results of the simulation and the crack map can be found in Figure 10.

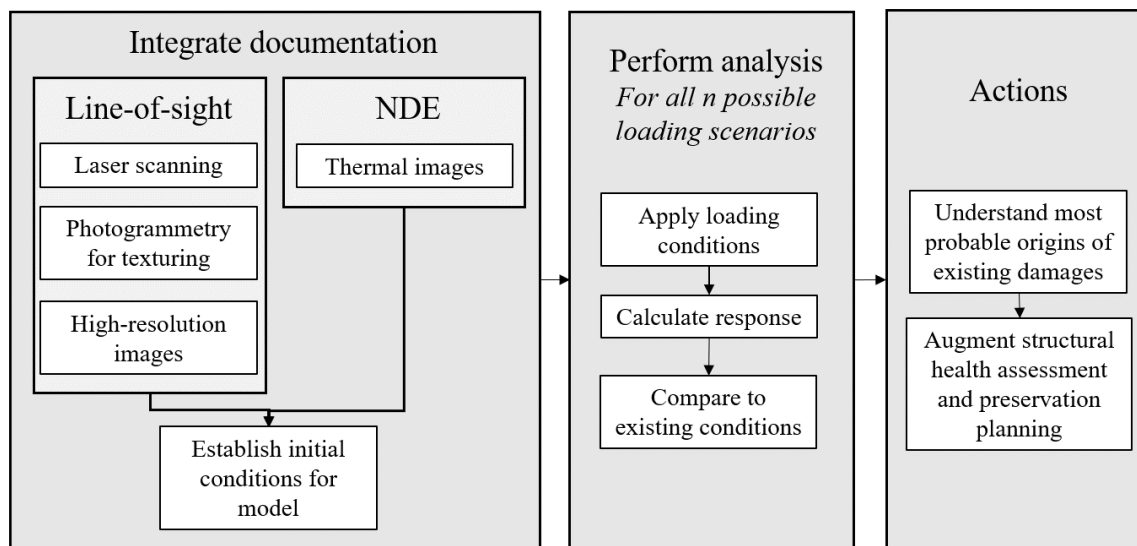
Figure 11. Workflow for integrating line-of-site documentation, non-destructive evaluation, and numerical modeling for understanding the extent and origins of existing crack patterns.
