Article

Study of Materials and Technique of Late Baroque Stucco Decorations: Baldassarre Fontana from Ticino to Czechia

Keywords: stucco decorations; gypsum; Mg lime; mortar analyses; stucco production technology

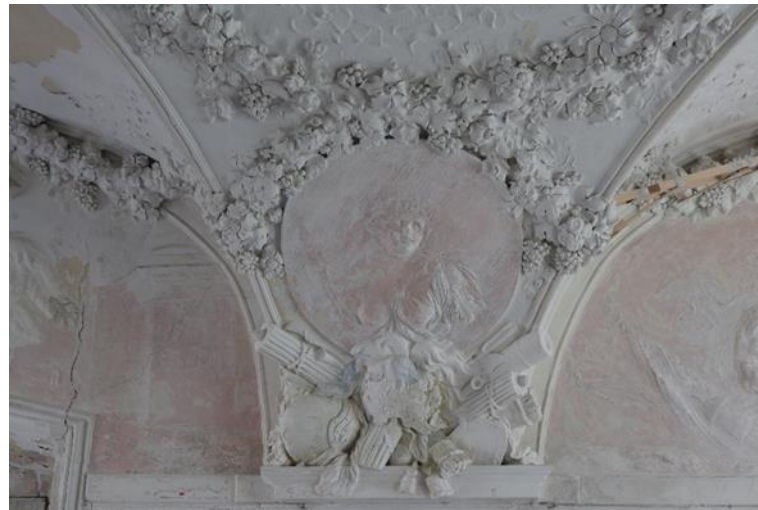
Figure 1. Heissler's study room in Uherčice Castle, image of a stucco relief before restoration works.

Donat Heissler of Heitersheim (1648–1696) commissioned Baldassarre Fontana and his assistants to decorate nine halls and the castle chapel in Uherčice, probably in the years 1692–1696 (until now the decoration has been dated 1705–1707, but by then Donat Heissler of Heitersheim was already dead) [10–12]. Although archive sources are not available to confirm which artist was responsible for the extensive stucco decoration or the date when it was created, we can quite certainly assume that they are the work of Fontana because of clear stylistic analogies with other works by this artist (Figure 1) [5–7].

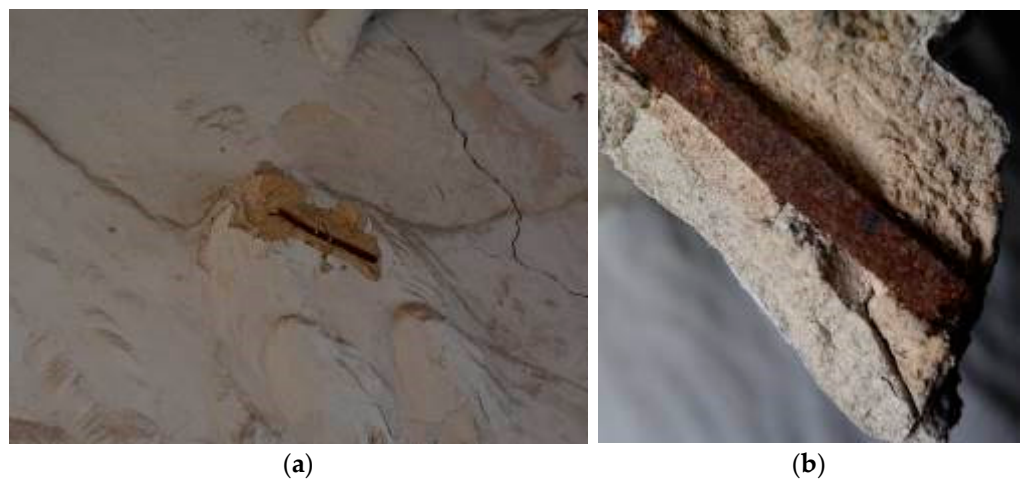
Figure 2. Heissler's study room: (a) broken eagle's head; (b) the close-up image shows the internal structure. The ground mortar (sample JUHE 002) is wrapped around a squared iron bar app. 10 mm × 6 mm across and finished with a stucco finishing layer (sample SUHE 002).

The figurative bas-reliefs were realized with three different layers of mortar (two internal ground layers and a finishing layer) applied wet-on-wet in order to model all the layers together. The phytomorphic decorations under the arches, ribs, and garlands are rich in detail, reproducing their natural shape perfectly. The support was prepared with a binder-rich mortar, applied in different thicknesses on a case-by-case basis. Leaves and fruits were inserted directly into the fresh mortar or applied after setting with the use of metal nails as anchoring plugs. Figures and forms that stood out from the background contained reinforcement (Figure 2). The cherubs were probably made directly on-site, with

their adhesion being reinforced with a metal nail. Around this nail, the ground layer is first applied as a draft of the final form. Afterwards, in order to model all the expressive details of their bodies and faces, the finishing was applied in a thick layer, between 1 and 5 mm in thickness.

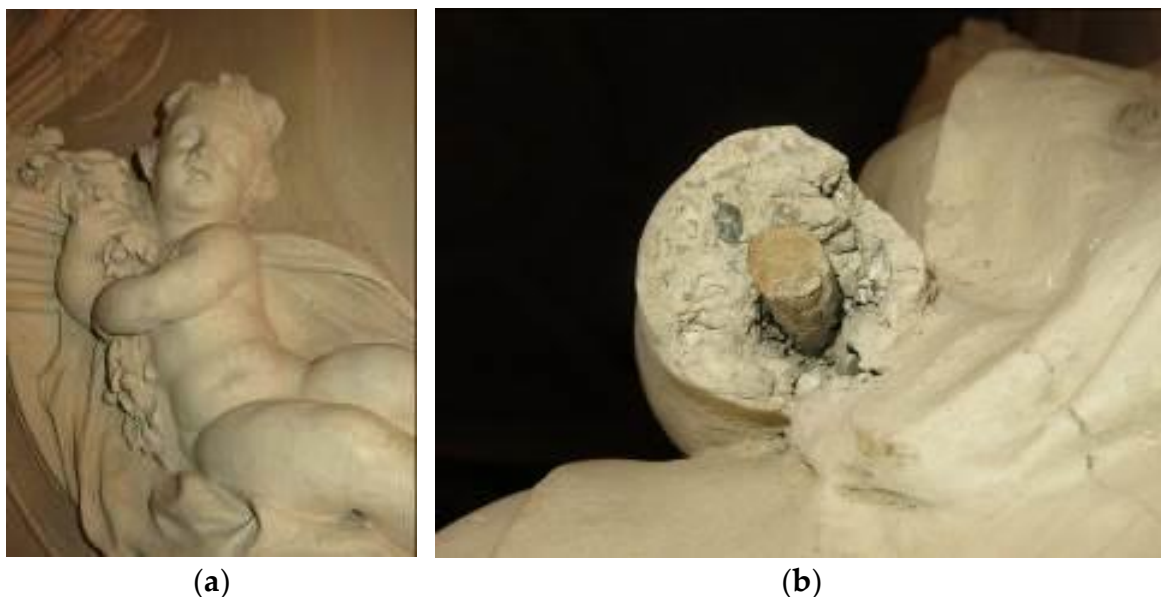
Figure 3. Stucco decoration of Casa Cantoni in Cabbio: (a) detail of a putto stucco decoration of the fireplace; (b) the close-up image shows the internal structure. It is made of two superimposed layers of mortar, a ground layer with coarse aggregate and a finishing layer, a few mm in thickness. Inside, the internal wooden structure is visible.

The stucco fireplace is made of two superimposed layers of mortar, the ground layer containing sand (with a grain size of up to 2–3 mm) and the finishing layer composed of fat lime, with a thickness of about 1–3 mm. In particular, in the two lateral puttini of the chimney, it is possible to see an internal wooden structure. It is a fine cylinder of wood, apparently a twig, whose light bark has not been removed, around which the amber-colored body mortar has been applied in a single layer (Figure 3). The finishing layer is about 1–2 mm thick and is smooth and well-polished. A survey with a pacometer confirmed the very limited use of iron elements, probably just a few nails with which the more projecting elements were anchored to the wall.

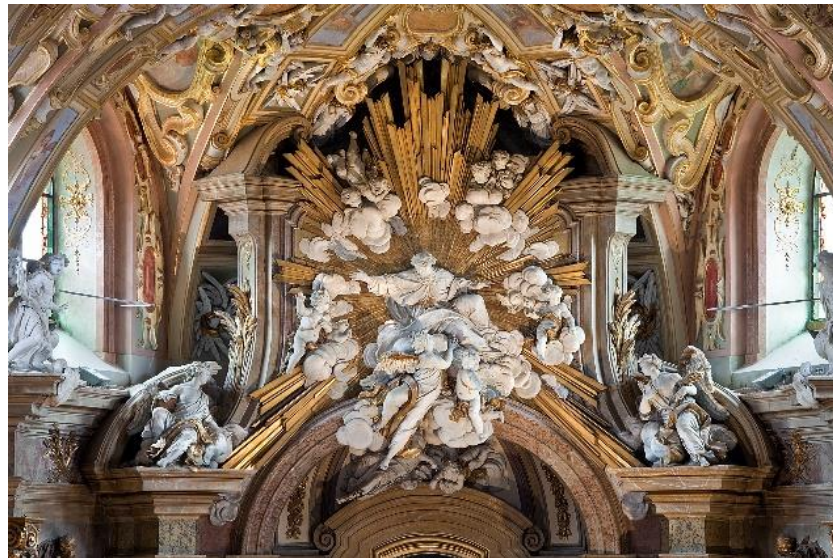
Figure 4. Stucco decoration in the Holy Hill near Olomouc, image before restoration works.

The stucco decoration of the basilica on the Holy Hill near Olomouc is definitely one of the late works of Fontana and his workshop, being well documented [5,6]. A number of archive documents relating to this work are available, including the contract, on the basis of which the stuccoes can be dated to the years 1722–1731. Because of the client's wish to give the original stucco decoration from the 1670s a modern look, Fontana enriched the older stucco on the walls and vaults with new figures. In many places throughout the basilica, he designed new stucco figures of angels and created new altars in the side chapels; in particular, he decorated the main altar with the monumental figure of God the Father and

angels (Figure 4). The Premonstratensians desired to give the interior an exclusive look, and therefore many of the stuccoes were inlaid with gold.

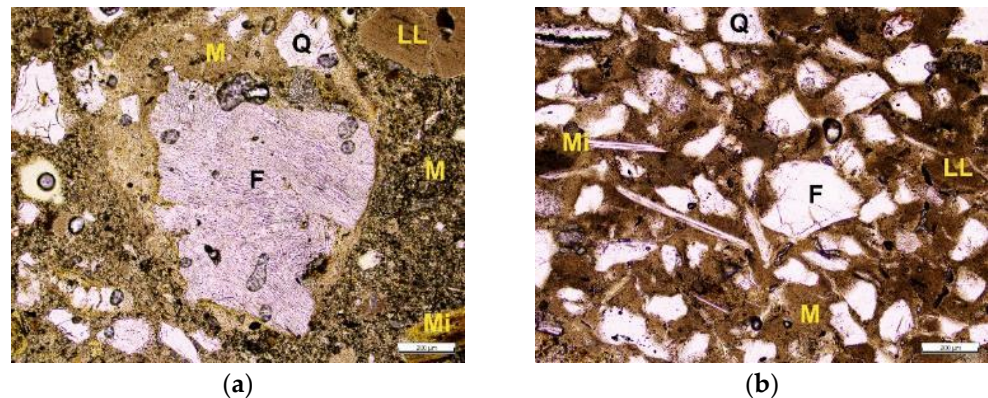
Figure 5. Photomicrographs of the ground mortar (JUHE 2): (a) detail of a putto stucco decoration of the fireplace; (b) the close-up image shows the structure. It is made of two superimposed layers of mortar, a ground layer and a finishing layer. Inside, the internal wooden structure is visible. LL = lime lump, M = binding matrix, Mi = micas.

The study of the flower bud mortars by PLM—see Figure 5—revealed that the ground mortar has a more heterogeneous aggregate (quartz, feldspars, muscovite, apatite, and limestone), with a typical size from 0.2 to 0.6 mm, but grains up to 2.2 mm can also be found, compared to the mortar of the finishing layer, where the aggregate is predominantly composed of well-sorted quartz and muscovite grains with a typical size from 0.2 to 0.5 mm. The elongated muscovite grains can even be up to 1 mm long. In both samples the grains are angular or semi-angular; some have sharp edges as a result of crushing. The binding matrix appears different in each of these samples. The ground mortar has a darker shade of brown and apart from lime it also contains gypsum. It is coarser and also more heterogeneous than the finishing layer. Binder-related particles (BRP) [21]—lime lumps *sensu stricto* which have rounded edges and are well-merged with the binding matrix—are relatively common in both mortars. They are rather compact, without too many cracks or frequent defects. No calcium sulphate (gypsum, anhydrite) particles or half-burnt lime particles were found in the thin sections. The ratio between binder and aggregate was estimated to be 1.5:1 for both mortars. Two separate clusters that had a slightly different binding matrix from the rest of the sample were found in the ground mortar; see Figure 5a.

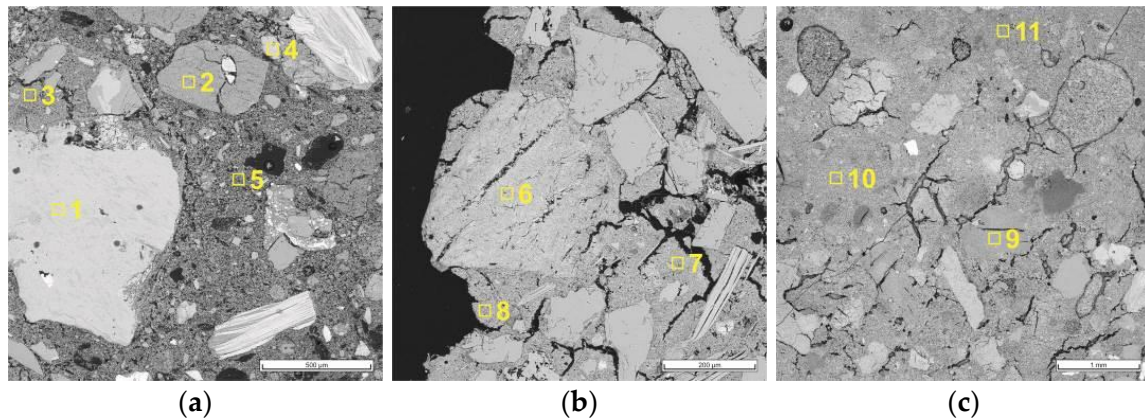
Figure 6. SEM BSE scans with positions that were analyzed: (a) ground mortar (JUHE 2), (b) the finishing layer (SUHE 3) of the flower bud, and (c) the wall render surface (stucco) layer (SUHE 1).

The SEM-EDS analysis confirmed the petrographic characterization and also made it possible to examine the composition of the binding matrix and the binder-related particles; see Figure 6 and Table 2. The binding matrix of the ground mortar JUHE 2 was made of calcitic lime with a minor content of magnesium. The content of SiO₂ around 8 to 10 wt. % suggests the presence of some impurities and possibly also hydraulic phases in the lime binder. The lime lump and the limestone particles present in the image are, however, quite pure high-calcium materials. The binding matrix also contains SO₃, which relates to gypsum, present in the binding system. In comparison, the binder-related particles and the binding matrix of the finishing stucco layers (SUHE 3 and also SUHE 1) have quite a high content of CaO, suggesting the use of air lime as the main and sole binder.

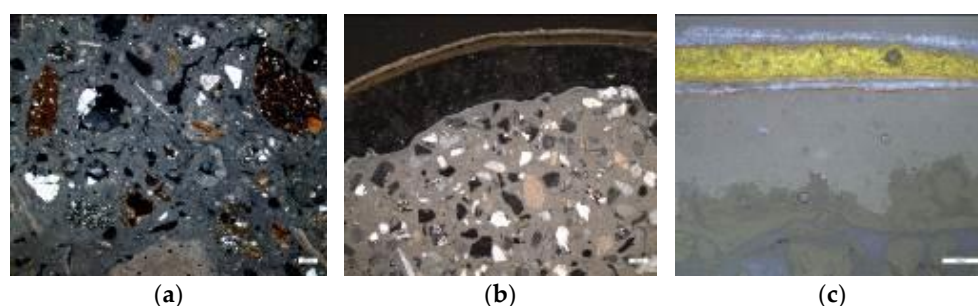
Figure 8. Photomicrograph of the thin sections, transmitted light, and crossed polars: (a) the ground layer; the binder is composed of gypsum and lime, and *cocciopesto* additions are visible; (b) the finishing layer made of lime binder and silicate fine sand; and (c) the decorative layer with the preparation for the gilding.

The three Holy Hill samples showed a very similar stratigraphy: the inner ground layer is composed of a lime-based binder with a lower gypsum content. The ratio between binder and aggregate is visually estimated under the microscope as 2:1. The aggregate has a homogeneous distribution and low sorting, with a fine to coarse sand grain size. The mineralogical composition is mostly silicate, with quartz and fragments of reddish silicate rocks with a high iron content, plagioclase, feldspar, and fragments of magmatic rock and micas. Fragments of bricks are frequent enough to suggest a voluntary addition, while fragments of wood are rare (Figure 8a). The finishing layer has a micritic lime binder with a homogeneous light beige color and well-sorted sand with a fine and very fine grain size. The composition of the sand is almost exclusively of quartz, plagioclase, and feldspar. On the other hand, fragments of magmatic rock and micas are scarce (Figure 8b). The presence of calcite and quartz in the finishing layer is confirmed by the FT-IR results (Figure 9).

It is noteworthy that the finishing layer is coated with a preparatory layer for gilding or false gilding (Figure 8c), consisting of animal glue and gypsum, covered with a very thin red ochre layer containing Fe, Al, and Si. The presence of gypsum is confirmed by the SEM-EDS results, while Au was not identified. Subsequent layers can be attributed to more recent decorative phases (Figure 10 and Table 4). Therefore, it can be assumed that these stuccos were originally designed to have a golden appearance.

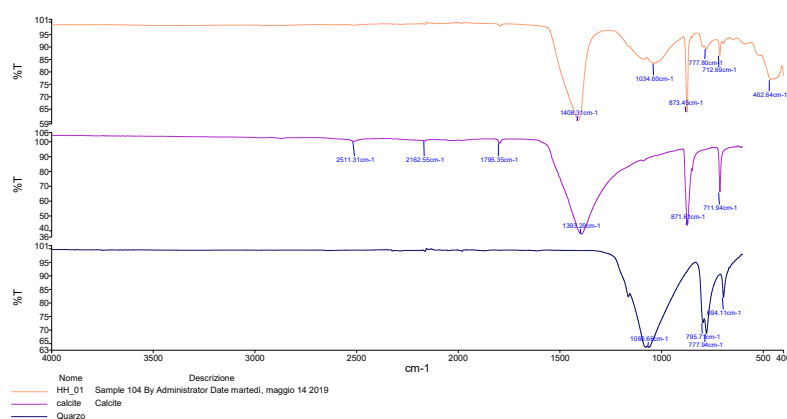
Figure 9. ATR-FT-IR spectra of the finishing layer of the sample HH_1. There is a large and strong band around 1403–1420 cm^{-1} as a result of the CaO stretching mode of the carbonate functional group together with a sharp band at 872 cm^{-1} of the bending mode and at 712 cm^{-1} . The reference spectra of calcite (violet) and quartz (black) are also shown for comparison.

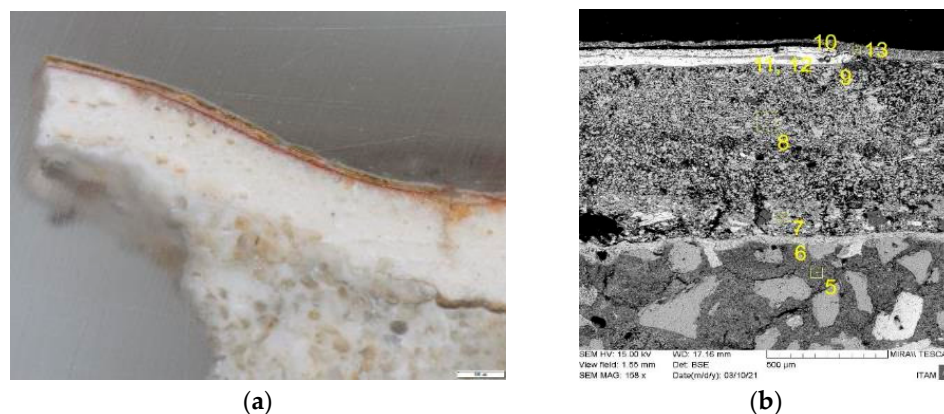
Figure 10. Sample HH1: (a) stratigraphy showing the finishing layer and the whitewash (lime putty) with the preparation for gilding; (b) images from where the SEM-EDS measurement points in Table 4 were taken.

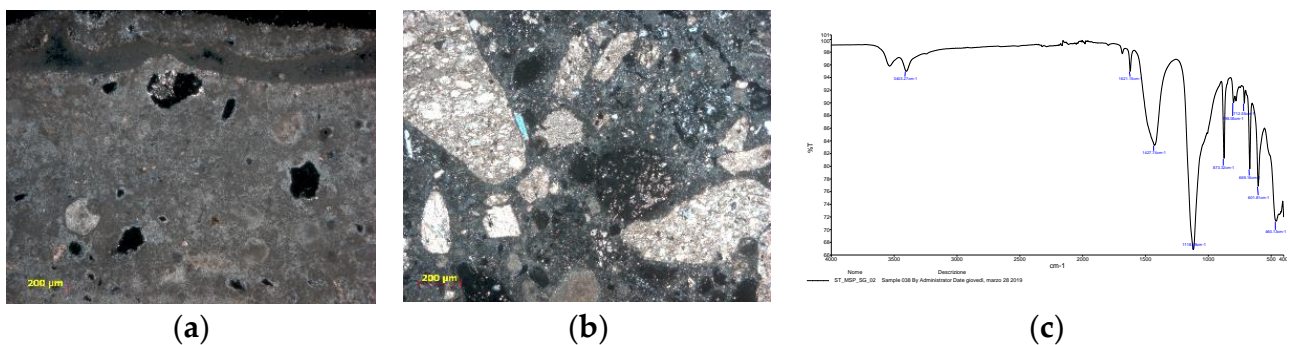
Figure 11. (a,b)-Photomicrographs of the thin sections, transmitted light, crossed polars, of samples: (a) MSP_SG 01 (finishing layer), made only of lime putty without aggregate, and (b) MSP_SG 02 (ground layer), made of lime and gypsum as a binder and calciferous limestone as aggregate; (c) FT-IR spectrum of the sample MSP_SG 02, showing the presence of lime, gypsum, and a silicate component.

Microscopically, these bas-relief stuccoes are composed only of a finishing layer, made of a solely lime binder with frequent lime lumps *sensu strictu*. On the other hand, the cornice, characterized by higher relief, is made of two layers. The ground layer, together with the lime binder, also contains gypsum and aggregate (Figure 11).

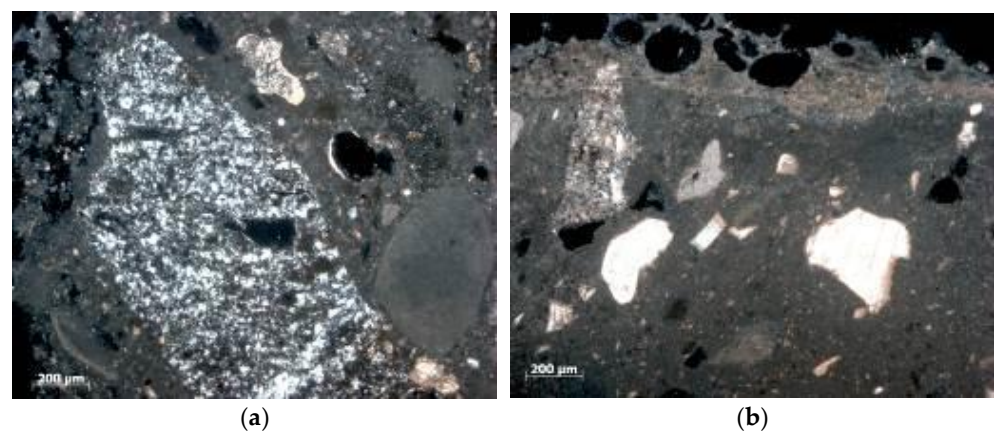
Figure 12. Photomicrograph of the thin sections, transmitted light, and crossed polars: (a) sample CB_CCC 01, ground layer with a coarse calciferous limestone fragment in the center and one lime lump on the right; (b) sample CB_CCC 03, stucco layer made of lime putty with sporadic fine fragments of calcite.

The ground layer is composed of Mg lime binder and gypsum. BRP of lime and gypsum are frequently present. The proportion between binder and aggregate is 1:1 by volume. The aggregate has a moderate sorting, with prevailing coarse and very coarse grain size. The composition is made up of calciferous limestone and fragments of metamorphic silicate rocks. The porosity has an irregular shape and elongated shrinkage cracks are also visible (Figure 12a). The finishing layer has a homogeneous isotropic dark and dense binder, with lime lumps. The use of aggregate is very sporadic and only a few fragments of calcite and rare quartz are observed (Figure 12b).
