# SfM photogrammetric techniques applied in the building archaeology works of the old cloister of the Monastery of San Francisco from the 16<sup>th</sup> century (Cazalla de la Sierra, Seville)

**Abstract:** The cloister from the old monastery of San Francisco (Cazalla de la Sierra, Seville) has been suffering a series of remodelling and transformations from its original construction, in the 16th century, to the current day. Thus, a study of building archaeology needed to be accomplished by using photogrammetric techniques by SfM (Structure from Motion) and laser scanning or TLS (Terrestrial Laser Scanning) that ensure a geometric exactitude and high resolution of the facings surveying. For that, over 500 images were taken for the 4 existing facings (about 78 lineal metres) from which a photogrammetric model was obtained of over 50 million polygons; as well as a cloud of over 40 million points from the laser scanning. It can be concluded that by using the techniques of SfM, the task of documenting, analysing and studying the facings of the historical buildings in order to establish its evolutionary process, gains, not only in precision and exactitude, but also opens the possibilit

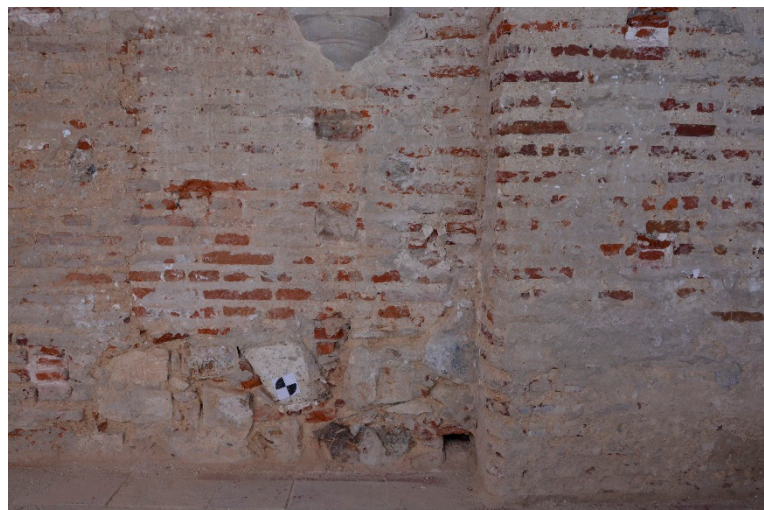
**Figure S2.** Detail of the facing of the church, the original wall and the reforms of the Cloister

It is possible that the face of the wall mentioned in the previous phase worked as an enveloping structure for the head of the church where a dome was developed that would require some kind of reinforcement on the perimeter walls of the church (figure S2). Almost certainly, behind this wall are the remains of the original building and probably a communication opening towards this sector, where there was either an earlier church or other monastery buildings. Perhaps this was the main reason for the reinforcement of the church facings in this area, as the existence of this previous opening could have provided less support for the church.

In any case, the construction of the church reuses part of the W wall of the cloister and transforms the rest in a manner that creates a special solution of connection between that and the cloister itself.

As far as this facing is concerned, the arch at the S extreme fits perfectly into the wall of the arcade that connected the church to the cloister, while the one at the N end must completely replace the facing of the original building with a new facing of solid bricks, in order to have the right consistency to fit the arch and its corresponding bracket (figure S2).

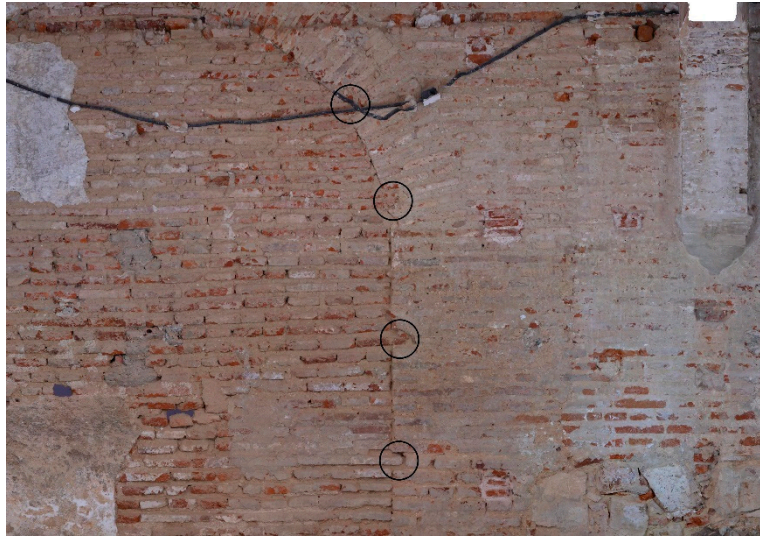
**Figure S3.** Detail of the railings in the arches

Thus, the first reform of the cloister and the edification of the church should have been carried out at the same time. Based on the original building, the production of the church was completed so as to define the rectangle of its perimeter. A supporting wall was built in the N extreme in order to provide support to the church's head and the original facing of the cloister was almost completely reformed to open four semi-circular arches that allowed the vision between both spaces, protecting the access with grids of which the traces of their crimping have been left on the arches and the pillars between the these (figure S3).

- The last arch on the N extreme was completely closed, flushed with the new facing on the cloister's side (figure S3).

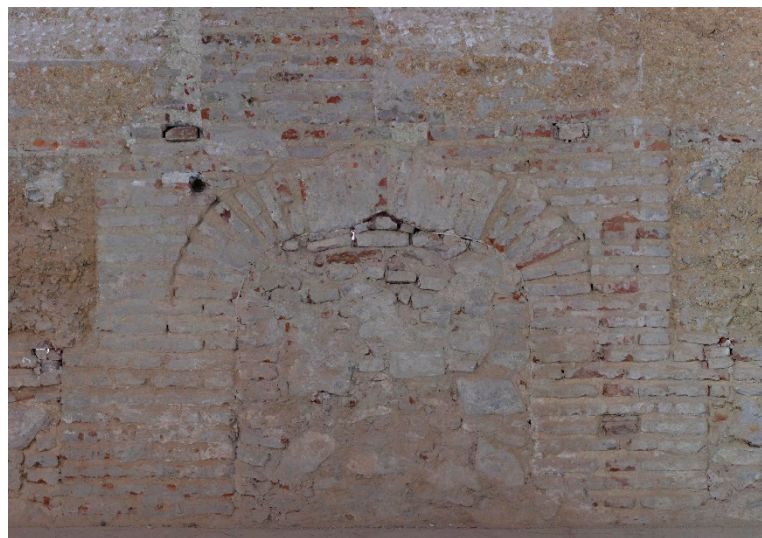
**Figure S6.** Main door of the original cloister with an ogee arch on the top

From all the hollows that can be observed in the facing, just one is originally from this phase. This is the small ogee-arched doorway, framed by a brick spandrel and located exactly in the centre of the facing (figure S6).

Possibly this door, special in its physiognomy, gave way either to a noble dependency of the monastery, or perhaps to the original chapel in which the monks of the monastery celebrated their liturgical acts before the construction of the church, which, as we have seen in the description of the previous facing, did not take place in the original construction of the monastery, but in a second phase.

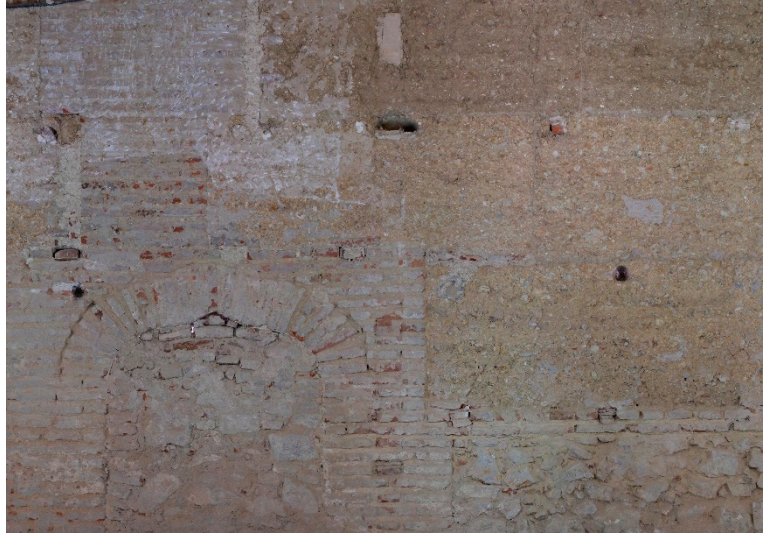
**Figure S7.** Original factory on facing 2

Moreover, in this facing, we can clearly observe the building typology of the monastery's original walls (figure S7).

This is a masonry plinth made of medium-sized stones, framed at the top by a brick wall made up of a double row. The function of this plinth is to insulate against dampness, making it difficult for water to rise to the upper part of the facing.

On this plinth, there are up to four rows of improved rammed-earth walling caissons of variable width depending on the needs of each wall, separated by strings of brick blocks whose function is to reinforce the facing at certain distances between the walling caissons. The height of the caissons varies between 0.84 and 0.87 metres and their standard width varies between 1.95 and 2.00 metres (there are smaller caissons depending on the distance available to fit the blocks). The spires of the caissons are not topped with any brick or stone (except in very isolated and punctual cases), and in a notable number of cases, the caissons are outlined with a fine line of lime and a thin line of stone.

This type of walling covers a possible chronology with a fairly broad spectrum, ranging from the 12<sup>th</sup> century to the 18<sup>th</sup> century, but if we take into account its main characteristics [43], moderate invasion of the chaining on the walling caissons, non-existent brickwork that is limited to the separation between the plinth and the walls, and very evident lines of marking and separation between caissons, the date of the 16<sup>th</sup> century fits perfectly to consider it as the date of its construction. This date, therefore, is in line with the other known chronologies for the entire building complex: the church was started to be built after the cloister was built and work began circa 1623, while the convent was built circa 1588 at the latest.

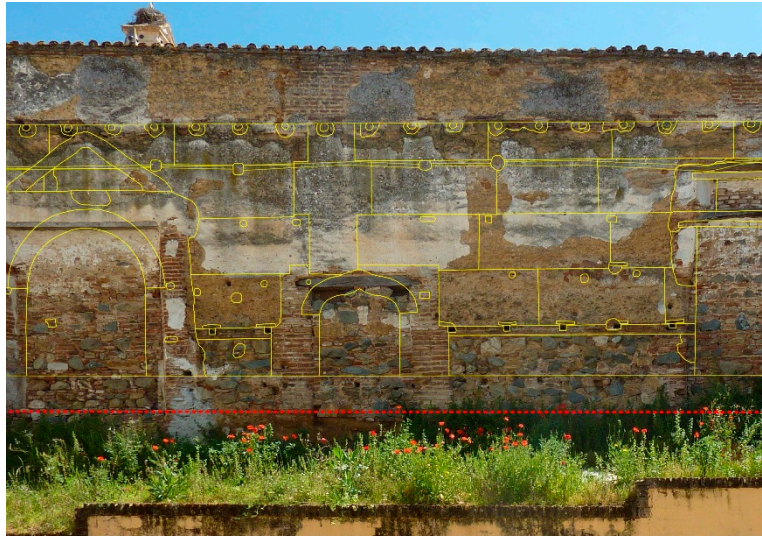
**Figure S8.** North facing 2, with the elements of the south face, georeferenced and indicating the original floor level of the cloister

This facing shows another very interesting feature. It is the original floor of the cloister. It is clear that the one that exists today is not; indeed, it can be affirmed that it was not at any time during the life of the cloister as such. Thanks to the view offered by the back of this wall, and by georeferencing a photograph taken of it on the ortho-photo obtained by photogrammetric methods for this work, it can be established that the original pavement is approximately 0.60 metres below the current one (figure S8). This would explain why there could be a doorway in this facing with a span of only 1.36 metres in height, since when these 0.60 metres are added together, it would be almost 2 metres, enough to facilitate the passage through it.

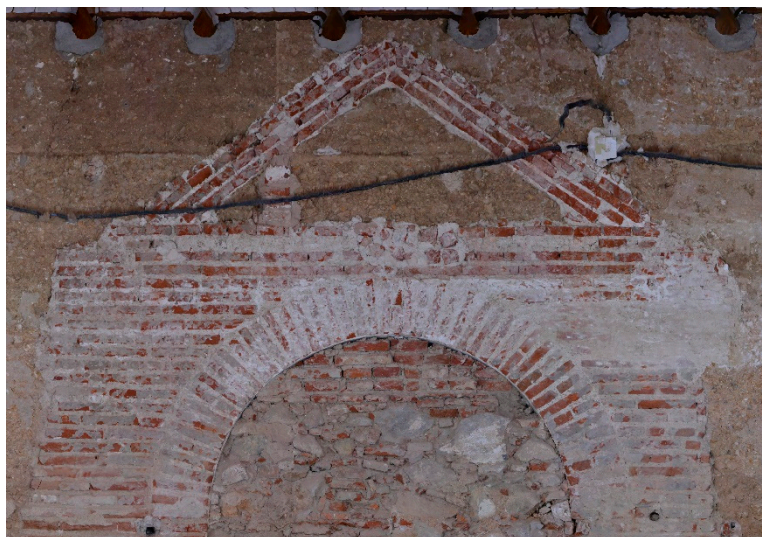
**Figure S9.** Detail of the front and the semicircular arch of the new open portal on facing 2

In facing 2, two hollows will be opened in addition to the existing one. The first of these is a new door in the W half of what is supposed to have been the monastery chapel. This chapel probably lost its function as such when the church was built and its use changed, although it must have had a certain singularity in monastic life due to the size of the new access door. This was built with a large round arch, framed in a brick spandrel, and was finished off with what was probably a pediment that must have protruded slightly from the wall and of which the part that was embedded in the original facing is still preserved. (figure S9).

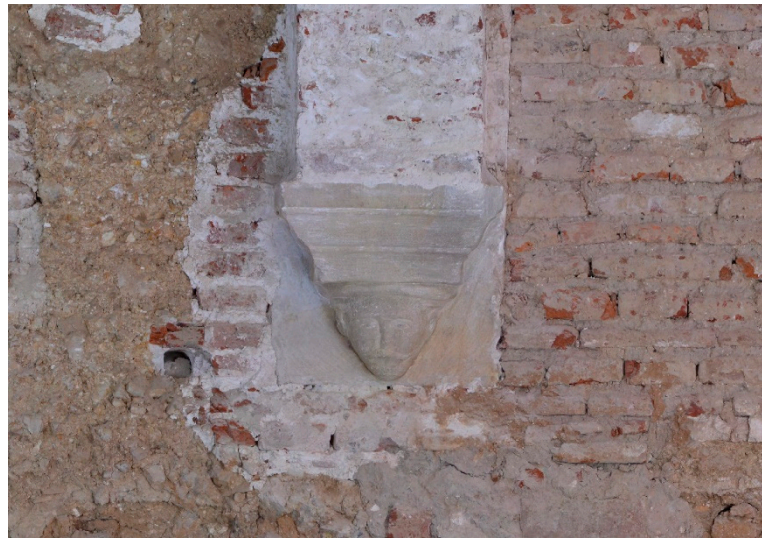
**Figure S10.** Corbel in the shape of a human head from an arch in the porticoed gallery on facing 2

In this phase, the cloister suffers a series of reforms that give it the aspect it displays nowadays. On facing 2, two corner arches of the new porticoed gallery of the cloister are placed, which must partially replace the existing mud wall with a reinforcement of solid bricks that help to give consistency to the arch and its corresponding bracket in the wall. The artistic quality of this corbel is noteworthy, as it shows a human head in relief in which all its parts are perfectly distinguishable (figure S10).

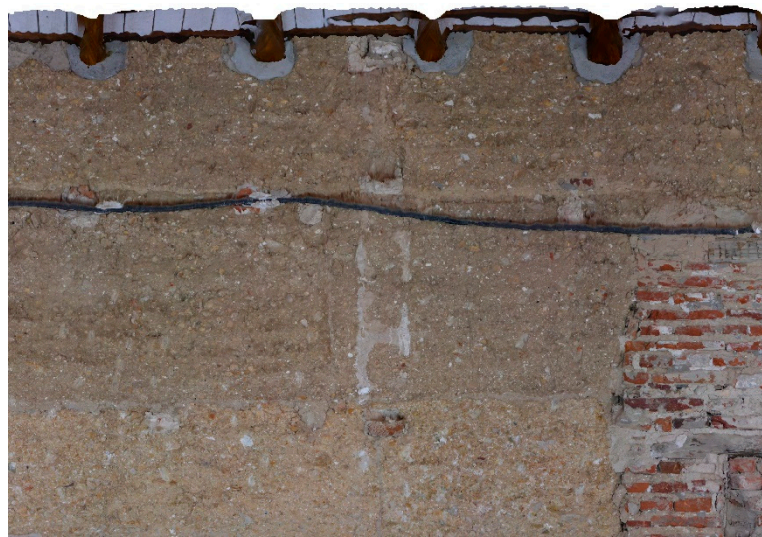
**Figure S11.** Imprint of the market walls, drawn on the wall of the cloister

The two moments of the Market are also visible on this facing, which was caused by the same reasons as those described for facing 1, and left the same evidence and traces on the facing (figure S11).

The first consisted of a brick wall, probably of masonry, from the cloister facing to each column of the porticoed gallery. In the spaces left among quoits should have been located market stands.

These walls have left as evidence some putlog holes of the fitting of the new facings in the cloister, as well as the trace that draws its profile on the cloister facing.

From the second phase, it remains the fillings of the open putlog holes for the walls of the first market, as well as the hollow brick facing of all the arcades. In this way, a completely smooth surface was achieved, to which a layer of cement plaster and white paint was applied.

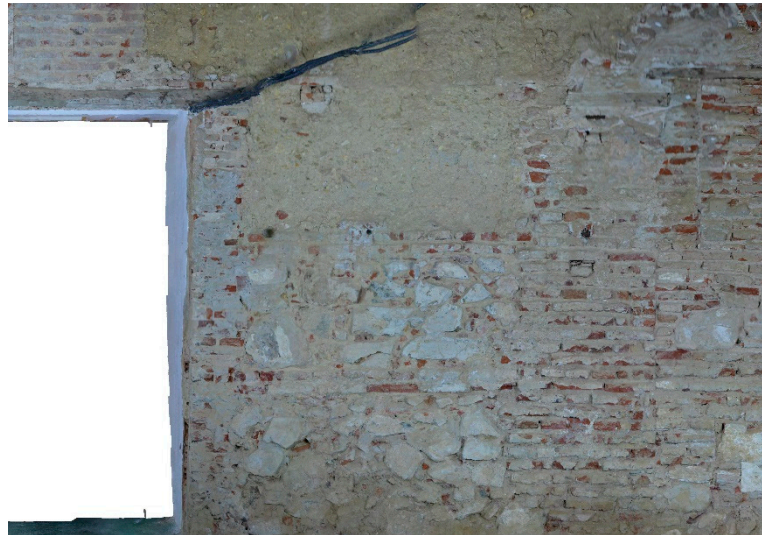
**Figure S13.** Detail of the masonry plinth and rammed earth wall of facing 3 of the original building

This facing shows the same original building typology of the monastery that we have already seen in facing 2. It is a masonry plinth made of medium-sized stones, framed at the top by a double course of bricks. In this case, the plinth is higher than that of facing 2, as a second section of masonry is placed on top of the finishing string course at the bottom of the plinth, which is again finished off by another double course string course. In turn, above the two doors of this facing, there is a new band of masonry on the upper lintel, this time topped by a simple single course of bricks. Possibly this extra band of masonry had a more aesthetic function than that of aiding the stability and robustness of the facing. (figure S13).

Returning to the original masonry of the facing, on the plinth, there are up to three rows of rammed earth boxes of variable width ranging between 0.80 and 0.85 metres in height and between 1.95 and 2.10 metres in width. The typology of the rammed earth has the same characteristics as those of facing 2, thus the discussion we made about its possible chronology is equally valid.

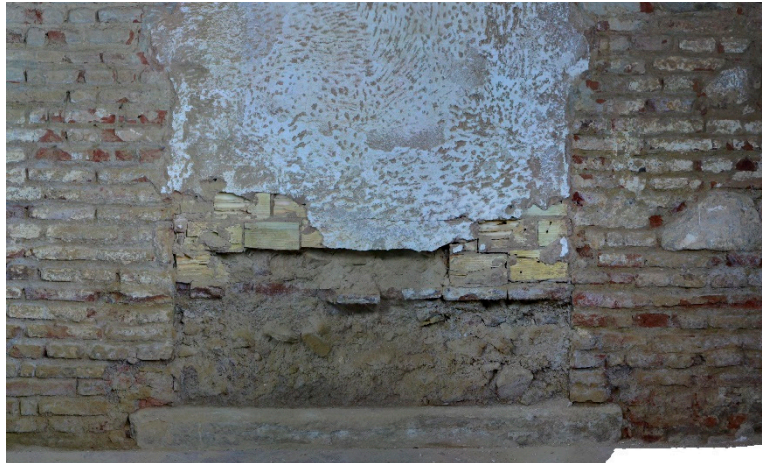
**Figure S14.** Start of the staircase indoor S of facing 3

To conclude this phase, we must highlight an important aspect of the door located to the S of the facing. It is the existence of a step with a tread height of between 0.18 and 0.20 metres. Bearing in mind that the floor in this place would be between 0.40 and 0.60 metres lower, it is highly probable that there are two or three more steps. All in all, this span makes sense in that it is the start of a staircase leading to the upper floor of the building attached to this wall on its E side (figure S14).

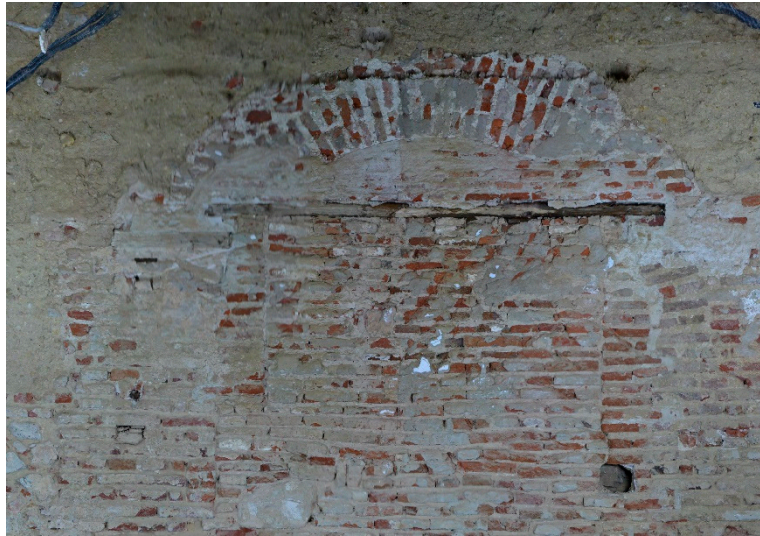
**Figure S15.** Start of the staircase indoor S of facing 3

The doorway of notable dimensions, opened in the previous phase, underwent a small alteration that slightly reduced its width and replaced the upper semi-circular arch with a straight wooden lintel. In the upper left corner of the new doorway, there is a small square opening (figure S15), which may have been a small niche.

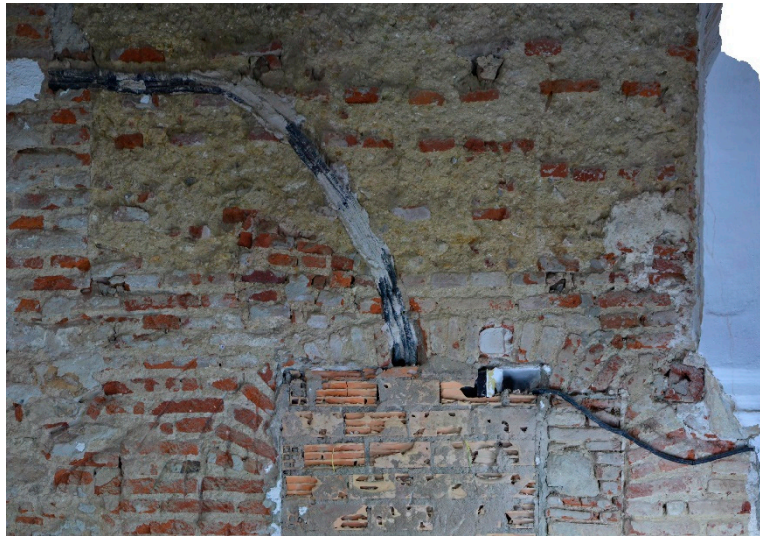
**Figure S17.** Detail of the factory of facing 4 of the original building; and basket-handle arch of the door of this facing

There is a hollow corresponding to a door, which has a bell-shaped arch in the upper lintel. It is framed by a brick spandrel like all the doors of the original building and all the hollows opened in the first cloister reform (figure S17).

The original masonry in this facing is very much obscured by the limited space available to document it, considering that most of the space is occupied by the hollow and its spandrel. However, on the E side, there is a brick wall and on the upper part of the wall, there are the mud-brick caissons that form the base of the facing. There is a small space between the door's spandrel and the buttress in which the masonry that also forms the building typology of the original building can be seen.
