# Characterization and Analysis of the Mortars of the Church of Santo Domingo in Quito (Ecuador)

**Abstract:** The religious art of the Dominican order is reflected in Santo Domingo Church, which was built between 1541 and 1688. This work of heritage architecture, one of the first to be built in the colonized city, was affected by multiple earthquakes, interventions, and constructions that have not been clearly recorded. A total of 13 samples were taken from the mortar inside the cloister, central nave, and side chapel, following the minor destruction-testing protocols and standards suggested by the research team. The analysis included mineral characterization studies and quantitative analysis by X-ray diffraction, petrographic, and scanning electron microscopy with microanalysis of the samples. The results showed the presence of volcanic aggregates and lime mortars, mortars of rustic composition and coarse manufacture. The results of mineralogical data and texture have allowed us to corroborate the historical information described by the chroniclers, to date relatively studied sites and to establish a hypothesis of constructive stages.

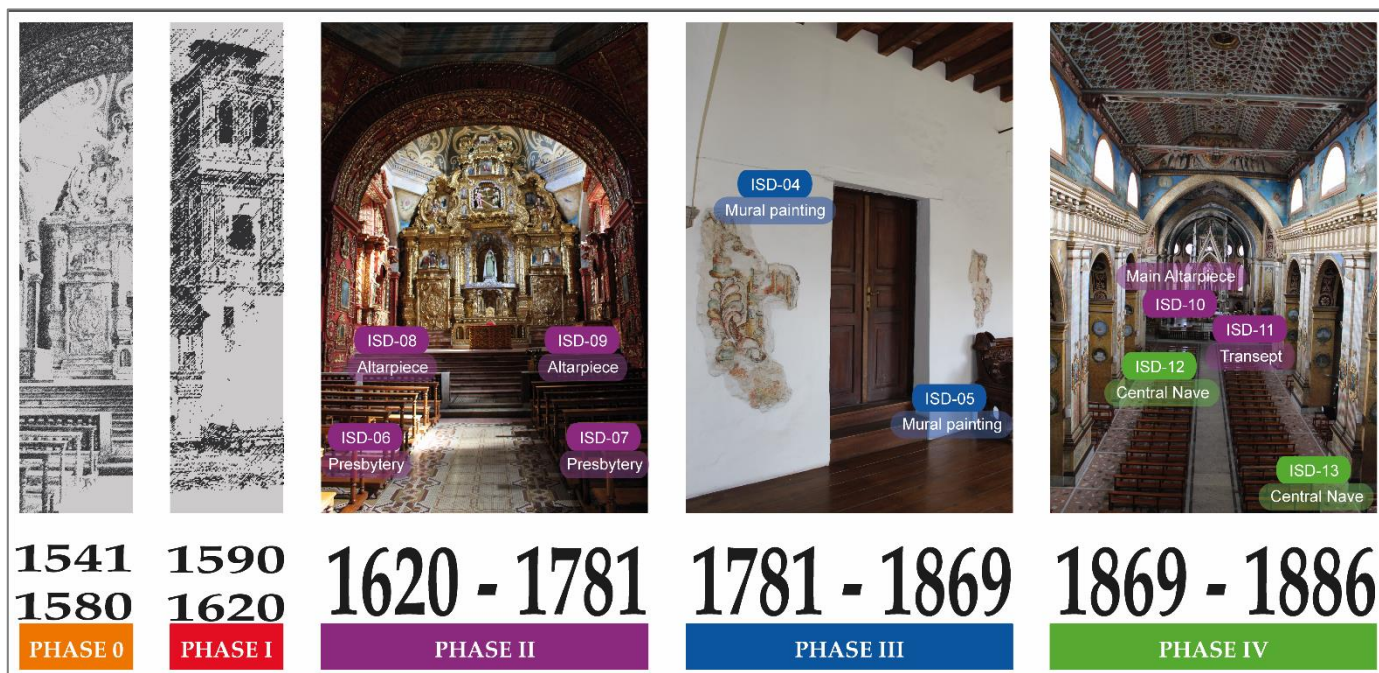
**Figure 2.** Image of the five chronological phases of the construction of the Santo Domingo church in 345 years. (1541–1580) Earth construction; (1590–1620) Phase I; (1620–1781) Photography of the Chapel of the Rosary; (1781–1869) Photography of the mural in the convent corridor; and (1869–1886) Photography from the central nave to the main altar, with the location of the places where the mortar samples were extracted.

The topographical conditions and accessibility to the property established that, between 1541 and 1580, the Dominican order built a provisional convent made of cedar wood and carved coffered ceilings (shown to Figure 2). It was located between the current courtyard of the main cloister and San Fernando College, according to studies by Josef Buys [8]. At the beginning of 1581, Francisco Becerra, who previously worked building temples in Mexico and Lima, began drawing the blueprints of the church and convent with serious modifications of the previous cloister with more generous dimensions for the faithful and religious, orienting it towards the south of the site [4,9].

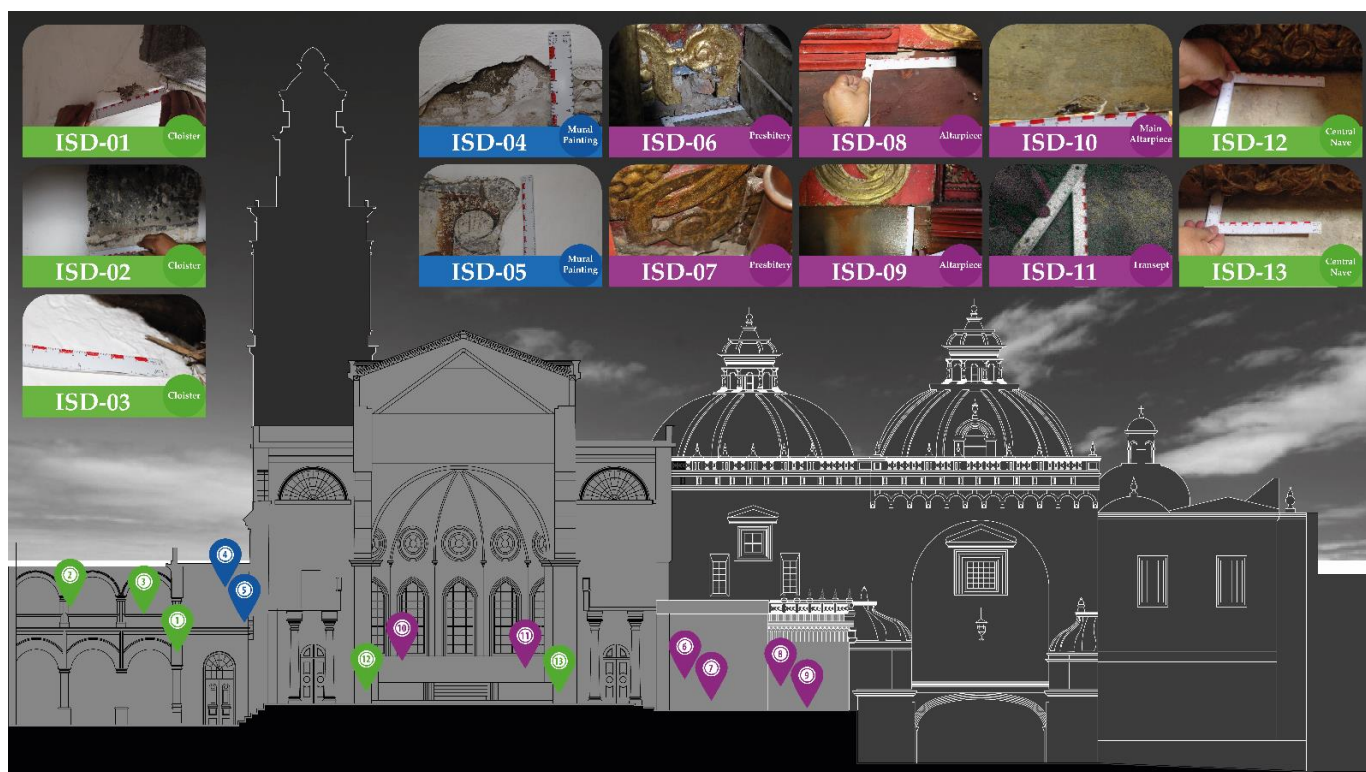
**Figure 3.** Blueprints of the church of Santo Domingo of Quito with the location of the analyzed samples; the figure describes the 13 samples with their locations.

For this work, 13 mortar samples (shown to Figure 3) were collected from the Santo Domingo church, considering the indications made by temple technicians about the places that presumably have not been altered in the rehabilitation stages. To carry out the sampling, three sectors were identified depending on the construction phase.

For Phase II (1620–1781), the samples were coded as ISD-06, ISD-07, ISD-08, ISD-09, ISD-10, and ISD-11. Samples 6, 7, 8, and 9 were extracted from the Chapel of the Virgin of the Rosary, sample 11 was extracted from the south surface of the transept, and sample 10 was part of the nineteenth century reconstruction of the novitiate.

In Phase III (1781–1869), samples coded as ISD-04 and ISD-05 were extracted from the surface of the wall of the convent cloister adjacent to the north wall of the temple.

For Phase IV (1869–1886), samples coded as ISD-01, ISD-02, ISD-03, ISD-12 and ISD-13 are identical to those of the Italian Reformation that intervened in the cloister of the convent (samples 1, 2, and 3) and the Central Nave of the Temple (samples 12 and 13).

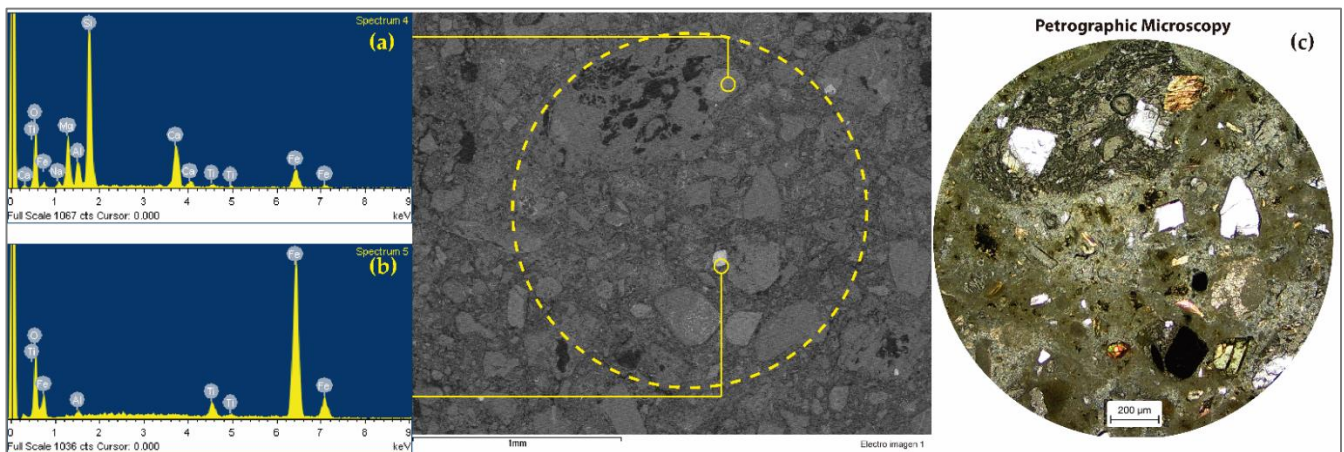
**Figure 5.** Sample ISD-08 (a,b) chemical analysis by EDX-SEM supported by a BSE image of lime mortar with volcanic aggregates, and (c) thin section image at 50× magnification under PM with X polarizer.

As shown in (Figure 5) of sample ISD-08, this EDX analysis was performed at nine different points of the main chemical elements. We have identified relevant points: (a) spectrum 4 with Si, Mg, Ti, Ca, Al, and Fe; (b) spectrum 5 with Fe, Ti, and Al; (c) an image obtained at  $200\times$  magnification of the petrographic microscope that allows visualizing the properties of double refraction or crystallographic directions of the sample of the Chapel of the Rosary by controlling the contrast of the image and color variation.

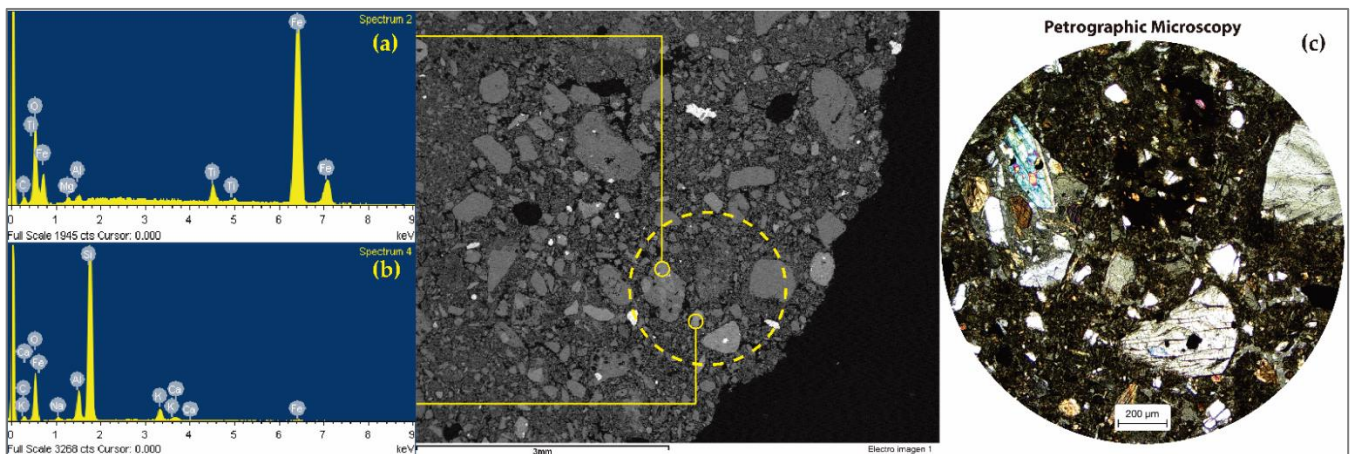
**Figure 6.** Sample ISD-11 (a,b) chemical analysis by EDX-SEM supported by a BSE image of lime mortar with volcanic aggregates, and (c) thin section image at 20× magnification under PM with X polarizer.

In the case of sample ISD-11 (Figure 6), this EDX analysis was performed at six different points of the main chemical elements, and we have pointed out some relevant points: (a) spectrum 2 with Fe, Ti, Al, and Mg; (b) spectrum 4 with Si, Al, Ca, K, and Na; (c) an image obtained at  $200\times$  magnification of the petrographic microscope that allows visualizing the properties of double refraction or crystallographic directions of the sample from the lower part of the transept by controlling the contrast of the image and color variation.

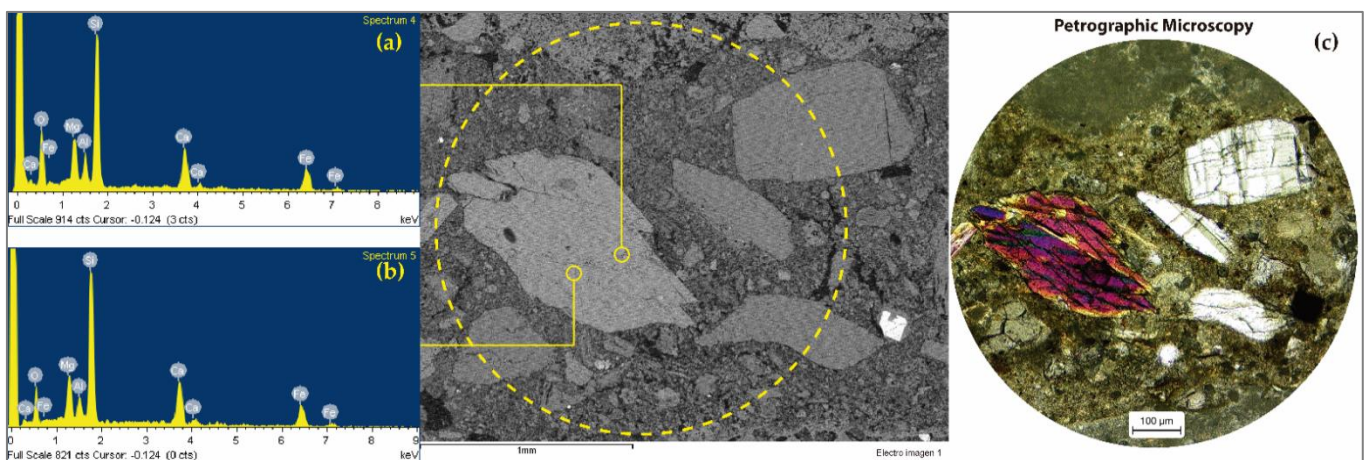
**Figure 7.** Sample ISD-05 (a,b) chemical analysis by EDX-SEM supported by a BSE image of lime mortar with volcanic aggregates, and (c) thin section image at 150× magnification under PM with X polarizer.

EDX analysis of sample ISD-05 (Figure 7) was performed at nine different points of the main chemical elements. We have pointed out some relevant points: (a) spectrum 4 with Si, Mg, Ca, Al, and Fe; (b) spectrum 5 with Si, Mg, Ca, Al, and Fe; (c) an image obtained at  $500\times$  magnification of the petrographic microscope that allows visualizing the properties of double refraction or crystallographic directions of the sample of coating of mural painting by controlling the contrast of the image and color variation.

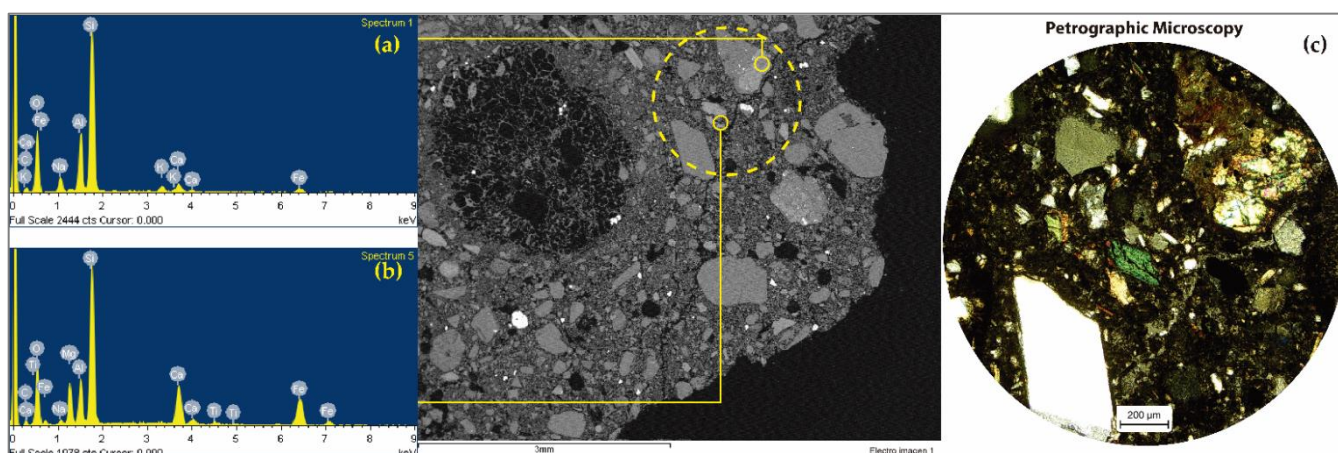
**Figure 8.** Sample ISD-12 (a,b) chemical analysis by EDX-SEM supported by a BSE image of lime mortar with volcanic aggregates; and (c) thin section image at  $50\times$  magnification under PM with X polarizer.

Finally, EDX analysis of sample ISD-12 (Figure 8) was performed at nine different points of the main chemical elements, and we have pointed out relevant points: (a) spectrum 1 with Si, Fe, Al, Ca, Na, and K; (b) spectrum 5 with Si, Mg, Ti, Al, Fe, Na, Ca, and Ti; (c) an image obtained at  $200\times$  magnification of the petrographic microscope that allows visualizing the properties of double refraction or crystallographic directions of the sample of the central nave of the temple by controlling the contrast of the image and color variation.
