# The Susceptibility to Salt Fog Degradation of Stone Cladding Materials: A Laboratory Case Study on Two Limestones from Portugal

**Keywords:** natural stone; building cladding; aging; salt-fog; flexural strength

**Citation:** Pires, V.; Rosa, L.G.; Amaral, P.M.; Simão, J.A.R. The Susceptibility to Salt Fog Degradation of Stone Cladding Materials: A Laboratory Case Study on Two Limestones from Portugal. *Heritage* **2023**, *6*, 492–504. <https://doi.org/10.3390/heritage6010026>

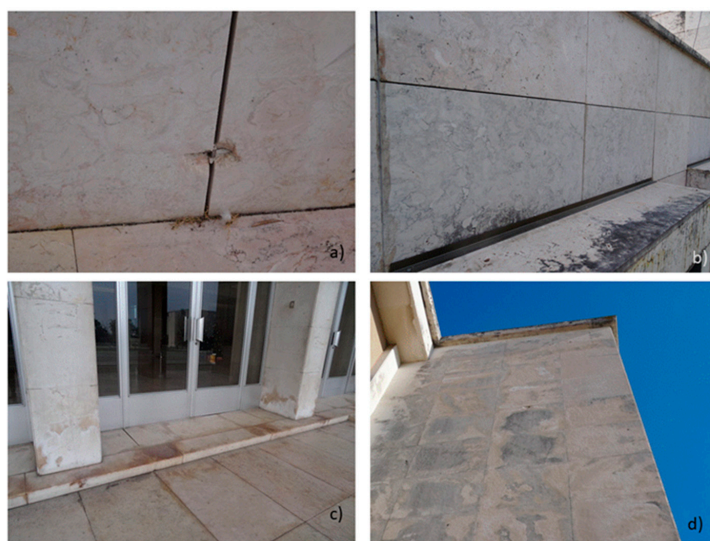
**Figure 1.** Examples of natural stone facade reactions to environmental conditions: (a) anchor rupture leading to strength loss; (b) biocolonization showing a relevant colour change; (c) white stains from saline efflorescence; (d) dark stains from water absorption, which might lead to slab detachment (photo credits: Vera Pires).

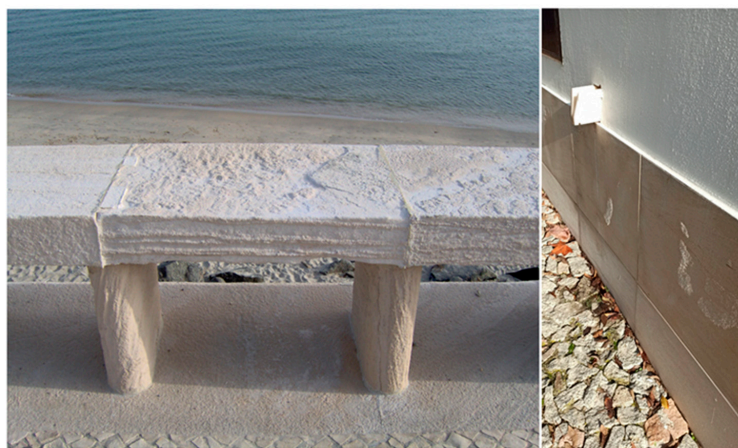
**Figure 2.** Examples of limestone elements subjected to natural salt weathering in a coastal area (photo credits: Joaquim Simão and Carla Lisci).

Salt fog activity involves mechanisms such as salt crystallization and deposition of salt on the stones surface, salt solution penetration in stone pores, and further salt expansion at each repeated imbibition–drying cycles, which cause the increase in voids in the stone framework, followed by removal of soluble salts and minerals that might lead to weight loss, porosity increase, and mechanical decay [16] (Figure 2).

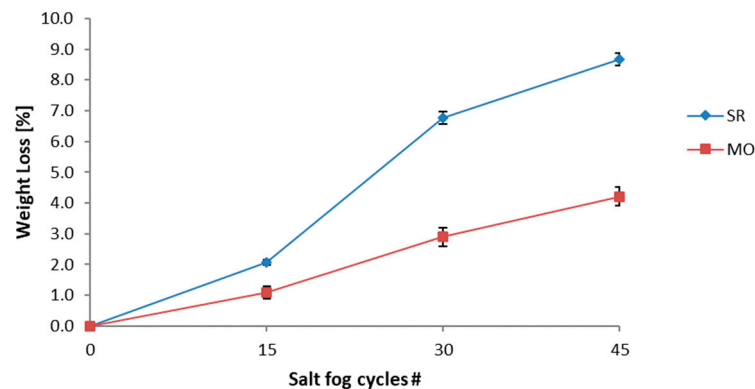
**Figure 6.** Average weight loss (%) evolution assessment of the studied limestones: MO and SR. For this assessment, 10 specimens were considered per lithotype.

Weight loss assessment allowed the following observations: the highest weight loss (%) was achieved by SR limestone ( $8.7 \pm 0.3\%$ ) at the end of the experiment. Comparatively, MO lost approximately 50% less ( $4.2 \pm 0.2\%$ ) (Figure 6).

The differences between SR and MO weight loss can be explained because SR has higher open porosity (approx. 17%) comparative to MO (approx. 6%), as presented in Table 1. Due to this difference in open porosity, SR has a higher superficial area, which led to a higher degree of salt deposition and crystallization on the limestone oolites, pores, and other features such as bioclasts, and consequently a higher degree of disintegration/crumbling—detachment of aggregates of grains from the substrate [39,40].

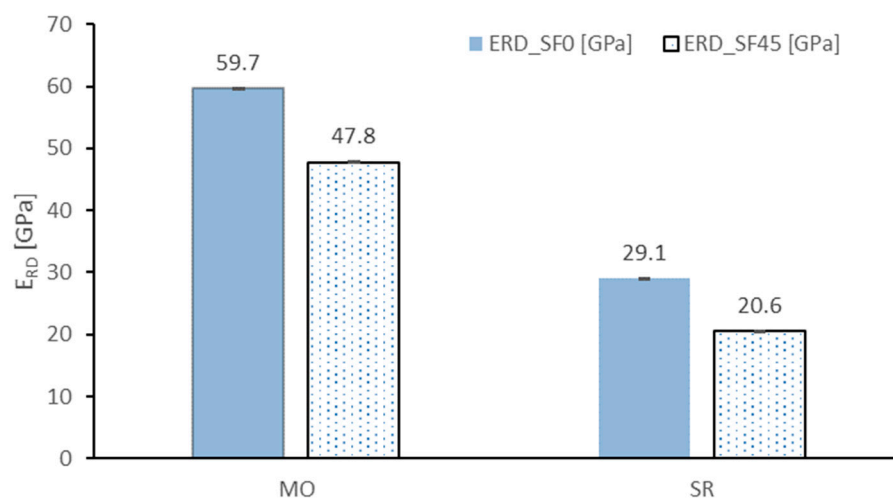
**Figure 7.** Elastic modulus ( $E_{RD}$ ) mean value comparison before and after 45 salt fog cycles.

In the present study, the ERD average values, depicted in Figure 7, show an average drop of 29% comparative to reference values for SR (altered from  $59.7 \pm 0.01$  GPa to  $47.8 \pm 0.02$  GPa). The MO elastic modulus decay was lower, showing an average drop of 20% (altered from  $29.1 \pm 0.03$  to  $20.6 \pm 0.05$  GPa) (Figure 7).
