# Assessing the Impact of the 2023 Kahramanmaraş Earthquake on Cultural Heritage Sites Using High-Resolution SAR Images

**Abstract:** Earthquakes are hard to predict, and the destruction caused by the events far outstrip the monetary damage. Important cultural heritage sites functioning as places of community and identity have a value which evades pure pecuniary calculation. This makes understanding the complete economic and social impact of earthquakes a difficult and daunting task. We use high-resolution TerraSAR-X data acquired after the 2023 earthquake in Turkey to assess its impact on selected cultural heritage sites. Leveraging different orbit and incidence angles of image acquisition allow us to show the difficulties in interpreting high-resolution SAR data. While large impacts, like the complete collapse of structures, can be detected successfully, small-scale damage and partial collapses are often difficult to detect from single SAR images. We find that single SAR scene interpretation for damage assessment of cultural heritage is not a viable option. While contextualizing data might help to understand the situation, SAR is only helpful if data of the intact cultural herit

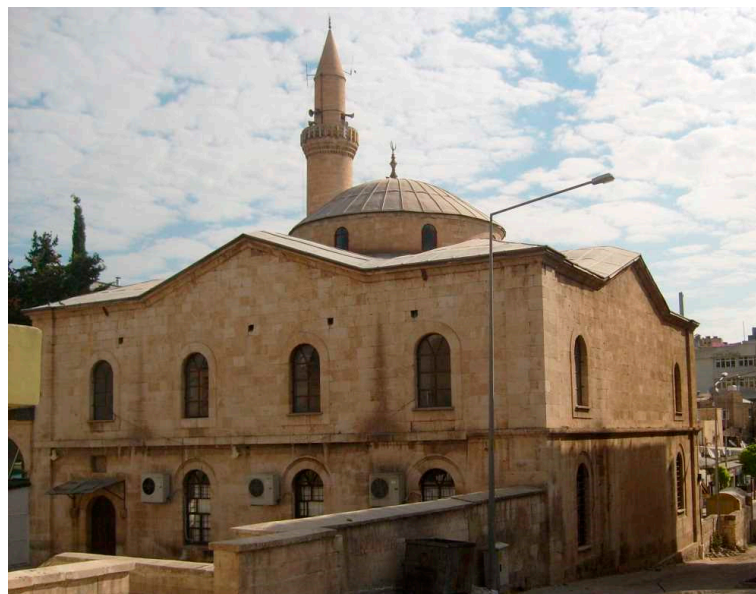
**Figure 3.** Adiyaman Ulu Mosque [17].

With its location, architectural design, and history, the Adiyaman Ulu Mosque (Figure 3), constructed as the city's first great mosque, dates back to the 16th century. Constructed by Bozkurt Bey in the Dulkadirli Principality, this unique piece of architecture was built using bricks with the dome centrally positioned on the roof. Mosques with central domes first appeared during the Ottoman Empire's classical era [16]. The mosque was built with stone bricks from the area and had one minaret in the northwest. The earthquake caused significant damage. Only the walls on the north and west sides were standing together with the part of the roof on the northwest of the mosque.

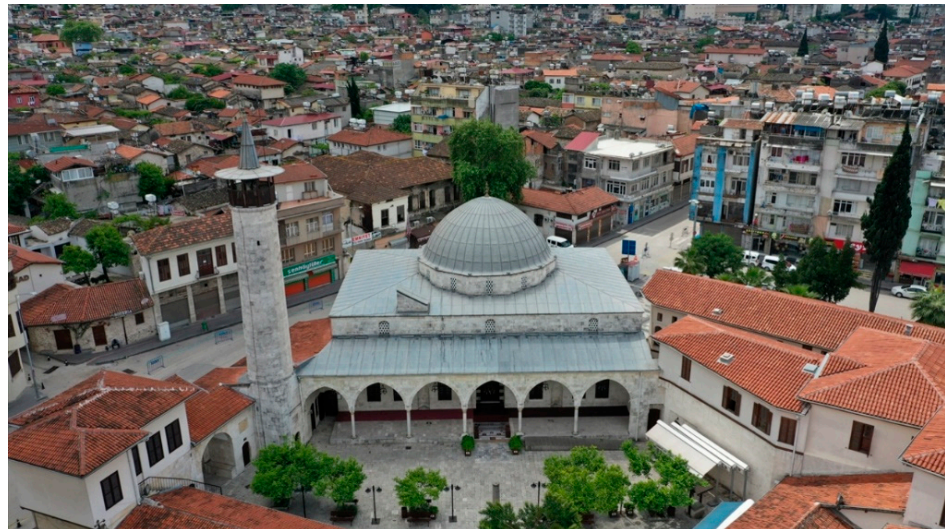
**Figure 4.** Habib-i Neccar Mosque [19].

A religious man named Habib-i Neccar worked to spread Christianity while living in Antakya during the Roman era (64 BC–396 AD). The precise date and method of construction of the Habibi Neccar mosque (Figure 4) are unknown. There are rumors that the mosque was originally a chapel, which the Syrian Mamluks had destroyed and replaced with a mosque [18]. Habib-I Neccar mosque, built with stone blocks, which had one minaret on the northeast of the mosque, had incurred significant damage to the dome with about 60% of the roof collapsing.

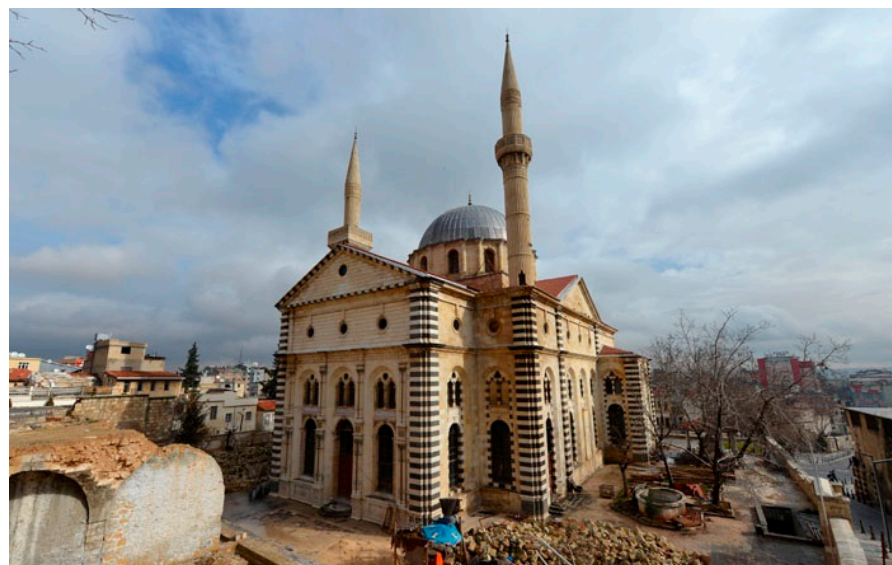
**Figure 5.** Kurtuluş Mosque [21].

Kurtuluş Mosque (Figure 5), which was the Saint Mary Church when it was built in the 17th century by the Armenians, was one of the biggest churches in Turkey. After 1930, the church was repurposed for prison use and later converted into a mosque in 1980 [20]. The mosque is made of small-scale stone bricks with a giant dome and two minarets beside the dome. This heritage site suffered minor damage to the dome and the two minarets. When the dome collapsed into the mosque, the upper part of the minarets broke off.

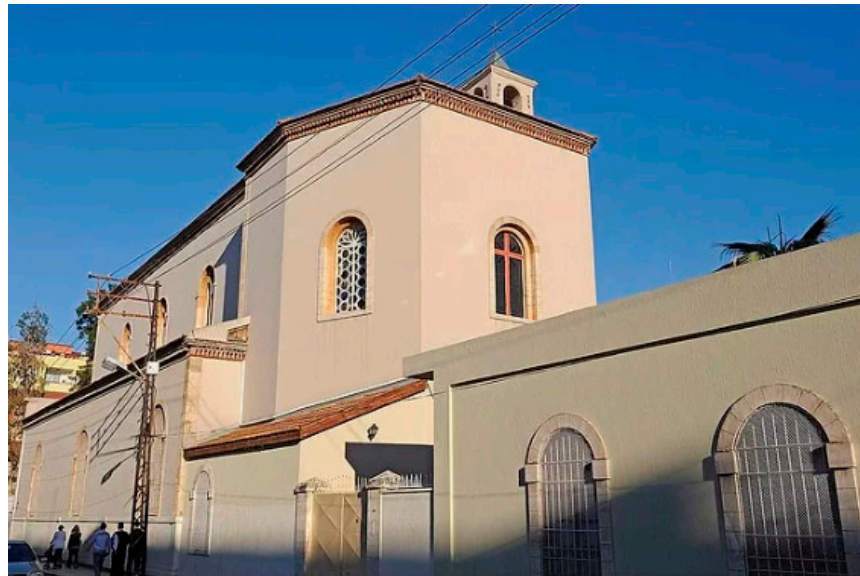
**Figure 7.** İskenderun Latin Catholic Church [25].

The church was first constructed in 1871, and then a monastery was added for the priests to live in. The 152-year-old church (Figure 7), which was made of red bricks (terracotta), experienced significant damage during the earthquake [24]. The roof of the church and the wall on the west side collapsed. The bell tower of the church remains in a standing position.

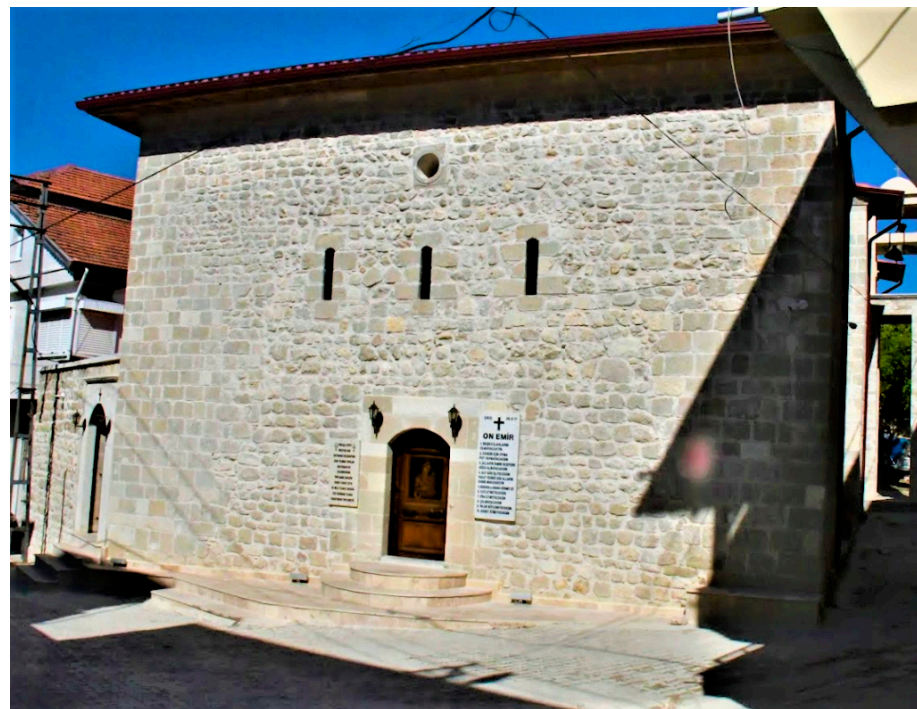
**Figure 8.** Saint Mary Orthodox Church [27].

The Greek Orthodox Church of the Virgin Mary (Figure 8), considered 700 years old, was almost entirely destroyed by the earthquake, except for the bell tower and some wall remnants on its western and southern parts [26]. It was made of stone blocks on the edge and irregularly shaped stones bonded with cement.

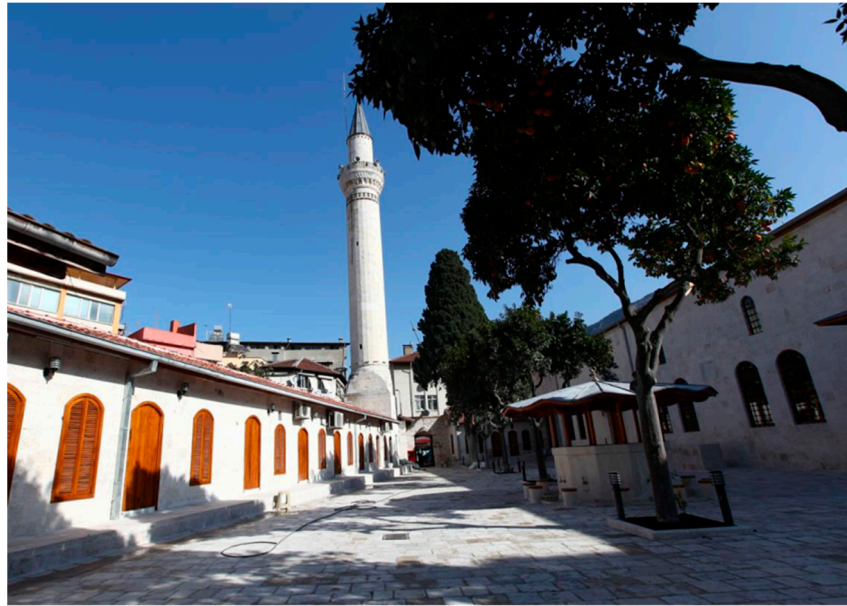
**Figure 9.** Hatay Ulu Mosque [29].

The exact date of construction of the mosque is not known. The oldest information that can be determined on this subject is the date of 1271 in the chess-shaped Kufic inscription on the minaret, which belongs to the period when the Mamluk Sultan I. Baybars dominated the city [28] (Figure 9). The mosque was built using a combination of stone blocks and

irregularly shaped stones. During the earthquake, the entire structure, including the minarets, collapsed.

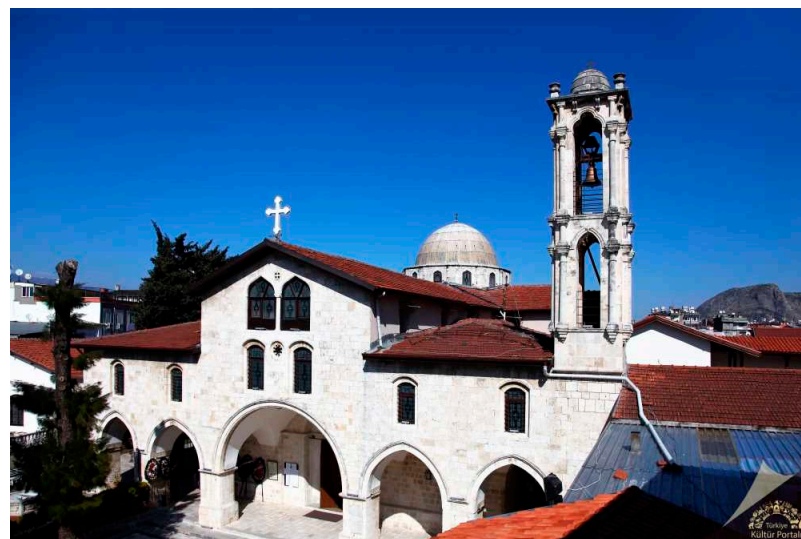
**Figure 10.** Greek Orthodox Church [31].

The Orthodox Church (Figure 10) was built at the beginning of the 1860s but was damaged in the 1872 earthquake. The Orthodox Church was established for worship in 1900 and is recorded as the location where the three monotheistic religions coexist. It has a rectangular shape and a bell tower in the southern part of the church [30]. The primary materials of the church were small-scale stone blocks and irregularly shaped stones as fillers inside the walls. The church suffered significant damage during the earthquake, and only some wall remnants are standing on the east and northeast sides.

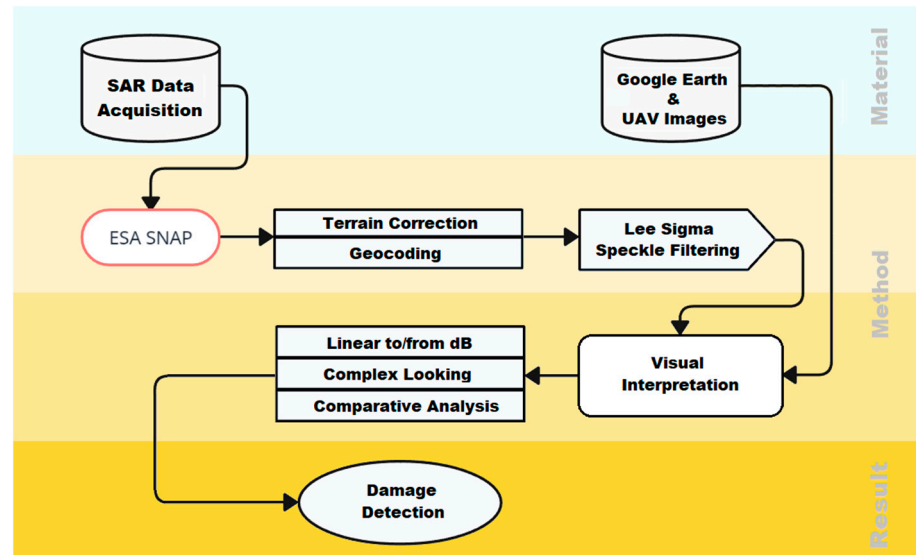
Figure 11. Workflow.

The workflow in Figure 11 simplifies the series of steps taken. We acquired TerraSAR-X images and applied speckle filtering and geo-correction before the interpretation step. In the interpretation step, the color transformation from the SAR backscattering within a

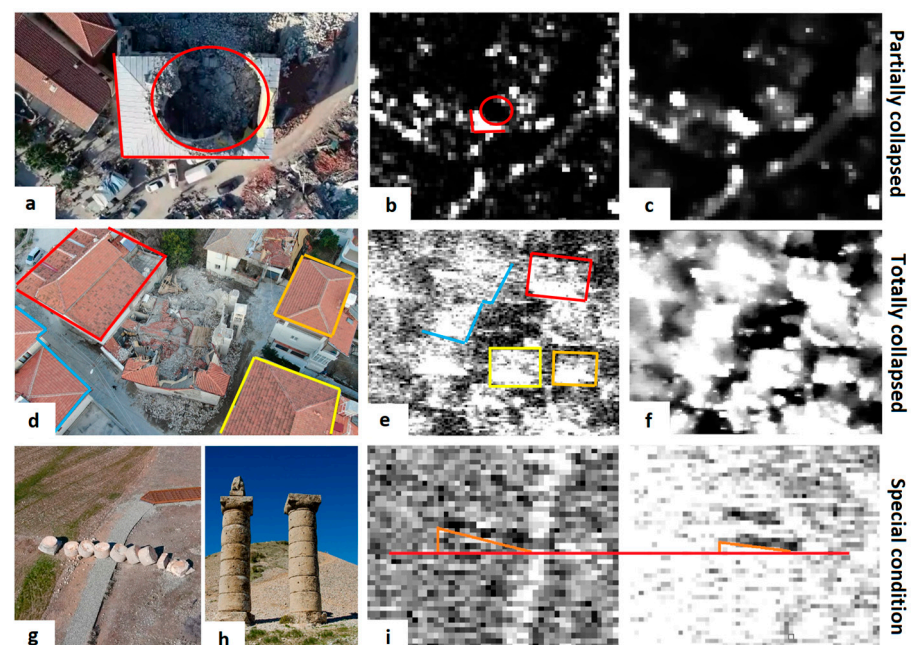
We devised a mechanism for detecting structural damage, because we were dealing with only post-disaster SAR images due to a lack of archived high-resolution images (Figure 13). To do this, we categorized the damage:

- **Partially collapsed:** In this situation, the shape and nature of the damage, e.g., Circular dome, curvature of the roof edges, and remaining walls, are used to identify damage.
- **Totally collapsed:** With little or no reflectance, we relied heavily on backscatter from the surrounding structures. In Figure 13, images a and b, we have marked the buildings around the target location, which helped us to identify the damage.
- **Special conditions:** In Karakus Tumulus, the acquisition parameters and the standing columns’ shadow angle were vital in identifying the collapsed column.

**Figure 13.** Mechanism for detecting different types of structural damage. **Partially collapsed:** (a) UAV image [37], (b) SAR image, (c) Filtered SAR image (Red lines and circle corresponds to the damage in UAV and SAR image). **Totally collapsed:** (d) UAV image [38], (e) SAR image, (f) Filtered SAR image (Shapes and colors in the UAV image corresponds to the backscatter in the SAR image). **Special Condition:** (g) UAV image of collapsed column [39], (h) Terrestrial image of standing columns [40], (i) SAR images (Drawing highlights the angle difference between backscatter of fallen column and shadow of standing column).

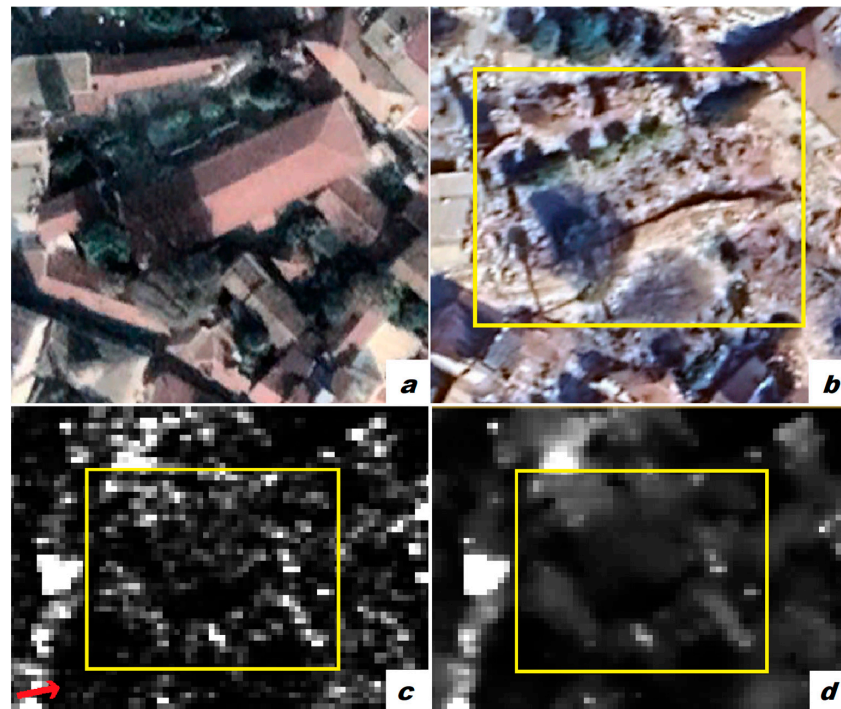
In some cultural heritage sites, like the Hatay Ulu Mosque (Figure 14) ( $36^{\circ}12'6.98''$  N,  $36^{\circ}9'42.74''$  E), the damage was extensive, and the mosque completely collapsed due to the earthquake. In situations like this, where the entire structure is damaged, detecting the location and damage in a single SAR image was even more complex. In comparison, detecting a partly damaged roof through the backscattering effect would be easier. Still, this example was harder to interpret because the only way to verify was by checking the structures' location and comparing coordinates.

**Figure 14.** Hatay ulu mosque. (a) Google Earth image before the earthquake, (b) Google Earth image after earthquake, (c) SAR image, (d) Filtered SAR image. (Yellow polygons indicate structure and red arrows indicate the viewing direction of the sensor)(SAR Acquisition date: 23 March 2023—© DLR, 2023).

Furthermore, we can see how the nature of the structural damage made a visible difference between Adiyaman Ulu mosque, Habib-i Neccar mosque, and Hatay Ulu mosque, where we could detect strong backscatter from the remaining northwest corner of the mosque roof of the Adiyaman Ulu mosque (Figure 17) and the collapsed circular dome of the Habib-i Neccar mosque (Figure 18). In the case of the Hatay Ulu mosque, there was almost no backscattering because of the entire roof collapse (Figure 14).

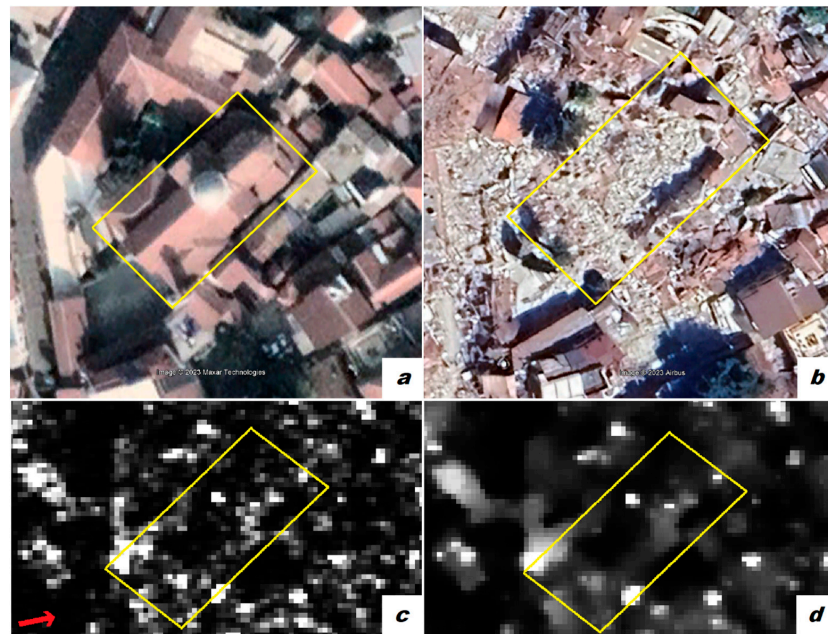
The Greek Orthodox Church (Figure 15) ( $36^{\circ}12'0.29''$  N,  $36^{\circ}9'39.65''$  E) is one of the cultural heritage sites that collapsed, leaving some walls on the northeast side intact. By comparing the church coordinates from Google Earth and the visual interpretation of the SAR image, we could not detect any linear backscatter, which should indicate the structure's roof. Therefore, the lack of consistent backscatters from the location possibly indicates heavy damage.

**Figure 15.** Greek Orthodox Church. (a) Google Earth image before the earthquake, (b) Google Earth image after earthquake, (c) SAR image, (d) Filtered SAR image. (Yellow polygons indicate structure and red arrows indicate the viewing direction of the sensor) (SAR Acquisition date: 23 March 2023—© DLR, 2023).

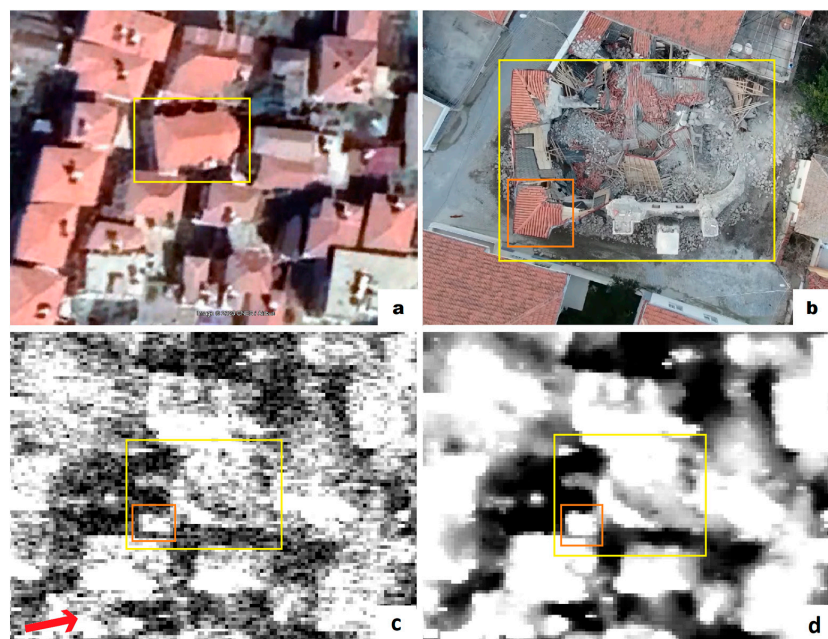
The situation of the Saint Mary Church in Hatay (Figure 16) ( $36^{\circ}6'5.48''$  N,  $36^{\circ}15'35.19''$  E) is unique because it is an almost wholly collapsed structure surrounded by residential buildings that are standing without any major or visible damage. Therefore, that situation allowed us to detect the missing structure by comparing backscattering and tonal differences from rooftops. As shown in the SAR image (Figure 16), the church's location is identified as a square area with a relative mix of dark and bright pixels surrounded by the brightly scattering roofs of the standing structures around it. Since buildings in that location are almost the same height and similar sizes, we would expect similar backscatter from the roofs.

**Figure 16.** Saint Mary Church. (a) Google Earth image before the earthquake, (b) UAV image after the earthquake [41], (c) SAR image, (d) Filtered SAR image. The yellow square shows the church area

where we expected strong backscatter from the roof, like other structures. The orange square shows the part of the standing roof corner of the church. (Yellow polygons indicate structure, orange polygon indicate standing roof corner and red arrows indicate the viewing direction of the sensor) (SAR Acquisition date: 12 May 2023—© DLR, 2023).

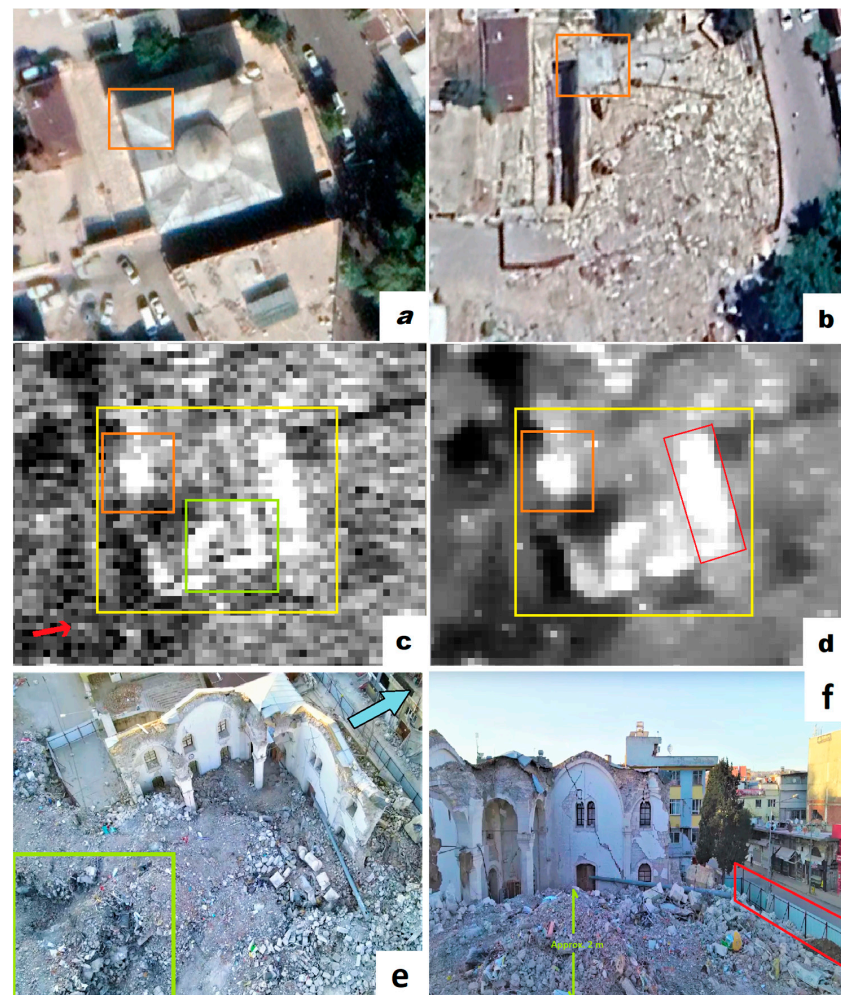
The Adiyaman Ulu Mosque (Figure 17) ( $37^{\circ}45'34.21''$  N,  $38^{\circ}16'38.70''$  E) mostly collapsed after the earthquake, and only the north and west walls and a small portion of the northwest corner of the roof were standing. Because of its square roof with a dome in the middle, we expected consistent backscatter from the SAR image. Still, in the result, we were only able to detect strong backscatter from the remaining northwest corner of the mosque; a very strong backscatter from the makeshift aluminum fence barrier marked with the red rectangle (see Figure 17f), and the approximately 2 m high rubble around the collapsed south and east wall highlighted with the green square (see Figure 17e,f marked) are visible in the SAR images.

**Figure 17.** Adiyaman Ulu Mosque. (a) Google Earth image before the earthquake, (b) Google Earth image after earthquake, (c) SAR image, (d) Filtered SAR image, (e) Aerial view indicating the rubble heap with green square [42], (f) Approximate height of the rubble (Green line) and the brightly scattering makeshift aluminum fence (Red marking) [42]. The orange square indicates the area where the standing part of the roof is northwest. The blue arrow in 'e' indicates north. (Yellow polygons indicate structure and red arrows indicate the viewing direction of the sensor) (SAR Acquisition date: 30 March 2023—© DLR, 2023).

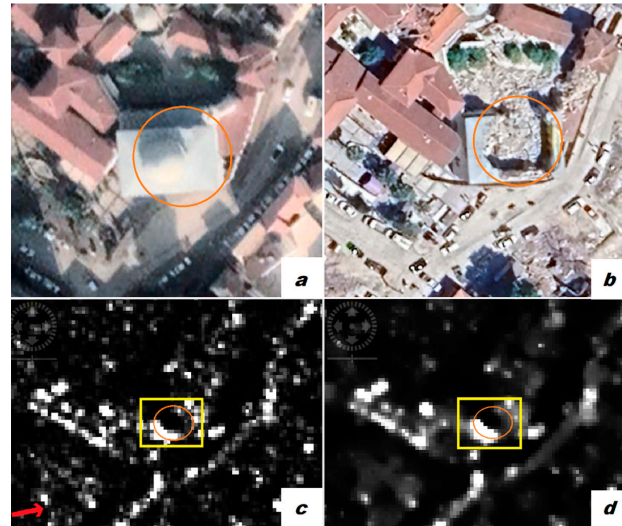
The Habib-i Neccar Mosque (Figure 18) in Hatay city center ( $36^{\circ}12'5.60''$  N,  $36^{\circ}9'55.93''$  E) was heavily damaged, and the dome of the mosque and minaret collapsed during the earthquake. Like in the Adiyaman Ulu Mosque example, there should have been a strong backscatter from the mosque's roof in the SAR image, but that was not the case because of the collapsed portion of the roof.

**Figure 18.** Habib-i Neccar mosque. (a) Google Earth image before the earthquake, (b) Google Earth image after earthquake, (c) SAR image, (d) Filtered SAR image. The orange circle indicates the area where the mosque's roof is collapsed. (Yellow polygons indicate structure and red arrows indicate the viewing direction of the sensor) (SAR Acquisition date: 23 March 2023—© DLR, 2023).

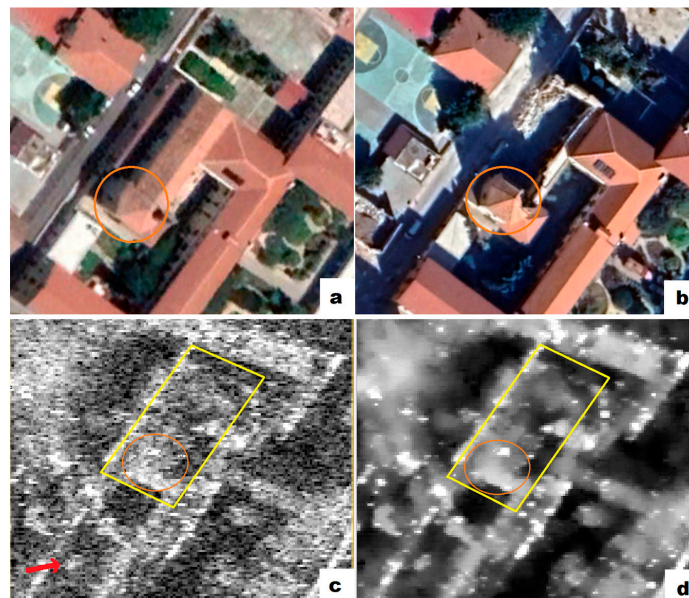
The Hatay Latin Catholic Church (Figure 19) ( $36^{\circ}35'28.11''$  N,  $36^{\circ}10'5.31''$  E) lost its roof, except for the abscissa and wall on the northwest part of the structure. In the SAR images, we detected backscatter from the roof of the abscissa and shadows on the south of it, outside of the church. The rest of the structure in the yellow area in Figure 19 is backscattered with different values of pixels, which are not consistent and linear.

**Figure 19.** Latin Catholic Church. (a) Google Earth image before the earthquake, (b) Google Earth image after earthquake, (c) SAR image, (d) Filtered SAR image. The orange circle indicates the abscissa where the roof is still standing. (Yellow polygons indicate structure and red arrows indicate the viewing direction of the sensor) (SAR Acquisition date: 20 April 2023—© DLR, 2023).

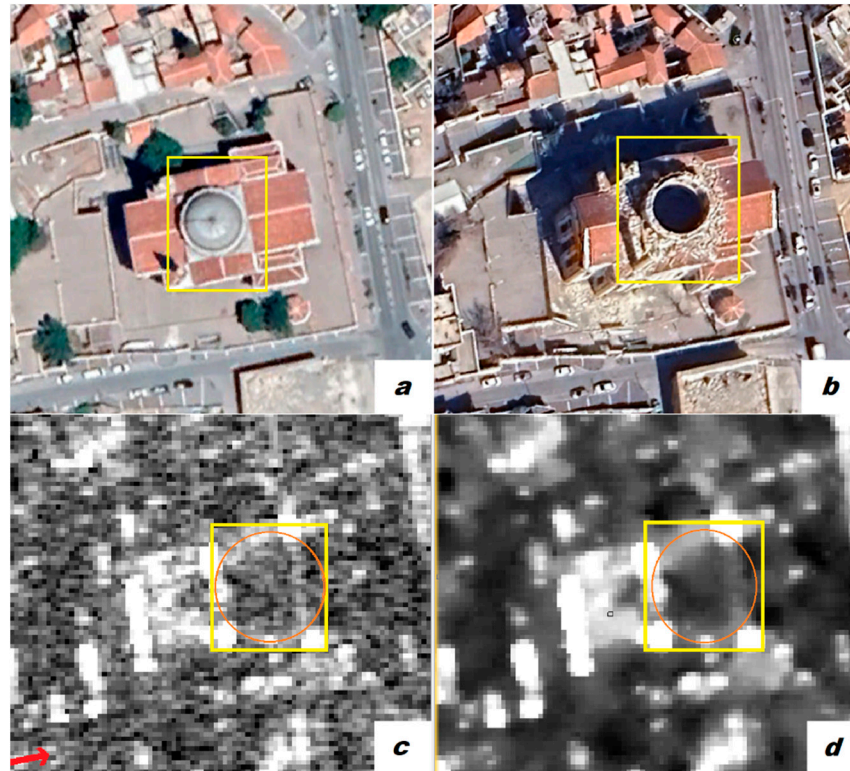
Another case is the Kurtuluş Mosque (Figure 20) ( $37^{\circ}3'37.03''$  N,  $37^{\circ}22'32.32''$  E). Its dome and two minarets were damaged, but the structural frame of the mosque was not damaged. The collapsed dome in the middle of the roof did not backscatter in the SAR image, allowing us to examine the damage in a circular form (Figure 20).

**Figure 20.** Kurtuluş Mosque. (a) Google Earth image before the earthquake, (b) Google Earth image after earthquake, (c) SAR image, (d) Filtered SAR image. The orange circle indicates the collapsed dome where we do not acquire strong backscatter. (Yellow polygons indicate structure and red arrows indicate the viewing direction of the sensor) (SAR Acquisition date: 29 March 2023—© DLR, 2023).

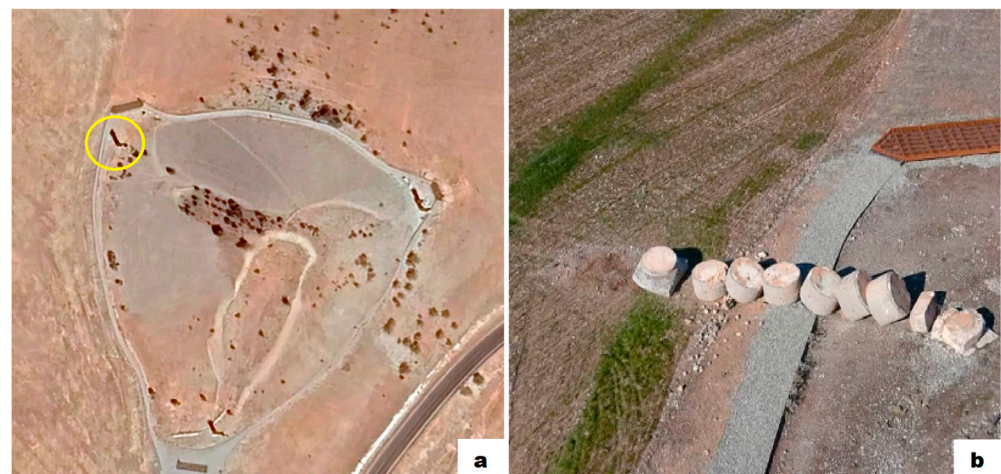
The Column in Karakuş Tumulus (Figure 21) ( $37^{\circ}52'11.41''$  N,  $38^{\circ}35'14.26''$  E) is a great example that shows the importance of using different orbits and incidence angles in SAR images, especially for visual interpretation.

**Figure 21.** Karakus Tumulus (a) and collapsed handshake relief (b) (Yellow circle shows the location of the collapsed column).

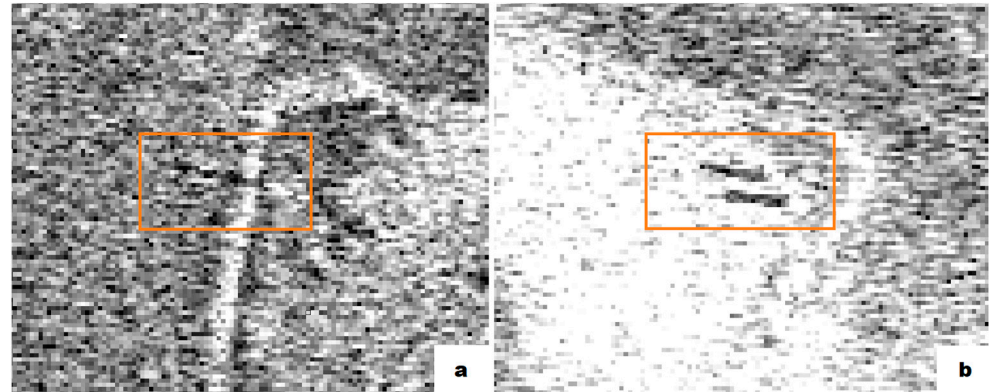
The tumulus has four columns, and it is easy to confuse shadows with the damage since their shadow fell to the west side in the first image taken from descending orbit, which is the direction of the column collapse (Figure 22). We tried to illustrate the backscatter of the collapsed column in Figure 23. In the image, it is clear that the angle of the collapsed column is slightly different from the shadow of the standing columns.

**Figure 22.** (a) Collapsed column on the northwest of the tumulus, (b) Shadow of standing columns on the northeast of the tumulus. (Orange polygon shows the location columns) (SAR Acquisition date: 12 March 2023, Incidence angle center:  $44.26^\circ$ —© DLR, 2023).

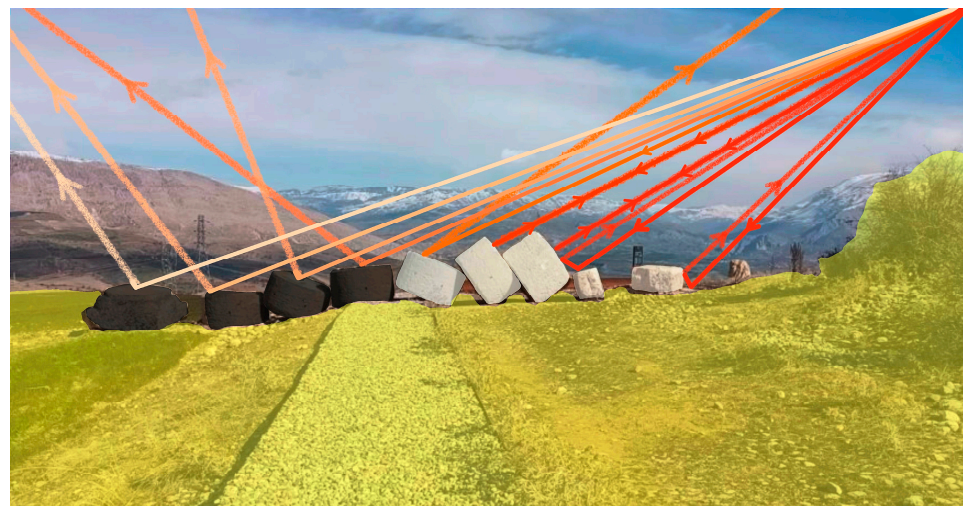
**Figure 23.** Illustration of backscatter of the collapsed column from descending orbit in Figure 22a [43] (The color variation highlights the strength of the signal. Darker shades bounces back to the sensor.)

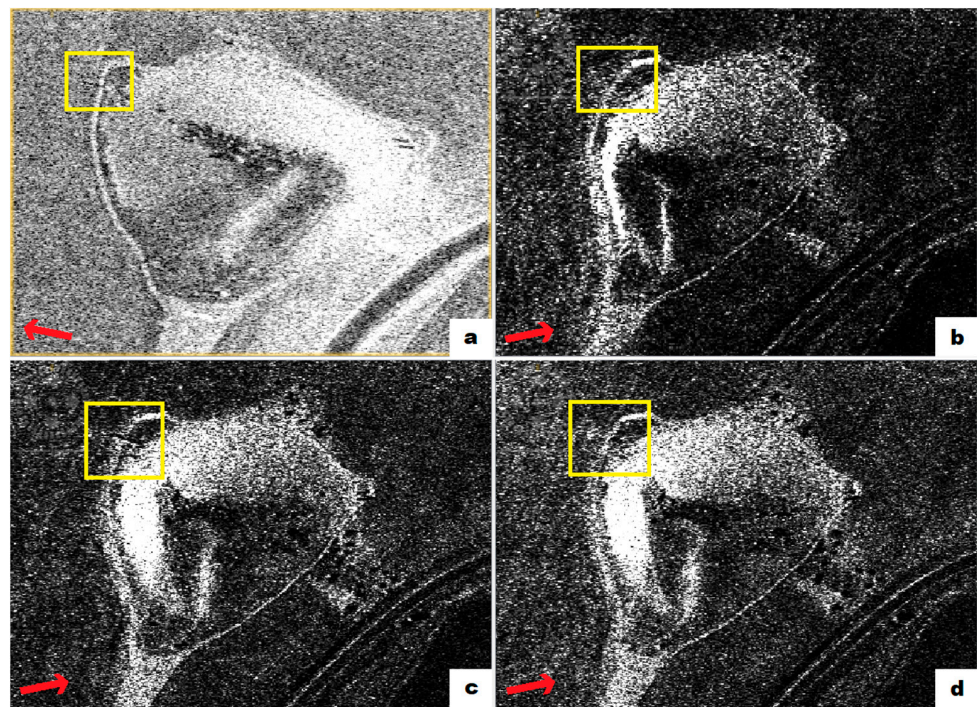
In the first image, it was challenging to observe this because the damaged/fallen column and the shadow of the standing columns appear the same. There is a slight difference between their angles but, to be sure, we acquired more images and used different parameters. Out of the four SAR images we received, one (c) had a clear display of the collapsed column (Figure 24). A detailed look into the acquisition parameters of Figures 24–26 showed that three (b–d) out of four images had the same pass (Ascending) and two (c,d) of them had the same incidence angle center of  $43.16^\circ$  but different first, last, near, and far longitude and latitude. Figures 24–26 show the Karakuş Tumulus terrain corrected SAR images, zoomed images onto the column, and filtered images.

**Figure 24.** Acquired SAR images of Karakus Tumulus. Out of four images, only in image (c) can we clearly see the collapsed column. (SAR Acquisition dates; (a) 12 March 2023, Incidence angle center:  $44.26^\circ$ , (b) 21 April 2023, Incidence angle center:  $27.49^\circ$ , (c) 26 April 2023, Incidence angle center:  $43.16^\circ$ , (d) 7 April 2023, Incidence angle center:  $43.16^\circ$ —© DLR, 2023) (Yellow polygons indicate structure and red arrows indicate the viewing direction of the sensor).

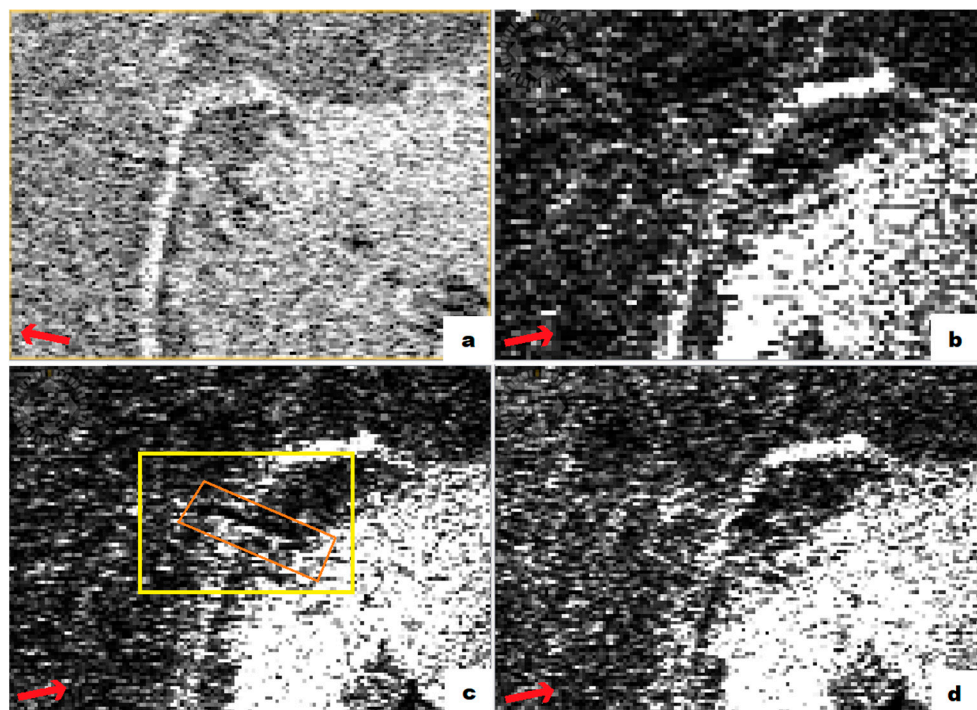
**Figure 25.** Zoomed SAR images into the collapsed column. The yellow polygon in image (c) indicates the area where the column is, orange polygon shows the collapsed column and red arrow indicate the viewing direction of the sensor (SAR Acquisition dates; (a) 12 March 2023, Incidence angle center:  $44.26^\circ$ , (b) 21 April 2023, Incidence angle center:  $27.49^\circ$ , (c) 26 April 2023, Incidence angle center:  $43.16^\circ$ , (d) 7 April 2023, Incidence angle center:  $43.16^\circ$ —© DLR, 2023).

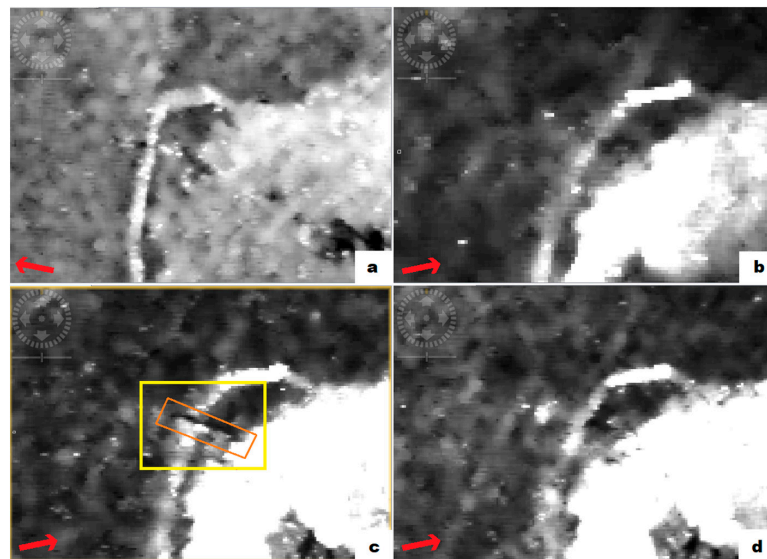
We could determine it was a collapsed column through visual recognition and examining all images with those differences, with and without filter.

**Figure 26.** Filtered SAR images of the collapsed column. The yellow polygon in image (c) indicates the area where the column is, orange polygon shows the collapsed column and red arrow indicate the viewing direction of the sensor (SAR Acquisition dates; (a) 12 March 2023, Incidence angle center:  $44.26^\circ$ , (b) 21 April 2023, Incidence angle center:  $27.49^\circ$ , (c) 26 April 2023, Incidence angle center:  $43.16^\circ$ , (d) 7 April 2023, Incidence angle center:  $43.16^\circ$ —© DLR, 2023).

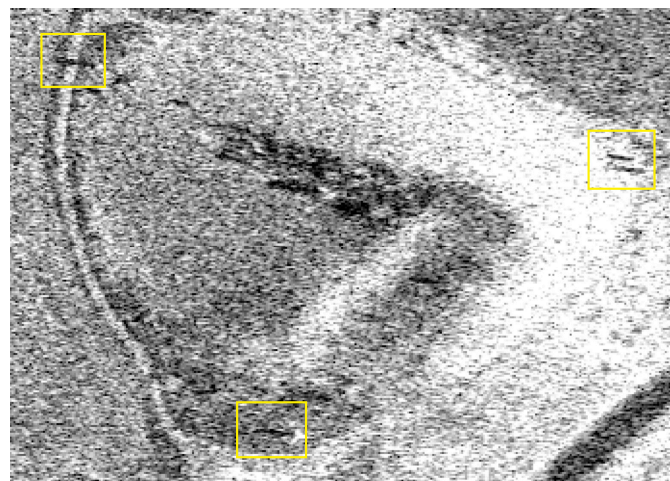
To validate the result of this section, we analyzed recently obtained images of the Karakus Tumulus with the same acquisition parameters after it was re-erected by archaeologists in Turkey a few months after the earthquake. It can be seen that the angles of the shadows of all = standing columns align now (Figure 27). The first image we acquired (from descending orbit) of the Karakus Tumulus, gave a faux shadow effect that could be misinterpreted as a standing column. However, we quickly observed that the supposed ‘shadow’ did not align with the other shadows. This necessitated the acquisition of more images with different parameters, mostly of ascending orbit and different incident angles. From the new images obtained from the ascending orbit, we could see the fallen column because, this time, the shadows naturally fall eastward (Figures 25 and 26). Therefore, acquiring a new SAR image from the descending orbit was crucial to compare the angles with the first image to verify our idea. In Figure 28, shadows of the first (a) and last (b) images taken from the Karakus Tumulus and the angular difference between their corresponding shadows can be compared.

**Figure 27.** SAR image of the Karakus Tumulus. Yellow squares show all four standing column shadows. (SAR Acquisition date: 24 August 2023—© DLR, 2023).

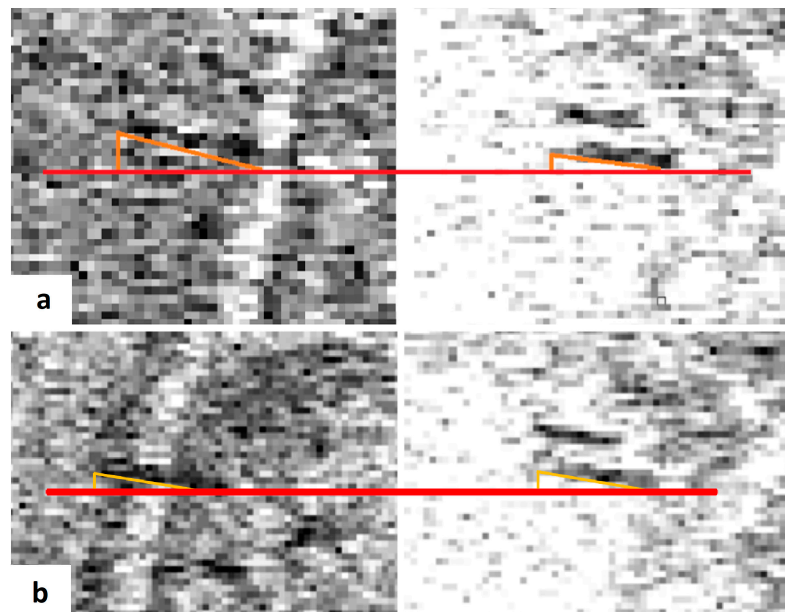
We could compare the results of the fallen and reconstructed columns to verify the mechanism we adopted to identify the damage.

**Figure 28.** (a) Shadow angle difference between the collapsed column and the standing one. (SAR Acquisition date: 12 March 2023), (b) The shadows of all standing columns are now aligned in the image taken after the column was re-erected. Yellow, orange and red lines are drawn to show the angle differences between columns and shadows. (SAR Acquisition date: 24 August 2023—© DLR, 2023).
