# An Interpretive Ruination Model of the Built Heritage in Inner Areas: The Case Study of the Neighbourhood Granforte in Leonforte

**Abstract:** In Italy, the current geography of abandonment is defined by the classification of the National Strategy of Inner Areas (NSIA). The support measures envisaged by the NSIA could contribute to reducing the marginality of inner areas and promote the protection, conservation, and enhancement of historic centres. In this perspective, actions on historical buildings should be selected based on a cognitive process aimed at specifying the phenomena that have led to the progressive abandonment of historical centres and a process aimed at identifying the values and dis-values. This research proposes a ruination model aimed at highlighting the risks that the built heritage of the inner areas are exposed to. This model was implemented for the case of the historic neighbourhood of Granforte in Leonforte. The model was developed based on a qualitative–quantitative approach aimed at detecting the preservation state and built heritage use; analysing the building fabric development; identifying the ruination drivers; building a building units database; de

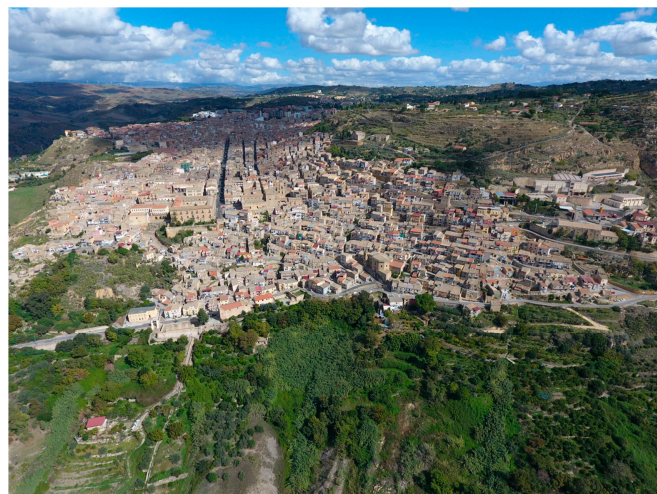
**Figure 1.** Aerial view of the southern slope of the town. The interaction between nature and the built environment characterises the southern edge of the town.

Leonforte is developed on the slopes of Mount Cernigliere with a linear structure that is strongly constrained by the orographic situation (Figure 1). The oldest neighbourhoods are concentrated to the south and are characterised by a compact built-up area that absorbed the contained demographic growth until the beginning of the 20th century; to the north-east, the most recent expansion appears to instead be marked by a growing urban and commercial sprawl. In the face of a cohesive population decline observable since the post-World War II period [57], a condition of imbalance between the different parts of the city is noted. In fact, while the northern area and its anonymous suburbs remain more attractive and densely populated, the southern edge, corresponding to the oldest area, is in a condition of progressive abandonment and decay (Figure 2). In this context, the historical Granfonte neighbourhood appears as an urban periphery located on the fringes of a larger land periphery. In the neighbourhood, the recognition of the qualities and values of historic buildings is struggling to emerge in the awareness of the community. Thus, the ruined buildings, which are increasingly numerous in the neighbourhood, are perceived as evidence of the disinterest of public actors who have so far not initiated any strategic action for the recovery of the historical town.

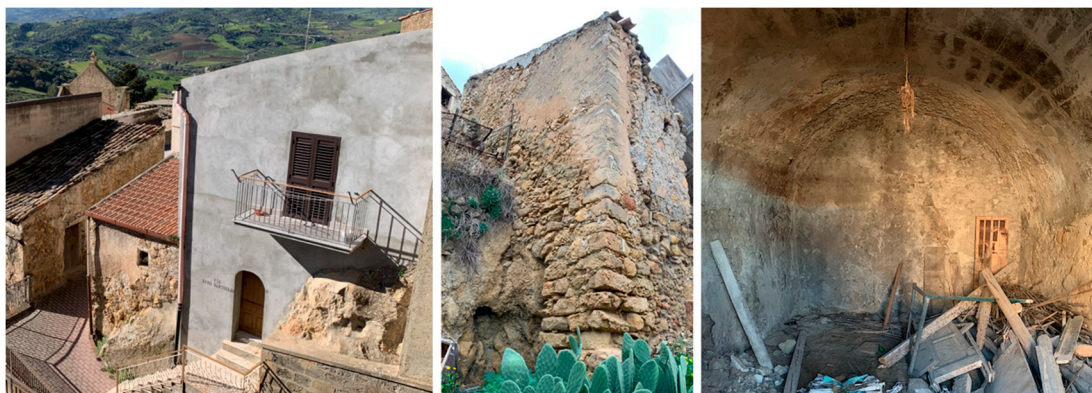
**Figure 3.** Examples of dwellings built against the rock outcrop. Depending on the ground conditions, the rock outcrop is often an integral part of the elevation walls. Walls are often built directly on natural rock outcrops; similarly, vaults may have a part directly carved into the rock.

The Granfonte neighbourhood is located on a steeply sloping terrain on the southern flank of Mount Cernigliere. Its settlement condition is a peculiar expression of a rupestrian building culture typical of the central-northern area of the metropolitan area of Enna [60]. Therefore, the coexistence of rock and the built environment is a constant, and the analysis of this relationship is the key to understanding the way in which they are combined. The presence of rocky outcrops and natural constraints conditions the overall layout, i.e., the construction solutions and distribution of houses, which tend to exploit the natural slope to optimise the limited space available [61,62].

The buildings retain a rather modest character. The dwellings have minimal dimensions and are usually developed with only one room per floor for a maximum of two floors; they only reach three levels in areas that are subject to several transformations. Simple volumes are associated with a rather essential architectural vocabulary and extremely simple architectural features. These characteristics are the product of an elementary way of building; nevertheless, it is the result of a building culture that is matured and consolidated over time and based on the precise correspondence between orographic conditions, the formal and structural layout, and specific needs (Figure 3). The most widespread dwellings layouts are the on-slope type and the type with an external staircase (profferlo) [63]. The units stand on a locally varying height difference depending on the slope of the land. It is common to have double access, one upstream and the other downstream, allowing for differentiated entry to the two levels. This layout is evidence of the functional separation of the dwelling from the workplace or even the presence of independent dwellings. In its original conception, the traditional dwelling contained a multifunctional use that was capable of satisfying not only living needs but also work needs in support of the activities

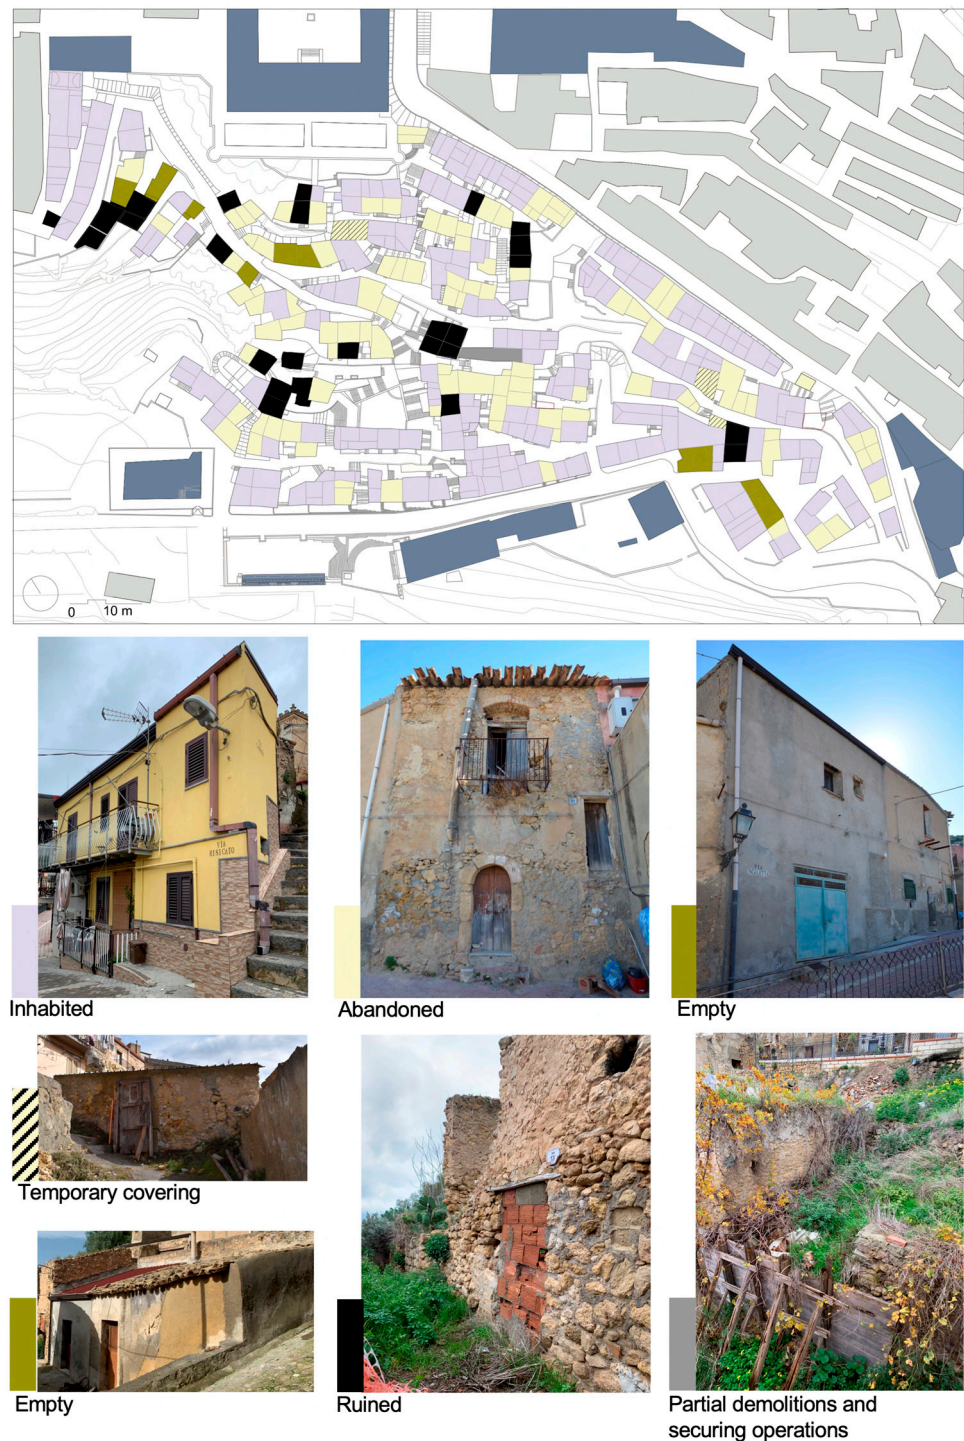
**Figure 5.** Survey of buildings according to their use and state of conservation. The analysis reveals a lack of homogeneity of conditions in the historic neighbourhood (our elaboration).

The close reading of the urban fabric has made it possible to assess the actual repercussions of the marginalisation phenomenon on the historic built-up area. The analysis of the building use reveals a diversified scenario corresponding to the evident fragmentation of residence: there are buildings in good condition and still inhabited—but often heavily transformed—alternated by empty, abandoned, and even ruined buildings. This investigation, shown in Figure 5, thus clearly highlights the partially abandoned condition of the neighbourhood; in fact, abandoned dwellings account for about half of the total. The critical reading of the building fabric has also made it possible to identify the presence of some building units that should already be considered as in a state of ruin according to the classification adopted here, as they have roof collapses of more than 50%. Some of these appear to be affected by processes of a more advanced ruination as they are involved in serious structural instability. On the other hand, a few building units had a provisional roof following the collapse of the original one.

The observation of the distribution of abandoned and ruined buildings highlights certain peculiarities of the residential vacancy. If the abandonment—and sometimes the subsequent phase of advanced ruination—appears to be mainly scattered in the fringe blocks, it is more extensive in the heart of the neighbourhood.

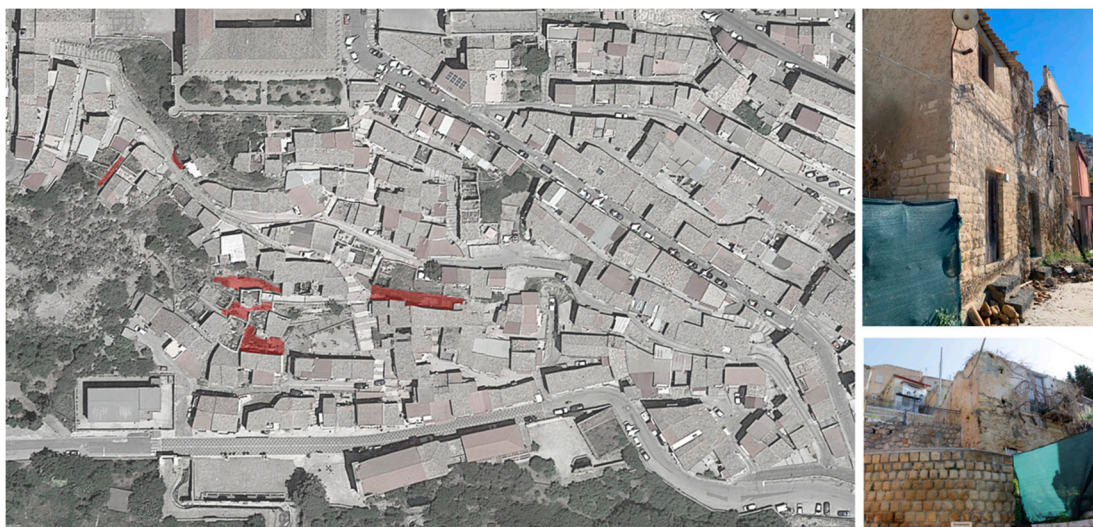
**Figure 6.** Roads and urban areas inaccessible for security reasons (our elaboration).

The analytical filing carried out after the field work revealed important criticalities. For example, in the case of more complex aggregative conditions and progressive densification and superelevation, while the upper levels are still permanently inhabited, those downstream are in a state of abandonment for reasons stemming not only from ownership fragmentation but also from poor accessibility or lack of light and air. In such a scenario, the lower floors that are in a condition of prolonged abandonment may even present structural instabilities, which are sometimes resolved using hasty consolidation operations. This is aggravated by the presence of superelevation structures that continue to be inhabited. Abandonment thus generates multiple risk situations with repercussions on both the stability of the buildings involved and those adjacent and on the safety of public routes. The clearly precarious conditions have indeed forced the closure of some roads, but the instability of many buildings continues to represent a *vulnus* for the entire urban environment (Figure 6).

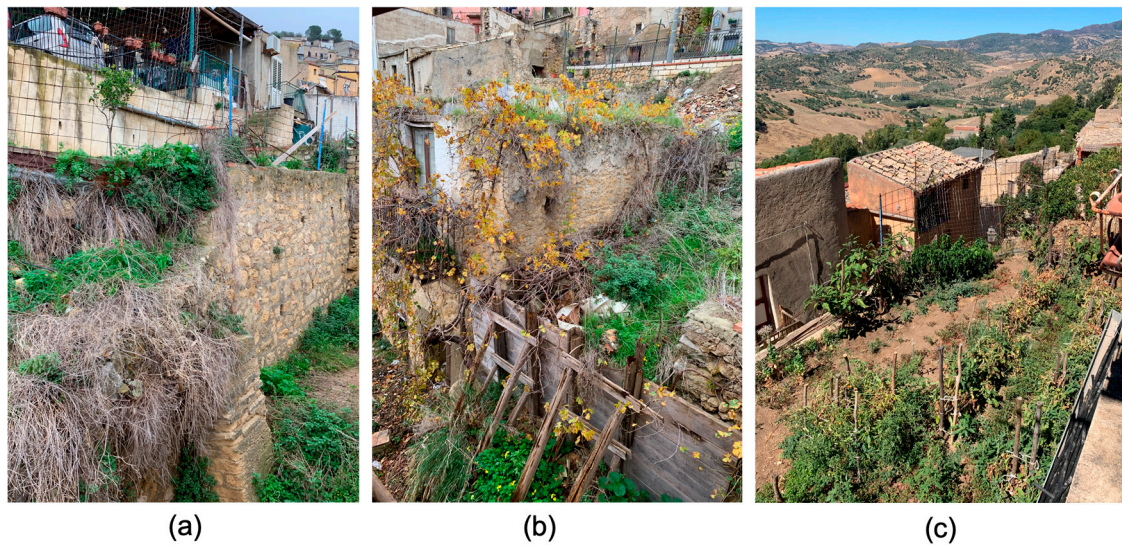
**Figure 8.** Partial demolition and securing along and between vico Vitale and via Riscato. (a,b) The downstream situation shows the provisional shoring and partial reconstruction of the retaining wall. (c) Upstream situation with the use of the infilled area as a private vegetable garden.

In addition to demolition, there is an alternative way of securing the ruins. Following their partial demolition, the buildings have been filled with rubble and waste; they have then been used as supports for terraces and belvederes or as car parks or have been transformed into private vegetable gardens. In this sense, the intervention carried out between vico Vitale and via Riscato is emblematic (Figure 8). The volumes of the houses on the slope, now devoid of roofs, were filled with soil and rubble, following the precarious secur-

ing of the facade walls downstream. This intervention is a symptom of an inappropriate way of dealing with the problem of ruins. In fact, in addition to definitively erasing the traces of pre-existing buildings, it is an inadequately designed consolidation operation that does not even ensure a safe response to the new function of being a retaining wall.

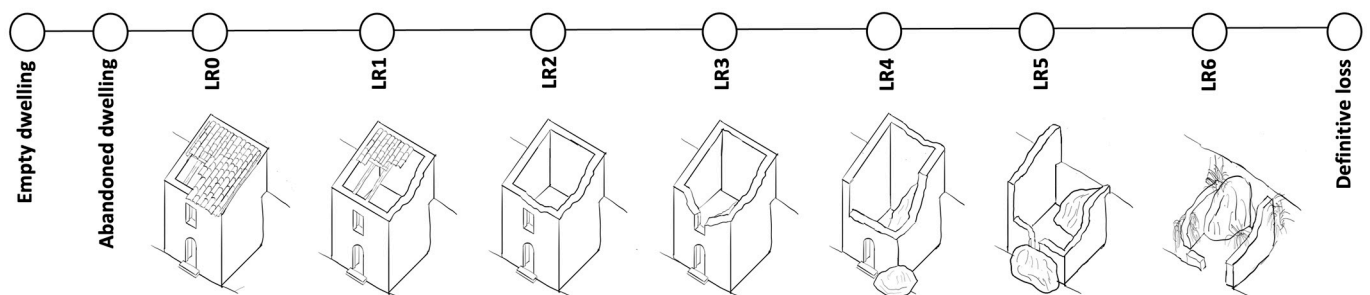
**Figure 9.** Scheme of the ruination process (our elaboration).

Following the diachronic reading, the survey of all ruined buildings inventoried allowed us to typify the phases of ruination (Figure 9). We schematised it into seven damage configurations, expressing the progressive degeneration of the building in ruin until it reached the state of collapse and total ruination. The reconstruction of this process considered two main parameters that are easily detectable from the outside: the extent of the collapse of the roofs and walls. For the more advanced stages, we added another parameter concerning the collapse of internal structures and floors.

The first configuration identified is LR0 and concerns buildings affected by deterioration and minor roof or wall collapses, e.g., at openings made close to the guttering line. The on-site analysis made it possible to identify several forms that may be part of the initiation phase of the ruination process. The shapes identified may vary depending on the construction sequence as well as the inherent vulnerabilities [81,82].

Phase LR3 involves the first collapses of the perimeter load-bearing walls, which is followed by phase LR4, in which more extensive collapses of the walls and the total collapse of the internal floors may also occur. It is worth pointing out, however, that the collapse of floors is a mode of damage that can also affect buildings that still have roofs. These are most frequently metal floors; only occasionally has the collapse of the barrel vault been verified. Phase LR5 is characterised by a very extensive collapse, which may affect the reading of the

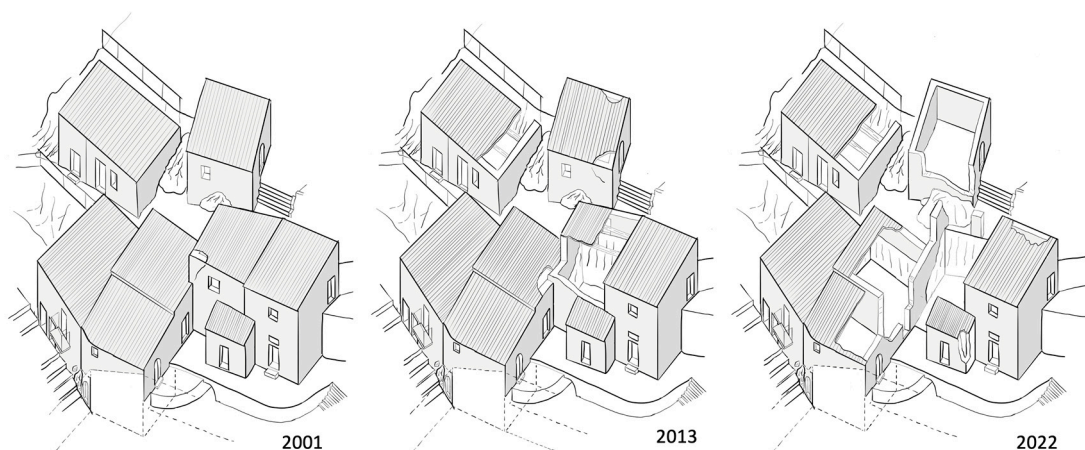
**Figure 10.** Study on the progress of collapses in an aggregate. In 2001, the building unit in the centre of the aggregate was affected by a first minor collapse. In 2013, the process advanced with the collapse of the corner and part of the façade and the first damage on the adjacent unit. The contiguity to a ruin has therefore induced the collapse of the roofs of the adjacent unit. In 2022, there is a progression of collapses that now also extends to the lower cell with which the unit shares a load-bearing wall. At present, the unit at the far end, adjacent to the first ruin, also shows marked signs of decay that attest to the beginning of ruination (our elaboration).

The study of the evolution of the phenomenon shows that these mechanisms may depend on the construction sequence or be amplified by the presence of intrinsic weaknesses (Figure 10). The position of the openings made close to the masonry ridge represents a vulnerability. This results in a thin masonry portion that constitutes a weakening of the top of the façade. The position adjacent to a ruin can increase the risk of collapse of the top portion of the wall in case of loss of the roof. The extensive collapse of roofs may also weaken the shared wall and induce further collapses of the roofs or floors of adjoining cells. These mechanisms also occur in cases where the extensive collapse of the façade wall leads to the expulsion, even partial, of an incorporated cornerstone, triggering the collapse of a wall portion of the contiguous building. Moreover, as the collapse in the first unit progresses, the adjacent unit will be exposed to an increasing risk of collapse with respect to the shared wall.

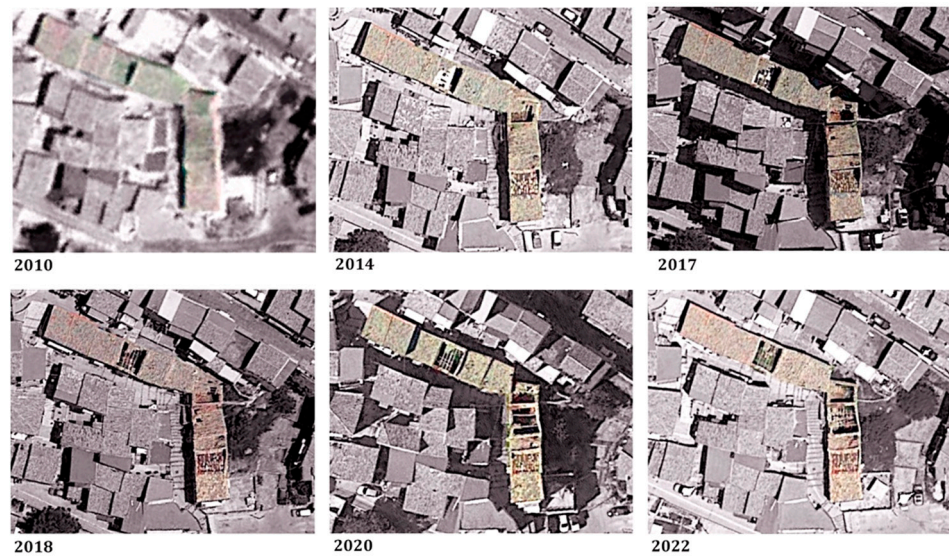
**Figure 11.** The progress of the collapse along via Cassarà. Elaboration based on area photographs from SITR and Google Earth (our elaboration).

The aerial photographs show the progression of the phenomenon just described. This is clear in the aggregate along via Cassarà. The extensive collapse of the roof of the corner cell, which acts as a link between the two parts of the aggregate, was followed by the collapse—at first minor and then extensive—of the roofs of the adjacent cells (Figure 11).

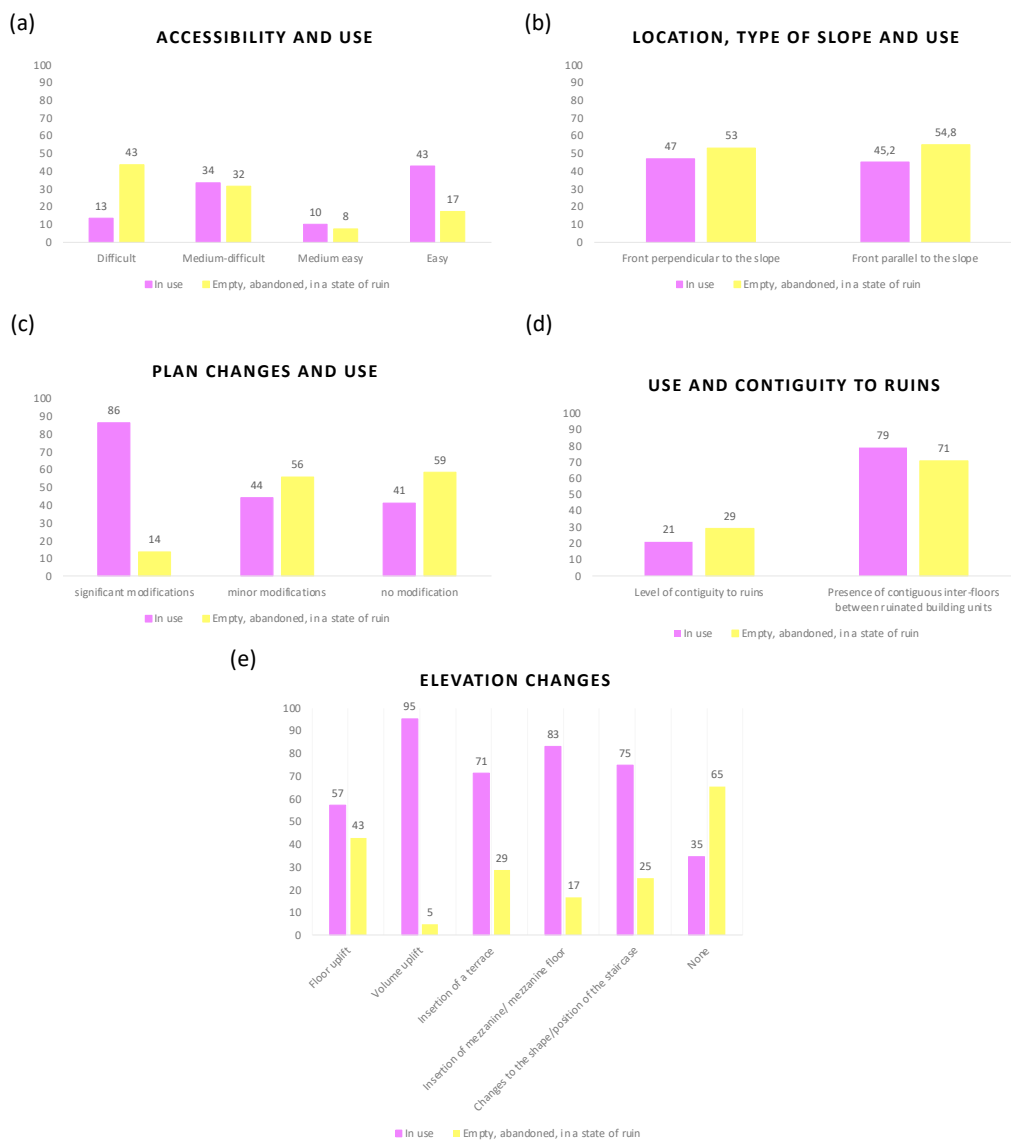
**Figure 12.** Relationship between the conservation and use conditions and certain settlement and architectonic characteristics of the building unit (our elaboration).

The first noticeable condition is the marginalisation of specific areas due to difficult accessibility. Figure 12a shows that the more accessible building units tend to be more inhabited, while the less accessible are generally empty, abandoned, or in a state of ruin. Figure 12b highlights how the relationship with the slope can influence the condition of use of the building unit. Figure 12c,e show a prevalence of elevation and planimetric transformations in building units in use, while those that are transformed are in a state of abandonment or ruin. Figure 12d highlights the relationship between the contiguity to ruins and the abandonment or ruination of building units.

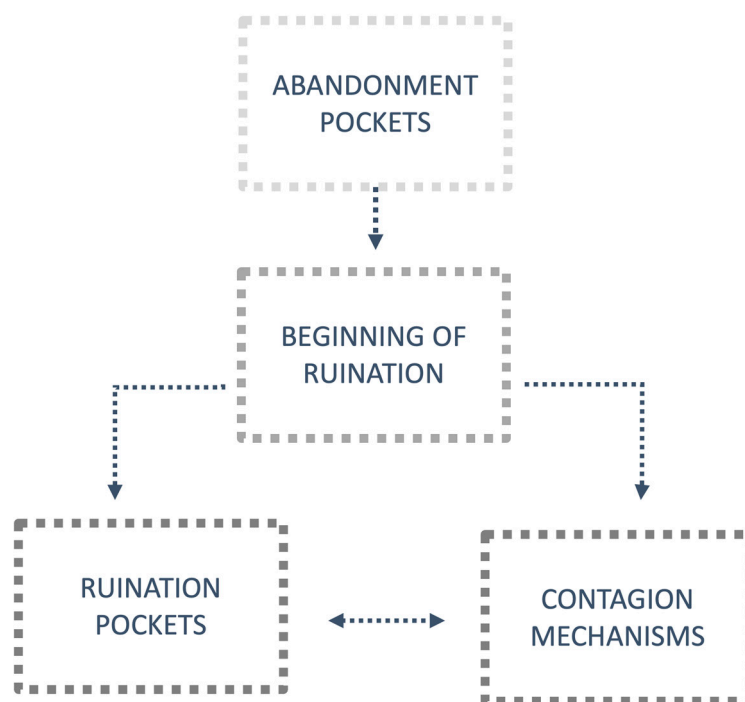
**Figure 14.** Diagram of the ruination process detected in the Granfonte neighbourhood.

The process observed in the neighbourhood can thus be represented by the diagram in Figure 14. Prolonged abandonment by pockets induces the initiation of ruination. The contagion effect triggers further mechanisms that generate ruination pockets, which continues to feed contagion mechanisms on the neighbouring units.
