# An Analysis Procedure for the Surviving Rural Architecture, Built with Raw Earth Mortars, in the Amatrice Area (Italy) as a Starting Point for the Development of Conservation Strategies

**Abstract:** The contribution of this article is that it provides indications for the conservation of the surviving architecture in the Amatrice area, which was severely affected by the long seismic sequence between 2016 and 2017. The traditional construction technique was carefully studied during the safety works that were carried out in the villages from 2018 to 2020. From the studies conducted, it emerged that most of the historical building fabrics date to a post-seismic reconstruction phase of the seventeenth–eighteenth century. The masonry construction technique found on the site is homogeneous throughout the area and is based on the use of local sandstone and raw earth mortars. The mineralogical nature of the materials used for building was identified by means of specific diagnostic analyses as well as the production processes of the materials. An interpretation of the use of different materials and processes was provided by cross-referencing the analytical results with the existing data

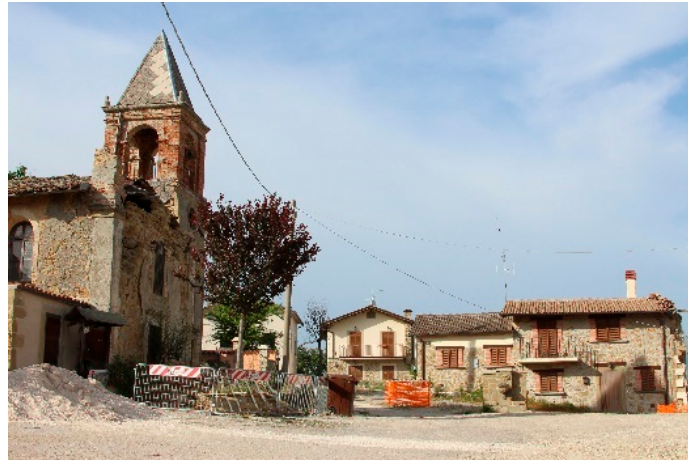
**Figure 1.** Piazza di Collegentile, a hamlet of Amatrice (RI). Author photo.

The conditions of collapse or severe damage have been converted into opportunities of a fast examination of the structures and building techniques (Figures 1–3).

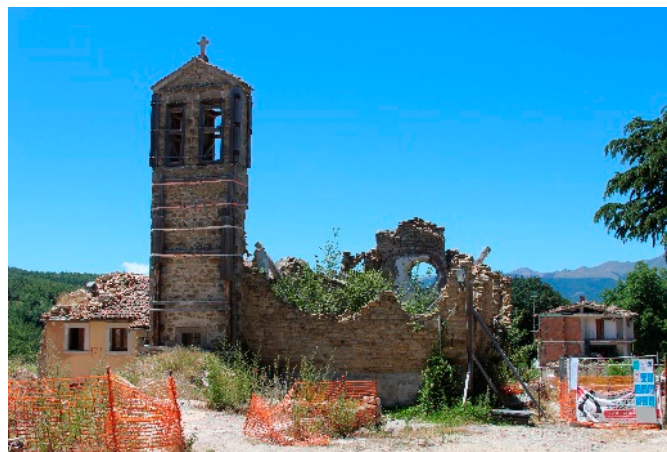
**Figure 2.** Remains of the church of San Clemente in Retrosi, a hamlet of Amatrice (RI). Author photo.

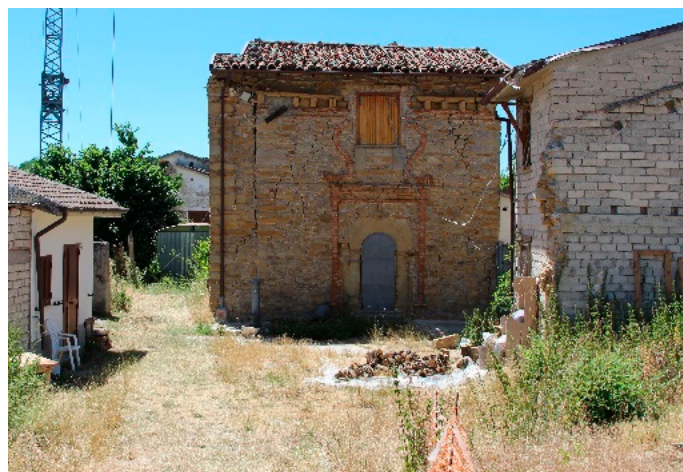
**Figure 3.** Palazzetto Ruggeri in Moletano, a hamlet of Amatrice (RI). Author photo.

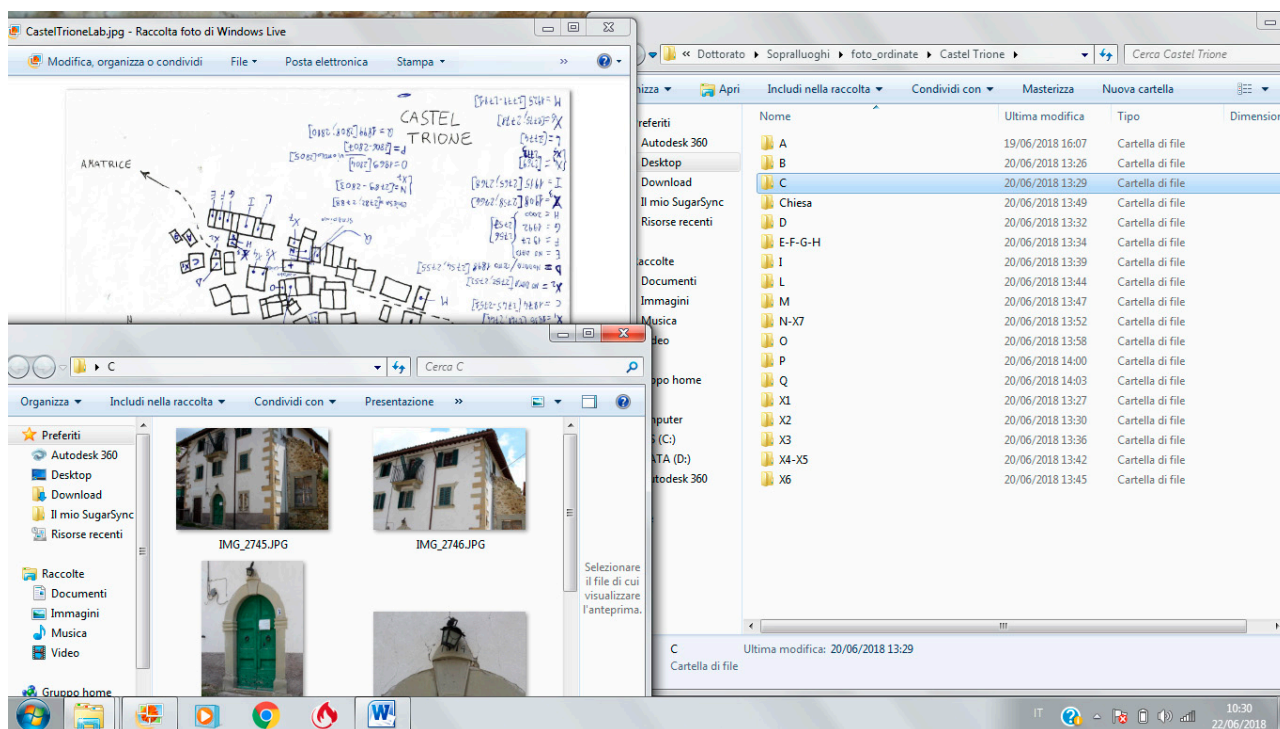
**Figure 4.** Summary image of the data processing process and archiving of photographic images taken during the inspections.

During the on-site survey campaign, the resistance of the bedding mortars was estimated by means of a campaign of on-site penetrometric measurements<sup>5</sup> (Table 1). Samples of bedding mortars and traditional plaster were collected (Appendices D and E). Samples of lithic materials from the masonry of the buildings and samples from quarries and natural deposits were also collected (Appendices B and C). In fact, it seemed appropriate to compare the characteristics of the lithic materials used in the masonry with those of the lithotypes available in the area to investigate how the possible selection of materials took place in the historical constructive tradition. In total, 16 samples were selected for diagnostics, 8 mortars and 8 lithic materials (Tables 2 and 3). The code assigned to each sample was derived from the mapping of the buildings, which was carried out during the on-site inspections. Any location that was inspected was coded using the capital initial letter (Capricchia = C, Cornillo Nuovo = C.N., etc.) and mapped, where we assigned each building a capital letter of the alphabet, as can be seen in the figure below (Figure 4).

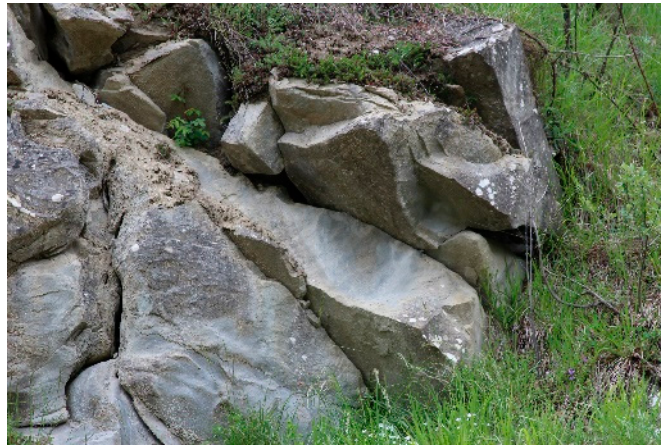
**Figure 5.** Sandstone layers in banks; outcrop near Preta, a hamlet of Amatrice (RI). Author photo.

Most of the masonry analysed were determined to be made up of lithic elements of local sandstone bonded with raw earth. Based on the masonry cataloguing criteria included in the AeDES forms, the wall textures fall within the case study defined as “irregular and of bad quality”. This does not mean that the walls are completely chaotic, but they are not made up of regular elements arranged in perfectly horizontal rows. In fact, in almost all of the buildings with exposed masonry, the stone elements have little to no work performed at all, presenting uneven dimensions. However, there is a good attention to the arrangement of the stone elements in order to respect some horizontal line of the rows. This construction technique has certainly developed as a result of making the most of the territorial resources and natural conditions of the available materials [10]. In fact, the fracture planes of the local sandstone, which emerge in benches throughout the territory, indicate that this type of stone tends to naturally detach in blocks of rather regular shape (Figures 5 and 6).

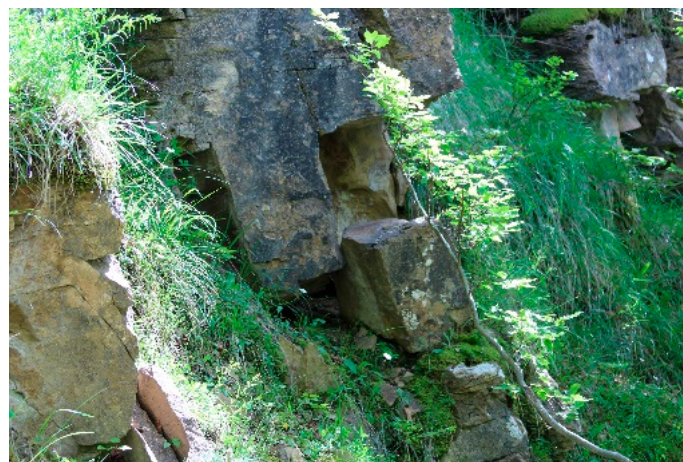
**Figure 6.** Sandstone outcrop in banks on the slopes of Monte Gorzano, Amatrice (RI). Detachment of material along the natural fracture planes. Author photo.

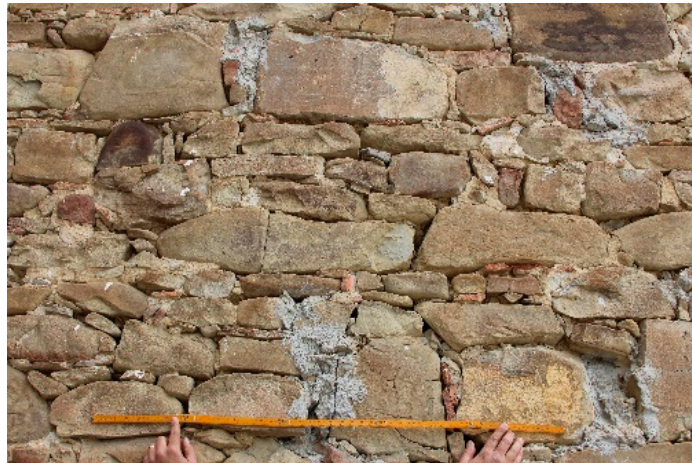
**Figure 7.** Typical wall texture of a historic building in the territory of Amatrice. Author photo, Cornillo Nuovo, Amatrice (RI).

The use of the local lithotype has therefore made it possible to build walls which, although not made of square blocks, respect a fair regularity of the textures (Figure 7).

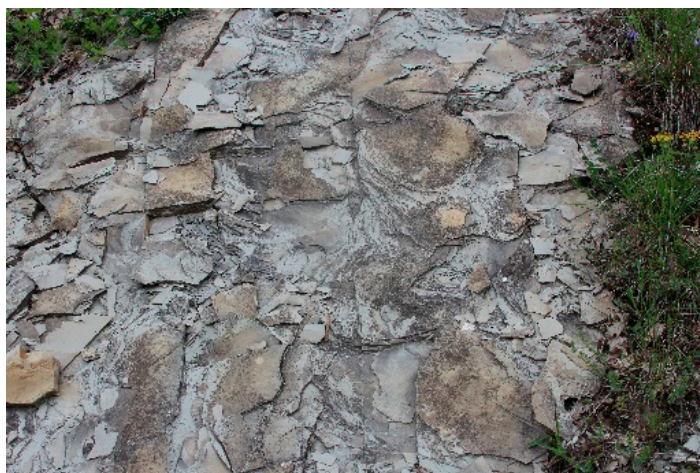
**Figure 8.** Flysch outcrop near Preta, a hamlet of Amatrice (RI). Author photo.

The alignments of the rows were also managed using another material available in the area, namely flysch. Flysch is a deposit of marly sandstone that detaches very easily from the substrate in the form of very regular plates with parallel and orthogonal breaking planes according to their typical laminar structure (Figure 8). This lithotype was used in the masonry to regularize the wall equipment by creating horizontal support surfaces for the sandstone blocks. However, there is no lack of more irregular stone elements with a rounded shape. The territory is in fact characterized by a complex network of water resources, mostly in a torrential regime, whose action transforms the arenaceous lithotype into a pebble formation (Figure 9). The use of pebbles was found in the upper parts of the walls and inside the wall cores as filling. The latter data were recorded by analysing the wall sections that were made inspectable due to the numerous collapses; the walls are almost always made up of two similar vestments and a core filled with flakes of stone, pebbles and raw earth. In all of the cases analysed, the presence of connecting headers between the wall leaves was recorded (Figure 10). The walls were covered with protective layers of plaster. In fact, in many of the buildings with exposed or partially exposed masonry, remains of thin plaster were found. (Figure 11). From the visual analysis, the plaster appeared to be created from lime. The diagnostic investigations have thus confirmed the use of lime as a binder.

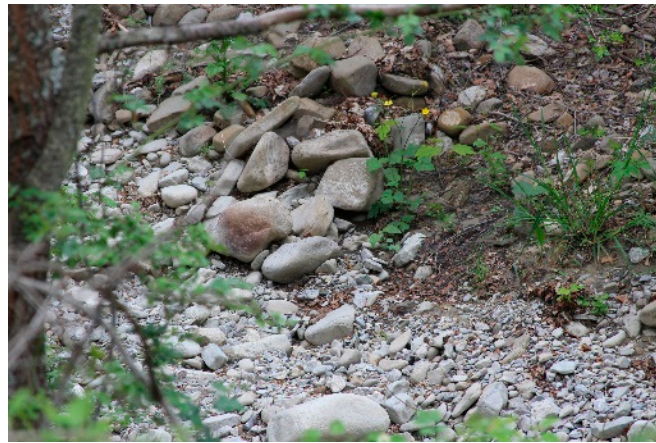
**Figure 9.** Deposit of sandstone in pebbles at the Ortanza Waterfall, Amatrice (RI). Author photo.

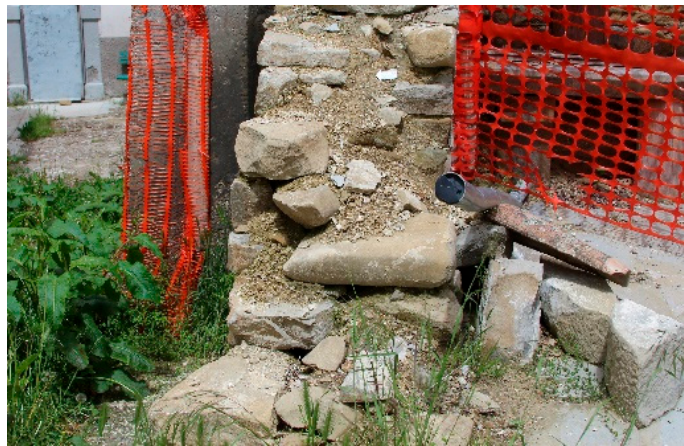
**Figure 10.** Wall section exposed following a collapse in Cornillo Nuovo, a hamlet of Amatrice (RI). Author photo.

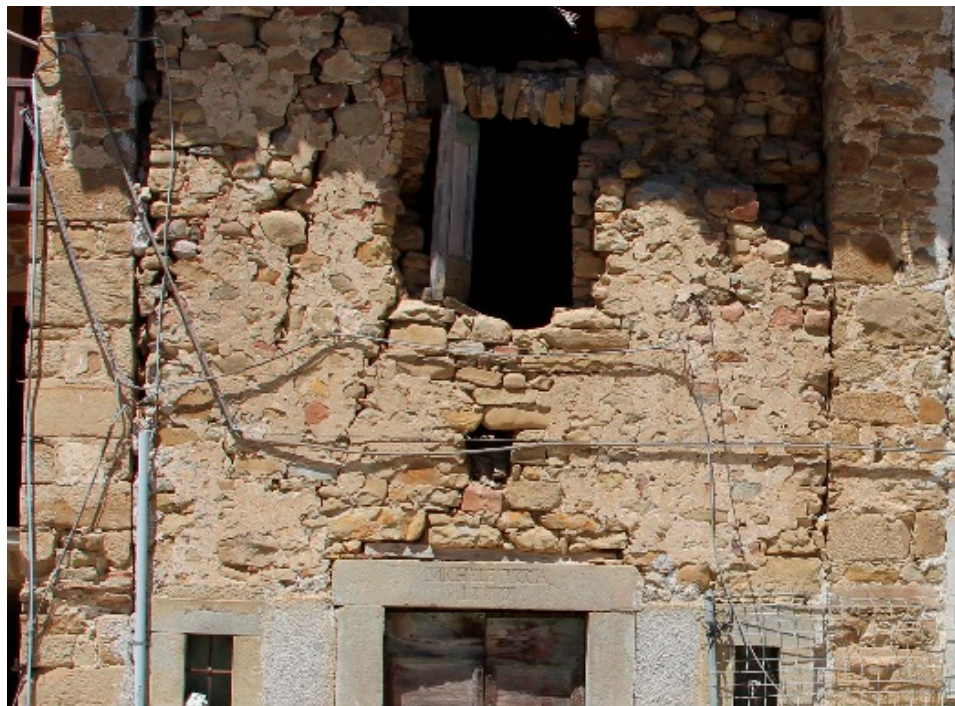
**Figure 11.** Building with traces of traditional plaster in Collocetra, a hamlet of Amatrice (RI). author Photo.

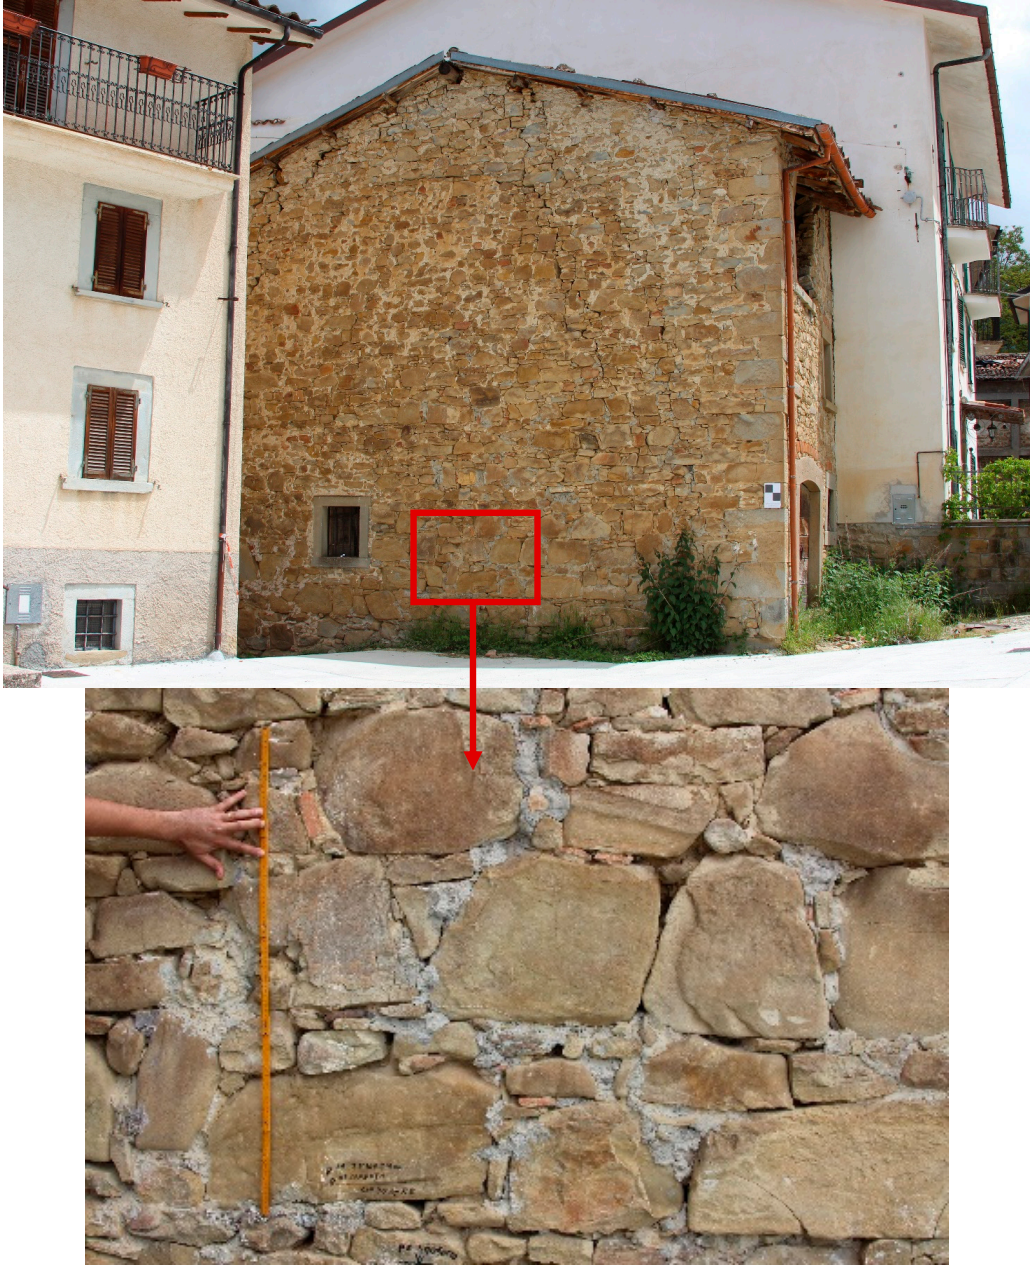
Mortars	Lithic Elements				
	① Non Processed Stone Elements	② Pebbles	③ Bricks	④ Other Elements	
<b>⑤ Traditional</b> <input type="checkbox"/> In a good state of conservation <input checked="" type="checkbox"/> In a bad state of conservation	<input checked="" type="checkbox"/>	<input checked="" type="checkbox"/>	<input checked="" type="checkbox"/>	<input checked="" type="checkbox"/>	
<b>⑥ Recent grouting</b> <input type="checkbox"/> In a good state of conservation <input checked="" type="checkbox"/> In a bad state of conservation	<input checked="" type="checkbox"/>	<input checked="" type="checkbox"/>	<input checked="" type="checkbox"/>	<input checked="" type="checkbox"/>	
Extension E	Decay	Joints Erosion	⑦ Lithic Element's Decay	Lack of Lithic Elements	
	E > 75%	<input checked="" type="checkbox"/>	<input type="checkbox"/>	<input type="checkbox"/>	
<b>NOTES:</b>					
① Local sandstone					
② Sandstone pebbles used to fill gaps between other irregular lithic elements.

③ Brick fragments used to fill gaps between other irregular lithic elements.					
④ Flysch laminar fragments used to create horizontal support surfaces for the sandstone blocks.					
⑤ Raw earth binding mortars.					
⑥ Cementitious grouting made to fill the eroded joints.

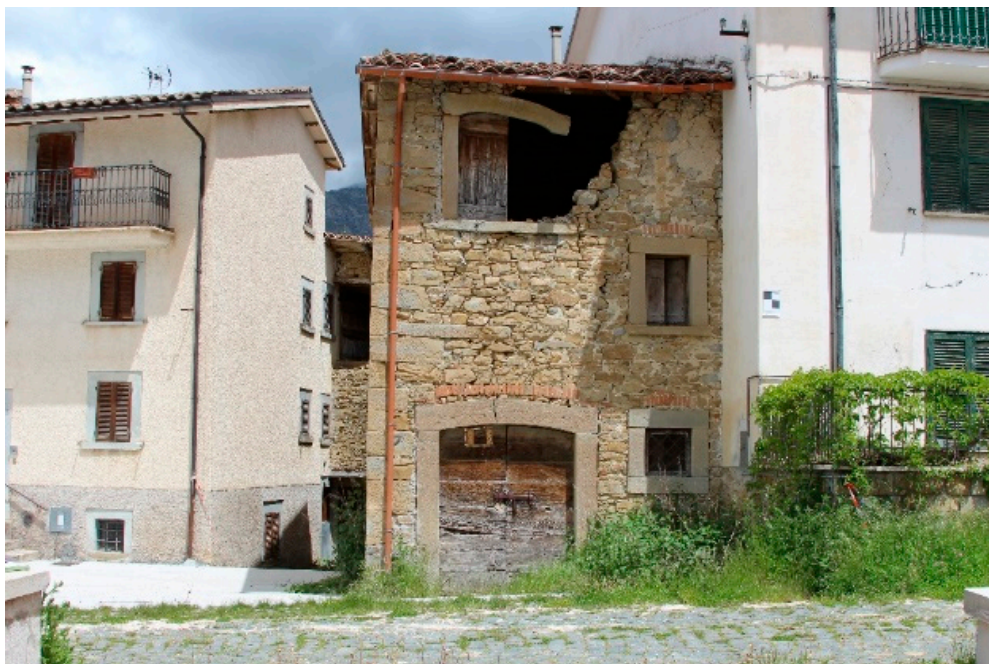
Table A3. Notable elements ▯.

▣ Corner structures	Made with carved blocks of local sandstone
▣ Frames	Windows frames: simple frames in local sandstone (partially collapsed).
▣ Portals	Very simple portal in local sandstone with a segmental arch.
▣ Decorative elements/Other type of elements	Flat arches made with bricks over the portal and the windows.

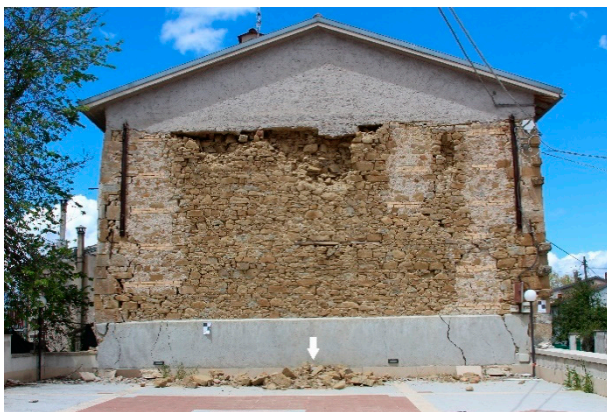
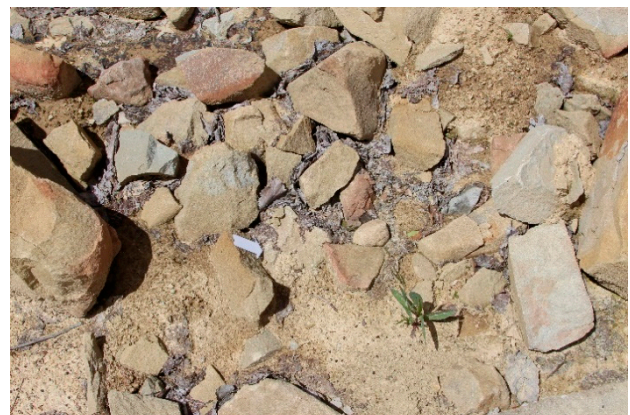
**Building description and sampling area**

- Typology: isolated house
- Masonry: exposed brickwork made with unworked pieces of local sandstone. Integrations made with mixed masonry in local sandstone and brick rows.
- Frames of doors and windows: simple, made with local sandstone.
- Roof: rebuilt with reinforced concrete.

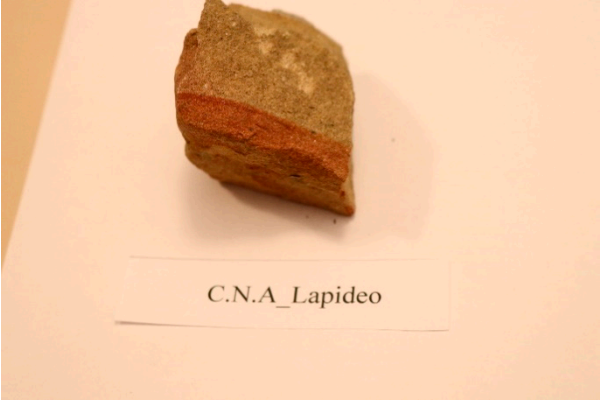
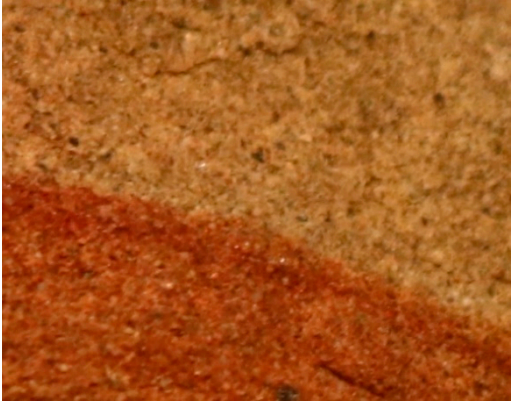
Sandstone sample. Double-colour sand and red, probable presence of iron oxides.		Double coloration detail.

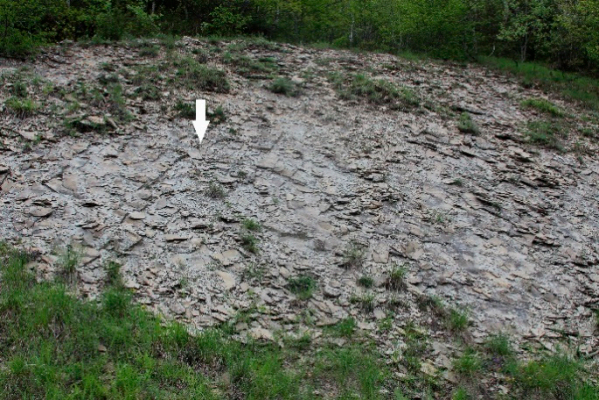
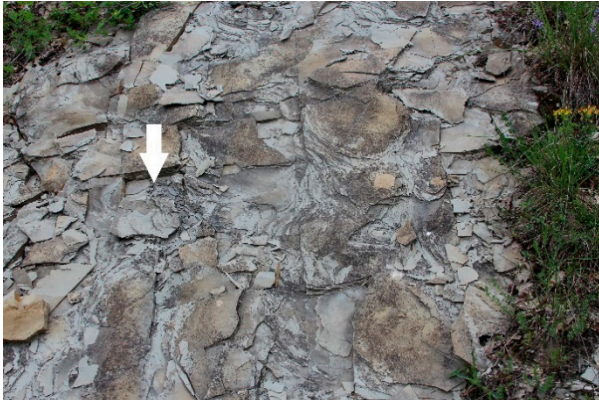
The Flysch splits according to orthogonal fracture lines.

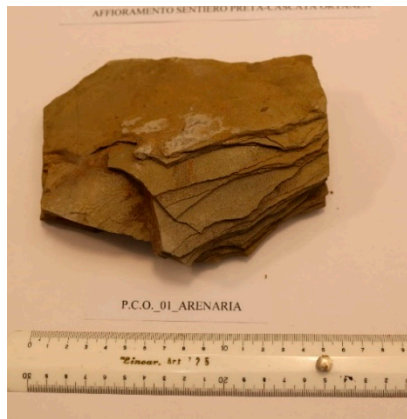
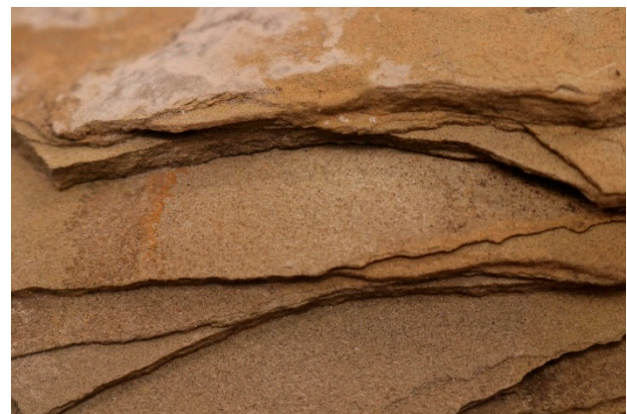
Flysch sample: laminar and layered.

Layered structure detail.

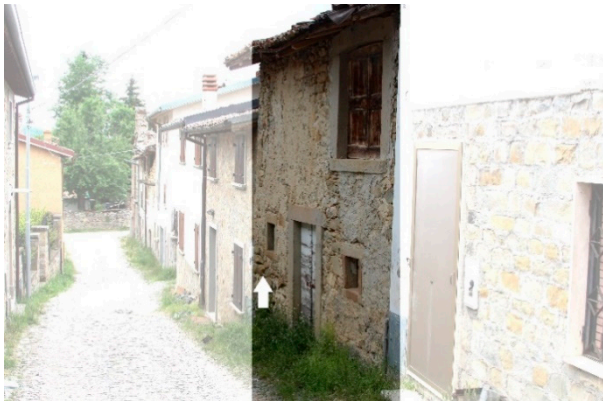
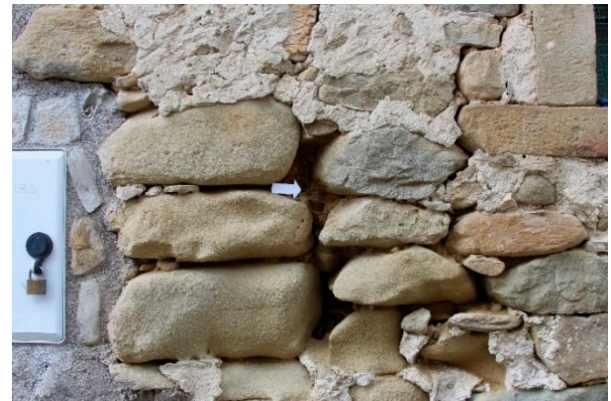
#### Building description and sampling area

- Typology: terraced house
- Masonry: exposed brickwork made with unworked pieces of local sandstone. Residual traces of traditional plaster.
- Frames of doors and windows: simple, made with local sandstone. Wooden window inner frames.
- Roof: traditional, made with wood.

- Description: joint between the lithic elements.
- Sampling characteristics: easy to remove. Earthy and breakable texture, tending to crumble.
- Masonry conservation state: lithic elements and joints are very eroded.

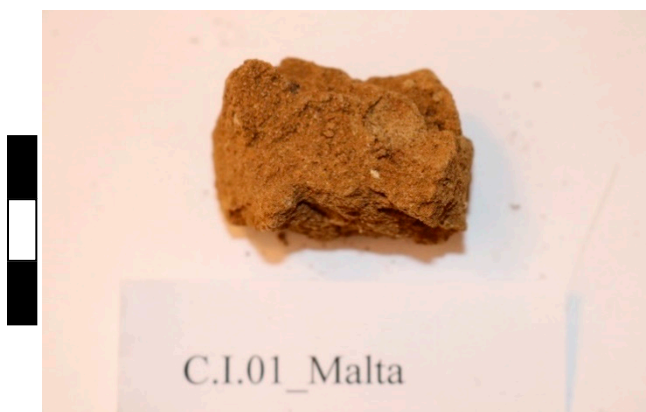
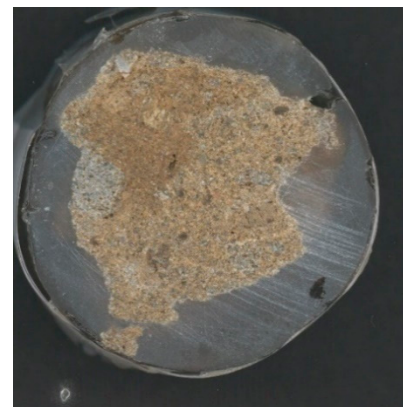
Binding mortar sample, breakable, wet, tending to crumble.  
Colour: umber.

Cross-section made by incorporating the sample in cyanacrylate resin and cutting with a Remet miter saw with a circular diamond blade at AStRe Lab Mat. Tablet diameter 3 cm.

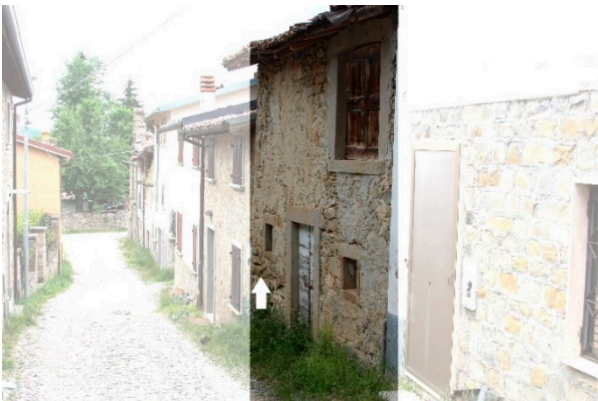
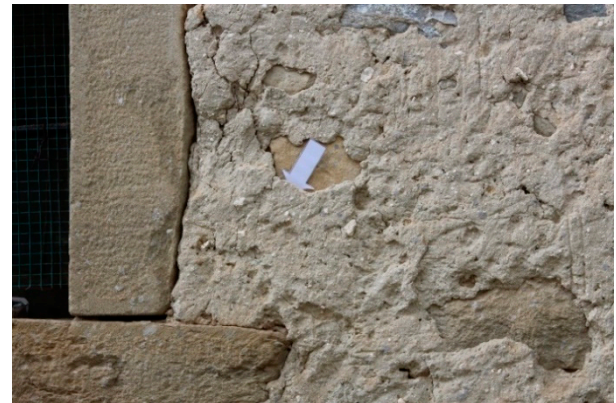
#### Building description and sampling area

- Typology: terraced house.
- Masonry: exposed brickwork made with unworked pieces of local sandstone. Residual traces of traditional plaster.
- Frames of doors and windows: simple, made with local sandstone. Wooden window inner frames.
- Roof: traditional, made with wood.

- Description: Traditional plaster, strongly detached.
- Sampling characteristics: easy to remove. Frail texture, onto.

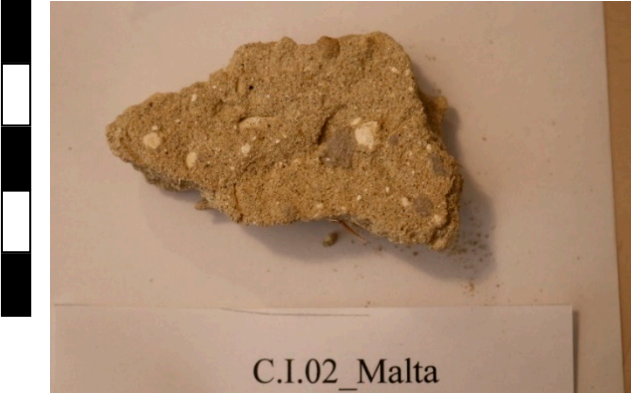
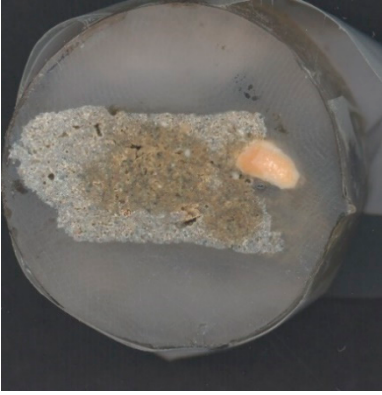
Plaster sample: frail, tending to crumble. Colour: beige/gray. Visible calcinelli. Visible vegetal fragments.			Cross-section made by incorporating the sample in cyanacrylate resin and cutting with Remet miter saw with circular diamond blade at AStRe Lab Mat. Tablet diameter 3 cm.
