Article

Physical and Mechanical Characterization of Lime Pastes and Mortars for Use in Restoration

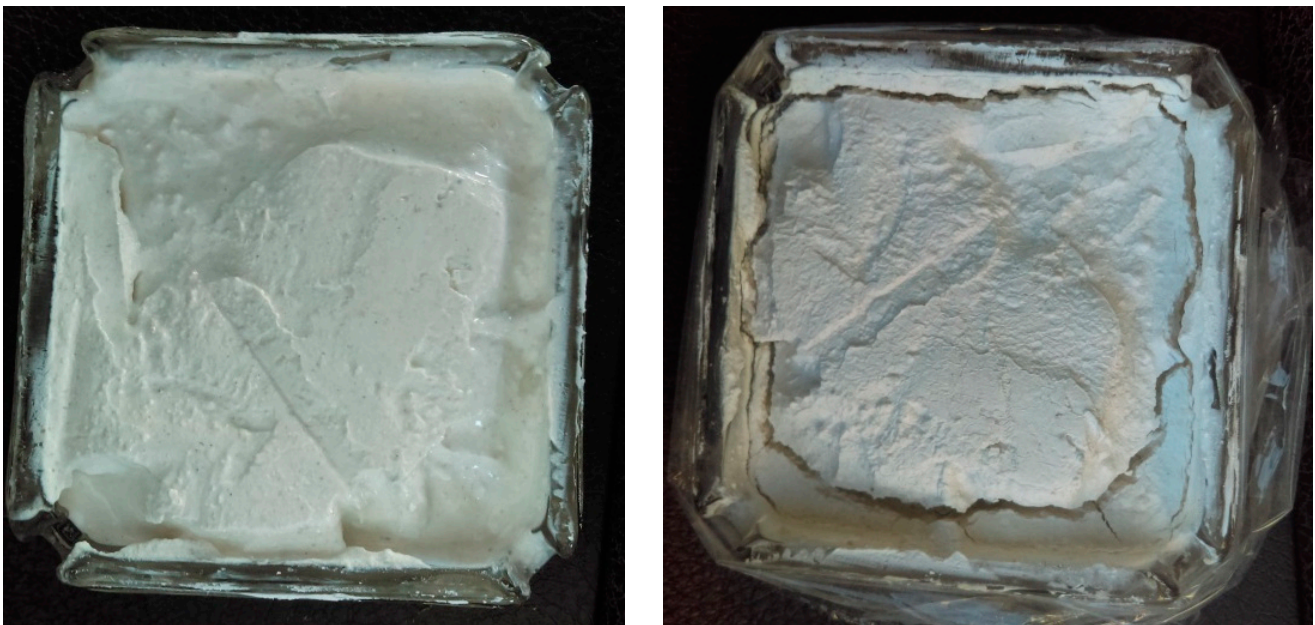
While the lime pastes contained a higher amount of water, there was no need to add more. The percentage of water contained in the lime pastes was obtained indirectly once the ideal consistency had been determined (see Table 6). To obtain the water content of the lime pastes, the specimens were weighed for days until the water completely evaporated, obtaining a constant weight of the sample (see Figure 2).

**Figure 2.** Fresh and dried state of the lime paste specimen.

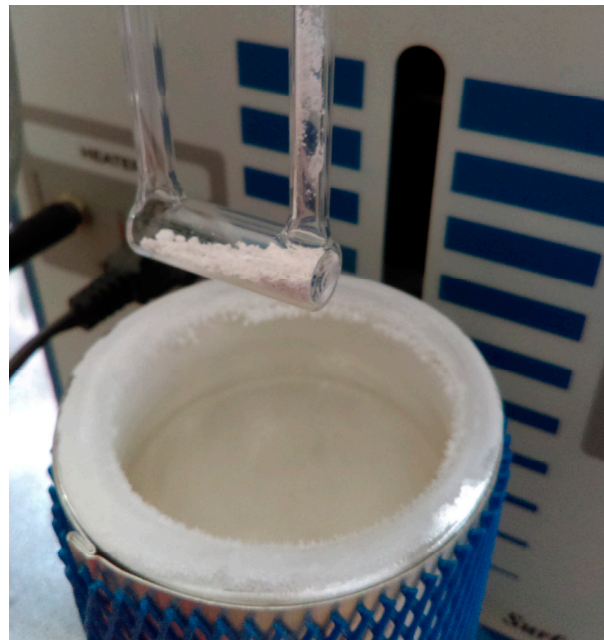
The purpose of this test is to determine the surface of the material in m^2/g ; with larger areas, we obtain higher reactivity [36]. The samples were analyzed in the Institute for Research in Metallurgy and Materials, at UMSNH, in Horiba equipment Model SA9601 STNE, MO (see Figure 4). The lime pastes were transformed into powder by drying the pastes in an oven at a temperature of 60° before performing the test.

Figure 4. Horiba SA9601 STNE equipment for surface area test.

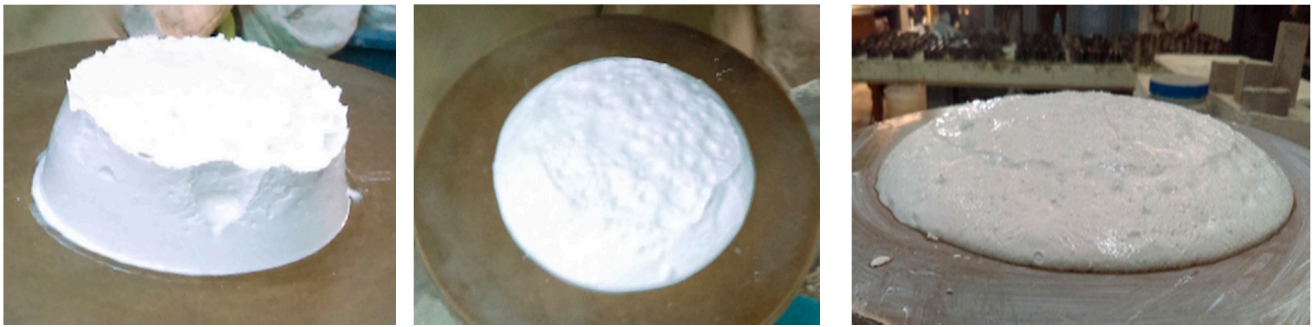
The mortars were tested with the flowability test in a fresh state to determine their workability (see Figure 5). This test was performed based on the cement standard NMX-C-144-ONNCCE-2015 [37]. The standard values for cement mortars should be around $110\% \pm 5\%$ to be acceptable, being similar to the common masonry mortars.

Figure 5. Flowability test.

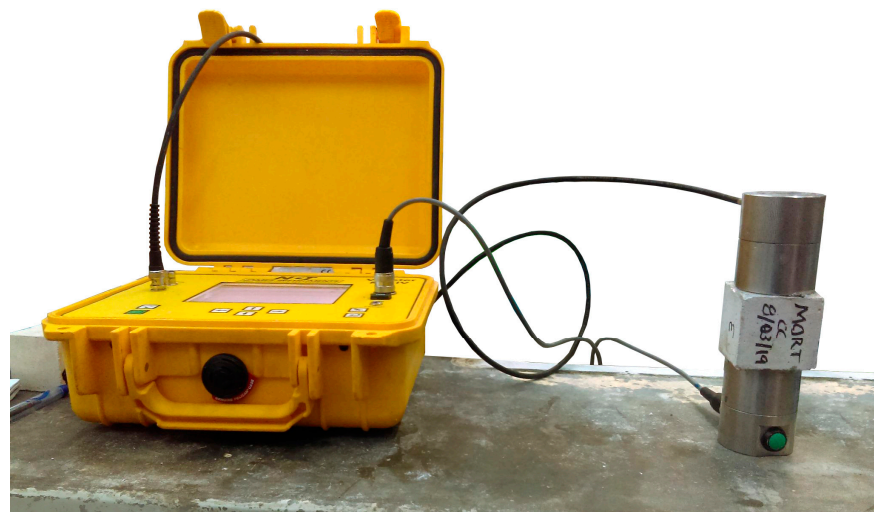
The ultrasonic pulse velocity (UPV) is a non-destructive test by means of ultrasonic wave propagation, which allows us to know the homogeneity and density of the mortar based on the NMX-C-275-ONNCCE-2020 [38] standard. The V-Meter MKIV equipment of the JAMES INSTRUMENTS brand was used to perform this test (see Figure 6). With this test, we can estimate the durability of mortars and pastes since limes have a higher water absorption compared to cement mortars, and therefore the deterioration factors related to environmental conditions can be studied comparatively [39]. For this test, specimens were tested at 100, 200, and 1400 days.

Figure 6. Ultrasonic velocity pulse equipment and testing on a sample.

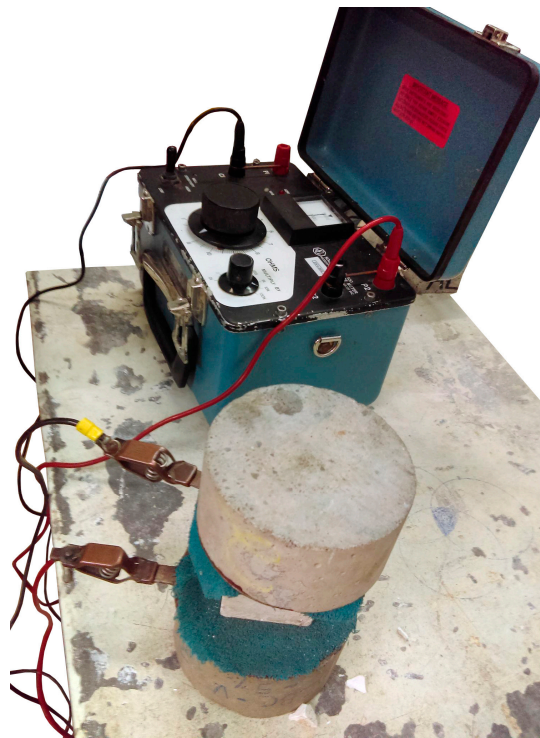
The electrical resistivity test can be used to determine the characteristics of some material, its porosity, and also its saturation state [40]. The Mexican standard NMX-C-514-ONNCCE-2019 [41] was used to perform this test. Porosity is a very important factor to study since the greater the porosity of the mortar, the greater its water absorption capacity will be, and consequently, its degradation speed will increase [42]. To perform this test, it is necessary that the specimens are saturated in water, but since lime is a material with a certain water solubility, the specimens were placed in molds submerged in one centimeter of water and were sprayed daily with water for seven weeks until a constant weight was reached. The saturated weight of the specimens was considered at 200 days and 1400 days, and after that, the test was performed according to the previously mentioned standard (see Figure 7).

Figure 7. Electrical resistivity performance of the test.

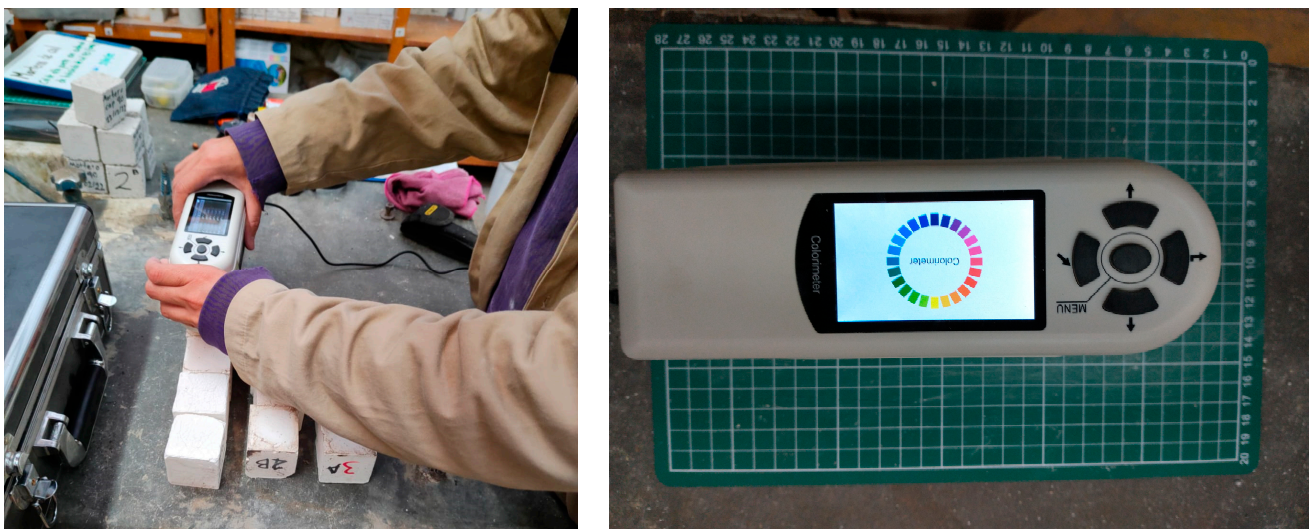
Colorimetry is a non-destructive test [43], which allows us to determine the real colour of an object with the following three parameters: the luminosity “L” (black-white range); and the chromatic coordinates “a” (red-green axis) and “b” (yellow-blue axis) [44]. This test was carried out to know the colour of the lime pastes and mortars studied since restorers consider the white color of lime as an important aesthetic value in restoration works. The CRLM-200 equipment was used (see Figure 8), which calculates the measurement through a spectrophotometer that measures the response of the luminosity by means of light emission on the surface of each specimen.

Figure 8. Utilization of the colorimetry equipment.

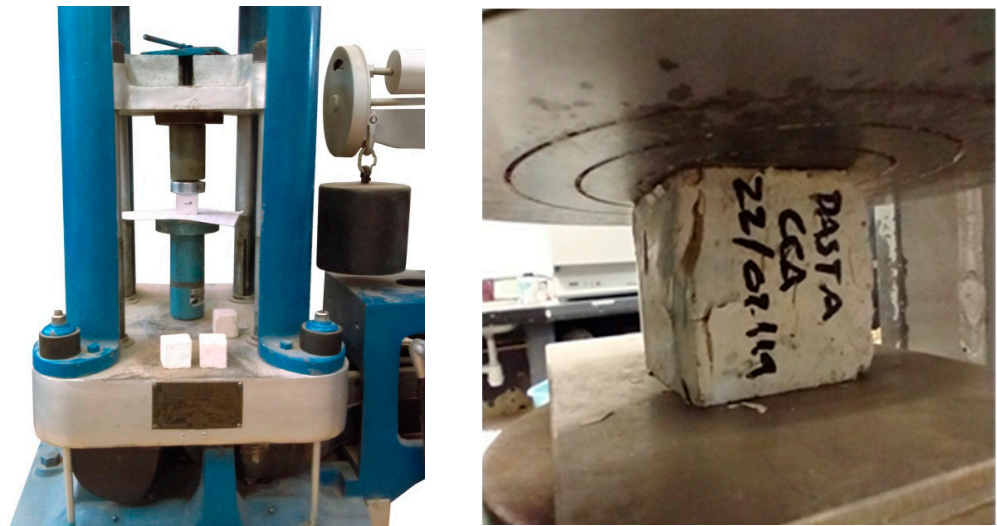
The compressive strength trial is a destructive test, and its performance was based on the Mexican standard NMX-C-061-ONNCCE-2010 [35]. The TINIUS OLSEN Universal Testing Machine, with a capacity of 50 tons and approximations to 1 kgf, was used to carry out the tests (see Figure 9); the specimens were tested at 100 days. In the case of lime pastes and mortars, their strengths were expected to be low at early ages, compared to the cement mortars, which are the objects of the regulations.

Figure 9. Universal Testing Machine and specimen failure.

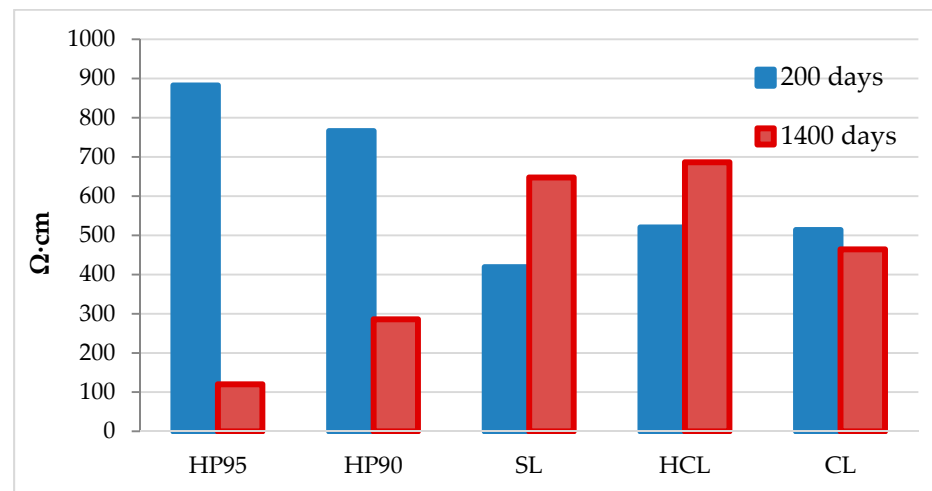
**Figure 15.** Electrical resistivity in pastes.

Electrical resistivity is the test that indicates how the material opposes the passing of electric current. This parameter is related to the porosity, and the higher the electrical resistivity of the sample, the higher its porosity. The pastes tested at 200 days ranged between 400 and 900 $\Omega \cdot \text{cm}$, while the ones tested at 1400 days ranged between 100 and 700 $\Omega \cdot \text{cm}$. The SL and HCL pastes are the only ones that showed an increase over time, while CL had a slight decrease, and HP95 and HP90 reported more variability, the latter being the ones with lower porosity and more suitable for use. Theoretically, an increase in the electrical resistivity over time would be expected; however, the values diminished for the HP95 and HP90 specimens, which could be on account of the formation of fissures in the samples, which prevent the continuity of the electric current.

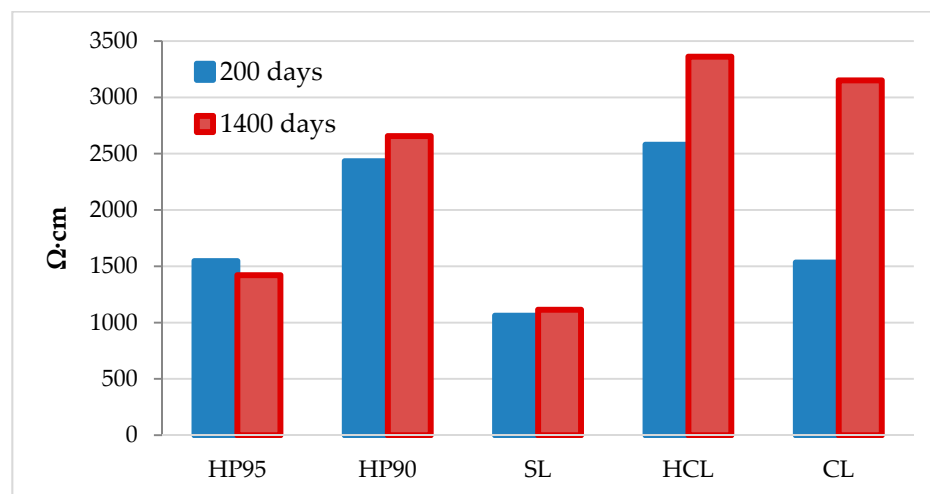
**Figure 16.** Electrical Resistivity in Mortars.

For the mortars, at 200 days of age, the range values obtained varied between 1000 and 2600 Ω -cm. The lowest measurement is SL, and the highest is HCL. For the tests performed at 1400 days, the range was 1100–3400 Ω -cm, with HCL being the highest and SL the lowest. In general, in the case of the mortars, the samples presented an increase in electrical resistivity, except HP95, which demonstrated a negligible decrease, probably due to the presence of some fissures.

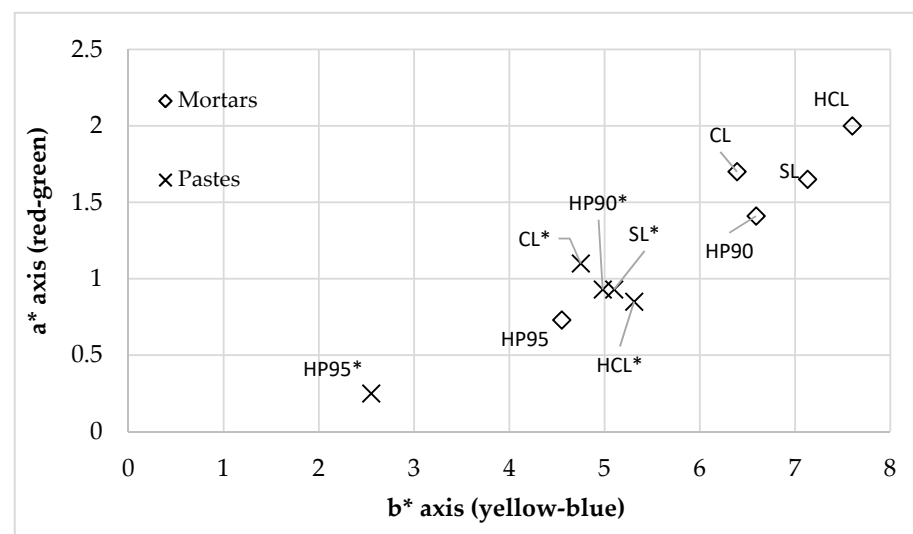
To identify the color variations between the different limes, the “a*” and “b*” coordinates are shown in Figure 17. The mortars are farther away from both axes, except for mortar HP95. Nevertheless, the tone of the pastes and mortars is totally influenced by the quarry and the place of extraction.

Figure 17. Colorimetric values a* and b*.

In the colorimetric study of the pastes and mortars, it was observed that the values of paste and mortar for HP95 lime, coming from Acajete (Puebla, Mexico), are in a more distant range than the other limes that come from Piedras de Lumbre (Michoacan, Mexico). However, all the specimens present an acceptable color for their use in restoration, being the cause of the lime quarry where the calcium carbonate is extracted for its production.

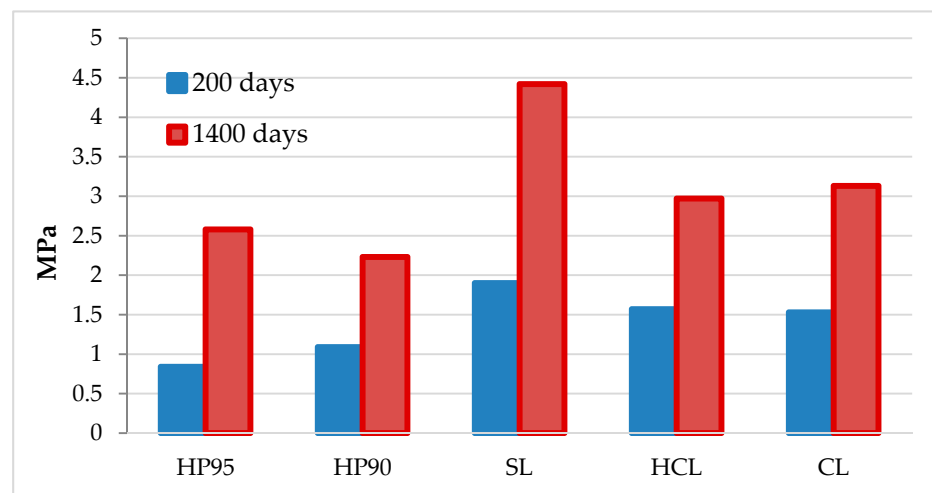
Figure 18. Compressive strength of pastes.

Regarding compressive strength, the results obtained in the pastes tested at 100 days were between 0.8 and 2 MPa, with the HP95 paste having the lowest value and the SL paste having the highest value. There was an increase in the results obtained in the tests carried out at 1400 days, obtaining results in a range of 2.2 to 4.6 MPa; SL obtained the highest value, while the lowest was for HP90. In the pastes, it was observed that the macerated limes obtained higher values than the powdered limes.

Table 12 shows the compressive strength of the paste and mortar specimens at 100 and 1400 days, with a logical improvement in the mechanical capacities of the materials. Figures 18 and 19 display these increases for each one of the groups. It is notable that the performance of pastes reaches high values, especially for SL, with a considerable increase in the resistance over time. On the other hand, the best specimens for mortars were HP90 and CL.
