Comprehensive Overview and New Research on Carbonate Rocks of the Sé Velha Cathedral in Coimbra, Portugal

Keywords: built heritage; carbonate stone; limestone; dolostone; marlstone; Porta Especiosa; Coimbra UNESCO site

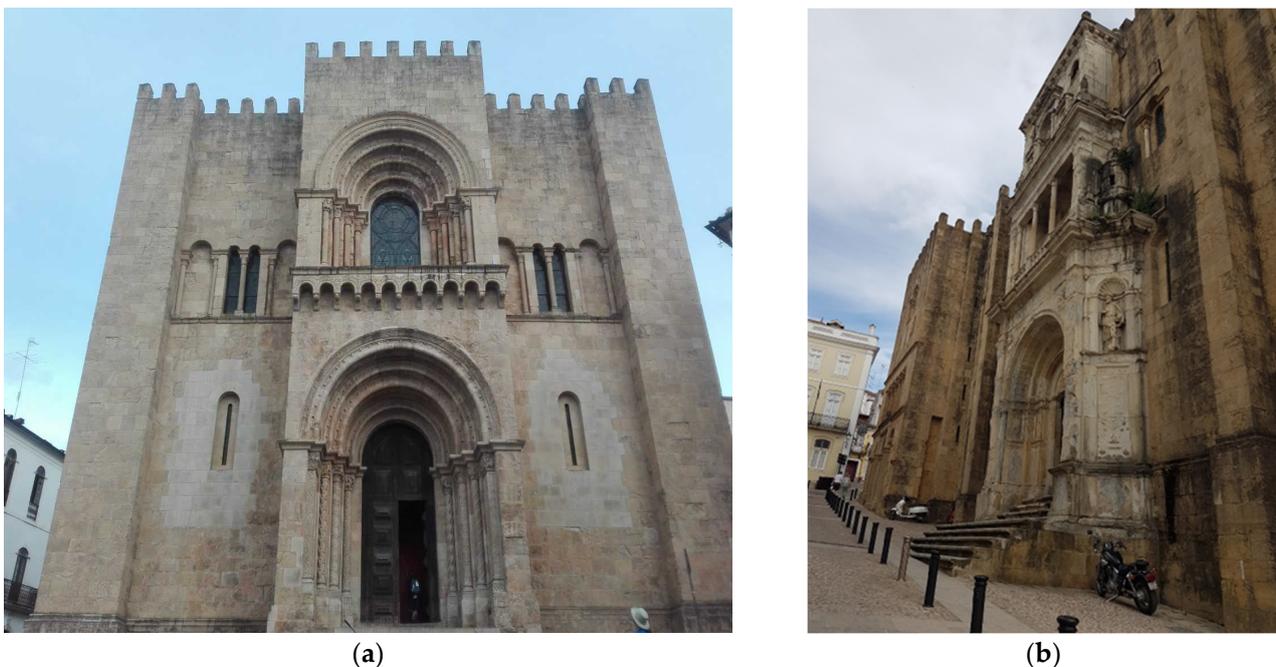
Figure 1. Different carbonate rocks in (a) Old Cathedral of Coimbra and (b) Porta Especiosa. Credits: Alice Tavares.

The Old Cathedral (Sé Velha) of Coimbra (Figure 1a), one of Portugal's most outstanding examples of Romanesque architecture, was chosen for this case study. Built in the 12th century, this cathedral exhibits characteristics typical of the period, including robust stone construction, arched entryways, and ornate sculptures [28]. In the second half of the 12th century, the original Old Cathedral of Coimbra was rebuilt in place of another church. Construction of the current structure began in 1160, during the episcopate of Bishop Miguel Salomão [9,16]. This church was labelled a Romanesque building by Master Roberto, a French architect [9].

The Porta Especiosa portal (Figure 1b) was commissioned by the Bishop of the Cathedral of Coimbra, Jorge de Almeida, and is one of the most representative works of the Renaissance in Portugal [9].

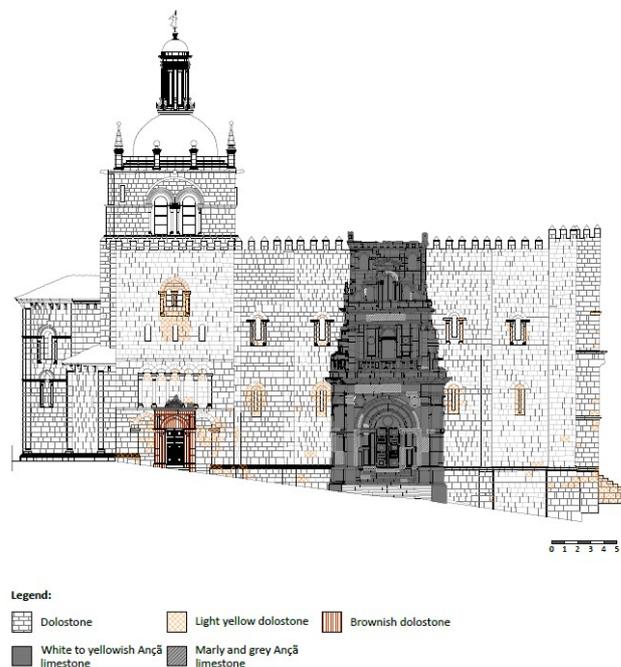
Figure 4. Mapping of stones from North facade of Coimbra's Old cathedral (based on the LNEC drawing) [16].
