Article

Scan-to-BIM Process and Architectural Conservation: Towards an Effective Tool for the Thematic Mapping of Decay and Alteration Phenomena

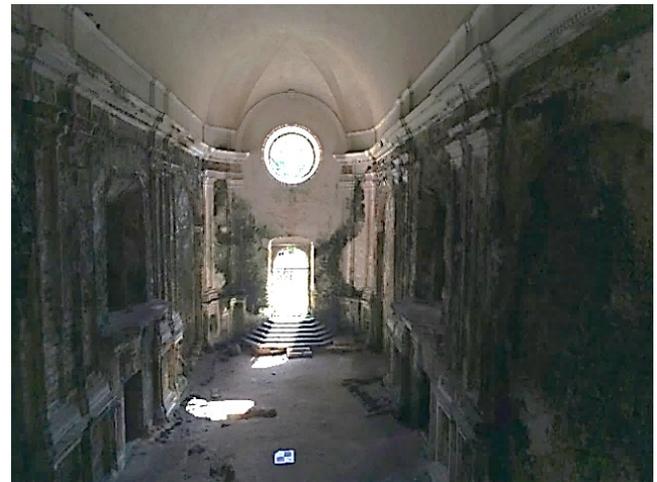
Figure 6. Interior of the church of “Santa Maria della Grotta”: (a) view towards the apse, (b) view towards the entrance. The decay and alteration phenomena are visible all over the walls.

The whole internal surfaces show an evident state of degradation, attributable to the lack of maintenance and the strong humidity linked to its specific underground conformation. In fact, the contact between the walls of the church and the sandstone bank led the monument to a constant presence of humidity along the vertical surfaces of the building.

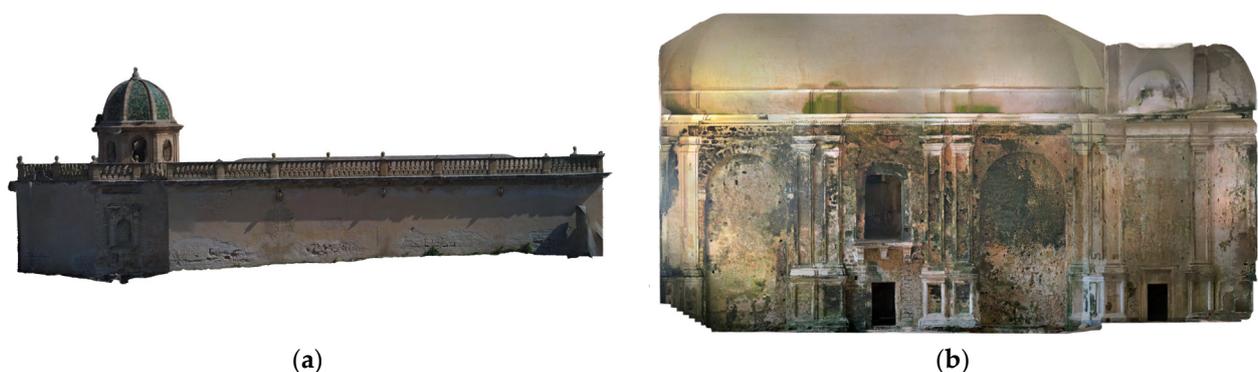
Figure 11. Orthophotos of the external (a) and the internal (b) wall of the left side of the church.

Instead, the orthophotos of the internal walls of the church were obtained with a photogrammetric project (using SfM elaboration) in Agisoft Metashape ver. 2.1.2 software that involved different indoor acquisitions. A unique project was created integrating aerial indoor image acquisitions from an Unmanned Aerial Vehicle (UAV) with terrestrial indoor image acquisitions. Overall, four orthophotos were produced for the two long sides of the nave of the church: two for the external and internal parts of the right side, and two for the external and internal parts of the left side (Figure 11). These products were necessary to conduct a detailed analysis regarding the state of degradation of the interior of the church.

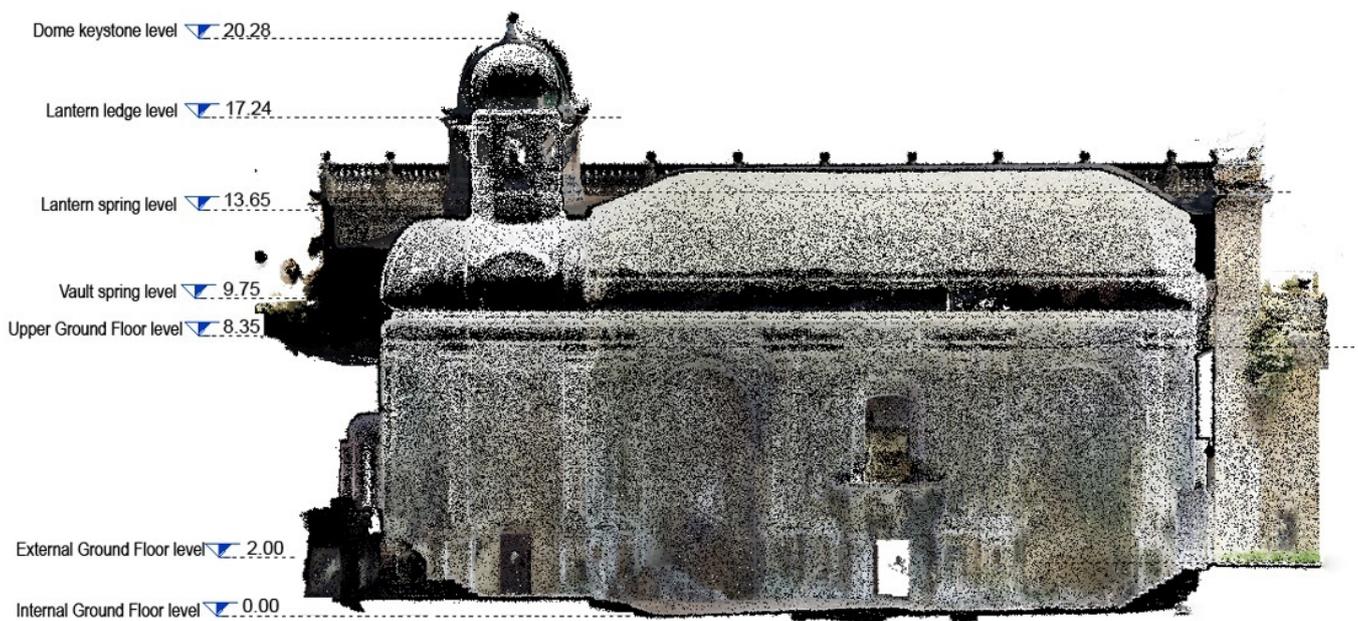
Figure 12. Main reference levels for parametric modelling.

The survey provided the necessary geometric data for the 3D parametric modelling and thematic mapping of decay in a BIM environment. Autodesk Revit ver. 2023 software was chosen for this stage of the work. The modelling phase was divided into several steps. The point cloud from the integrated surveys was first imported into the software, blocked in its position, and used as a geometrical reference for BIM modelling operations [38]. After the definition of the main reference planes such as levels and significant sections (i.e., internal and external ground floors, the roof springing, the dome extrados, axial cross and longitudinal sections on different spans of the church, etc.) (Figure 12), a system of views was created for the identification of the architectural system and the correct spatial insertion of the parametric items.

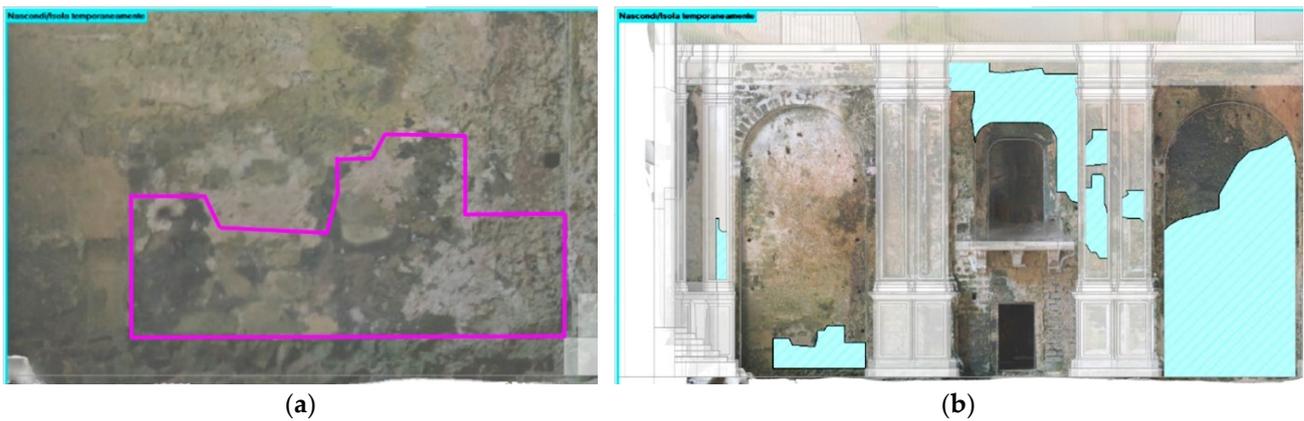
Figure 23. An example of contour tracing: (a) detail of fragmentation on surface layer; (b) the parametric families created accordingly.

The fragmentation, defined as “the complete or partial breaking up of a stone, into portions of variable dimensions that are irregular in form, thickness and volume”, can be observed on the indoor wall surface corresponding to the apse. The separation of the superficial scales is attributable to the presence of humidity and dissolution of the

As previously highlighted, the identification of the decays inside the church was carried out for the internal and external walls to obtain complete documentation and to reach the 3D representation of decay phenomena; the analysis was performed using the high-resolution orthophotos of the wall. The orthophotos were imported into Revit software and overlapped with the corresponding surfaces to create a mapping texture. The decays have been parametrically traced according to their actual shape starting from the 2D visualization (Figure 23).
