Article

Structural Analysis of the Sympathetic Restoration and Conservation of the Gopinath Temple, Kathmandu, Nepal

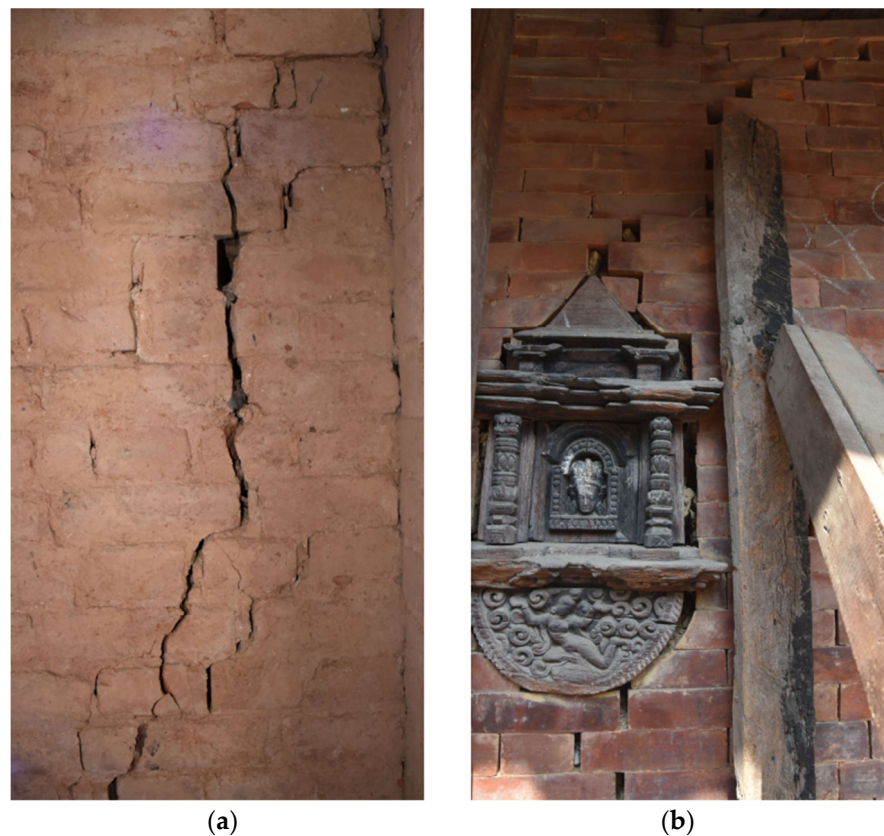
The most severe damage can be seen at the ground-level masonry walls, which have diagonal cracks, 1 to 30 mm wide, and crushing at the lower corners. Figure 2a shows a crack at the ground level in the interior wall, Figure 2b shows the same crack extended up to the exterior face. Furthermore, the exterior masonry leaf at the ground-level wall separated and moved out-of-plane up to 90 mm.

Figure 2. Shear cracks at ground level: (a) interior perspective; (b) exterior perspective.

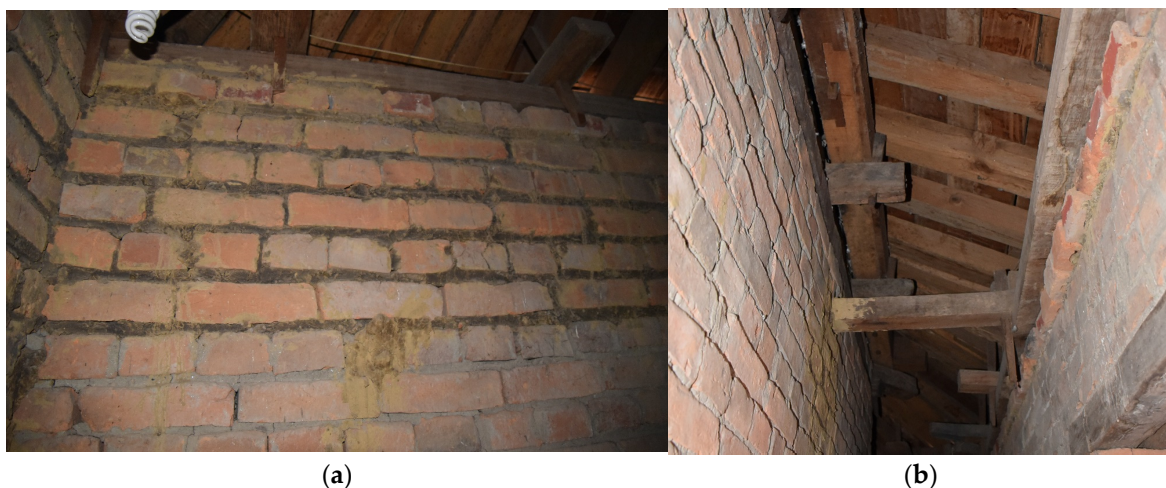
The exterior wall at the first level shows severe out-of-plane movement at the upper middle section; the variation of mortar between the lower and upper parts (Figure 4a) suggests that previous repairs were performed in this section. It is likely the upper wall was rebuilt after the 2004 intervention due to similar out-of-plane damage as that observed at the present moment. The present damage is evident by the relative displacement between the exterior masonry wall and the crown timber beam. The beam was clearly meant to prevent this movement, but the existing damage proves its inefficiency in fulfilling this role. The lack of strength in the masonry resulted in the sliding of the upper bricks' layers, allowing movement of the biggest portion of the upper wall, while the top layer of bricks was held in place by the timber plate.

Figure 4. Exterior wall damages: (a) evidence of previous repairs; (b) relative out-of-plane displacement between upper timber crown beam and masonry wall.

Clear evidence of repair work on the upper section of the exterior wall on the first floor is observed, where previous interventions utilized a mortar type differing from the original (as discussed in Section 3.2). A numerical model was constructed to simulate a scenario devoid of connectors between the interior and exterior walls, representing a situation where these connectors either failed or were absent altogether. Analysis of this model (as depicted in Figure 12) reveals the appearance of cracks at the corners, suggesting the potential for detachment at the wall's apex and consequent out-of-plane damage, akin to the findings of the damage assessment reported in the visual inspection report in Section 3.2.

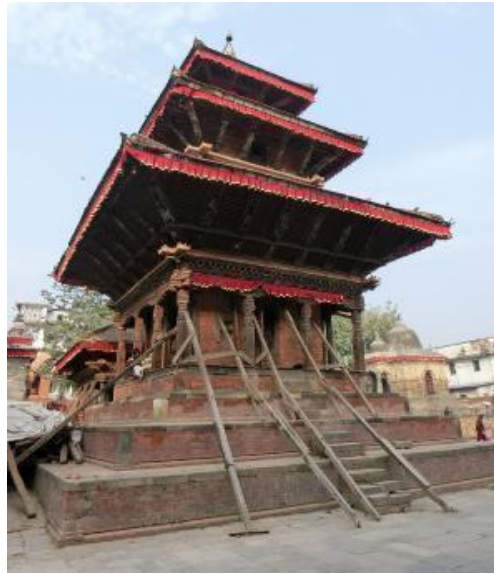
Timber connections were highly affected and showed a permanent deformation with big openings at the joints. Timber columns show torsional movement and tilting as well. The temple has been propped and shored since 2015, as shown in Figure 5.

Figure 5. Gopinath temple's current state (2017).

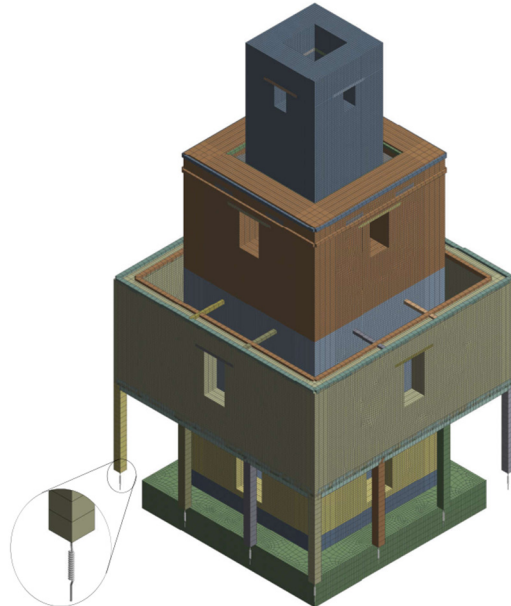
A 3D finite-element model (see Figure 6) was created to study the structural response of the temple under seismic loads and to evaluate the efficiency of the retrofit intervention proposed. All simulations were performed using ANSYS®. The geometry of the model was directly created using the native tools provided in Ansys Workbench and was based on the detailed information available from architectural plans (see Figure 1).

Figure 6. A 3D view of the finite-element model of the Gopinath temple, including a zoom in of the timber column base spring connection.

The ground floor wall base was modeled as simply supported. The boundary condition for the timber column was modeled as no lateral displacement combined with a spring that prevents penetration to the ground but allows uplift. The decision to use springs is based on the type of connections used in Nepali architecture, where timber columns have a small wood pin carved at the base and are set in a stone base. This type of connection prevents lateral displacement but no uplift. The values adopted for the material mechanical properties are presented in Table 1.

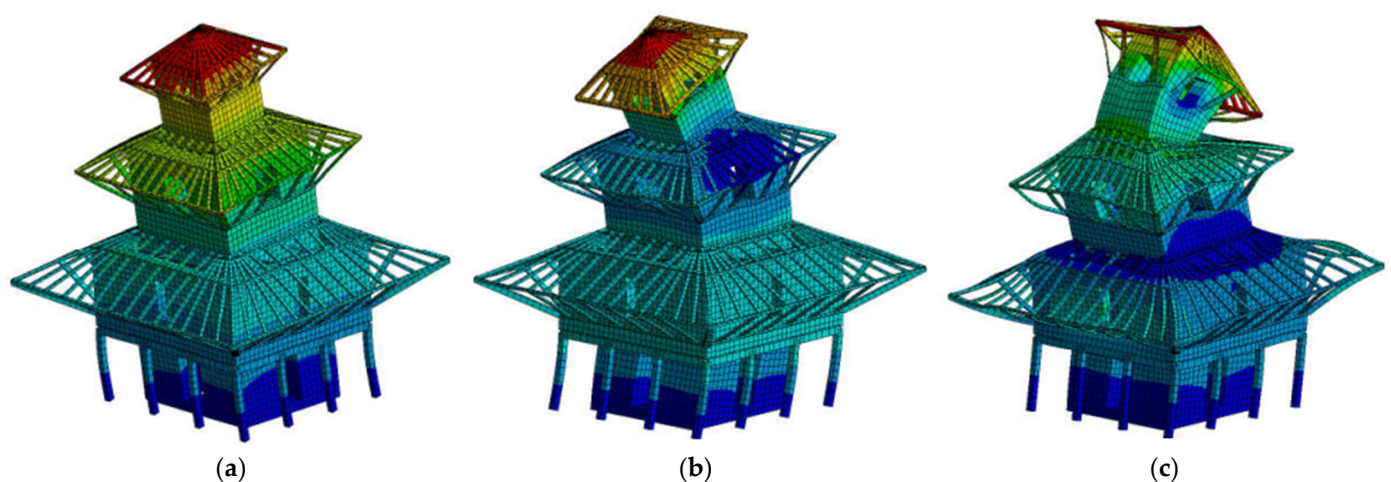
Figure 7. Modal shapes obtained from the calibrated Gopinath temple model: (a) first mode; (b) second mode; (c) third mode.

Various combinations of modulus of elasticity were iteratively tested in the computer model until the deviation between the experimental (Japanese results) and the computer-reported values fell below 5%. The finalized values of the modulus of elasticity, resulting in the minimal difference between the experimental and the computer-model results, are summarized in Table 2. Additionally, a Poisson’s ratio of 0.24 was uniformly selected for the masonry at all levels, while a value of 0.3 was chosen for timber. By comparing the modulus of elasticity values obtained after calibration for each floor to the standard value of sound masonry (250 MPa), a quantification of damage was obtained.

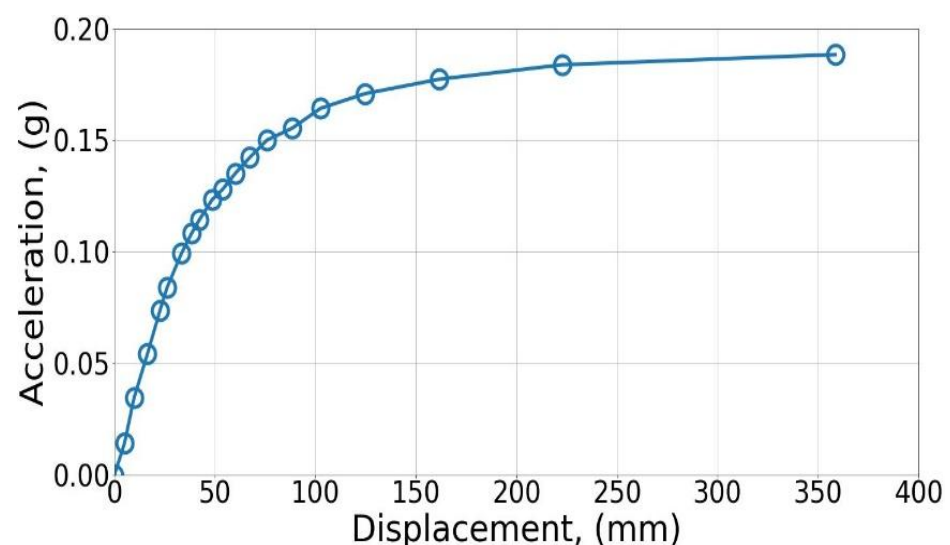
The structural response is evaluated through its acceleration–displacement curve, which represents the value of the applied horizontal action in relation to the displacement of the control point. The top point of the structure was chosen as the control point. While showing a high degree of symmetry, there is an additional opening in the south wall on the first floor, which results in slightly less stiffness in the east–west direction. Thus, the pushover analysis was performed in the east–west direction, as this is the more critical direction and corresponds with the displacement direction of the first mode shape of the temple. Figure 8 shows that, at approximately 0.09 g, the increment of displacement starts to become non-linear, and above 0.17 g, the displacement approaches the collapse condition and is used as an indicator of the structure capacity. The Ghoroka earthquake from 2015 had a peak ground acceleration of 0.16 g and, as expected, resulted in heavy damage to the structure. Figure 9 shows the total equivalent strain as a measure of crack opening and compares it to the crack patterns found in the damage-assessment phase (damage produced by the Ghoroka earthquake). The model shows a good correlation, even though the pushover analysis cannot fully replicate the complex load scenario that generated this type of damage [63].

Figure 8. Pushover curve for the Gopinath temple without retrofit.

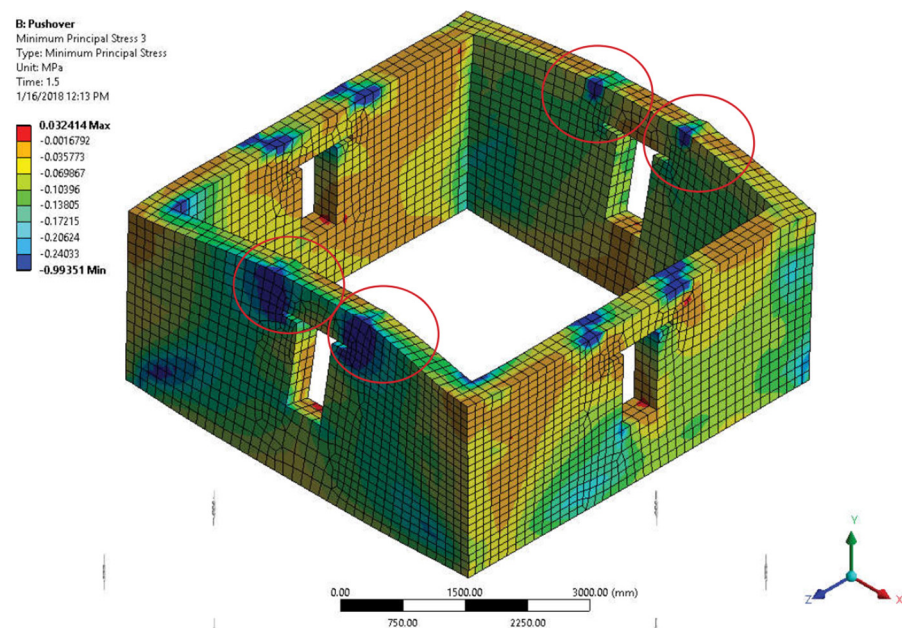
The structure features two timber beams on each face, facilitating horizontal load transfer between the interior and exterior walls at the first-floor level. However, the load transfer capacity of this connection appears inadequate due to a highly concentrated load path. This stress concentration is evident and resulted in elevated tensile and compression stresses at the beam ends (see Figure 10). Evidence of this issue manifests in the form of crushed or broken bricks and peg connectors, as illustrated in Figure 11.

Figure 10. Concentration of stress in timber beam connectors between inner and outer wall at first-floor level.

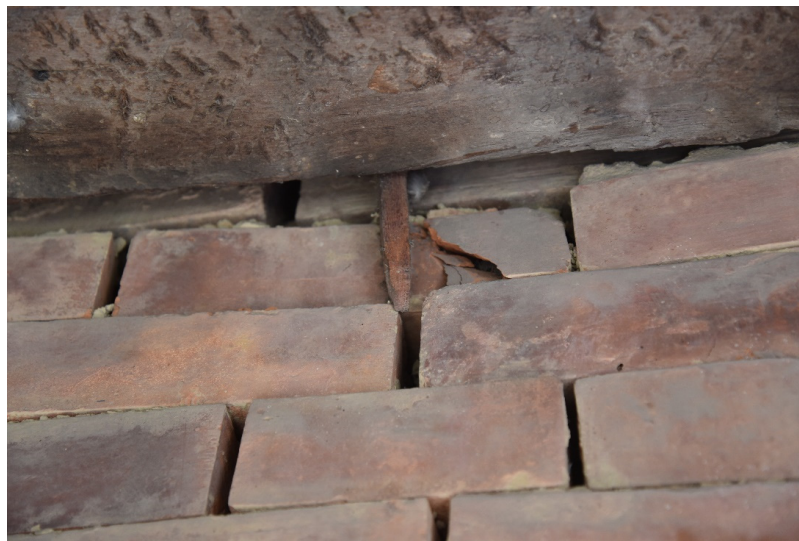
Figure 11. Broken bricks in contact area between peg and masonry wall at first-floor level.

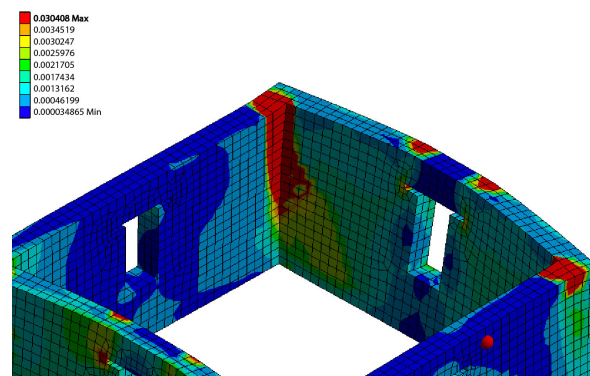
Figure 12. Total strain as an indicator of damage to the exterior wall at the first-floor level.

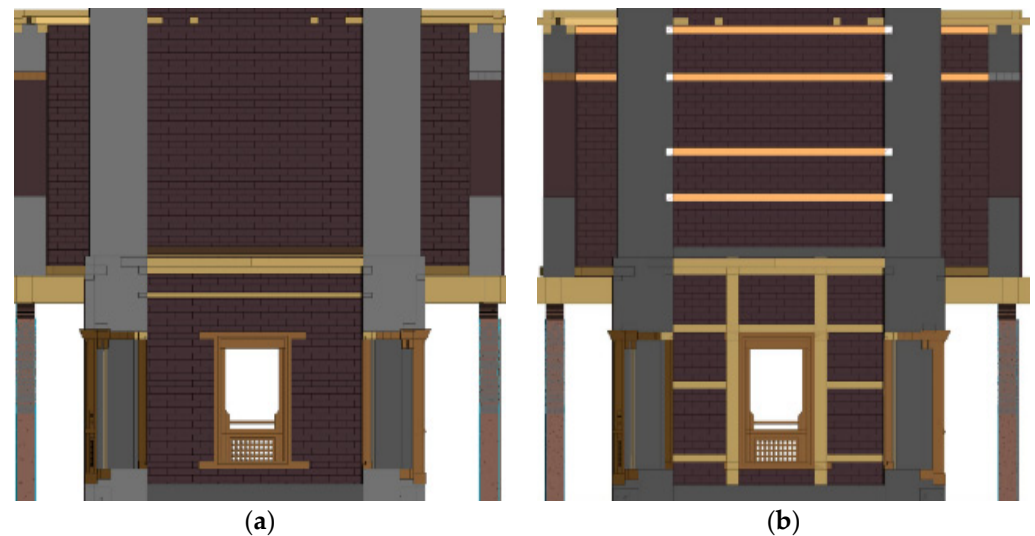
Due to the high seismic activity in the Kathmandu Valley, the Nepalese building code imposes high requirements for seismic design. The temple is required to prevent full collapse against earthquakes, with peak ground accelerations up to 0.30 g [64]. The traditional way of reinforcing masonry structures in Nepal is based on the addition of timber plates. These plates are timber elements embedded in masonry walls (a line of bricks is removed, and the timber plate is installed in its place) to create rings. The timber rings (also known in the literature as timber laces) provide shear capacity and improve the box behavior of the building. Therefore, the presented proposal of repair is based on this traditional construction technique, which consists of adding three wall plates at the ground level and four at the first level (see Figure 13b). The timber plates were modeled in ANSYS® as beam elements using the BEAM188 finite-element type, and their connection to the masonry walls was implemented using bonded contact, thus, matching the degree of freedom of these elements with those of the masonry walls. The retrofit proposal also

suggested an increase in masonry capacity from the current value of 1 MPa in compression to 2 MPa by reconstructing the ground- and first-floor masonry walls using a stronger lime-based mortar compatible with the existing fire clay units.

Figure 13. Retrofit proposals for the Gopinath temple: (a) original; (b) timber and steel.

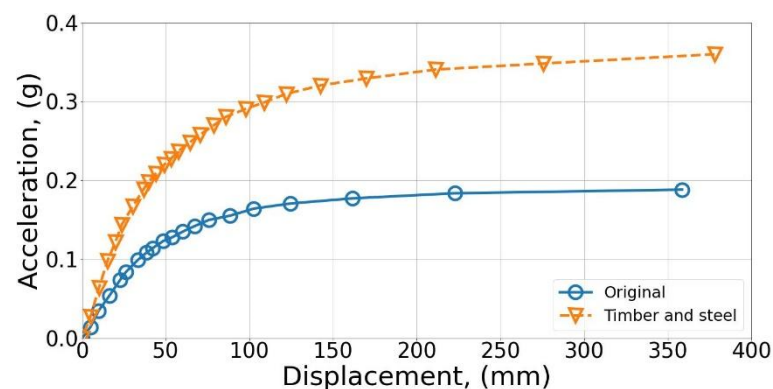
Figure 14 shows the acceleration–displacement curves for the temple in its damaged (original) and retrofitted state. As can be seen in the case of the unreinforced model, failure initiates at a seismic coefficient of 0.17 g. In the case of the reinforced model, as seen in the acceleration–displacement curves in Figure 14, the reinforcement has proven to be effective, with failure initiation approximately around 0.3 g. This increase in the seismic coefficient in comparison to that for the unreinforced model is significant. The pushover analysis proves the intervention proposals to be effective, improving the building resistance to the horizontal forces, without a significant loss of ductility. By comparing the displacement that both the original and the retrofitted models would experience under a similar peak ground acceleration as the one recorded under the Ghorka earthquake, which was 0.16 g, it can be observed that the retrofitted model would be 350% stiffer than the original unreinforced temple. This observation proves the effectiveness of the strengthening strategy suggested.

Figure 14. Acceleration–displacement curves for the Gopinath temple before and after retrofit.

Furthermore, by improving the compressive strength of the masonry walls on the ground- and first-floor levels, which is where the higher levels of load are concentrated, along with the enhanced load transfer effect of the newly incorporated timber rings along the walls' perimeter, the concentration of stresses (see Figure 10) and the consequently induced strains (as presented in Figure 12) would be reduced to acceptable values without fundamentally affecting the structural configuration of the temple. This ensures the sympla-
