Emergency Response for Architectural Heritage in Seismic Areas: An Integrated Approach to Safety and Conservation

Lia Ferrari

Citation: Ferrari, L. Emergency Response for Architectural Heritage in Seismic Areas: An Integrated Approach to Safety and Conservation. *Heritage* **2024**, *7*, 4678–4696. <https://doi.org/10.3390/heritage7090221>

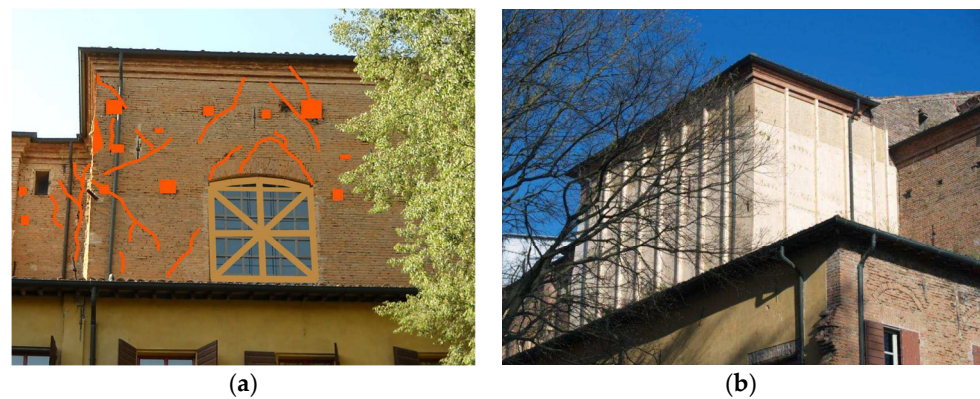
Figure 2. Transept of the Church of Jesus in Mirandola (MO, Italy). Crack pattern documentation (a) realized before the installation of the wooden confinement (b). Photo credits: Comune di Mirandola Provincia di Modena, Allegato 3 Scheda opera provvisoria urgente.

However, this application is not always possible and requires a careful evaluation of the specific case. In this regard, the example of the Church of Jesus in Mirandola (MO, Italy), damaged by the 2012 Emilia earthquake, is worth mentioning. After the emergency interventions that secured the external parts, further safeguarding measures were needed to access the internal spaces for the assessment of the state of conservation to be finalized with the executive design. During the authorization process of these stabilization works, the Ministry of Culture required a specific document taking into account the temporary nature of safeguarding measures [55]. For each emergency action, different strategies and solutions were considered in relation to the realistic needs and, above all, the possibilities of reuse in the following phases. The aim of such a preliminary assessment is to demonstrate that the adopted solution is the most effective and that, where possible, reusable and definitive interventions are preferred to temporary ones. For example, the new tie-rods installed in the central nave during the emergency (against overturning mechanisms), originally set up to be temporary, were modified to be permanent. Traditional pole anchorages (*bolzone* in Italian) were used to permanently integrate the new anchors with the existing ones. This was actually a requirement of the superintendency, to reduce the impact of the definitive works on the masonry. Moreover, different solutions for the temporary cover have been considered. Although the safety conditions did not allow for the realisation of a permanent roofing, the covering structure was set up to create a walking surface to carry out restoration work both on the roof and inside the church. Moreover, a structural scaffolding needed to be installed inside to stabilize the perimetral walls. To this regard, the possibility of using the scaffolding installed in the emergency phase to carry out the final work was also verified in the document, taking into account the safety of the workers and the economic advantage of purchasing then reselling the scaffolding. The document cited is thus an example of integrated approach to recovery, where urgent interventions are designed in view of their impact on future restoration works.

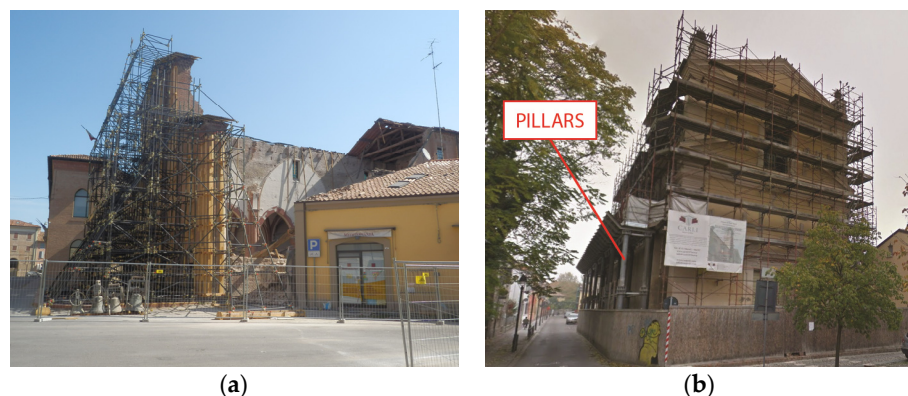
Figure 3. Structural scaffoldings in (a) Church of San Francesco d’Assisi in Mirandola (MO, Italy) and (b) Church of Beata Vergine del Rosario in Finale Emilia (MO, Italy). Photo credits: (a) MiC, (b) Google maps, 2016.

Moreover, to investigate the state of conservation of a building, safety and accessibility are needed. Urgent stabilization can help approaches to the building if correctly set up in the emergency. To this regard, Figure 3 shows two different interventions with stabilisation measures against overturning mechanisms using scaffolding. The scaffolding in the Church of San Francesco d’Assisi in Mirandola in Mirandola (MO, Italy) is made up of multiple layers to support shoring of the façade (Figure 3a). In the Church of Beata Vergine del Rosario in Finale Emilia (MO, Italy), the single-layer scaffolding is instead set up as a hooping element, connected laterally to metal pillars with their own foundations (Figure 3b). Although the technology is similar, the first example does not account for accessibility requirements, while the second allows easy access to both external and internal spaces.

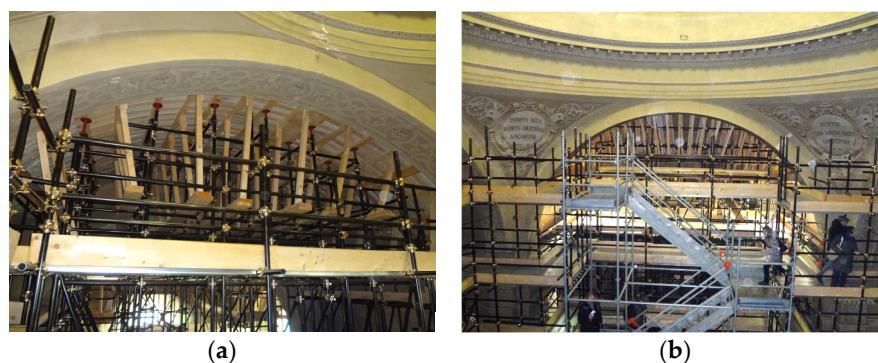
Figure 4. Church of Santa Maria Assunta in Reggiolo (RE, Italy): (a) Emergency scaffoldings to support the damaged vaults; (b) In situ inspection for executive design, using emergency scaffoldings. Photo credits: L. Ferrari, 2017.

Structural scaffolding can also be used to carry out on-site inspections and diagnostics from a short distance away. This was the case in the Church of Santa Maria Assunta in Reggiolo (RE, Italy), where the structural scaffolding was installed in the emergency

phase to support the damaged vaults (Figure 4). For further optimisation it was also used for the final rehabilitation, avoiding the need to replace it with new temporary supports which would have resulted in higher costs and wasted materials. This was made possible with an awareness in the design of the structural scaffolding from the outset; engineered in accordance with the operational and safety requirements of the future building site, constant maintenance and minor adjustments ensured efficiency throughout the entire recovery process.

Although technically effective, this security technology can be quite expensive. However, for an installation period of more than eighteen months (data updated to 2012), purchasing rather than renting improves the efficiency of this solution from an economic point of view [51]. In the latter case, for example, the purchase of the scaffolding (at a cost of around 150,000 euros) proved to be the most cost-effective solution, not only because of the long installation time and its reuse during the final retrofitting, but also because it was installed inside the church (and therefore protected from decay) and sold to the contractor carrying out the final restoration work, reducing the actual cost by 25%.
