Contributions to Architectural and Urban Resilience Through Vulnerability Assessment: The Case of Mozambique Island's World Heritage

Abstract: Mozambique Island, a UNESCO World Heritage property, faces significant challenges due to climate change and extreme weather events. This study proposes a comprehensive framework for assessing morphological vulnerabilities and enhancing urban resilience in this unique historical urban landscape. The research methodology involves a thorough analysis of historical cartography, urban evolution, topography, and vernacular architecture, combined with recent conservation assessments and case studies from other climate-vulnerable regions. This study reveals the island's dual urban structure, comprising the Stone and Lime town and the Macuti town, each with distinct morphological characteristics and vulnerabilities. Historical maps and topographical analysis demonstrate how the island's geography has shaped its urban development, with the Stone and Lime town built on higher ground and the Macuti town situated at or below sea level, increasing its flood risk. The research highlights the importance of integrating traditional knowledge with resilience

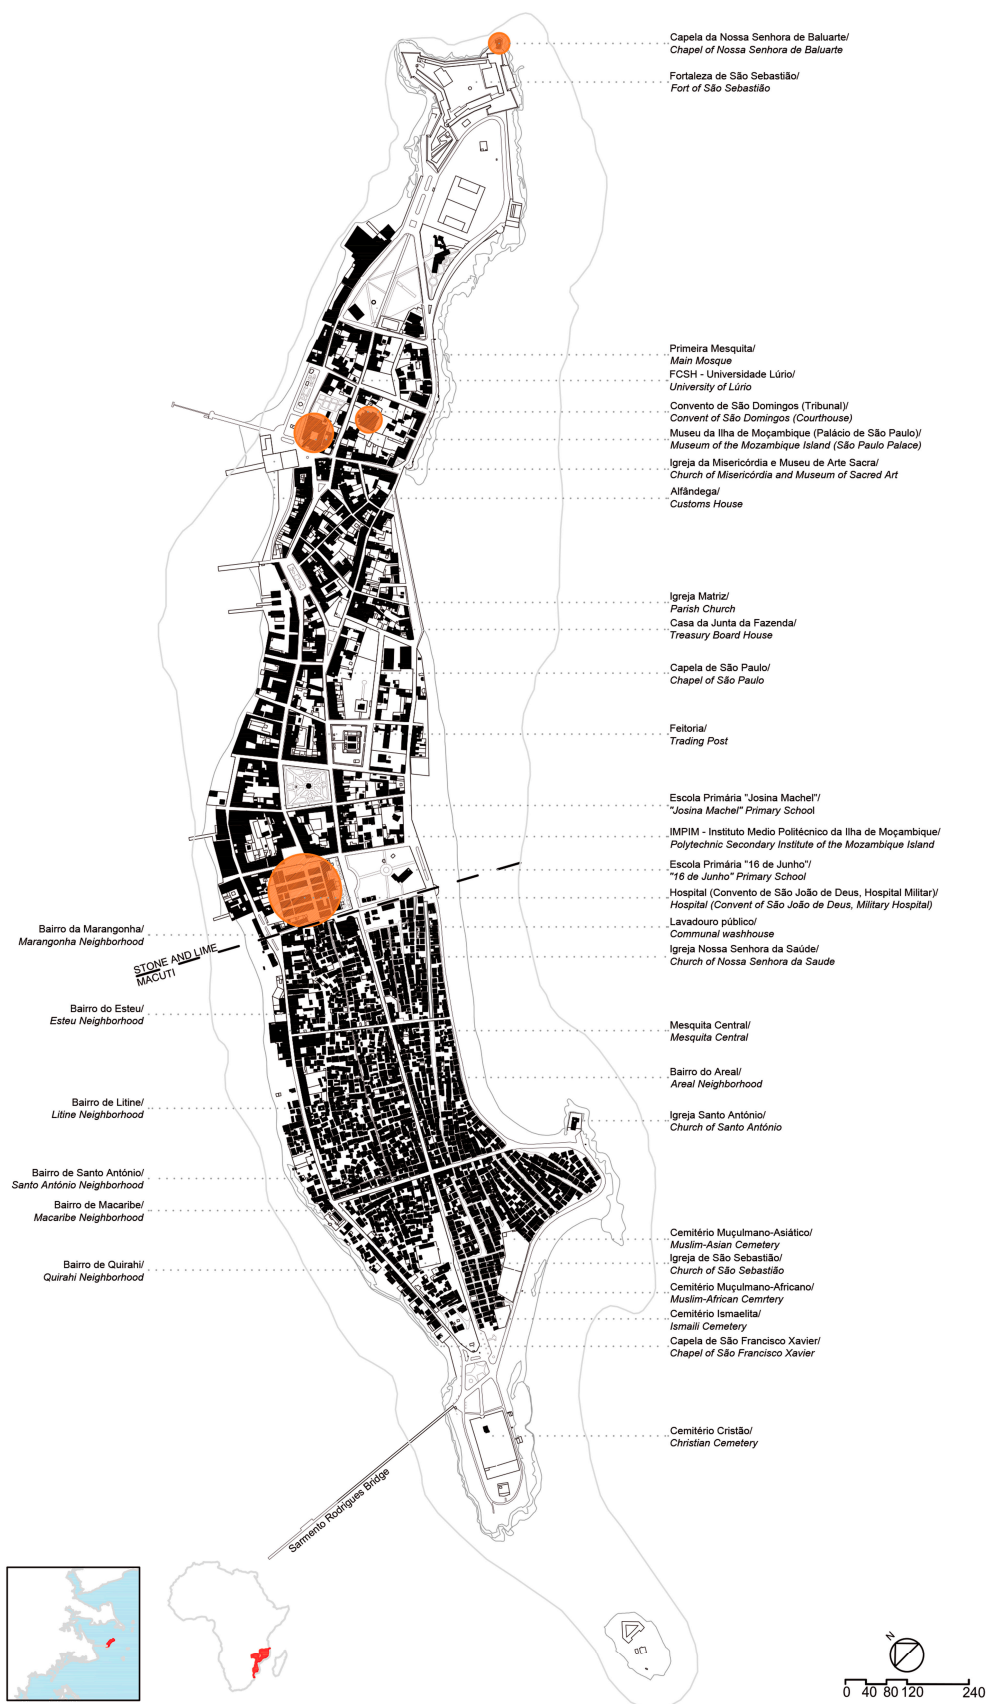
Figure 2. Cartography of Mozambique Island and its geographical location. Red circles mark the buildings and areas most affected by Cyclone Gombe. Produced by the authors, 2024.

Mozambique Island is a dual urban structure divided into (i) the Macuti town: an area with traditional buildings made of macuti (palm leaf) roofs, and wattle and daub structures, and more recently with traditional brick masonry and informal concrete houses; and (ii) the Stone and Lime town: the historical colonial area built of stone masonry buildings and lime plaster originated from the island (Figure 2).

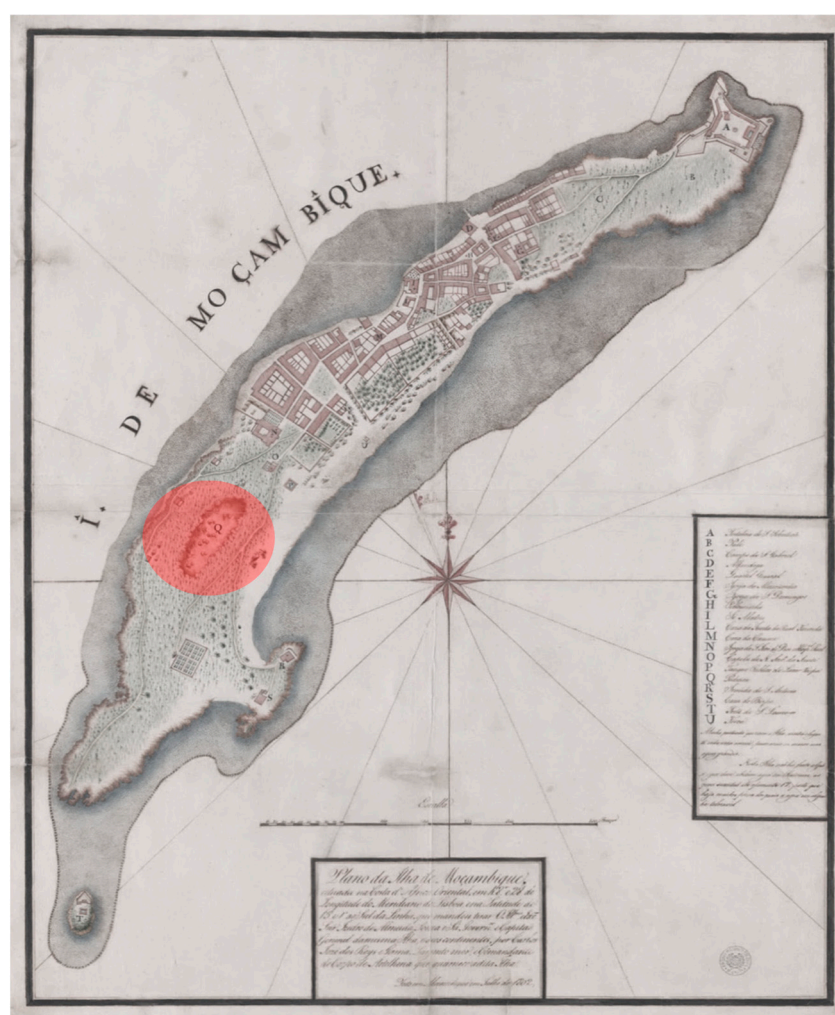
Figure 3. Cartography of 1802 with a red circle of the stone quarry. Document provided by Portugal, *Arquivo Histórico Ultramarino* [24].

The urban development of Mozambique Island was shaped by various historical, economic, and social factors [23]. The Portuguese colonial period in particular had a profound impact on the spatial organization and architecture of the island, introducing new elements and construction techniques that merged with local traditions (Figure 3).

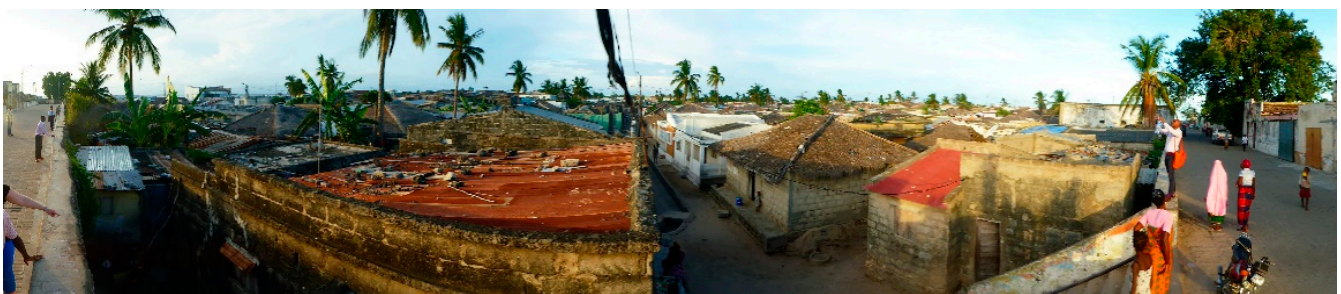
- (a) Traditional construction with a natural fiber roof, which is considered the “original” vernacular construction.
- (b) Traditional construction covered with an industrial roof.
- (c) Conventional construction covered with industrial tiles, as well as three versions involving coral stone construction and a concrete slab roof (Figure 6).

Figure 6. Panoramic view of Macuti town. Reproduced with permission from Mariana Correia, author archive, 2018.

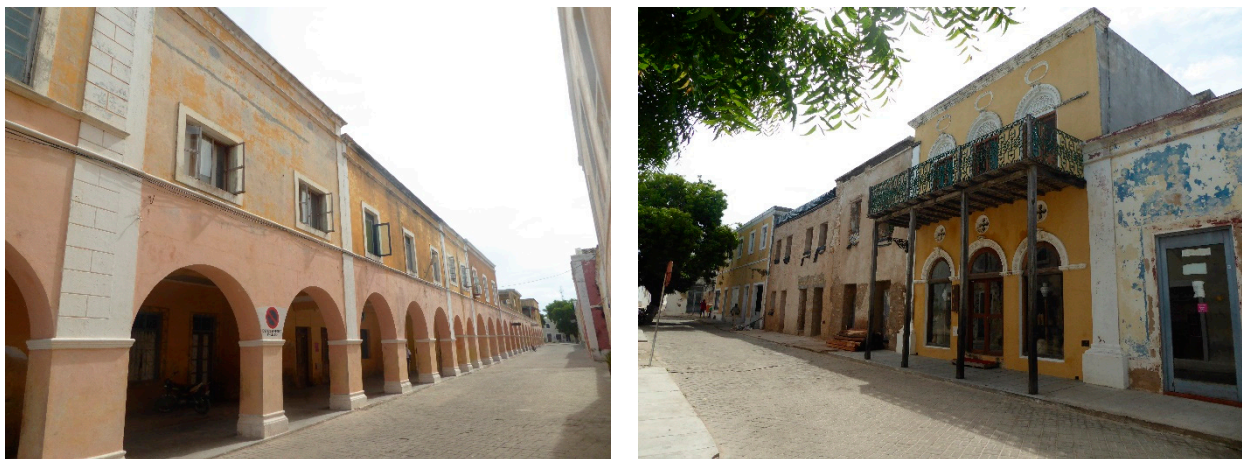
Figure 7. Two examples of street view façades from Stone and Lime town. Reproduced with permission from Mariana Correia, author archive, 2018.

The architecture exhibits homogeneity in its use of materials and construction techniques, which is particularly evident in Stone and Lime town (Figure 7). Buildings in this area share common architectural elements and construction methods, characterized by the widespread use of coral stone and lime mortar. The structures typically feature thick load-bearing walls made of coral limestone blocks, with lime-based plaster and whitewash finishes on both exterior and interior surfaces.

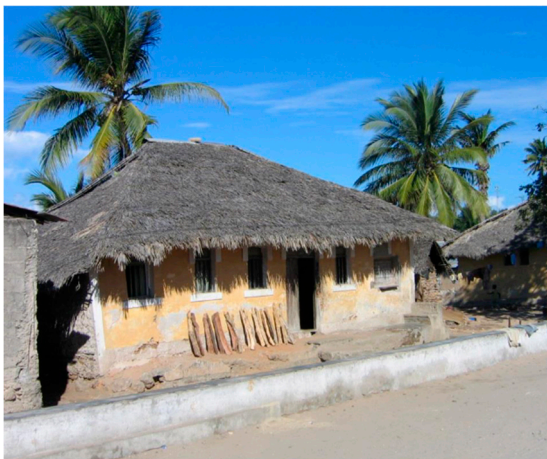
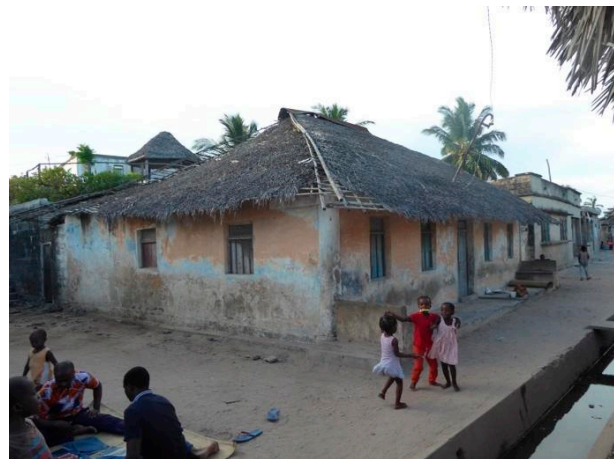
Figure 8. (a) Photo of Macuti buildings. Reproduced from [28]. (b) Photo of Macuti buildings and the drainage channel. Reproduced with permission from Mariana Correia, author archive, 2018.

The Macuti town features a dense urban fabric with narrow, winding streets and alleys. The architecture is predominantly traditional, with houses built using local materials like wood, earth mixture, and palm leaves (macuti) (Figure 8). The Macuti town is divided into distinct quarters, each with unique characteristics. The oldest quarter is in the northern part, closest to the stone town, with a more regular street pattern and some stone buildings mixed with traditional houses. The central area is the most densely populated, with a maze-like network of narrow paths between closely packed houses. The southern part is less densely built, with more open spaces and larger plots. The western edge faces the mainland and has a more linear structure along the shore, while the eastern side borders the ocean and includes some flood-prone areas. Each quarter has its own social dynamics and community structures, often centered around small squares or open spaces. The architecture throughout Macuti town reflects the cultural heritage and traditional building techniques of the local population, adapted to the tropical climate and available resources [26].

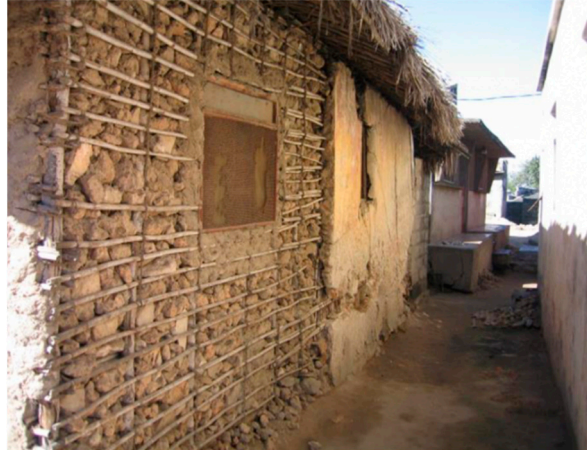
Figure 9. Photo of Macuti buildings with the wattle-and-daub structure. Reproduced from [28].

sometimes animal dung. This creates a sturdy wall structure that is well-suited to the local climate (Figure 9).

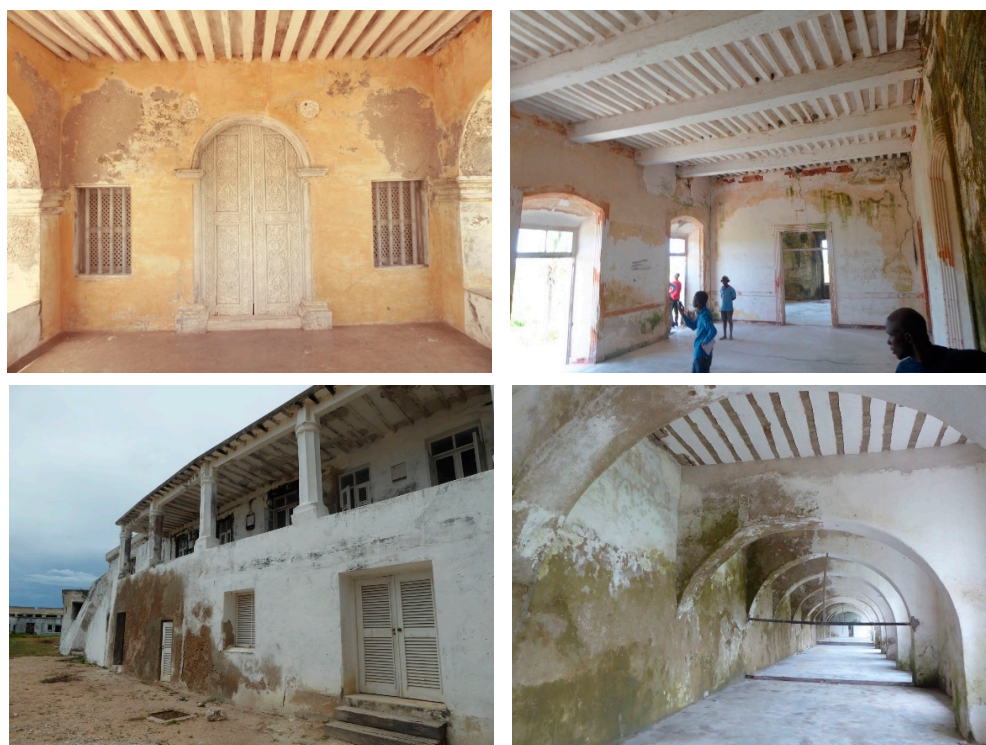
Figure 10. Some examples of the degradation phenomena (cracks, humidity areas, paint degradation, and weathering) observed in the Stone and Lime buildings. Reproduced with permission from Mariana Correia, author archive, 2018.

Overall, while both towns share several common degradation phenomena, the Stone and Lime town appears to be in a more advanced state of deterioration, particularly in terms of flooring adhesion, façade humidity, and roof conditions.
