Article

Acoustical Impact of Architectonics and Material Features in the Lifespan of Two Monumental Sacred Structures

Zühre Sü Gül

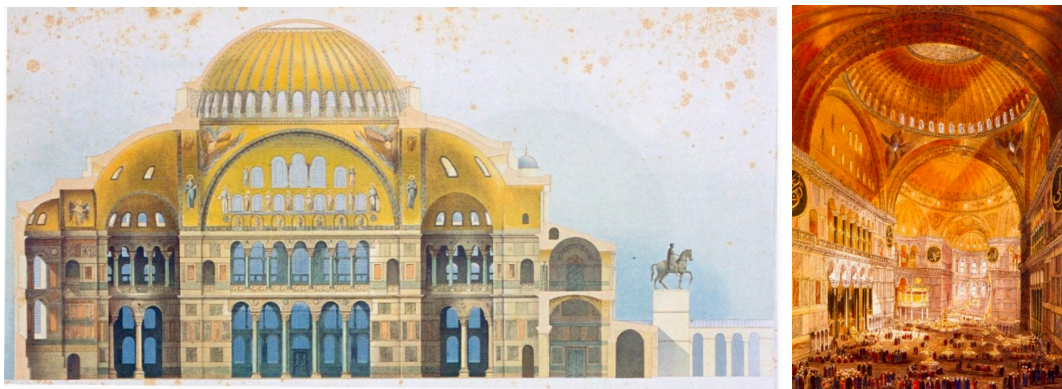
Figure 2. On the left: section view of Hagia Sophia from the central axis by Salzenberg [25] (p.280), on the right: interior view—an old painting [25] (p.284).

The major figure of Hagia Sophia is an expanded dome basilica: a rectangular building covered by a central dome between two half domes and integrating longitudinal and centralized planning (Figure 2). This structure has an interior length of 73.5 m and a width of 69.5 m, excluding the narthex and the apse. The length of the entire interior from the exonarthex to the edge of the apse is 92.3 m. The central nave is built on an east-west axis, and a large dome is constructed right in the center to cover up the space. The central dome that rises 55 m above the pavement of the nave is not exactly round but slightly elliptical today, with a diameter of 31.2 m on one axis and 32.8 m on the other [18]. The domed central space is skirted by two large hemicycles covered by half-domes to the east and west. The diameter of these half-domes roughly equals to that of the central dome. From the crown of each of the main piers and between the four great arches, the pendentives fan out on the interior and rise to a roughly circular projecting cornice [25,26]. The side aisles are separated from central nave by columns and arches sheltered with vaults. There are galleries over the side aisles and inner narthex, creating a U-shape that reinforces the centralizing tendency of this expanded dome basilica. The central oval vessel of enclosed space is further expanded by barrel-vaulted spaces that terminate along the building's longitudinal axis at the east and the west ends of its nave [18]. Overall, Hagia Sophia has an approximate interior acoustical volume of 150,000 m³, which creates an outstanding visual and acoustical environment.

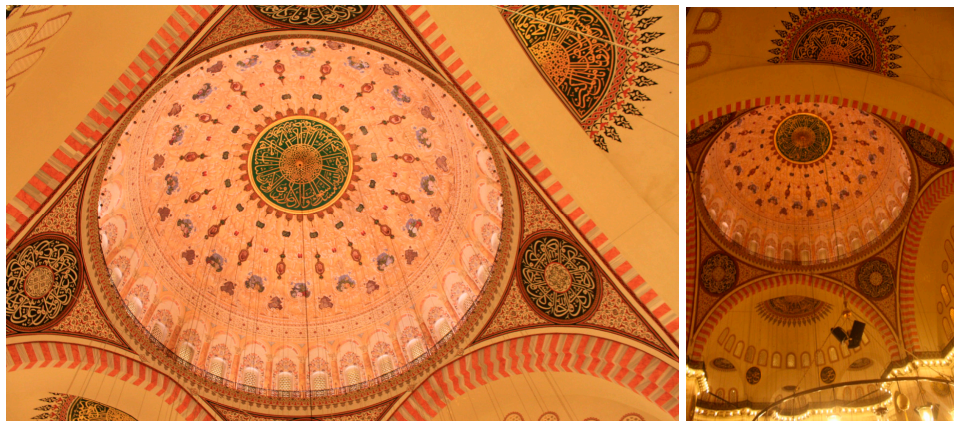
Figure 5. Interior views of domes and pendentives in Süleymaniye Mosque (photos by the author).

Süleymaniye Mosque's main structural elements are domes, arches, and flying buttresses. The mosque is covered centrally by a single dome which is supported on two sides by semi domes. The two semi domes align with the direction of the mihrab. Side aisles are sheltered by five smaller domes which complete the upper structure. Pendentives are utilized to smooth the central dome, secondary half dome, and arch connections. The inner plan of the mosque measures approximately 63 by 69 m. The main dome rests on four elephant feet and 32 footings on a circular wheel with a diameter of 26.2 m. The height from the foundation to the impost is 33.7 m. The inner rise of the dome is 14.0 m, and thus the height of the dome from the ground to the keystone is 47.8 m (Figure 5). The middle and corner smaller domes on aisles have diameters of 9.90 and 7.20 m [32,33]. Süleymaniye Mosque's interior acoustical volume is approximately 75,000 m³.

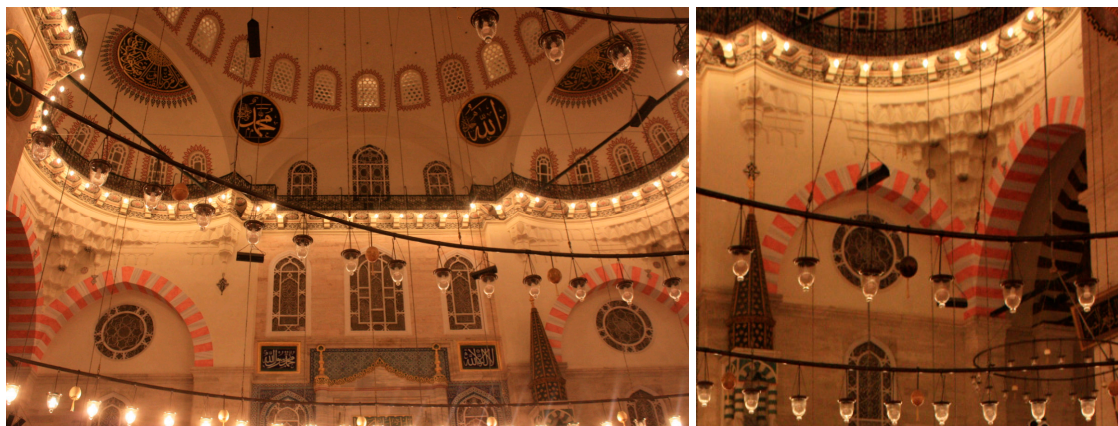
Figure 6. Muqarnas details (photos by the author).

Limestone is the main structural stone as well as the facing stone for interior walls and wall footings. Piers carrying the main dome and suspension arches are of cut limestone while the inner faces are painted as of Hereke conglomerate and Proconnesian marble. Columns are of Egyptian porphyry (red sparrow eye). Different bricks were utilized as the core material of domes due to its lightness. Painted brick domes are then decorated with gold foiled pen paintings. The mihrab and the minbar are of carved white marble and have stained glass windows on the sides [35–37]. Lime, fine sand, gypsum, linen, and straw are the basic ingredients of plaster layers and seams. Linen is applied in dome plasters of Süleymaniye Mosque in its original state. Wood in the interior is mostly used for flat ceilings, doors, window frames and furniture. Only the two windows on each side of mihrab have künde-kari wooden work shutters. The floor finish of the mosque is carpet with straw backing—which were collected from the finest straws grown in Nile delta—as stated in original documents. Carpets had originally been woven in Egypt and Aydın-Tire [35,36]. Another feature of Süleymaniye Mosque of its original state is the use of Sebu's (clay pots), that are essentially applied to lessen the weight of the dome, but also believed to function as cavity resonators for the control of excessive low frequency sound (Figure 6).

In accounting registers of Süleymaniye Mosque construction (account book number 108), it is declared that for plaster finish of dome (Beray-i siva-i kubbeha-i cami'-i şerif) 134 kantar of linen was purchased [35]. This is significant information in terms of acoustical assessment of historical plasters that is detailed in following sections. As a final acoustical point, within the mosque muqarnas/stalactites are used as a transition element in column heads, in the skirting of half domes. These elements do not have any structural function and are out of gypsum. Muqarnas helps to enhance the sound diffusion in mostly curvilinear and concave transition planes by fragmenting these surfaces (Figure 6).

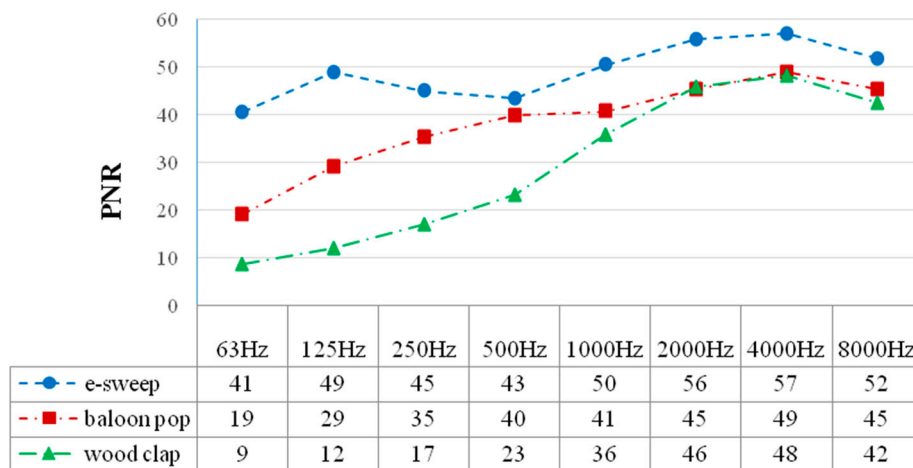
Figure 7. Hagia Sophia PNR measurements in 1/1 octave bands in Hz; comparison of e-sweep, balloon pop, and wood clap source signals.

Field tests, within this study's scope, were held in Süleymaniye Mosque on 23 February 2013, in between the hours of 19:30 p.m. and 3:00 a.m. at the main prayer hall, and in Hagia Sophia on 25 August 2014, in between the hours of 09.00 a.m. and 12.00 a.m. at the ground floor, for both in unoccupied conditions [17]. In assessing room acoustic parameters, field measurements were held in accordance with ISO 3382-1,2009 [41]. B&K (Type 4292-L) standard dodecahedron omni-power sound source was used in acoustical signal generation with B&K (Type 2734-A,) power amplifier. The impulse responses at various measurement points were captured by B&K (Type 4190ZC-0032) microphone, incorporated into the hand held analyzer (B&K-Type 2250-A). Sampling frequency of the recorded multi-spectrum impulse was 48 kHz, covering the interval of interest between 100 and 8000 Hz. DIRAC Room Acoustics Software Type 7841 v.4.1 was used for both generating different noise signals and for post-processing of the measured impulse response data for each receiver position. For reliable decay parameter estimations, it was aimed to obtain signal that was at least 45–50 dB higher than the noise in all octaves. Tested signals were E-sweep, MLS, MLS-pink, balloon pop, and wood clap. Up to five pre-averages were applied over multiple measurements, with impulse response length of 21.8 s. E-sweep provided the highest PNR values, thus those samples were mostly utilized in post-processing. As an example, comparison of some sample source signals is provided in Figure 7.

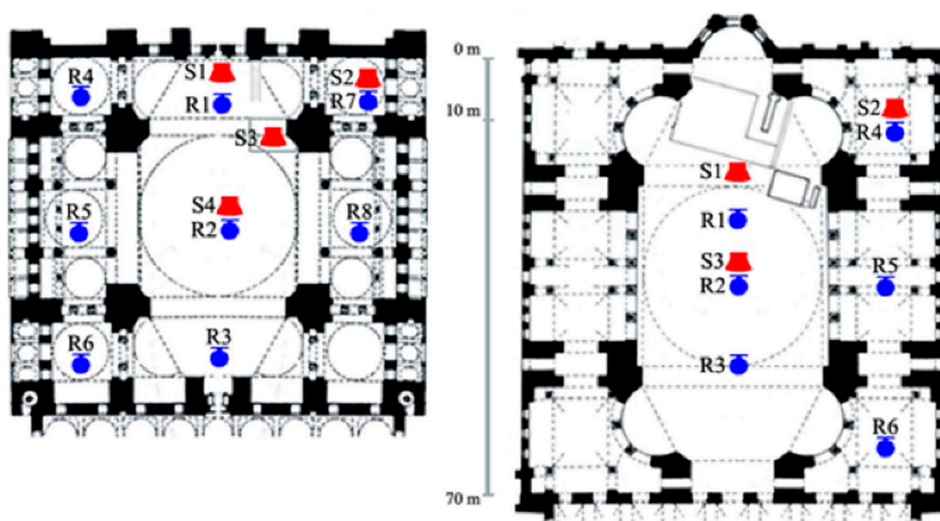
Figure 8. Sound source (in red) and receiver (in blue) locations used in field tests of Süleymaniye Mosque—METU-2013 tests (on the left) and Hagia Sophia—METU-2014 tests (on the right).

The measurement positions of field tests are represented in Figure 8, in which the sizes of each structure in relation to one another can also be compared on the plan scheme. Major source locations in Süleymaniye Mosque are one in front of mihrab (S1) and the other at müezzin mahfili (S3). The positioning of sound source is important to assess the acoustics of Süleymaniye Mosque for its traditional use. For acoustical coupling or multi-decay rate investigation, additional source locations including one underneath the main dome (S4) and one underneath side corner dome (S2) were tested [42]. Eight receiver locations (R1–R8) were coupled with four source locations (S1–S4) providing measured source–receiver configurations. In order to observe multi-slope decay formation for different locations and to discuss the effects of spatial variations—such as main central space versus space underneath side galleries—in Hagia Sophia, three source (S1–S3) and six receiver (R1–R6) positions were tested in numerous configurations (Figure 8).

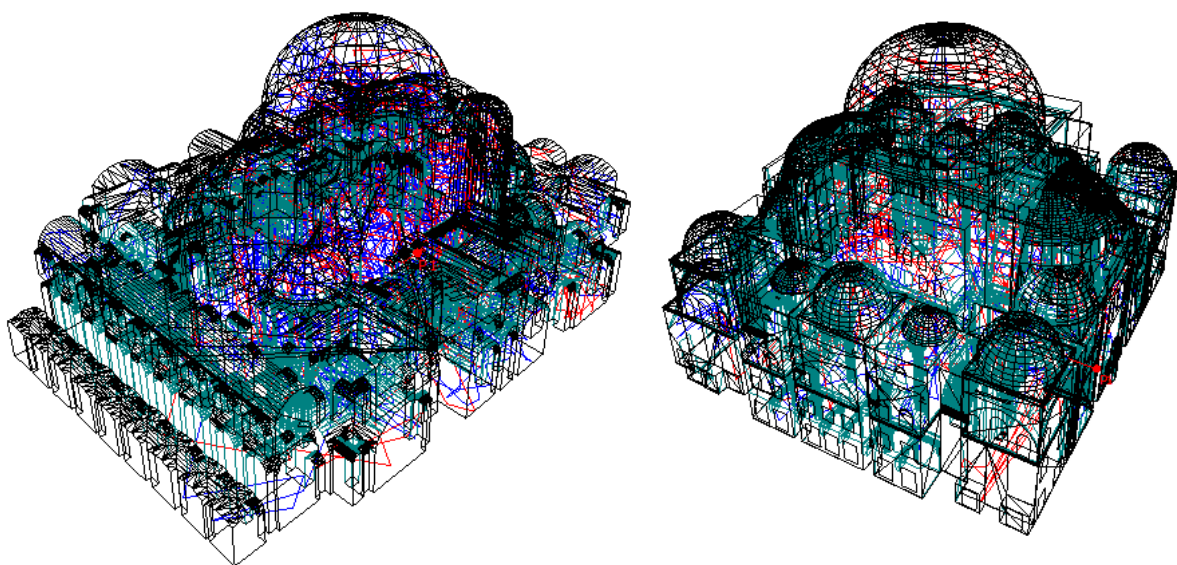
Figure 9. Ray tracing models of Hagia Sophia (on the left) and Süleymaniye Mosque (on the right).

The acoustical simulations of historical structures are carried out in a broader frame of this research by two main methods that are ray-tracing simulations and diffusion equation model (DEM) analysis in a finite element scheme. For applying different estimation methods, the acoustical models of both structures were generated, utilizing the latest building survey registers (röleve) for Hagia Sophia provided by the Turkish Ministry of Culture and Tourism—General Directorate of Turkish Cultural Heritage—and for Süleymaniye Mosque provided by the General Directorate of Pious Foundations. For highlighting the different volumetric relations and major form of the encapsulated interior sound fields, in Figure 9 the ray-tracing models of both structures are presented.

For testing the above argument, the acoustical model of Süleymaniye Mosque (Figure 9) was utilized in a simulation study that compares today's plasters, after multiple restorations, with historical multi-layered pozzolanic lime-based plasters. The procedure of model tuning for current state with field tests are presented in Section 4.2. The results are initially attained for unoccupied condition as in field tests, later the results are obtained for occupied condition. The simulations are done for both current state of the Mosque and for modified acoustical model with historical plaster data [49]. Occupied condition represents the full-occupancy as in Friday's Sermon when clarity of speech is more important.

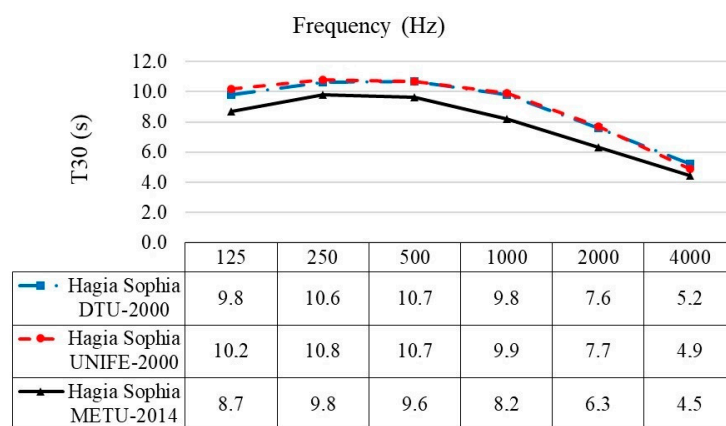
Figure 10. Comparison of T30 results over collected impulse responses in Hagia Sophia by Denmark Technical University (DTU)-2000, Ferrara University (UNIFE)-2000, and METU-2014 in field tests, in 1/1 octave bands from 125 to 4000 Hz.

In Figure 10, DTU and UNIFE indicate measurements taken in 2000 under the supervision of the CAHRISMA project [3]. Hagia Sophia field tests held in 2000, highlight that T30 values in overall are higher than field test results of METU-2014 measurements. The drop of T30 values in METU-2014 measurements below 250 Hz in Hagia Sophia could be the result of the barrier wall separating one side aisle from main volume over the whole longitudinal length, which was present within the space during field tests due to ongoing restorations. Out of single layer gypsum board connected to back studs/profiles in certain intervals, it is probable that the system behaved as an effective low frequency membrane absorber. As another outcome, the mid to high frequency drop in T30 values of METU-2014 measurements in comparison to pre-2000 restorations are one probable result of present scaffolding in on-going restorations that were re-built after 2012. Thus, the presence of additional architectural elements/constructions within the space during METU-2014 measurements resulted in a drop of 1 to 2 s, in the overall frequency spectrum, of reverberation times. On the other hand, the trend of the sound decay over the frequency spectrum is similar for all Hagia Sophia field tests.

Overall, in the current state of Hagia Sophia, the T30 results obtained in recent years by different research groups indicate very high reverberation times within the mega-structure. Mid and low frequency T30 averages are around 9 s and high frequency averages are around 5 s. This superb and extraordinary aural environment is unique and has the potential to provide acoustical field conditions in relation to coupled spaces for specific locations. Non-exponential sound energy decay is one outcome of Hagia Sophia's architectonic language, a brief discussion of which is presented in Section 5.4.

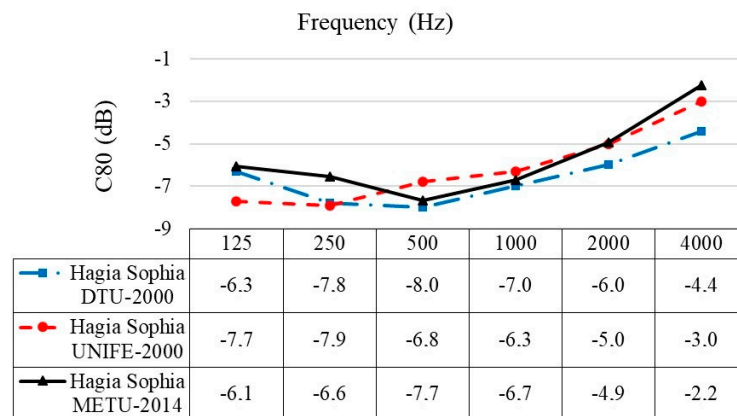
Figure 11. Comparison of C80 results over collected impulse responses in Hagia Sophia by DTU-2000, UNIFE-2000, and METU-2014 in field tests, in 1/1 octave bands from 125 to 4000 Hz.

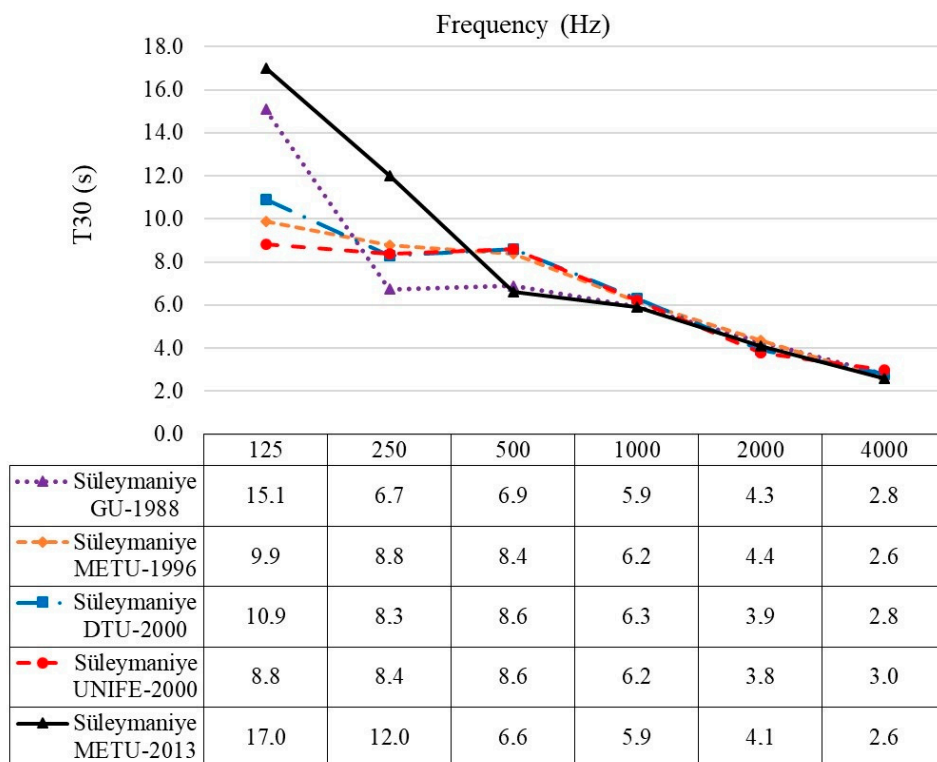
Figure 12. Comparison of T30 results over collected impulse responses in Süleymaniye Mosque by Gazi University (GU)-1988, METU-1996, DTU-2000, UNIFE-2000, METU-2013, and AU-2013 in field tests, in 1/1 octave bands from 125 to 4000 Hz.

Mosque is the reverberation time (T30). Thus, measured T30 values over octave bands are the basis of comparisons (Figure 12). Some previous literature recommends reverberation times of 4-4,6 s for mid frequencies as an optimum range for mosques with similar volume [3]. According to Figure 12, all of the field tests indicate very long reverberation times, higher than recommended ranges for the mosques for unoccupied condition. Especially, 125 Hz is very problematic considering the intelligibility of speech; which will be even worse when the electro-acoustic system is on, as in today’s applications. The T30 values over 2000 Hz are comparatively more suitable for the Mosque’s function in comparison to mid to low frequencies. The main reason of this drop in higher bands is the absorption of air of such an immense volume.

In METU-2013 measurements below 100 Hz, reverberation times reaching 20 s are observed. It is also noted that there are some measurement spots reaching 20 s at 125 Hz in GU-1988 measurements that are excluded from the average as considered to be the highest deviation [43]. The rise in 250 Hz of METU-2013 measurements are due to the very high values of T30 at 200 Hz in the 1/3 octave band. One reason for the deviations among different measurements might also be due to the averaging of 1/3 octaves or only plotting 1/1 octaves. In 1996 and 2000 field tests, T30 values at 125 Hz were measured in between 9 and 11 s, which are much lower than 1988 and 2013 measurements. This result is most probably caused by the insufficient capture/impulse response lengths of the other field tests. For instance, the DTU-2000 measurement set-up uses 10 s of impulse response length, in the real case, which could easily have missed the chance of estimating a longer reverberation time. On the contrary, both of the first measurements taken by GU-1988 with analogue equipment and the final measurements taken by METU-2013 with digital equipment and with an impulse length of 22 s, indicate 15–17 s of T30 values at 125 Hz. Thus, it could be stated that 2007–2011 renovations have not significantly affected the T30 values at 125 Hz, which are still very high and above the acceptable limits for mosque function.

According to METU-2013 measurements, reverberation times for octave bands in between 500 and 4000 Hz have been lowered by different ratios compared to previous years' test results. The major change is the 2 s of drop at 500 Hz. When T30 values at 250 and 500 Hz are compared for 1988 measurements and 1996–2000 measurements, an increase of 1.5 to 2 s is observed in the latter. In order to be able to explain this increase, the probable undocumented minor-restorations or material changes in between the years of 1988 and 1996 should be known. Another point is that the measurement positions vary in different field tests, so only average values could be compared.

The comparative analysis of field test results indicate that the 2007–2011 restorations resulted in a slightly positive decrease in reverberation time at 500 Hz, whereas overall, the values are still higher than the recommended ranges. The attempts for removing cement-based plasters, and application of plasters that are compatible with historical lime-based plasters, as so declared, are constructive but not yet efficient acoustical interventions; especially in control of low frequency sound content. The effects of so stated intrusion on Sebu (clay pot) voids—opening the mouths and repair of inside cracks—are still vague in acoustical terms. In order to be able to scientifically comment on acoustical effects of Sebu repairs, the present geometrical and dimensional properties of these elements should be identified, which can only be possible by their systematic inspection on site.

The plot of the simulations tuned by the acoustical field tests in Süleymaniye Mosque's current condition is quoted as "Current plasters (U)" in Figure 13. The measurement results used in this tuning are given in Figure 12 indicated by "Süleymaniye METU-2013." According to the simulation results for unoccupied condition, the replacement of cement-based repair plasters with historical ones ended up with a drop of 2.8 s in T30 value at 500 Hz and almost a drop of 8 s at 125 Hz (Figure 13). T30 values for the fully-occupied mosque in its current state is 6.6 s lower than that of its unoccupied condition for 125 Hz, and 3.6 s lower than unoccupied condition for 250 Hz. However, the low frequency reverberation times are very high and distracting for intelligibility in its current state.

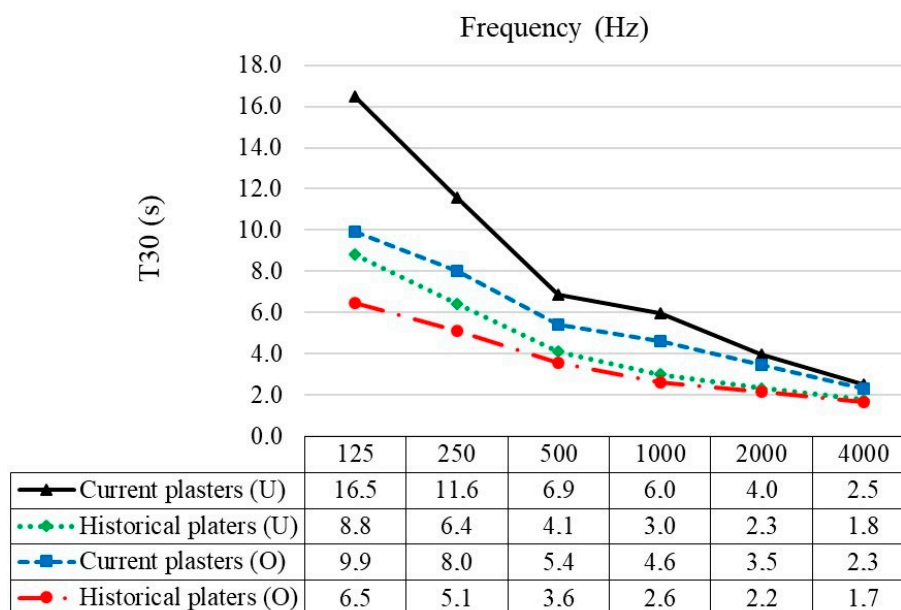
Figure 13. Simulated T30 results of Süleymaniye Mosque Hz in 1/1 octave bands from 125 to 4000 Hz for its current state and trial with historical plasters for unoccupied (U) and unoccupied (O) conditions.

In spaces with excessive volume as in Süleymaniye Mosque, the expected long reverberation times have to be controlled by increasing the sound absorptive surface area. For an even distribution of reverberation over frequency, the sound absorption of materials in octave bands should be well balanced. Carpet is an absorptive material for mid and high frequency range only, unless it has at least 5–10 cm height platform, or air space, underneath. In the records of construction documents of Süleymaniye Mosque such a platform is not mentioned [35]. This means that the original carpet’s sound absorption performance would be similar to that of today’s carpet for low frequencies, and not much of a difference is expected from high frequencies in reference to some other research on carpet effects’ in mosques [50]. One other significant piece of information is that in its original state, straw is laid underneath carpet of Süleymaniye Mosque [35], which would have provided a slight improvement in absorption of mid frequency sound content. Carpet is still significant in terms of providing positive absorption area for intelligibility (of consonants). Apart from those, in a prayer scenario the presence of people and their compactness improve sound absorption as well as scattering within the Mosque, as observed in full-occupancy simulation results (Figure 13).

The absorptive carpet floor surface is still not sufficient to tolerate the long reverberations of this immense volume. On the other side, in Süleymaniye Mosque shiny and tight stone walls, column, and elephant feet surfaces compose the reflective areas. The sound absorption coefficients of applied stones within Süleymaniye Mosque can be predicted for the current and original states in the range of 0.05–0.10. The unknown is the sound absorption coefficient data of original/historical plasters with or without paintings that are renewed in several restorations. These plasters are applied at dome, arch, and mostly upper wall surfaces, and compose a very large surface area of approximately 19,000 m². The influence of these plasters on reverberation times would be noteworthy [52].

This situation causes even worse acoustical defects, in fact, when the electro-acoustic system is on. In the fully-occupied state of the Mosque with the application of representative historical plasters, the reverberation times are lowered by 2 to 3 s in mid and low frequencies in comparison to the same occupancy state with current plasters. The reverberation time values in between 5 and 6.5 s in the low octaves and 2.6–3.6 s in the mid frequency range indicate that with this trial of historical plasters, Süleymaniye Mosque's interior sound field is much suitable and closer to the recommend limits for mosques with similar volume [3,55]. Although there were some recent attempts in removing cement-based plasters (2007–2011 restorations), the 2013 field measurements show that the problems are not thoroughly solved. Results indicate that if the historical plasters could have survived till now or if the Mosque underwent repairs with the plasters totally compatible with the historical ones, the acoustical conditions would be much more suitable for the function of a mosque today, as well.

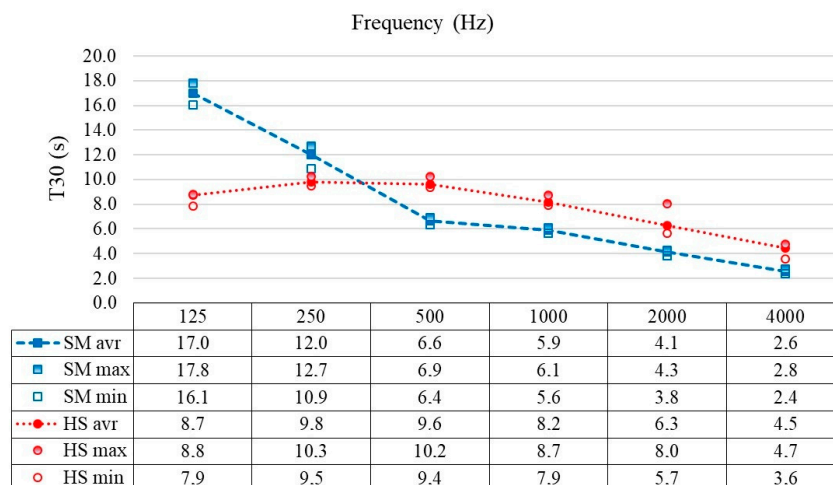
Figure 14. Comparison of T30 results over collected impulse responses in field tests of Süleymaniye Mosque by METU-2013 and in Hagia Sophia by METU-2014, in 1/1 octave bands from 125 to 4000 Hz.

Due to volumetric differences, dimensional proportions and variable sound absorption characteristics of interior finish materials Süleymaniye Mosque have expectedly lower reverberation times in the frequency range over 250 Hz in comparison to Hagia Sophia. This result was expected considering the doubling of acoustical volumes, which is roughly around 75,000 m³ for Süleymaniye Mosque, whereas roughly around 150,000 m³ for Hagia Sophia. The plan schemes of two structures are compared in Figure 8, indicating the considerable differences in size, even in plan layout. Another significant aspect in relation to reverberation, aside from the interior volumes, is the interior finish materials. Marble floor surface in Hagia Sophia in comparison to the carpet floor finish in Süleymaniye Mosque is also very much effective in the increase of reverberation times, specifically over mid to high frequencies. Whereas, the carpet is not that effective under 250 Hz, and this time the reverberation is higher in Süleymaniye Mosque.

In Süleymaniye Mosque, T30 values at 125 Hz are observed to rise to very high levels, which are even much longer than T30 values obtained at 125 Hz in Hagia Sophia. That indicates a probable occurrence of resonances within the main space of Süleymaniye Mosque within that particular frequency band interval. Overall, the distribution of reverberation times over source-receiver positions are smooth and there are no big differences between the average and minimum-maximum values. This indicates a reasonably even distribution within both structures with such great volumes. The diffuseness is due to the surface fragmentations provided by efficient scattering of sound by means of arches, muqarnases or stalactites and mahfili's. It should also be noted that high reverberance inside Hagia Sophia provides suitable repertoire and singing ability in terms of liturgical music, while in Süleymaniye Mosque music is not practiced that much, but only ritual sermons. Thus, the interior sound field of Süleymaniye as a mosque and Hagia Sophia as a church are practically much more suitable for their authentic function of use.

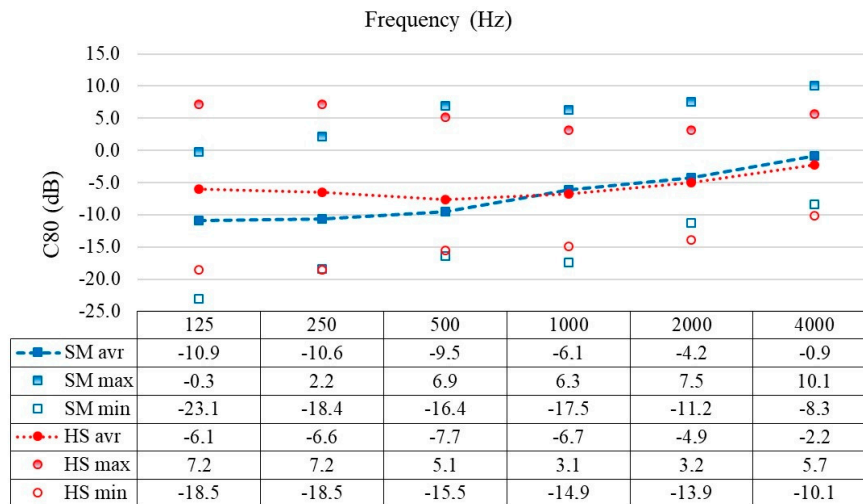
Figure 15. Comparison of C80 results over collected impulse responses in field tests of Süleymaniye Mosque by METU-2013 and in Hagia Sophia by METU-2014, in 1/1 octave bands from 125 to 4000 Hz.

As shown in Figure 15, the average trend of C80 values over frequency spectrum obtained for Hagia Sophia and Süleymaniye Mosque are similar, while values for both structures are much lower than those typically obtained in other venues such as concert halls. It is not surprising that such high reverberation times in overall frequency spectrum would cause low values of clarity. Another reason for very low clarity is the major geometric attributes of both mega-structures. The great sizes and heights of central domes and the lack of close-by surfaces to the receiver zone—such as overhead reflectors in concert halls—cause late reflections to dominate early reflections. The C80 parameter is very much dependent on receiver position, so the deviations in the data that can be observed from average, minimum, and maximum values obtained in both structures are as expected. The C80 information is provided not essentially for comparison but mostly for archiving the measured data obtained within the case historical structures over years.

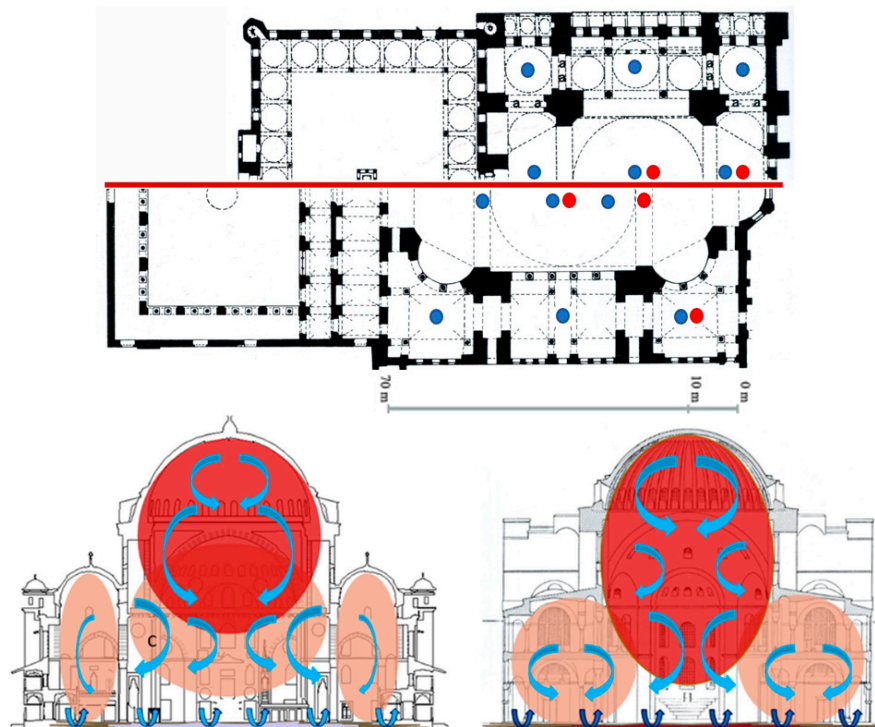
Figure 16. Above: partial plans of Süleymaniye Mosque (above) and Hagia Sophia (below); below: conceptual section view of sound energy flows of Süleymaniye Mosque (on the left) and Hagia Sophia (on the right).

On the other hand, the span of arches which separate the main prayer hall in Süleymaniye Mosque and the arches connecting the side galleries to the central nave in Hagia Sophia differ in dimension (Figure 16). Due to the larger proportions of arches in Süleymaniye Mosque, the side aisles behind those major arches supporting the central dome are not restricted as much as arcades separating side aisles of Hagia Sophia. While, the smaller arches of Hagia Sophia create much more defined coupling apertures and occasionally cause triple slope decays underneath side aisles. To summarize, interior finish material distribution and/or geometric attributes of the two mega-structures provide sound energy flows inside, among sub-volumes. All these geometric and material attributes cause sound energy concentration and fragmentation within the spaces that augment the non-exponential or multiple sound energy decay formation [17].
