Strengthening Strategies for Existing Rammed Earth Walls Subjected to Out-of-Plane Loading

Abstract: The paper reports an experimental campaign to study the effectiveness of strengthening measures proposed for rammed earth (RE) wall in an out-of-plane direction. Two simple and feasible strengthening techniques were explored, namely, mesh-wrapped and timber-framed strengthening techniques. The test involved testing three full-scale U-shaped RE walls in an out-of-plane direction. The first specimen without any intervention served as the reference wall, while the two others were strengthened with two different strengthening methods. It was observed that both proposed strengthening techniques improved the load-carrying capacity of the wall and the maximum displacement and the energy absorption. The mesh-wrapped strengthening technique was found to be more effective than the timber-framed strengthening technique, which disrupted the visual aspects of the wall's facade and needed proper anchoring to the foundation.

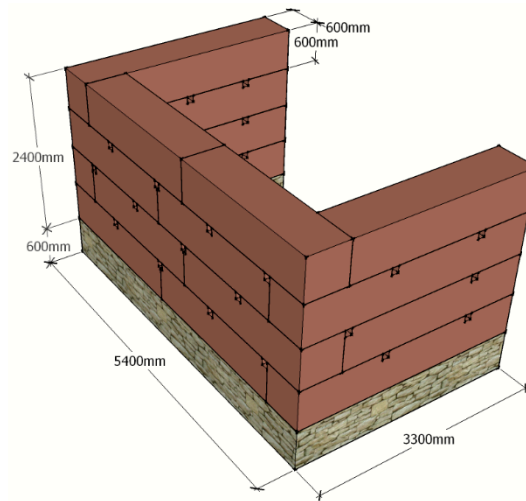
Figure 1. Specimen details.

The experimental program included a pull-down test of U-shaped wall to understand the out-of-plane behavior of rammed earth wall while assessing the feasibility and effectiveness of the proposed strengthening techniques. The test specimen prototype represented a real-scale wall facade and transverse walls. Three U-shaped full-scale rammed earth walls were constructed, namely, unreinforced rammed earth (U-RE), mesh-wrapped strengthened rammed earth (Mesh-RE), and timber-framed strengthened rammed earth (Timber-RE). The unreinforced rammed earth (U-RE) represented a typical house built without any seismic components, and it served as the reference wall, while the rammed earth wall strengthened with a mesh and timber frame were aimed at retrofitting existing buildings. The details of the adopted specimen are presented in Figure 1, and Figure 2 illustrates the grain size distribution of the soil used [5]. All specimens were constructed on top of a rubble masonry foundation of 600 mm height and 600 mm thickness by local Bhutanese craftsmen following the traditional construction procedures practiced in the region to realize the actual behavior of such structures. The construction process for RE wall involved the installation of wooden formwork, as shown in Figure 3a, which consisted of (i) shutter planks on both sides, (ii) horizontal joining members at the top and bottom, (iii) and vertical members to connect the shutter planks and horizontal members. The local term for each formwork component is shown in the figure in italic word. Wedges were inserted between the vertical members and shutter planks to keep the formwork stable, thus preventing the wall from bulging. This single formwork section gave a rammed earth block of around 2500 mm length, 600–700 mm height, and 600 mm thickness. The next step included pouring of moistened earth inside the formwork (Figure 3b), followed by compaction of 240 mm soil to around 120 mm manually with wooden ramming tools. The water content in the mixture was checked through a traditional field test. A handful of moist earth was squeezed and tossed up in the air about a meter away from the ground, and the mixture was considered suitable if, upon falling on the ground, it broke into two or three major pieces [12,24]. The final finished RE block looked smooth and shiny (Figure 3c). A single block consisted of five layers labeled as 1, 2, 3, 4, and 5 in Figure 3a. The formwork was

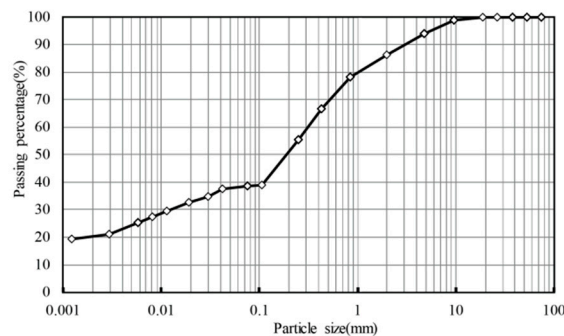
Figure 2. The grain size distribution of the soil used.

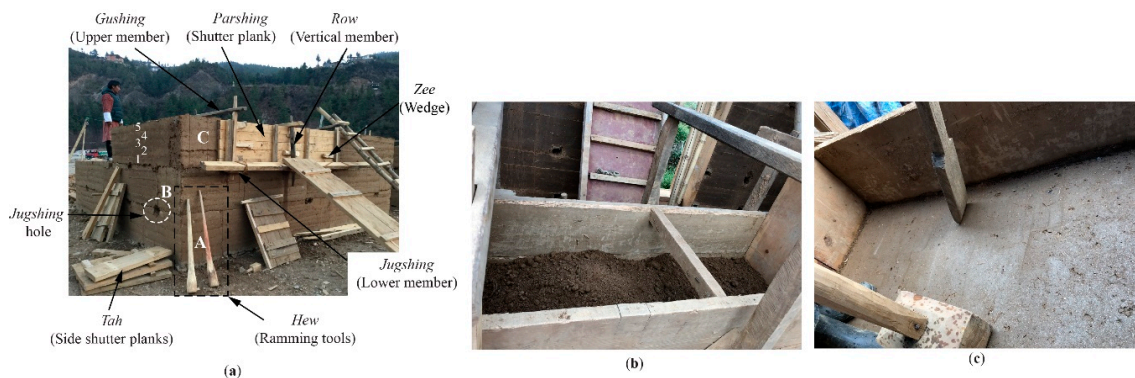
Figure 3. Construction details of U-RE specimen: (a) Rammed earth at third block showing formwork details, (b) Loose earth inside formwork before compaction, (c) Smooth and shiny finish after compaction.

removed immediately and reinstalled to construct the next block. The blocks in the corners were placed alternatively to avoid a continuous head joint between the two rammed earth blocks marked A, B, and C in Figure 3a.

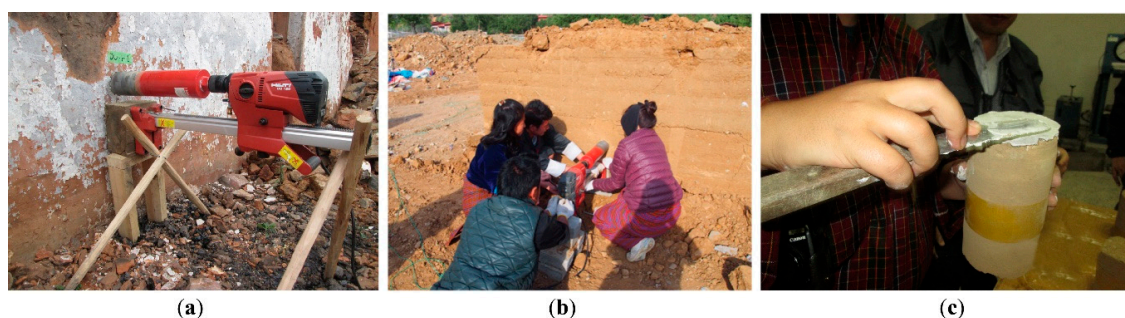
Figure 6. Sample collection: (a) Hilti core drill machine, (b) core sampling, (c) capping with white cement.

Right after the completion of the pull-down test, samples were extracted using a core drill machine with a diameter of 100 mm (DD120, Hilti Corporation), as shown in Figure 6a,b. It can be observed from the figure that the direction of the extraction was parallel to the rammed earth layer. For Mesh-RE, the extraction was followed after peeling off the mesh layer. Samples were first trimmed and capped with white cement plaster to ensure a flat surface at both the top and bottom surfaces (Figure 6c). Three samples were tested each under compression and tensile strength testing. Due to the difficulty of core drilling of rammed earth, the length of the extracted cylindrical samples varied from one another. The samples had diameters ranging from 92 to 94 mm and lengths ranging from 146 to 200 mm. For the stabilized earth-based plaster (1 cement: 4 earth), three cylindrical samples were prepared in the standardized molds with 100 mm diameter and 200 mm height. The samples had an average diameter and length of 99.98 mm and 197.58 mm, respectively.

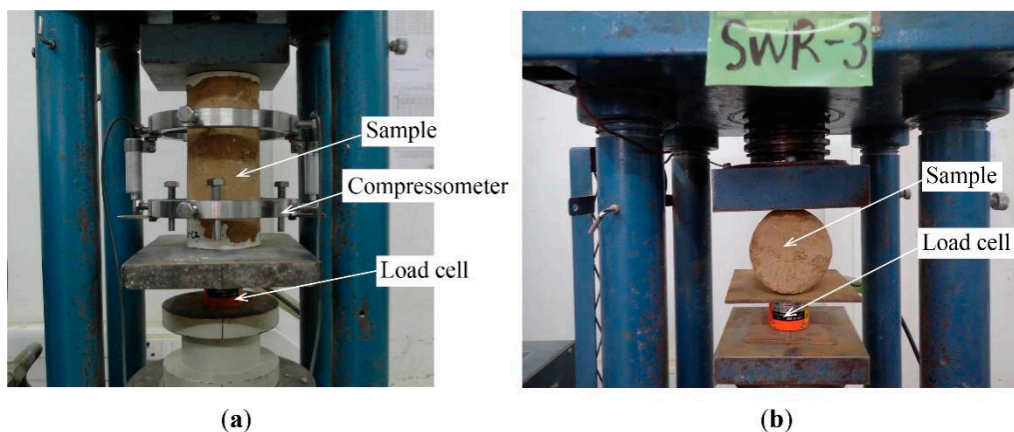
Figure 7. Material characterization test: (a) compression test, (b) splitting tensile test.

The compressive strength and splitting tensile tests on cylindrical samples were conducted according to ASTM C39 [27] and ASTM C496 [28], respectively. The tests were conducted in the Bhutan Standards Bureau (BSB). The test setups for compressive strength testing are presented in Figure 7a, and tensile strength testing is shown in Figure 7b. Here, the load applied was measured through the compressive load cell (KCM-200KNA, TML (Tokyo Measuring Instruments Laboratory Co., Ltd., Shinagawa Ward, Tokyo, Japan), which was then recorded in a multichannel dynamic strainmeter, DS-50A (TML), with LAN interface setting. The vertical displacement was recorded by a high-sensitivity strain gauge installed within the compressometer (CM-10, TML). The test results from the material characterization are summarized in Table 1. The maximum average dry density observed was 2045 kg/m³ for Mesh-RE and the minimum observed was 1926 kg/m³ for Timber-RE. The difference in strength characteristics of the rammed earth samples was observed, although they were constructed from the same soil composition. Such variability was influenced by the place where the samples were extracted [13]. It should be noted that core drilling was done within a single layer, avoiding the interface between the layers. Further, the core drill samples were extracted in a horizontal direction perpendicular to the direction of ramming. The anisotropy of rammed earth [29] affecting material characterization tests is not within the scope of this paper. The samples extracted from the location favoring the wall drying had higher strength than the samples extracted from the least-favored drying place. Furthermore, it was influenced by the gradient of density from the bottom section to the top section of the wall due to the construction process involving manual ramming [30]. The elastic modulus reported in Table 1 was calculated from the elastic–linear range of the compressive stress–strain curve, between around 0% and 40% of the maximum compressive strength. Figure 8 shows the effect of the ratio of height (H) and diameter (D) of the extracted samples on compressive and tensile strengths. Clearly, there was minimal effect of the H/D ratio on the strength characteristics of the tested core samples.

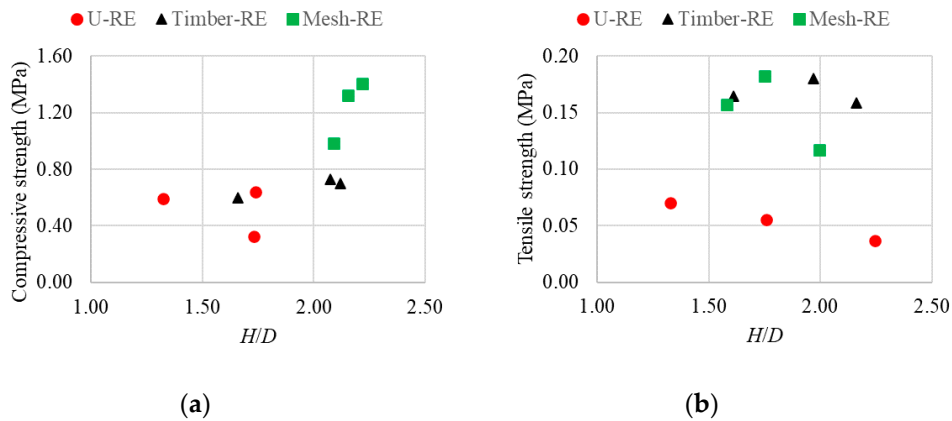
Figure 8. Size effect on the material strength: (a) compression strength, (b) tensile strength.

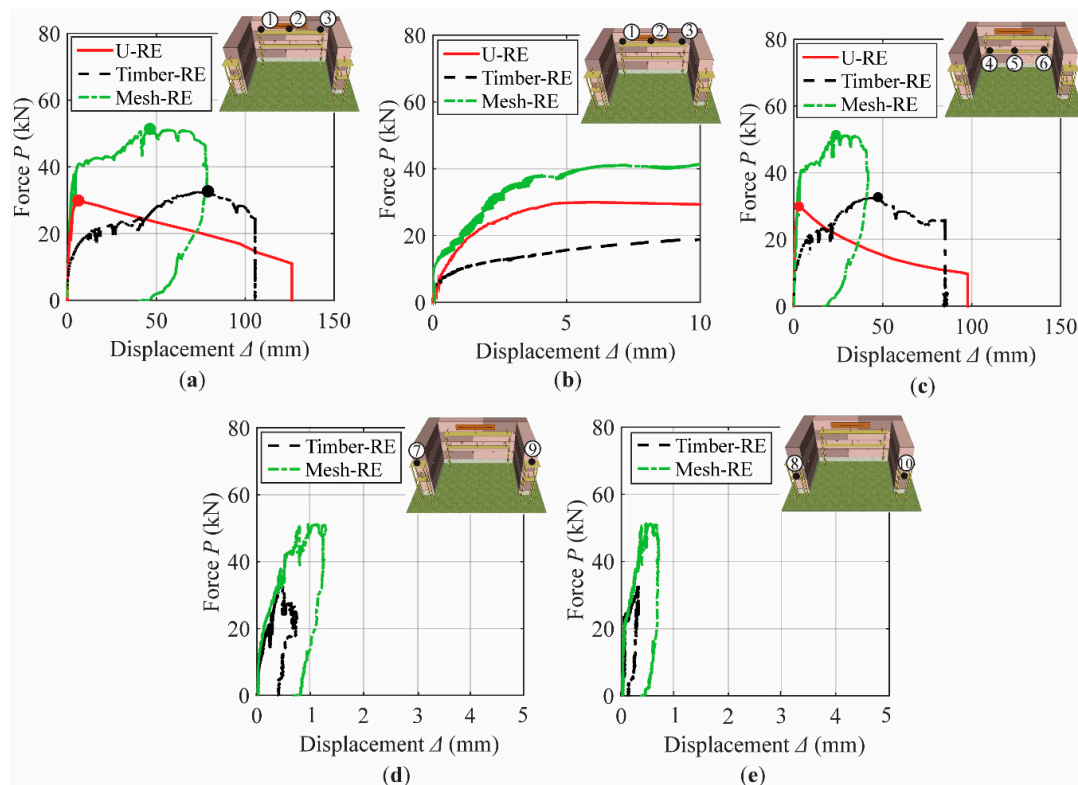
Figure 10. Load displacement relationship: (a) at the top level of the facade wall, (b) zoomed at the top level of the facade wall, (c) at the midlevel of the facade wall, (d) at the top level of the transverse walls, (e) at the midlevel of the transverse walls.

Figure 10 shows the relationship between the pull-down force and horizontal displacement for U-RE, Mesh-RE, and Timber-RE. The plot for the pull-down load for each specimen is made against the displacements at the top level of the facade wall (mean of sensors 1, 2, and 3) in Figure 10a, midlevel of the facade wall (mean of sensors 4, 5, and 6) in Figure 10c, top level of the transverse walls (mean of sensors 7 and 9) in Figure 10d, and midlevel of the transverse walls (mean of sensors 8 and 10) in Figure 10e. Figure 10b shows a zoomed-in curve of Figure 10a with displacement up to 10 mm, showing the elastic and initial crack phase of the wall. The initial stiffness, reported in Table 2, was calculated as the ratio of the pull-down load to the corresponding out-of-plane displacement up to the linear range of the load–displacement curve. Clearly, a slight improvement in stiffness was observed in the Mesh-RE and Timber-RE specimens as an effect of the mesh-wrapped and timber-framed strengthening techniques. From Figure 10d,e, it is clear that the back section of the transverse walls showed deformation for both Mesh-RE and Timber-RE. The larger deformation of the back walls of Mesh-RE attributes to the effectiveness of the mesh-wrapped technique in uniting the facade wall and the transverse walls. It should be noted that for U-RE, the deformation of the transverse wall was negligible and thus was not reported in Figure 10d,e. The peak load recorded for each specimen is marked by the red, green, and black circles for U-RE, Mesh-RE, and Timber-RE, respectively, and it is also reported in Table 2. It was observed that the peak pull-down load recorded for Mesh-RE and Timber-RE was 1.72 times and 1.09 times their unreinforced counterpart, respectively. Further, the corresponding displacements at peak load at the top level of the facade wall for Mesh-RE and Timber-RE were 46.17 mm and 78.95 mm, respectively, which are 7.76 times and 13.27 times the U-RE.

From the load-displacement curve of the U-RE, it was observed that there was a sharp increment in the load until the maximum pull-down load. Once it reached its peak load, the facade wall suddenly collapsed, showing the brittle nature of rammed earth. A similar case was reported for unreinforced wall tested under in-plane loading [3]. Only one zone was observed for U-RE before the peak. However, the pull-down load-displacement curve of Mesh-RE and Timber-RE was characterized by three zones before the maximum pull-down load and one zone after the peak load, as presented in Figure 11. In the first zone (zone A), the load-displacement curve was almost linear, representing the uncracked zone. In zone B, the crack initiated in the mesh plaster for Mesh-RE, and there was disconnection in the joineries and intersections of the timber members in the case of Timber-RE. The third zone (zone C) was characterized by a gradual increment in load until it reached the maximum pull-down load. At this stage, the existing cracks in the mesh plaster widened due to mesh elongation for Mesh-RE. In the case of Timber-RE, a sharp splitting sound of timber was heard due to dislocation. Gradually, the bed joint crack evolved in the rammed earth wall for both Mesh-RE and Timber-RE. The fourth zone (Zone D) was the post-peak behavior of Mesh-RE and Timber-RE, showing a larger deformation capacity with almost a quasi-constant load until the failure. This larger deformation capacity after the peak shows that the strengthening measures adopted are effective in delaying the out-of-plane collapse of the facade and distributing the load over the larger section of the wall. Such improvement in deformation capacity with the use of strengthening measures was also reported in previous studies [3,22].

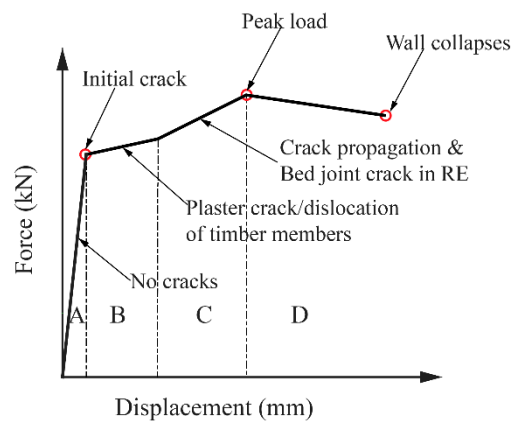
Figure 11. The typical load-displacement curve of the strengthened rammed earth wall.

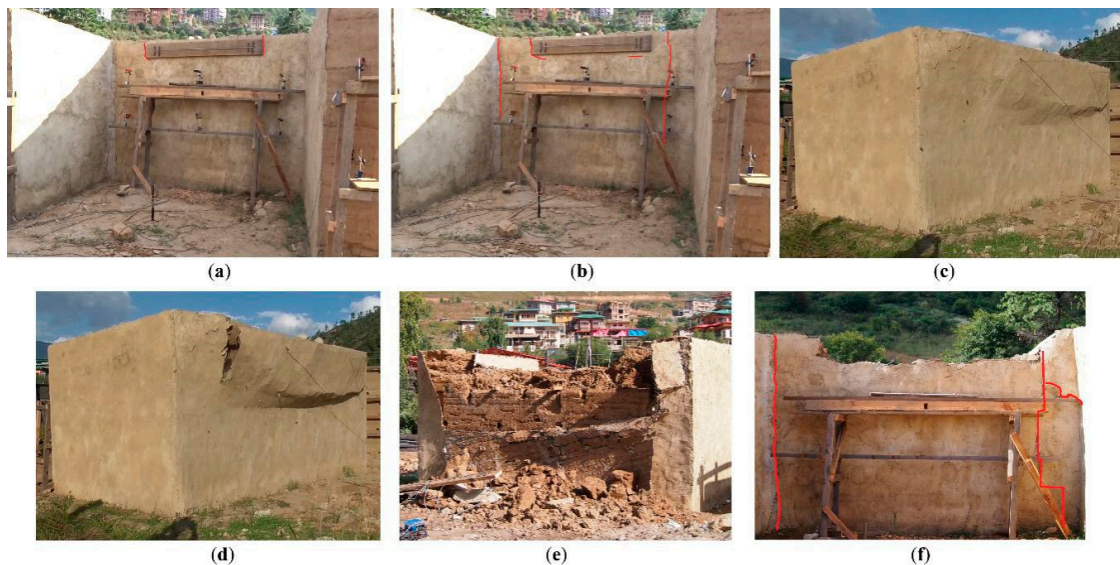
Figure 13. Failure mode of Mesh-RE: (a) crack initiation mesh plaster, (b) vertical cracks in mesh plaster, (c) bed joint crack in RE, (d) tearing of mesh, (e) and (f) final failure mode from the front and back view, respectively.

The failure of the Mesh-RE wall was preceded by the appearance of the plaster cracks in the back side of the front facade near the loading point, as illustrated in Figure 13a. In the next stage, the plaster crack in the left corner of the wall initiated, and simultaneously, a plaster crack also emerged on the right side of the front wall away from the corner (Figure 13b). Till this stage, there were no traces of cracks from the front view of the facade wall. On further application of the load, the previously existing plaster cracks in the corners widened and propagated downward with clear visibility of the mesh inside. The bed joint crack also exhibited, characterized by the bulging of the top block of the facade wall, as shown in Figure 13c. The wall continued to displace until the top block of the wall collapsed with the tearing of the mesh, as illustrated in Figure 13d. Figure 13e,f shows the final view of Mesh-RE from the front and back, respectively. The final failure mode was local with a sliding of the top RE block; however, before that, there was effective load transfer over the wall's section through mesh-wrapped strengthening characterized by the deformation of the transverse walls. Throughout the loading process, the cracks were seen within the mesh-plaster, and no delamination of plaster was seen. The delamination of the mesh with tearing at the lapping region and plaster spalling at the front facade was observed only at the final failure. Further, mesh strengthening retained a relatively large portion of the top block with controlled failure, preventing the crack at the bed joint and overturning of the entire facade as observed in the case of U-RE.
