Article

Resiliency and Recovery of Aquatic Vegetation Following Scouring Floods in Two First-Magnitude Springs, Missouri, USA

David E. Bowles

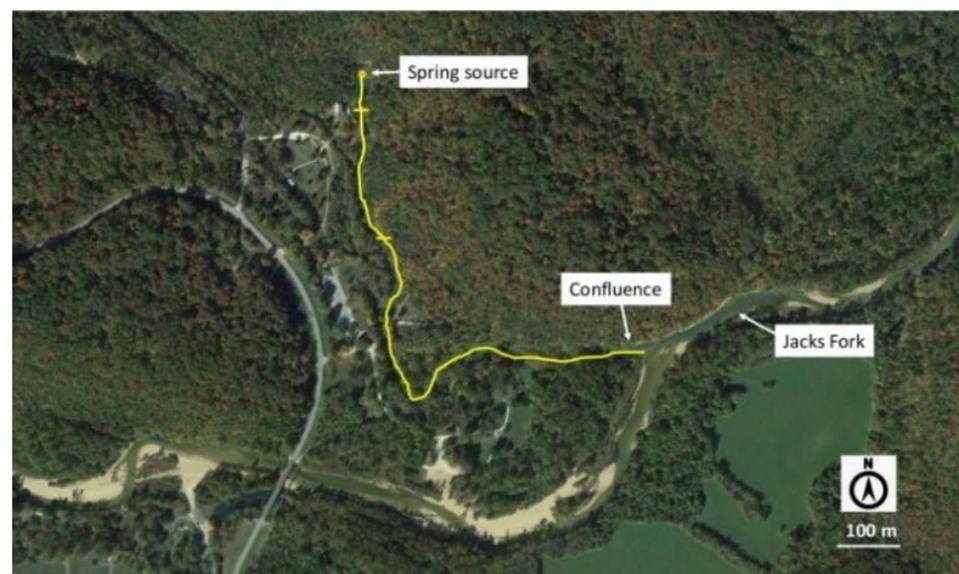
Figure 2. Map of Alley Spring showing the flow path to the Jacks Fork. Base photo from Google Earth. Perpendicular bars on the channel marker define the sampling reach for this study.

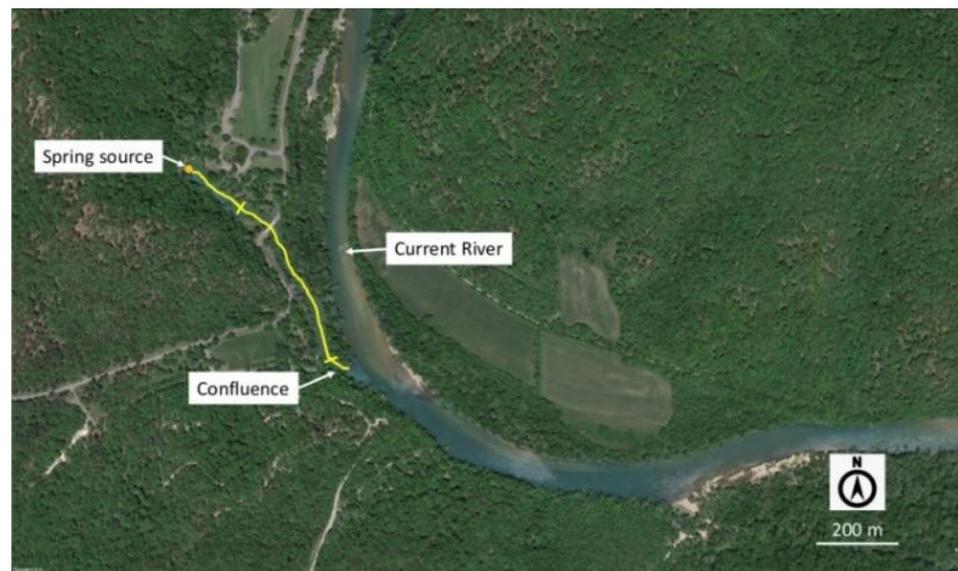
Figure 3. Map of Big Spring showing the flow path to the Current River. Base photo from Google Earth. Perpendicular bars on the channel marker define the sampling reach for this study.

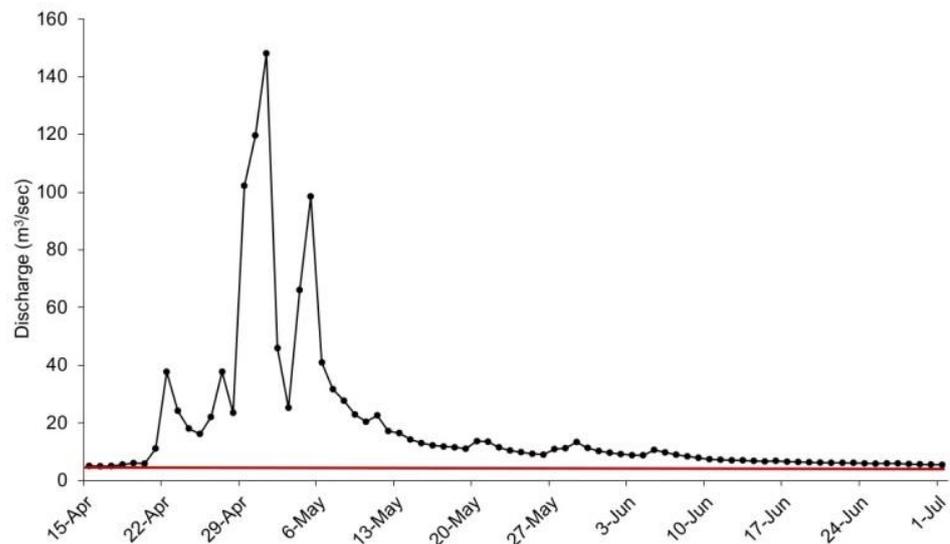
Figure 4. Estimated discharge (m^3/s) at Alley Spring Missouri, 15 April–1 July 2017. Data extrapolated from [27]. The solid horizontal line represents the historic mean flow for this spring of approximately $3.60 \text{ m}^3/\text{s}$.

Substantial precipitation events in the Current River Watershed in southcentral Missouri began on 17 April 2017 and continued through 23 April 2017, resulting in over 12.7 cm rainfall being deposited to the recharge basins of the two springs. Subsequently, the last weekend of April 2017 saw torrential rainfall in the Ozarks physiographic region. From Friday 28 April to Sunday 30 April 2017, area rainfall ranged from 20.3 to 30.5 cm. The collective rainfall during this period caused widespread flooding. On 30 April 2017, the Current River at Van Buren, Missouri crested at a record 11.3 m. Flood stage at this location is 6.1 m. This historic, '100 year', flood event caused substantial and unprecedented damage to natural resources and park infrastructure at OZAR, which resulted in much of the park being closed to the public for several months while repairs and cleanup were conducted. In addition to the flooding and damage on the Current River and its major tributary the Jacks Fork, there also was destructive flooding of springs at OZAR. Because there is no discharge gage at Alley Spring, flood specific flow data are unavailable. However, discharge was estimated for this area during the flood event as the difference between the discharge for the Jacks Fork approximately 0.9 km upstream of its confluence with Alley Spring USGS gage 07065495 [27]) and the discharge for the Jacks Fork at Eminence approximately 9 km downstream USGS gage 07066000 [27] (Figure 4). Under typical flow patterns, Alley Spring contributes approximately 80% or more of the discharge in the Jacks Fork at the downstream location. There are three tributaries in this stretch of river and each has a discharge of approximately $0.20 \text{ m}^3/\text{s}$ or less. Those respective adjustments were applied to the total discharge measurement. The estimated discharge is not likely accurate for the spring because the flood flows upstream of Alley Spring were far greater than previously recorded, but it reasonably reflects the dynamics and duration of the flood event in that drainage. The peak discharge for Big Spring during this flood was approximately $35 \text{ m}^3/\text{s}$ and flows above $30 \text{ m}^3/\text{s}$ were sustained for several days (Figure 5).

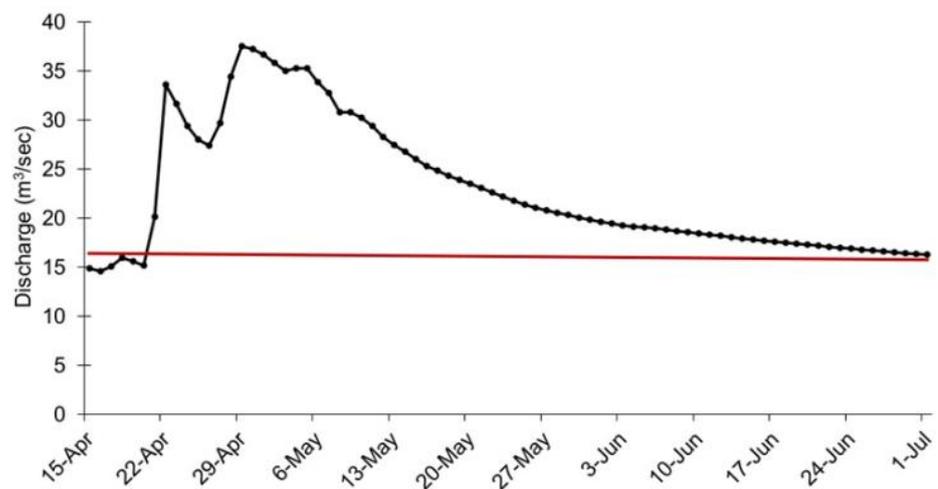
Figure 5. Discharge (m^3/s) at Big Spring, Missouri, 15 April–1 July 2017. Data from [27]. The solid horizontal line represents the historic mean flow for this spring of approximately $15.90 \text{ m}^3/\text{s}$.

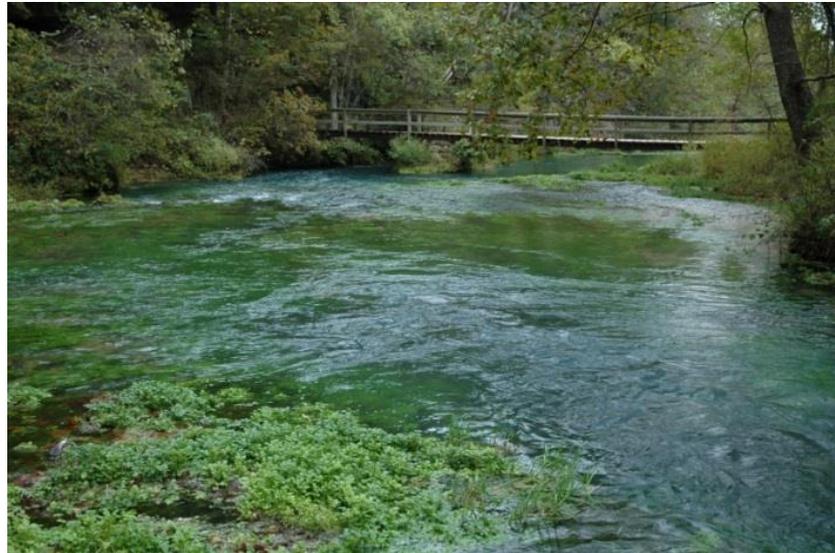
Figure 6. Alley Spring, Missouri. Downstream perspective from the upper end of the sampling reach showing typical vegetation patterns. The bridge crossing the channel was washed away during the 2017 flood. Photo taken by author in July 2005.

Alley and Big springs each have robust growths of aquatic vegetation in their respective channels (Figures 6 and 7). The upstream boundary of the sampling reach in each spring is located at the first wadable area downstream of the spring source [24]. The accessible reach of Alley Spring is 190 m and that of Big Spring is 460 m. Aquatic vegetation was sampled at six transects oriented perpendicular to flow with three equally-spaced sample cells (1 m^2) per transect ($N = 18$) using a 1 m^2 PVC sampling frame and view bucket to observe vegetation. Plant species foliar cover in each sample cell was recorded using a modified Daubenmire scale: 1 = 0–0.99%, 2 = 1–5%, 3 = 5–25%, 4 = 25–50%, 5 = 50–75%, 6 = 75–95%, 7 = 95–100% [24,29]. All sampling was done during July and August. The 2017 sampling data were collected three months following the flood. See Bowles et al. [24] for further details on methodology used for monitoring vegetation in the springs. Additional data on water quality and instream and riparian habitat at the springs can be found in Bowles and Dodd [18]. Ten years of aquatic vegetation monitoring data are available for each spring collected prior to the 2017 flooding event that were used for baseline compar-

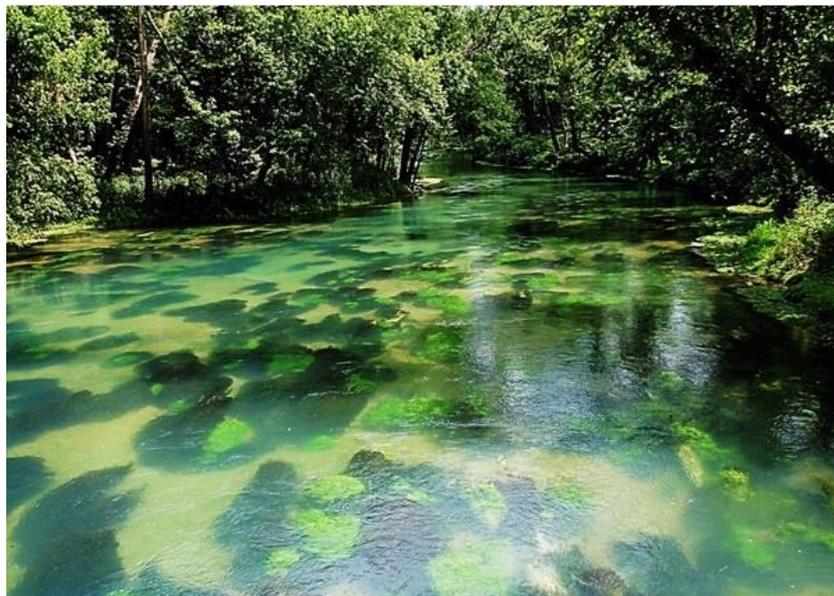
Figure 7. Big Spring, Missouri. Downstream perspective from the bridge crossing the channel showing typical vegetation patterns. The dominant plant species in this photo are *Ranunculus aquatilis* (dark green) and *Nasturtium officinale* (light green). Photo taken by author in July 2008.

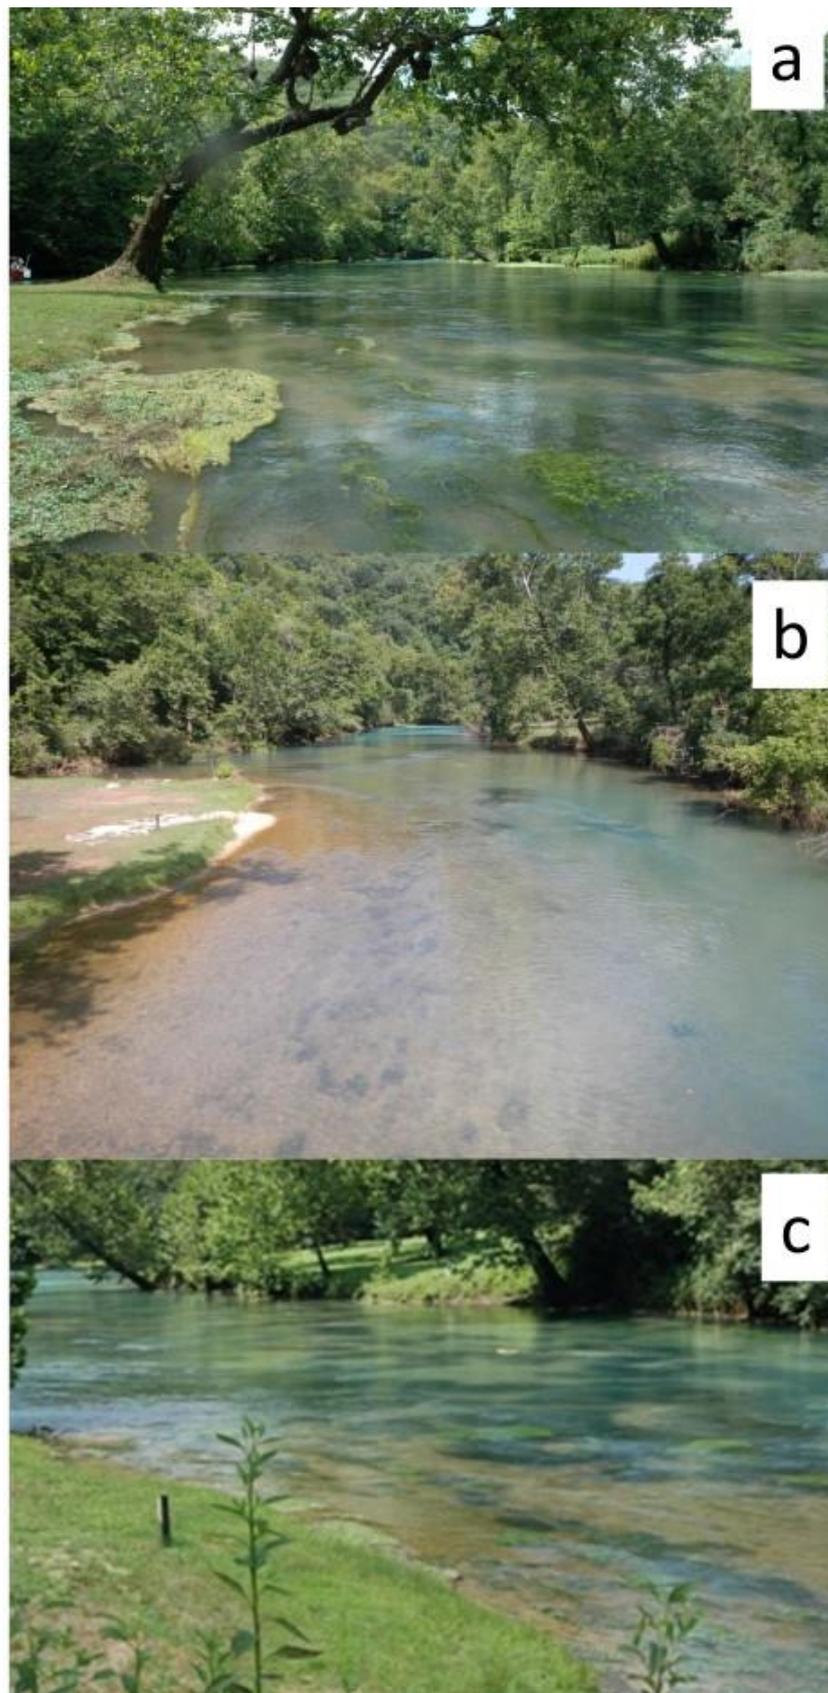
Figure 8. Big Spring, Missouri. Upstream perspective from the bridge crossing the channel: (a) Top photo taken in 2008; (b) middle photo taken in July 2017; (c) bottom photo taken in August 2020. Note large tree in top photo is missing in post-flood photos. All photos by author.

Alley Spring and Big Spring experienced catastrophic flood damage to their respective channels, resulting in aquatic vegetation being denuded so that mostly bare substrate remained immediately following the flood (Figure 8). Community diversity metrics (S , H_e , and D_e) decreased at Alley Spring in 2017, but they recovered to pre-flood levels in 2018 (Figure 9), and those differences were not significant (Epps–Singleton test $p > 0.05$, Table 2). Although mean species richness declined in Alley Spring in 2012, H_e and D_e did not decline appreciably compared to 2017 when all three metrics decreased (Figure 9). Discharge for Alley Spring in 2012 at the time of sampling was $1.23 \text{ m}^3/\text{s}$, which was the lowest discharge measured for this site during annual sampling between 2007 and 2017 (mean = $3.62 \text{ m}^3/\text{s}$). The low flow at Alley Spring in 2012 resulted in a smaller area of channel that was assessed, thus leading to decreased species richness for this site. Similar to that observed for Alley Spring, the community diversity data for Big Spring also decreased following the 2017 flood (Figure 10) and remained below the pre-flood average through 2020, but only the observed decrease in species richness (S) was significant (Epps–Singleton test, $p = 0.02$, Table 2). Although the observed p -value of 0.08 for H_e was not significant, biological significance cannot be ruled out.

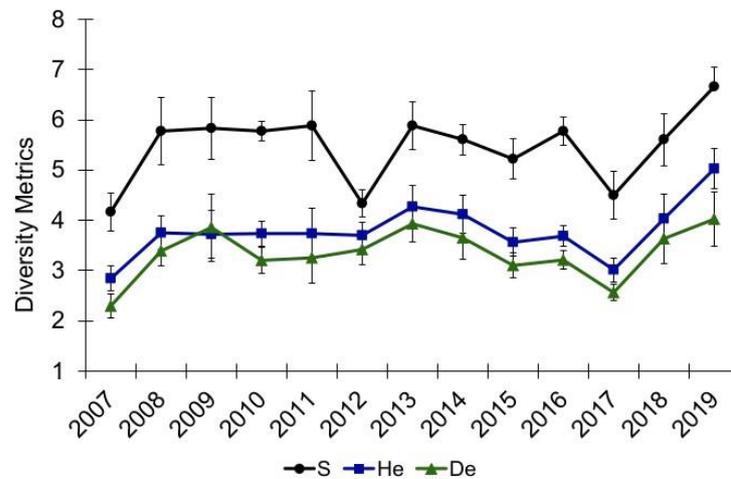
Figure 9. Community diversity metrics for aquatic vegetation at Alley Spring, Missouri. S is taxa richness, He and De are the effective numbers of species for the Shannon's diversity index, and Simpson's diversity index, respectively. Values are the means with standard error bars.

For Alley Spring, taxa evenness in 2017 remained essentially unchanged from the preceding year (2016), and the comparison of pre- and post-flood data was not significant (Epps–Singleton test, $p = 0.93$, Table 2). The average evenness at Alley Spring for the 2007–2016 pre-flood period was 0.74 (se = 0.01) while it was 0.73 (se = 0.01) in 2017 (Figure 11). In contrast, taxa evenness for Big Spring in 2017 was 0.36, which is markedly lower than the pre-flood average evenness value of 0.61 (se = 0.03), and it remained lower through the 2020 sampling event (Figure 12). Although the comparison of pre- and post-flood evenness data for Big Spring was not significant (Epps–Singleton test, $p = 0.05$, Table 2), the potential for biological significance cannot be ruled out.

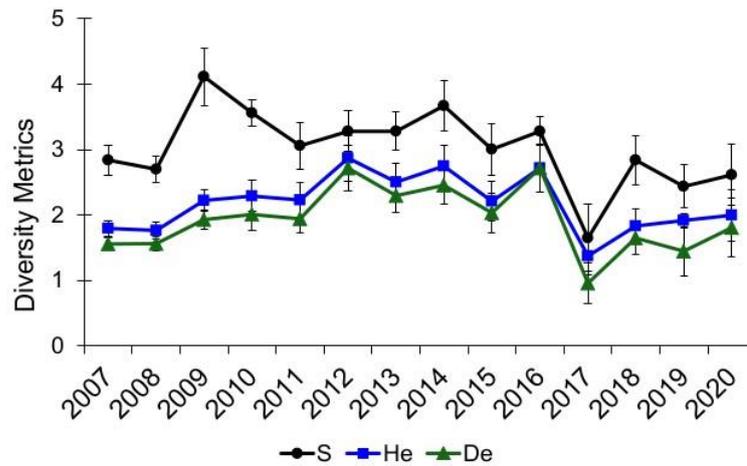
Figure 10. Community diversity metrics for aquatic vegetation at Big Spring, Missouri. S is taxa richness, He and De are the effective numbers of species for the Shannon’s diversity index, and Simpson’s diversity index, respectively. Values are the means with standard error bars.

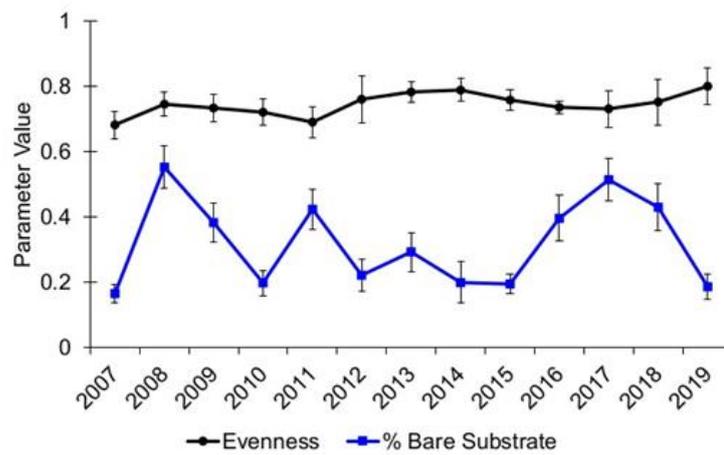
Figure 11. Species distribution evenness for aquatic vegetation and percent bare substrate at Alley Spring, Missouri. Values are the means with standard error bars.

The amount of bare substrate measured at Alley Spring increased in 2017 (mean = 51.42%) relative to most previous years, although the average amount of bare substrate had been comparably high in other years, especially following floods in 2008 and 2011 (Figure 11). Bare substrate measured in 2019 (mean = 18.65%) show values have largely returned to pre-flood levels in that spring (Figure 11), and the comparison of pre- and post-flood portions of bare substrate in Alley Spring showed they are not significantly different (Epps–Singleton test, $p = 0.42$, Table 2). Taxa evenness remained higher than the amount of bare substrate in all years at Alley Spring. Data from previous sampling years show the dynamic nature of vegetative cover at this spring. Collectively, the data show that aquatic vegetation at Alley Spring has largely recovered since the 2017 flood.

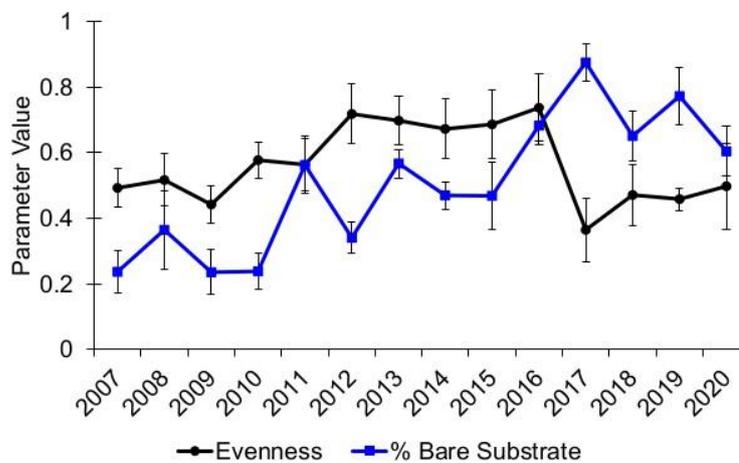
Figure 12. Species distribution evenness for aquatic vegetation and percent bare substrate at Big Spring, Missouri. Values are the means with standard error bars.

In contrast, the amount of bare substrate at Big Spring greatly increased following the flood (mean = 87.50%) and remained significantly higher than that recorded during previously sampled years through the 2020 sampling date (Figure 12, Epps–Singleton test, $p = 0.02$, Table 2). Moreover, taxa evenness was consistently greater than the average amount of bare substrate prior to the flood, but the percentage of post-flood bare substrate remained greater than taxa evenness (Figure 12). The data show that the vegetative community at Big Spring had not fully recovered to pre-flood levels by the 2020 sampling date. Generally, the recovery of vegetation in the two springs was slower than hypothesized, and it occurred at different rates.

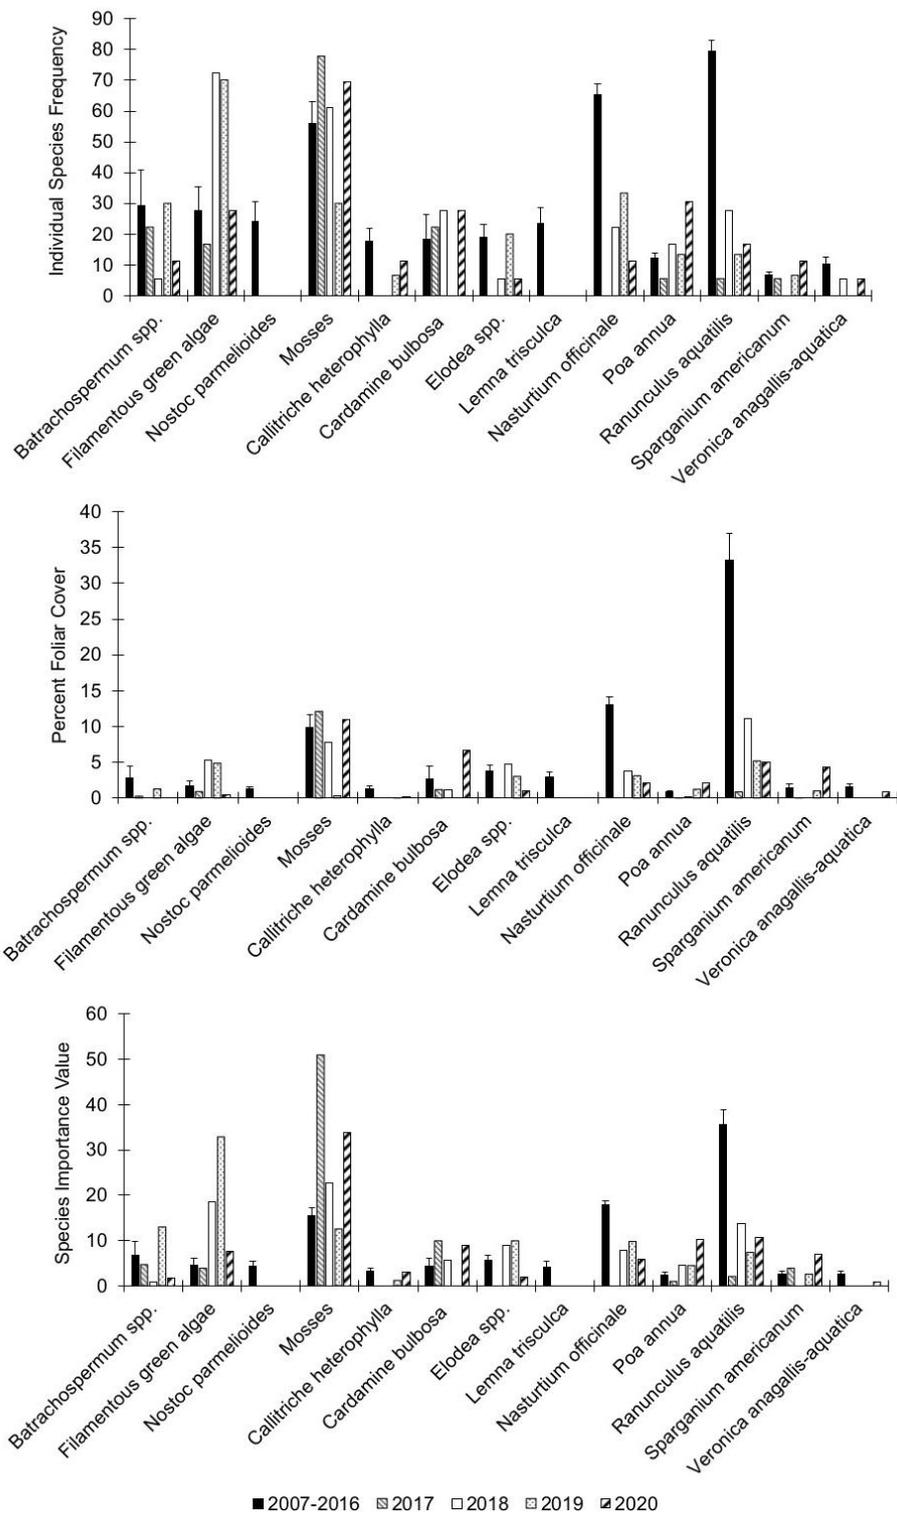
Figure 13. Individual species frequency, percent foliar cover, and species importance values for aquatic vegetation at Alley Spring, Missouri. Values for the period 2007–2016 represent the means for that period and the error bars are the standard error for the entire period. Values for 2017 to 2019 represent the means and standard errors across transects for those specific years. Rare and singleton species occurrences are excluded from these graphs.

Individual species dynamics for the effective number of species at Alley Spring across years showed that various taxa of algae responded positively to the flooding event of 2017 and generally showed increased occurrence and abundance post-flood, which is reflected in their overall higher species importance values (Figure 13). This was especially true for filamentous green algae, whose pre-flood average SIV was 10.56, had increased to 11.58 in 2019. It is noteworthy that the pre-flood mean SIV of 8.36 for the red alga *Batrachospermum* increased to 23.81 after the flood only to drop precipitously thereafter (Table 3). However, the only significant post-flood responses were for *Batrachospermum* (PFC, $p = 0.005$), filamentous green algae (ISF, $p = 0.002$), and the cyanobacterium *Nostoc parmeliioides* (SIV, $p = 0.04$) (Epps–Singleton test, Table 3). Mosses, in comparison to algae, at Alley Spring stayed at relatively high densities following the flood and maintained their high species importance values across years sampled. Only the ISF for mosses was significantly higher post-flood (Epps–Singleton test, $p = 0.03$, Table 3). Moss rhizoids firmly attach to the rock substrate making them more resilient to increased flood velocities during floods.

Hydrophytes at Alley Spring exhibited a broad range of responses in the effective number of species after the flood (Table 3). Most hydrophyte species showed a marked decline in effective numbers of species compared to the pre-flood average, only to rebound and substantially increase in the last year of sampling, thus recovering their approximate species important values relative to their pre-flood averages. However, most of the observed differences were not significant. The exceptions were for *Callitriche heterophylla*, which had significantly lower PFC post-flood (Epps–Singleton test, $p = 0.002$), and *Veronica anagallis-aquatica* had significantly lower ISF and SIV (Epps–Singleton test, $p = 0.0003$ and 0.004 , respectively). Interestingly, the submersed duckweed, *Lemna trisulca*, exhibited increased frequency, percent foliar cover, and species importance following the flood, but returned to near average values in 2019, although those responses were not significantly different (Epps–Singleton test, $p \geq 0.07$).

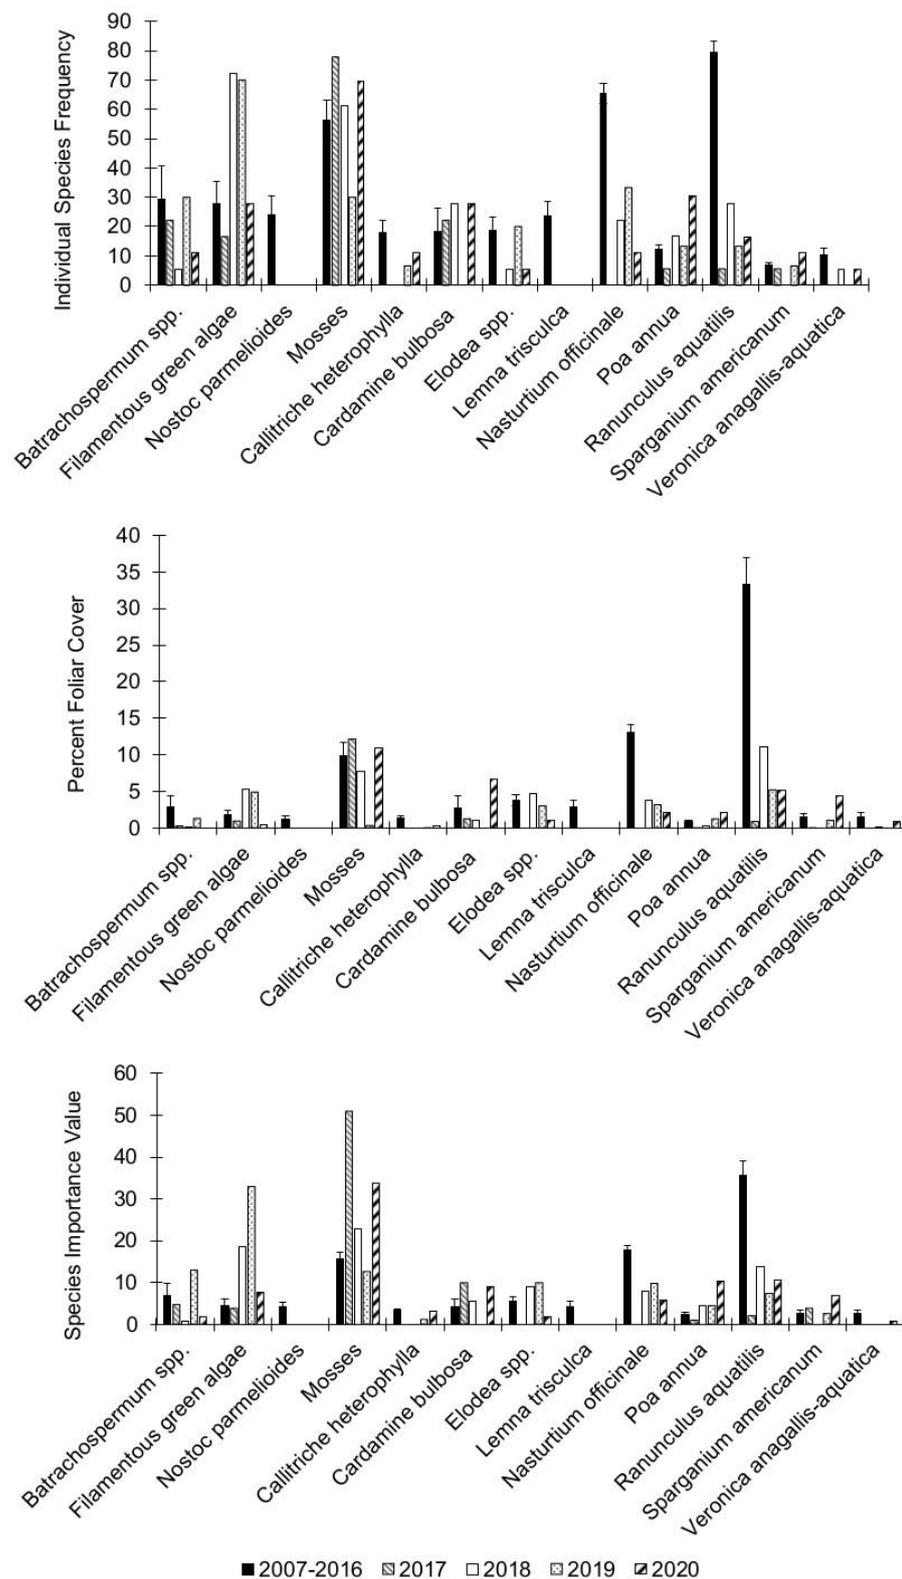
Figure 14. Individual species frequency, percent foliar cover, and species importance values for aquatic vegetation at Big Spring, Missouri. Values for the period 2007–2016 represent the means for that period and the error bars the are standard error for the entire period. Values for 2017 to 2019 represent the means and standard errors across transects for those specific years. Singleton species occurrences are excluded from these graphs.

The plant community at Big Spring showed a much different pattern compared to Alley Spring (Figure 14) with multiple taxa showing significant trends among taxa relative to the post-flood data (Table 3). Similar to that observed for Alley Spring, filamentous green algae showed dramatic increases in frequency, cover and species importance values in the years following the flood and remaining higher than the pre-flood average three years after the flood in 2020 (Figure 14), but those differences were not statistically significant (Table 3). Similarly, *Batrachospermum* also showed no significant differences pre- and post-flood. *Nostoc parmeliodies* could not be tested because no examples of this species were not detected in post-flood samples. Thus, although it could not be tested statistically, the population of *N. parmelioides*, in Big Spring clearly was negatively impacted suggesting that the effects of scouring may be long-term. Moss showed a recovery response similar to that observed at Alley Spring, and it generally retained a high species importance value at Big Spring (SIV = 33.75 in 2020).

In stark contrast to Alley Spring, several species of hydrophytes in Big Spring had marked decreases in their respective frequency, foliar cover and species importance values (Table 3). In the post-flood years at Big Spring, recovery of most hydrophyte species has been slow with metric values far lower compared to those of the pre-flood years. The most striking examples of this response were for *Nasturtium officinale* and *Ranunculus aquatilis*, which showed significant differences in pre- and post-flood responses for ISF, PFC, and SIV (Epps–Singleton test, $p < 0.0001$), and *V. anagallis-aquatica*, for which ISF and SIV were significantly different ($p < 0.0001$). *Veronica anagallis-aquatica* with a pre-flood SIV of 2.61 was not found again in Big Spring until sampling was conducted in 2020. For *N. officinale*, the pre-flood average SIV was 17.81, but the SIV did rise above 9.77 through the 2020 sampling event. Similarly, the pre-flood average SIV for *R. aquatilis* was 35.52, but following the flood the SIV has not increased above 13.76. In contrast, the non-native grass (*Poa annua*) gained in frequency, foliar cover, and importance following the flood, although these gains were not significant. The emergent bur reed (*Sparganium americanum*) and spring cress (*Cardamine bulbosa*) exhibited reduced foliar cover in the post-flood years, but, conversely, their importance values in the community increased after the flood, thus indicating their resilience to flooding. For *C. bulbosa*, the observed post-flood decrease in ISF and increase in SIV were significant (Epps–Singleton test, $p < 0.0001$).
