Field Applications of Ultra High Frequency Techniques for Defect Detection in GIS

Jun Xiong ¹, Yuan Wang ², Guo-Ming Ma ^{2,*}, Qiang Zhang ² and Shu-Sheng Zheng ²

¹ Guangzhou Power Supply Co., Ltd., Guangzhou 510620, China; xiongj@guangzhou.csg.cn

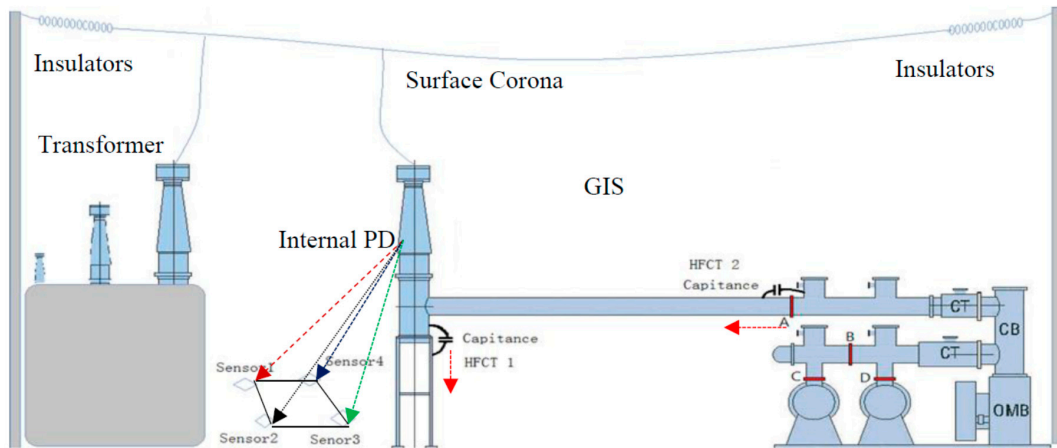
Figure 1. The diagram of 220 kV GIS high-voltage interval of phase C.

Live test means the detection is conducted when a suspicious fault or fault occurs in the substation which is in operation. Also, live tests should be conducted within a certain period of time to find out possible failures and then ensure the reliable operation of the equipment. UHF live test technology based on DMS, which frequency ranges from 300 MHz to 1.5 GHz, was used in the test. There were totally 12 test points for this interval (four cone-type spacers named as A, B, C, D were available as measuring points in each phase), which is shown in Figure 1.

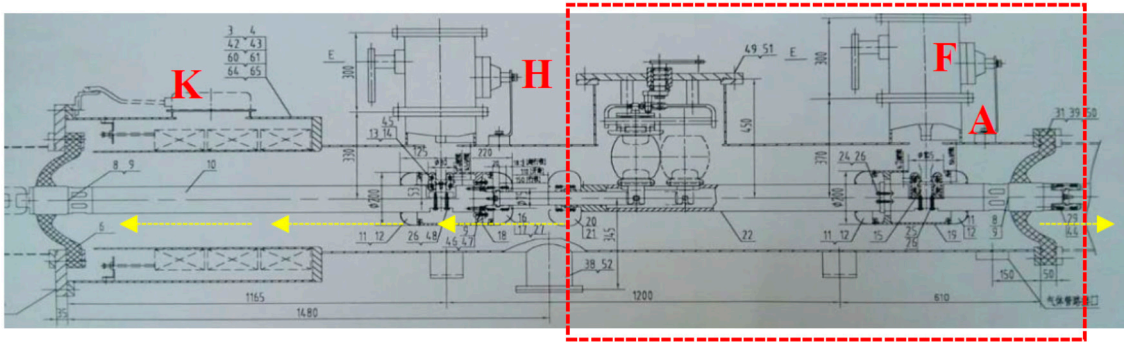
Figure 10. The sensors layout which improved the precise positioning.

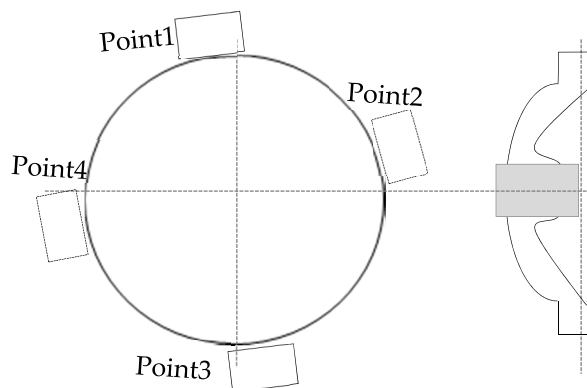
The principles of UHF-SHF based detection and location technology are as below: four UHF-SHF sensors in the system are arranged along the circumference of the spacer at equal distances. If the partial discharge occurs from the coaxial direction of the conductor, the time difference of the antenna array will be close to 0. If not, when the PD source deviates away from the coaxial direction (or PD source is next to one of the antennas), the time difference between the four antenna arrays will get increased. The layout of the four antennas array is shown in Figure 12, and the time difference of four points are shown in Table 2.

Figure 12. Distribution diagram of antennas array.
