Bathymetric Monitoring of Alluvial River Bottom Changes for Purposes of Stability of Water Power Plant Structure with a New Methodology for River Bottom Hazard Mapping (Wloclawek, Poland)

Received: 27 July 2020; Accepted: 31 August 2020; Published: 3 September 2020

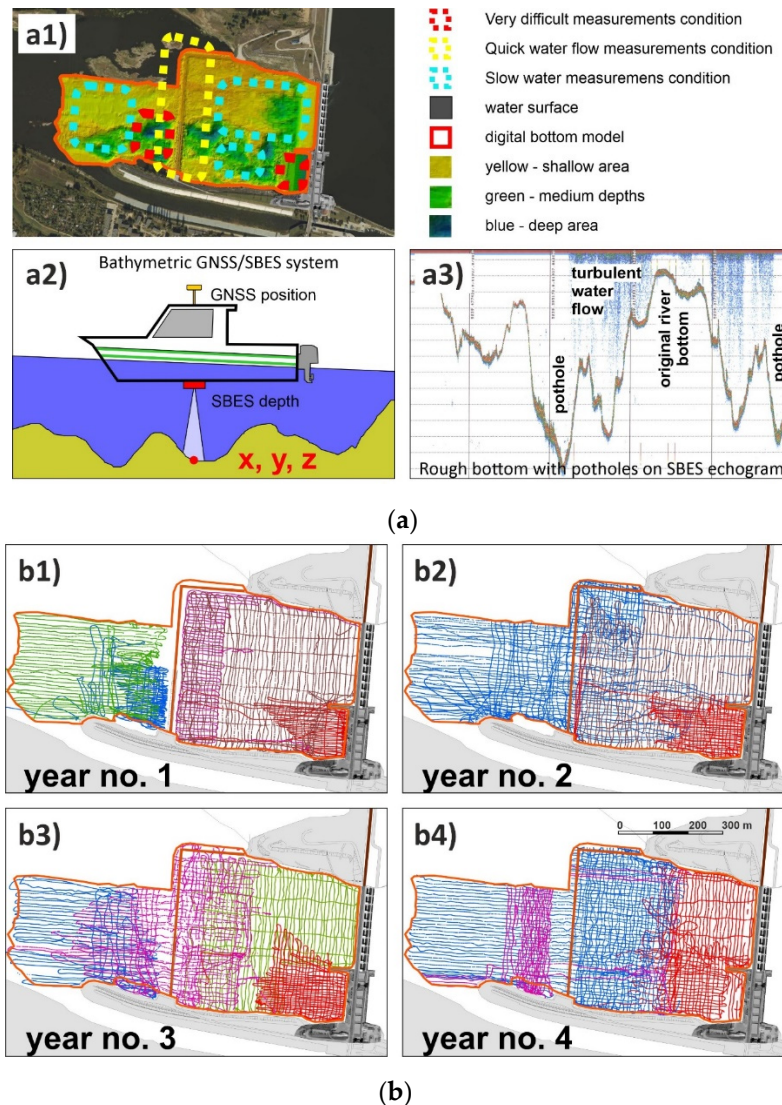
Figure 4. Bathymetric monitoring (a) measurements condition, (b) stages of measurements, (a1) study area measurements condition, (a2) bathymetric equipment, (a3) rough bottom and turbulent water flow, (b1–b4) hydrographic motorboat trajectories during measurement stages.

The key problem during practical surveys (Figure 4(a3)) were the height of the water surface and waterflow speed during depth measurements (rough and choppy water and quick water level changes depending on the schedule of the power plant work and on the distance from the dam). Particularly dangerous were the areas behind the turbines of the power plant and behind the damming threshold. Zones of different measurement conditions are presented in Figure 4(a1).
