Train Hunting Related Fast Degradation of a Railway Crossing—Condition Monitoring and Numerical Verification

Xiangming Liu *

and Valéri L. Markine *

Department of Engineering Structures, Delft University of Technology, 2628 CN Delft, The Netherlands

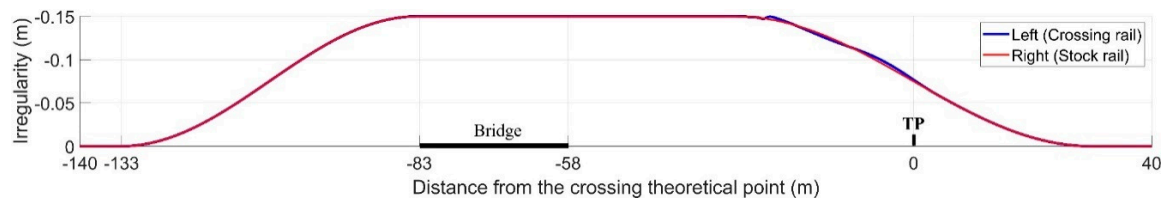
Figure 19. Equivalent lateral irregularities in the track.

In order to verify the effect of the track lateral misalignment on the performance of the crossing, both the bridge-introduced curve and the track gauge variation were input into the MBS vehicle-crossing model (Figure 9). The equivalent track lateral irregularities as the model input are shown in Figure 19.

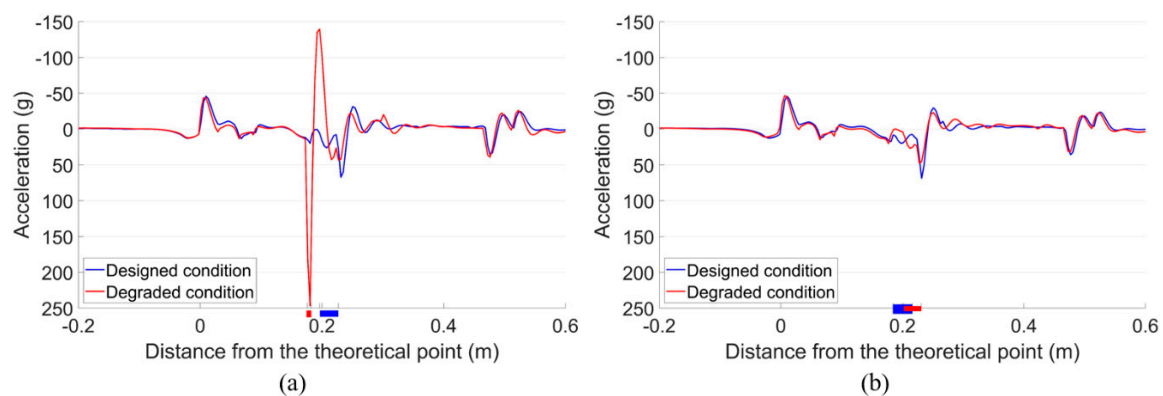
Figure 20. Vertical impact acceleration responses and transition regions. (a) Front wheel. (b) Rear wheel.

With the track misalignment taken into account, the crossing condition was considered as degraded. The simulation results of both wheels in the bogie, including the wheel impact accelerations and transition regions, were compared with the results in the designed condition [29], as shown in Figure 20.

It can be seen from Figure 20a that with the lateral irregularity taken into account, the impact of the front wheel was dramatically increased to 247 g, which was 4 times higher than the reference value (around 62 g) in the designed condition. While for the rear wheel from the same bogie, the impact was 48 g, which was even lower than the reference value. Despite the slight difference in the absolute values, the simulation results were consistent with the measurement results (Figure 11). Meanwhile, the transition region of the front wheel was 0.176–0.182 m from the TP with a size of only 0.006 m. Compared with the reference level (0.196–0.217 m with a size of 0.031 m, [29]), it was much narrower and closer to the TP, indicating earlier wheel impact and much sharper wheel load transition in the crossing. For the rear wheel, although the transition region was located farther from the TP, the size was almost the same as the reference value.

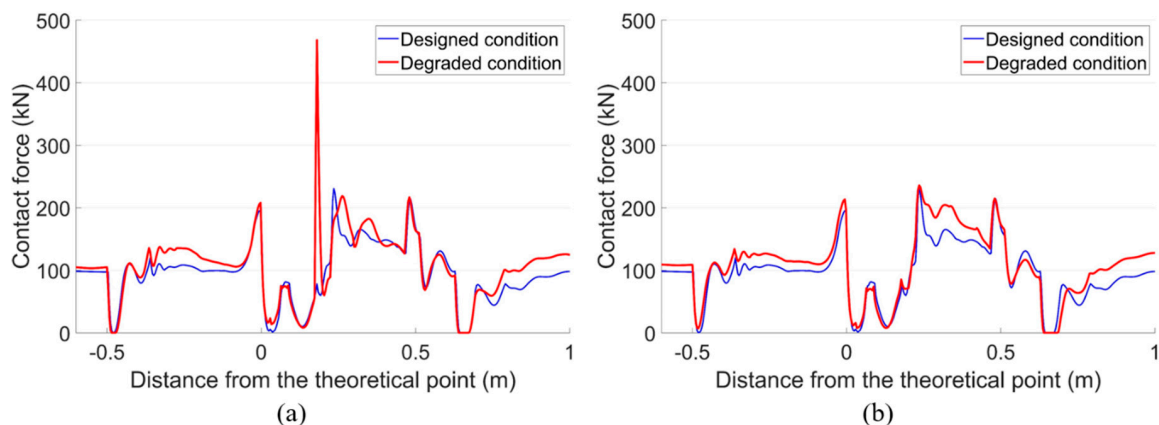
Figure 21. Vertical wheel-rail contact responses of the facing crossing. (a) Front wheel. (b) Rear wheel.

For the wheel-rail contact forces, the tendency was similar to the acceleration responses, as shown in Figure 21. With the degraded track condition, the maximum contact force of the front wheel in the degraded condition was 468 kN, which was twice as high as that in the designed condition (235 kN).

While for the rear wheel, the difference between the degraded condition and the designed condition was limited.

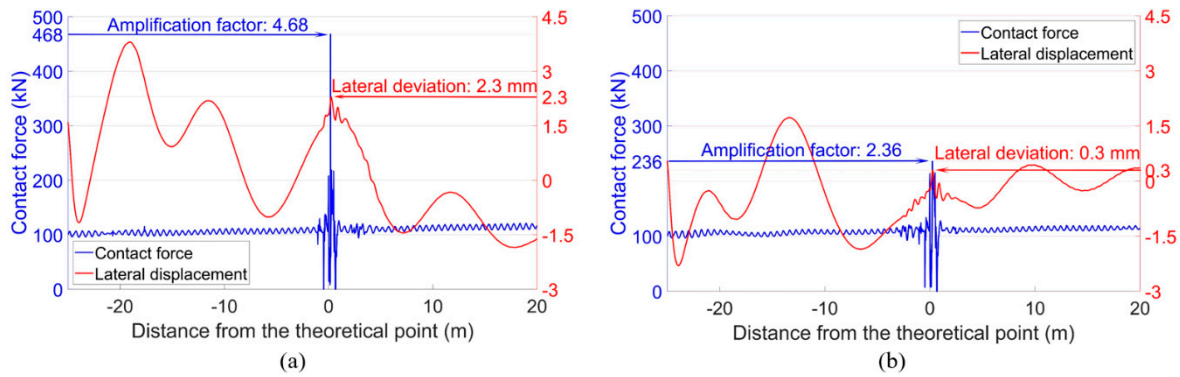
Figure 23. Wheel-rail contact forces and wheel lateral displacements. (a) Front wheel. (b) Rear wheel.

In the degraded condition with track lateral irregularities, the lateral displacements of the wheels were dramatically changed, as shown in Figure 23. It can be seen that both the front wheel and the rear wheel showed activated hunting oscillation before and after passing through the crossing, but the trajectories were quite different. For the front wheel, the lateral movement was more intense and ran toward the crossing nose rail near the TP. The maximum lateral displacement corresponding to the position with the highest contact force was 2.3 mm, which means that compared with that in the designed condition, the wheel flange was around 1.6 mm closer to the nose rail. Comparatively speaking, such displacement of the rear wheel was only 0.3 mm. Such results indicate that the wheel-rail impact was profoundly affected by the movement of the wheel. When the wheel approaches closer to the crossing nose, the wheel-rail impact is likely to be increased. It can be concluded that the train hunting activated by the lateral track misalignment in front of the crossing is the main cause of the extremely high wheel-rail impacts.

The train hunting effect also explains the unstable wheel-rail impacts. For the rear wheel, the lateral movement was affected not only by the track misalignment but also by the front wheel from the same bogie. As a result, these two wheels led to quite different wheel trajectories. It can be imagined that in the real-life situation, there are much more factors that may affect the hunting motion of each passing wheelset such as the initial position of the wheel when entering the misaligned track section, the mutual interaction between the adjacent wheelsets, the lateral resistance of the track, and even the weather condition [28], etc. The combined effect of all these factors ultimately resulted in the polarized distribution of the impact acceleration responses (Figure 11a).

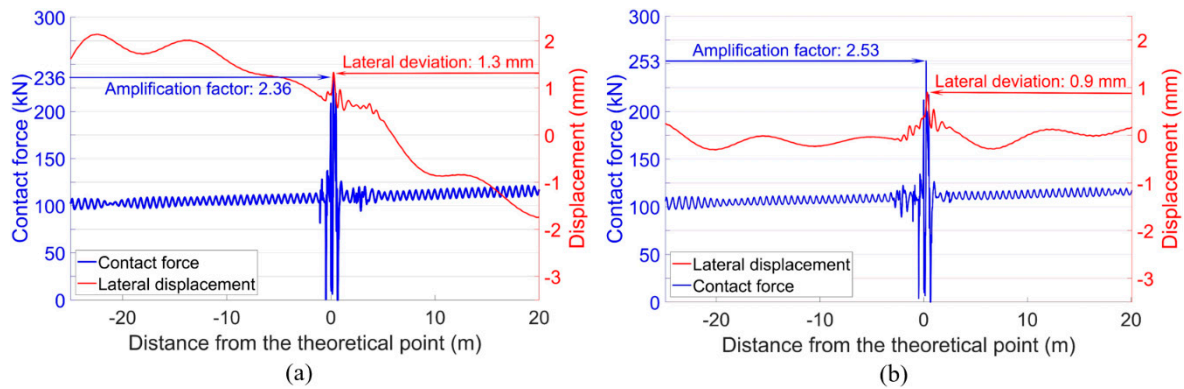
Figure 24. Wheel-rail contact forces and lateral wheel displacements. (a) Front wheel. (b) Rear wheel.

Considering the bridge-introduced lateral curve, the wheel-rail contact forces and the lateral wheel displacements were calculated, as presented in Figure 24. It can be seen that in the front wheel, the bridge-introduced curve mainly resulted in the lateral shift of the wheel trajectory due to the centripetal force. Such a shift was only 0.5 mm near the crossing nose when compared with the designed condition, and the effect on the wheel impact was limited. For the rear wheel, the combined effect of the curve and the motion of the front wheel resulted in the lateral deviation of 0.9 mm, which was quite close to that in the designed condition and had no significant influence on the wheel-rail impact.

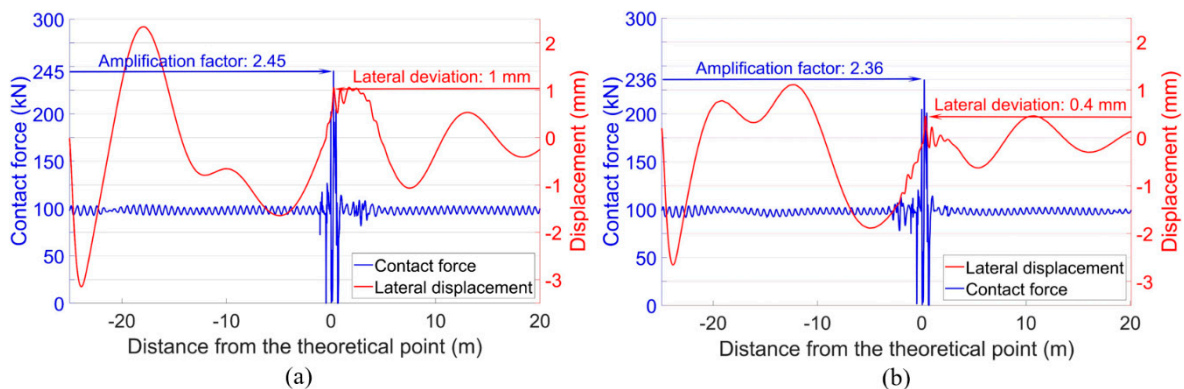
Figure 25. Wheel-rail contact forces and wheel lateral displacements. (a) Front wheel. (b) Rear wheel.

The effect of the track gauge deviation on the wheel-rail interaction is demonstrated in Figure 25. Different from the effect of the bridge-introduced curve, the deviated track gauge activated the hunting motion of the passing wheels. Still, the resulted lateral wheel displacements were not large enough to amplify the wheel-rail impact. The maximum displacements corresponding to the wheel impacts were 1 mm in the front wheel and 0.4 mm in the rear wheel, respectively.

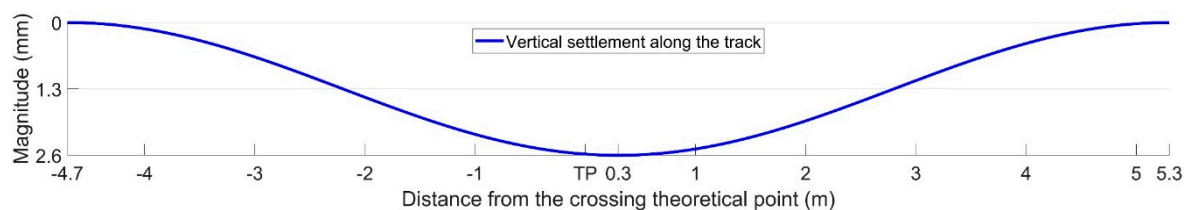
Figure 26. Ballast settlement introduced in the MBS model.

It is shown in Figure 13 that the detected ballast settlement was around 2.6 mm. To simplify the problem, a vertical irregularity was introduced in the MBS model to simulate the ballast settlement, as shown in Figure 26. In this irregularity function, the amplitude was 1.3 mm, and the wavelength was 10 m. The trough of the wave was located 0.3 m from the TP of the crossing, which was consistent with the instrumented accelerometer and the installed displacement target.

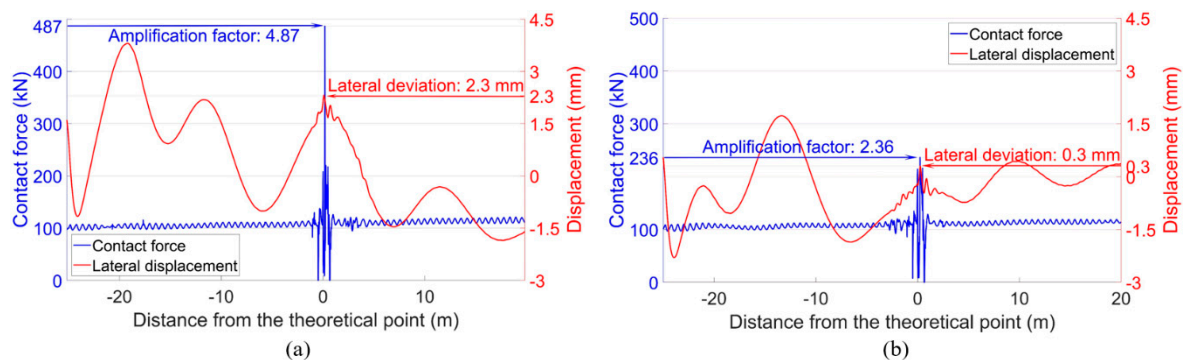
Figure 27. Wheel-rail contact forces and lateral wheel displacements. (a) Front wheel. (b) Rear wheel.

With the ballast settlement taken into account in the MBS model, the dynamic performance of the crossing was simulated. The representative results are shown in Figure 27. It can be seen that the simulation results were almost the same as those without ballast settlement (Figure 23), despite the slightly increased impact force of the front wheel (from 468 kN to 487 kN). It can be concluded that the existence of ballast settlement had a limited influence on the dynamic performance of the crossing. From another point of view, the ballast settlement was more likely to be the accumulated effect of the

high wheel-rail impacts. Such results further explain the ineffectiveness of the frequently performed ballast tamping since ballast settlement is not the main cause of the extremely high wheel-rail impacts.

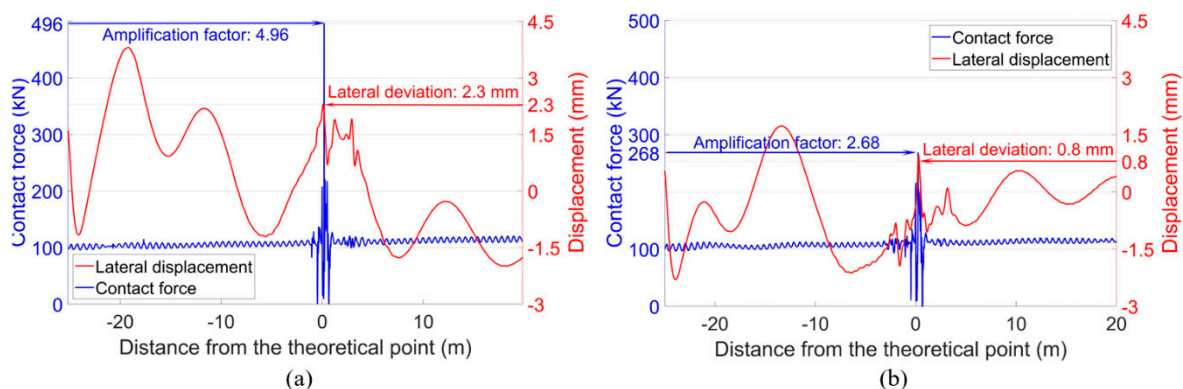
Figure 28. Wheel-rail contact forces and lateral wheel displacements. (a) Front wheel. (b) Rear wheel.

It can be seen from Figure 28 that with the reduced lateral stiffness and damping of the clips, the impacts of both the front wheel and the rear wheel were slightly increased (compared with the results in Figure 23). Moreover, the hunting motion of wheels in the crossing panel was more intense. As a result, the lateral deviation of the rear wheel increased from 0.3 mm to 0.8 mm. It can be imagined that with the impacts of the passing trains, the track alignment will continuously be changing due to the reduced structural integrity. The changed track alignment will, in return, act on the wheel-rail interaction and eventually lead to more unstable wheel impacts in the crossing (Figure 17). From this point of view, renovating the defected fastening system is necessary for a monitored crossing. Enough track lateral resistance can help to maintain better crossing performance.
