# Preservation and Protection of Cultural Heritage: Vibration Monitoring and Seismic Vulnerability of the Ruins of Carmo Convent (Lisbon)

**Abstract:** Preservation of cultural heritage sites is of paramount importance. The ruins of Carmo Convent in Lisbon stand as a poignant reminder of the city's rich history, but challenges regarding structural integrity and safety are present in a highly populated and touristic area. In this paper, a comprehensive study of the Carmo Convent is presented, focused on non-destructive testing (NDT), structural health monitoring (SHM) and numerical modelling. Given its state of ruin and historical relevance, the study relied heavily on NDT. Additionally, a metro line passing underneath the convent raised concerns regarding potential hazards from induced vibrations. Thus, metro vibration monitoring (MVM) was implemented to assess the impact of induced vibrations on the structure. One of the challenges was the scarcity of standards specific to historic structures. However, through a combination of finite element method (FEM) and discrete element method (DEM) numerical modelling, valuable insights into the current condition of the structure were obtai

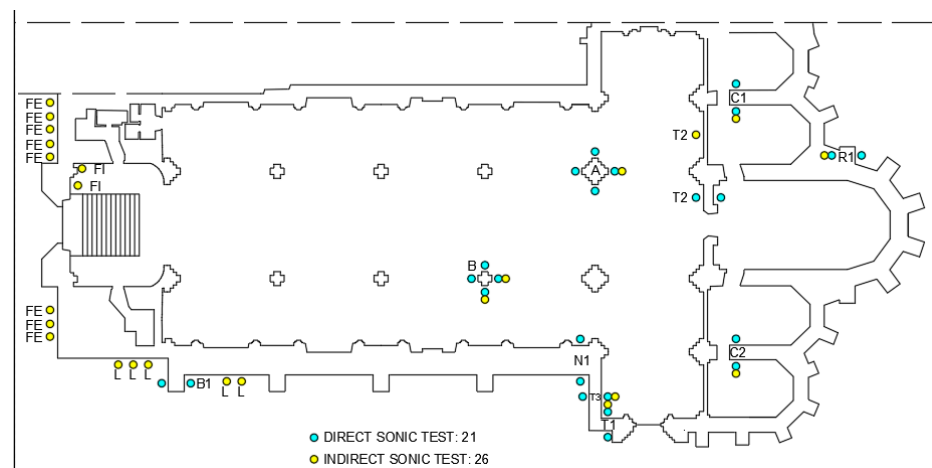
Figure 8. Sonic test locations.

The elements that were measured using sonic testing included two columns, seven walls and two buttresses. A total of 21 direct and 26 indirect tests were performed. These tests were performed multiple times at each of the positions, with the average velocity and Young's moduli obtained for each. The location of each of the tests is presented in Figure 8, and Table 1 shows the results obtained from the direct and indirect sonic testing.

The results included very high direct sonic test results in comparison to the indirect ones. This may be related to the uncertainties in the determination of the arrival of the R waves for the indirect sonic tests and location with a high percentage of solid units (stones) in comparison with the mortar in the direct sonic tests. Besides that, these results are used as initial values for the numerical modelling because the results obtained from the indirect tests are closer to the expected values found in the literature. Afterward, the material properties are calibrated based on the modal properties estimated from the dynamic identification tests.

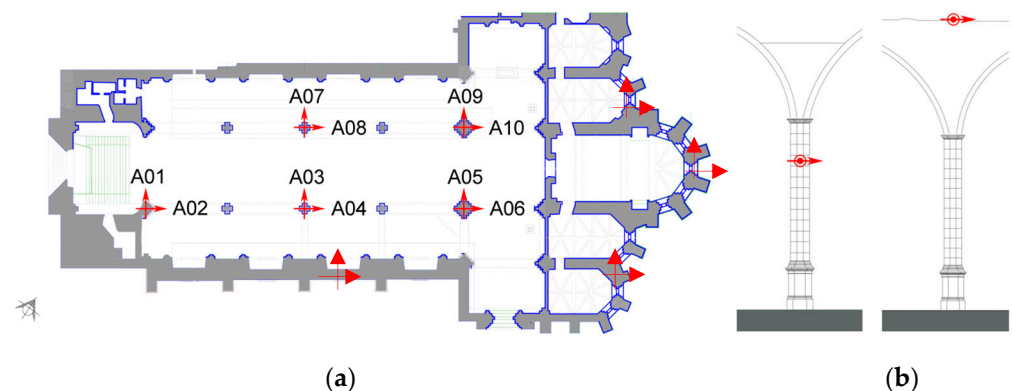
The freestanding nature of the arcades and columns not only makes them structurally vulnerable, but their access is also difficult for dynamic identification testing. However, the arcades are slender and mostly unaffected by the main structure. To access the tops of the arcades, it was necessary to hire a professional climber to place the accelerometers safely. For this reason, the installation of the accelerometers on the south arcade took a considerable amount of time, so the accelerometers on the north arcade were installed with a ladder on the column faces rather than the top of the arcades. The testing plan utilised 10 accelerometers placed in pairs to measure the response in both the transverse and longitudinal directions at the arcades (Figure 9).

**Figure 9.** Indicative testing setup of the dynamic identification tests: (a) plan; (b) height for accelerometers on the north arcade and the south arcade (arrows indicate reference axis of the accelerometers).

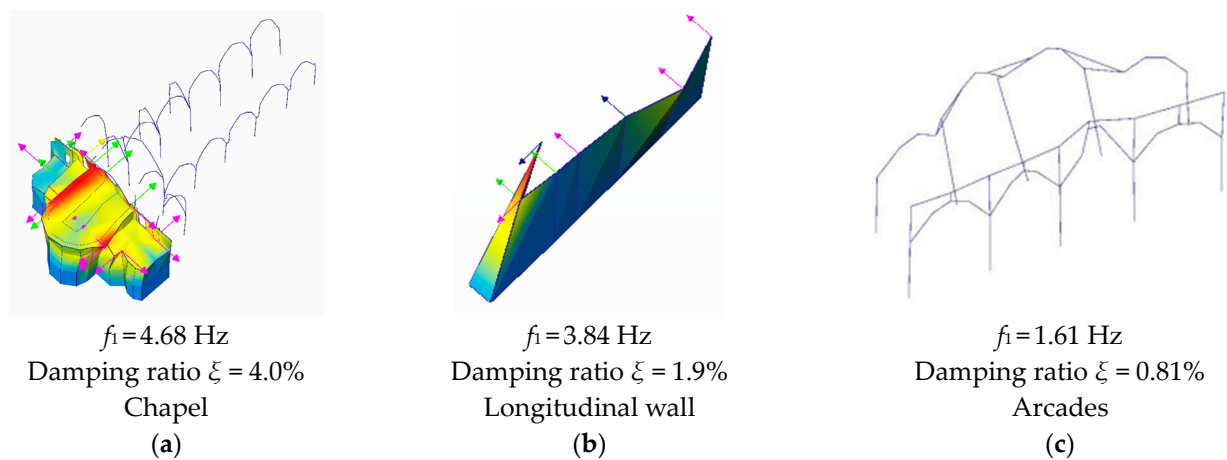
Regarding the chapels, four modes with a frequency ranging from 4.68 Hz to 12.24 Hz were estimated. The first mode (4.68 Hz) corresponds to the first global mode of the chapel in the transversal direction of the church (Figure 10a). The second mode (6.59 Hz) is the second global mode of the chapel in the longitudinal direction of the church. Mode 3 (8.60 Hz) is also a global mode, corresponding to a distortional mode of the chapel in the transversal direction of the church. The last mode (4th mode–12.24 Hz) is the first local mode of the central part of the chapels in the transversal direction of the church.

Regarding the longitudinal wall, a further four modes with a frequency ranging from 3.84 Hz to 7.24 Hz were estimated. The first mode (3.84 Hz) corresponds to the first local mode in the longitudinal direction of the church (Figure 10b), which can be associated with the local mode of the main façade. The second mode (4.35 Hz) is the first local mode of the longitudinal wall in the transversal direction of the church, with the highest amplitude

Lastly, regarding the arcades, five modes were estimated. Local modes of 1.61 Hz and 3.05 Hz correspond to transverse and longitudinal modes, respectively, on the north arcade (Figure 10c). Local modes on the south arcade were found to be 2.26 Hz in the transverse direction, 3.57 Hz for the first curvature and 3.91 Hz in the longitudinal direction. These frequencies were considered to be within the acceptable range of the structure. Peaks above the frequency of 3.91 Hz were considered too high to be accurate, as higher resonant frequencies are stiffer and thus more difficult to excite through ambient vibration alone. Furthermore, the first modes have the highest contribution to the dynamic behaviour of building structures [19].

**Figure 10.** First experimental modal shapes estimated from the dynamic identification tests: (a) for the chapels; (b) for the southern longitudinal wall; and (c) for the arcades (arrows corresponds to the accelerometer locations).

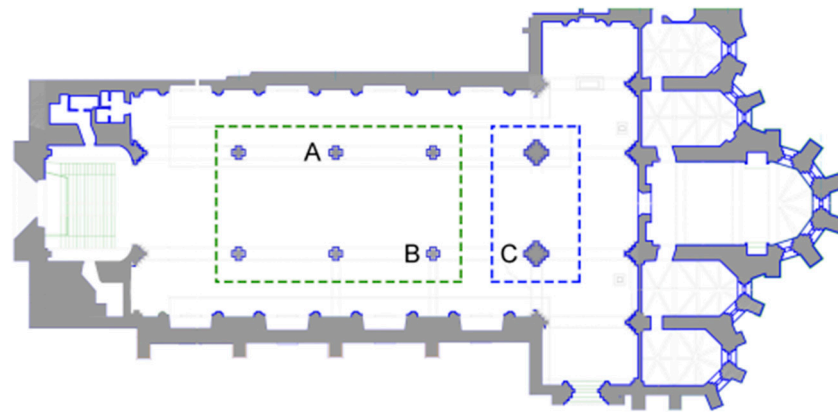
Ground-penetrating radar (GPR) was used to garner a better understanding of the arcade columns that divide the church's three naves. GPR was performed on three of the arcade columns. The columns within the green box in Figure 11 are essentially identical; thus, only two were chosen for GPR, namely columns A and B. In the blue box, the two larger columns are also assumed to be identical, so only the column labelled C was analysed with GPR.

**Figure 11.** Floor plan of the church of the Carmo Convent depicting the columns chosen for GPR testing (A, B and C).

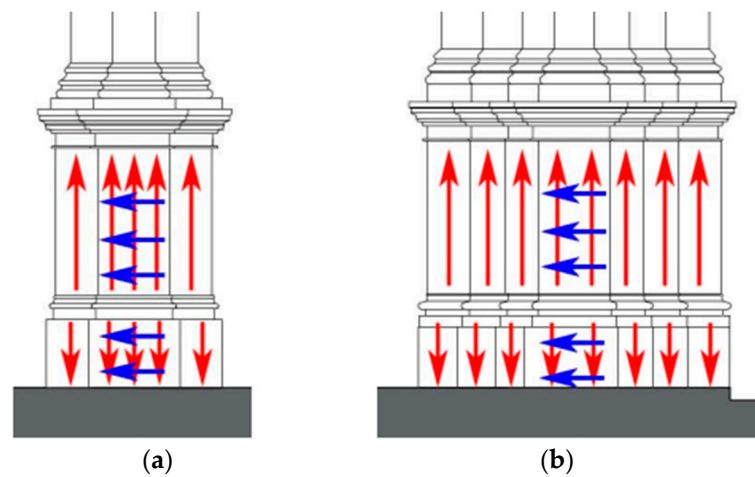
The goal of the analysis was to understand the dimensions and potential interlocking of the limestone units used for the base of the columns. Thus, the scanning process shown in Figure 12 was adopted, where the red arrows represent vertical scans and the blue arrows represent horizontal scans. Here, the direction of the arrows indicates the direction in which the antenna was oriented. Using a 1.6 GHz antenna that can record depths up to 1 m, ten scans were taken in the vertical direction and five scans in the horizontal direction on each of the four faces for columns A and B. For column C, 16 and 6 scans were made on all four faces vertically and horizontally, respectively. The redundancy of these scans protects against misinterpretations or missing data due to bad or noisy readings. In addition, scans taken orthogonally allow for evaluation of the stone arrangement and the inaccessible interiors of the columns.

**Figure 12.** Drawings of the bases of the two column types: (a) columns A and B in Figure 11 and (b) column C in Figure 11. The red arrows show the vertical scans taken on the columns, and the blue arrows show the horizontal scans.

The clarity of the scans (Figure 13) made it reasonable to conclude that the stones seen on the column's exterior are solid and extend approximately 28–30 cm into the column. Beyond the singular stones, the scans are less clear. These portions of the scans, represented by the hatch, show significant wave reflection, which indicates that the interiors of the columns are likely not made of solid stone, nor does it appear that these are clean-cut stone blocks fitted together. Rather, it is likely that the interiors are at least partly filled with limestone rubble and compacted with good-quality mortar. It is possible that the upper portion of the column extends into the base or that there are larger solid stones at the interior that were not reached by the electromagnetic wave from the GPR.

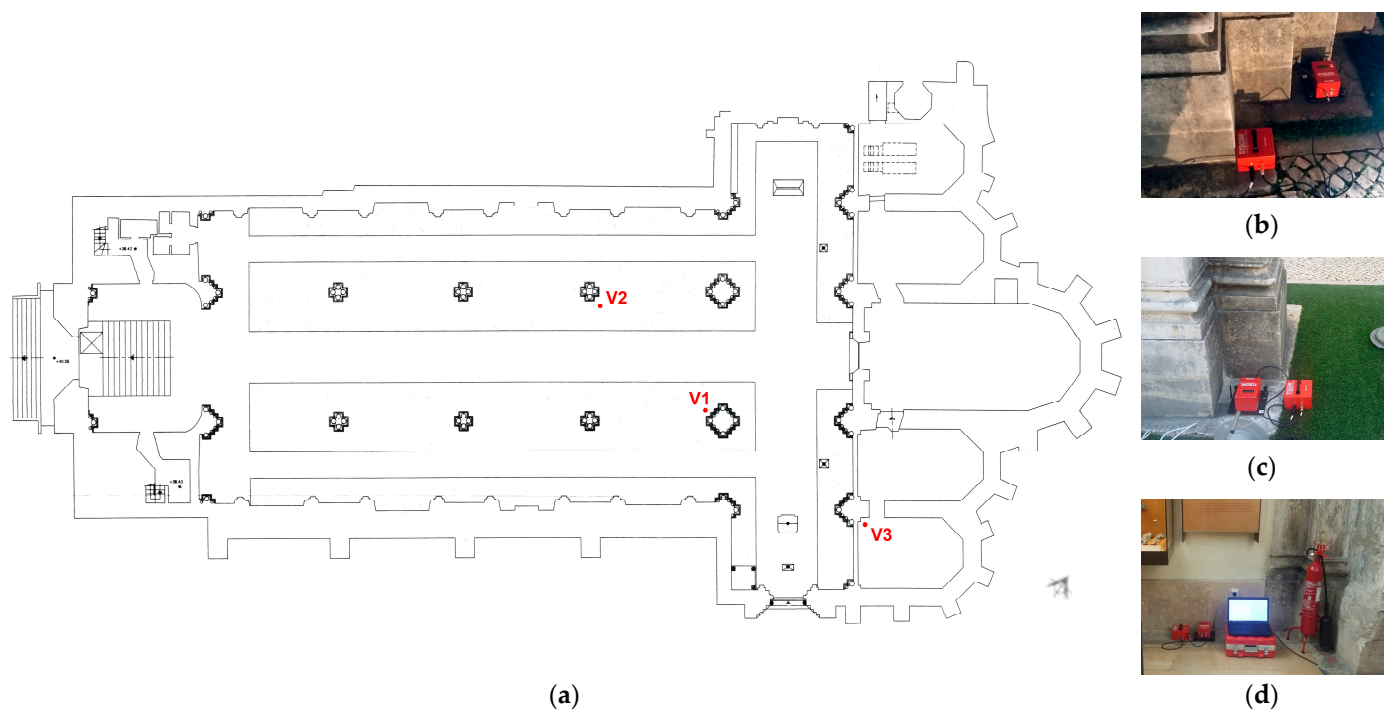
The ground-borne vibration tests were carried out within a time window of 3 days, placing a vibration measurement system, a triaxial velocimeter-geophone (MR3000C), at the bottom of two selected piers (V1 and V2 in Figure 14) and inside the south chapel (V3 in Figure 14). The geophone has a recording sampling range of 250–4000 Hz, a measurement velocity range of  $\pm 100$  mm/s and a frequency range of 1–350 Hz. Vibration recordings were taken from 6:00 pm to 01:00 am in the first measurement (V1), from 7:00 pm to 09:00 am in the second one (V2) and from 11:00 am to 01:00 pm in the third one (V3), with time durations setups of half hour and a sampling rate of 1000 Hz.

**Figure 14.** Plan view of church of the Carmo Convent: (a) with testing locations of acquisitions of induced vibrations V1 (b), V2 (c) and V3 (d).

For V2, the acquisitions in which the metro is not working (01:00–06:30 am) constitute a base reference for comparison during the post-processing. Here, basic statistics for absolute particle velocities in each direction with no metro operation are presented in Table 2. Considering the median values, the base zero reference particle velocities are in the range of 7–11  $\mu\text{m/s}$ . Further, Tables 3–5 present basic statistics of absolute particle velocities during metro operation for V1 (6:00 pm to 01:00 am), V2 (7:00 pm to 01:00 am and 06:30 am to 09:00 am) and V3 (11:00 am to 01:00 pm), respectively. The maximum recorded particle velocity is found in V3, equal to 0.1441 mm/s, with the corresponding time-history plots in all directions and the vectorial sum presented in Figure 15a,b, respectively. For the specific signal, the fast Fourier transform (FFT) plot in Figure 16a reveals the dominant frequency, with the highest energy content equal to 18.1 Hz. Thus, accounting for NP 2074 [24], with a maximum particle velocity limit for sensitive structures and a dominant frequency range of 10–40 Hz, is equal to 3 mm/s. Thus, the maximum recorded particle velocity is found to be 21 times lower, as also presented in Figure 16b. In conclusion, the structure is not affected by the metro operation for the monitored period, also accounting for the low speed of trains moving, as the metro station is located directly below the structure.

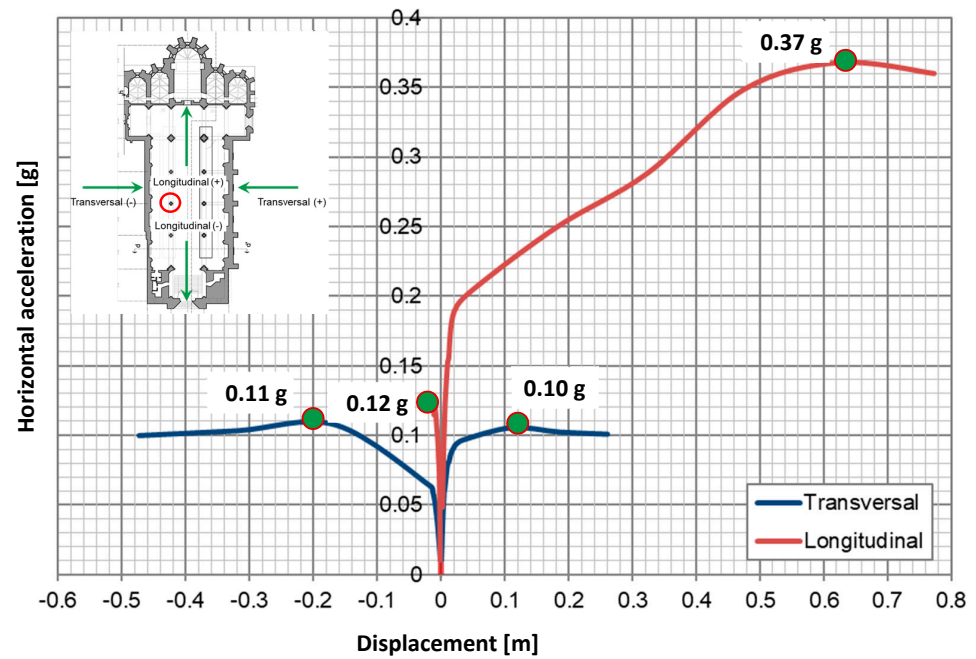
Considering all the conducted pushover analyses, the least vulnerable for the structure is in the positive longitudinal direction (0.37 g), mainly due to the in-plane stiffness provided by the arcades, longitudinal wall and chapels. The arcades can deform more in their plane before the structure fails. However, severe damage is endured in the process (Figure 19a). Instead, in the negative longitudinal direction, the capacity is equal to 0.12 g, with the north arcade failing under comparatively little displacement due to the differences in stiffness and strength between the free span of the arches and the nave room walls together with the front façade (Figure 19b) given by the transverse arches. For the pushover applied in the negative transverse direction, the structure presents a low increase in capacity (0.11 g) with respect to the positive one (Figure 20b). Hence, the transverse direction structure is considered the most vulnerable for the structure, even if by a small

Figure 18. Capacity curves for the global FEM model (control point highlighted in red).

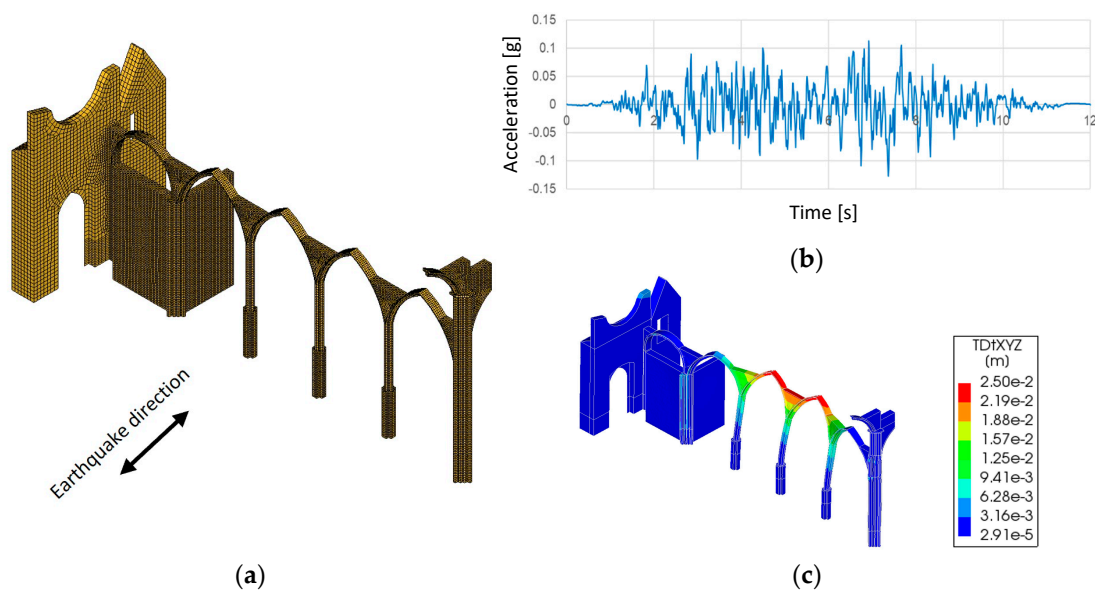
Finally, a nonlinear dynamic analysis with time integration was performed for a partial FEM model of the north arcade (Figure 21a). Taking into account the results obtained in the pushover analysis in the transversal directions, an artificial accelerogram, generated in the SIMQKE\_GR 1.3 software and compatible with the response spectrum for Type 2 earthquakes of Eurocode 8 [36] and scaled for a PGA equal to 0.12 g (about the PGA expected for Lisbon and soil type C), was applied in the orthogonal direction to the arcade (Figure 21b). Rayleigh damping with coefficients equal to 0.522787 ( $\alpha$  proportional to the mass matrix) and 0.000823 ( $\beta$  proportional to the stiffness matrix) was adopted. The results of this analysis allowed us to verify that the north arcade presents a similar behaviour to one obtained from the pushover analysis for the same seismic action, namely collapse mechanism and displacements (Figure 21c).

**Figure 21.** Nonlinear dynamic analysis: (a) partial FEM model of the north arcade; (b) accelerogram; (c) maximum displacements.

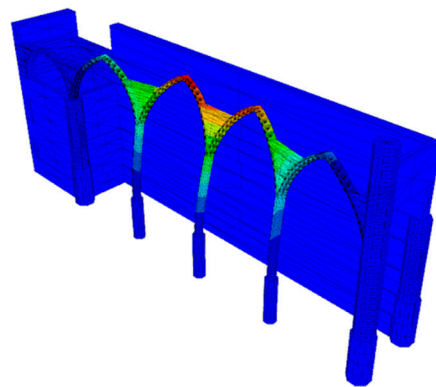
A calibration of the joint normal stiffness was performed based on the first mode of the north arcade in the transverse direction (Table 8 and Figure 23), accounting for its highest contribution to the seismic behaviour. Next, the calibration was performed through iterative eigenvalue analyses to obtain a numerical frequency that matches the experimental value.

Figure 23. First mode of the north arcade in the transverse direction (DEM model).
