Practical Experience of Operational Diagnostics and Defectoscopy on Photovoltaic Installations in the Czech Republic

Petr Mastny *, Jan Moravek and Jiri Drapela

Department of Electrical Power Engineering, Brno University of Technology, Technicka 12, Brno 61600, Czech Republic; E-Mails: jan.moravek@phd.feec.vutbr.cz (J.M.); drapela@feec.vutbr.cz (J.D.)

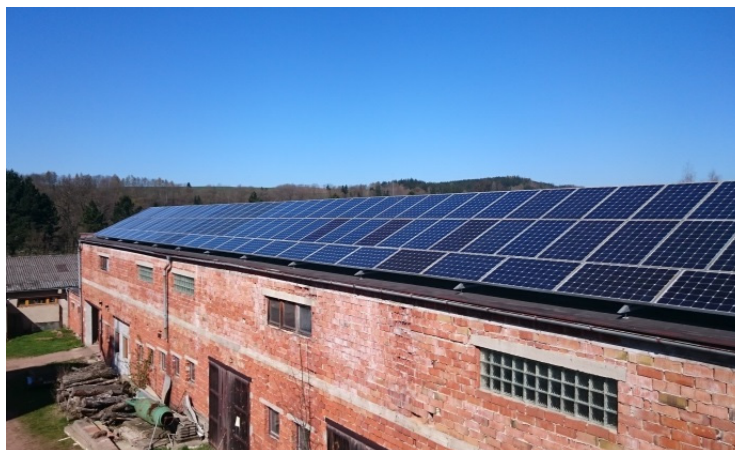
Figure 15. Selected part of the 100 kWp PV plant [27].

The PV plant is situated on the roof of agricultural buildings (Figure 15). The results of the measurement of I-V curves confirmed a significant but uniform power decrease of the PV panels. The panels are CEEG SST240-60M, with a nominal power of 240 Wp. The measurement was performed at the installation site and, in agreement with the valid IEC 61215 standard, the values measured were converted to STC using the thermal coefficients given in the datasheet of the respective panels.

The results for two different strings measured on a single panel are given in Table 3. The average power decrease is between 9.7% and 12.2%. The PV panels are four years old, with visible color changes of the EVA foil. The measured strings show no PID presence indicated usually by a power decrease at one end of the string. Moreover, none of the main prerequisites was present at the inspected PV plant.

The open-circuit voltage of the string reaches the value 333 V, therefore the potential to the ground is low. Neither of the DC poles was grounded [27].
