Failure Analysis of a Humeral Shaft Locking Compression Plate—Surface Investigation and Simulation by Finite Element Method

Abstract: A case study of a failed humeral shaft locking compression plate is presented, starting with a clinical case where failure occurred and an implant replacement was required. This study uses finite element method (FEM) in order to determine the failure modes for the clinical case. Four loading scenarios that simulate daily life activities were considered for determining the stress distribution in a humeral shaft locking compression plate (LCP). Referring to the simulation results, the failure analysis was performed on the explant. Using fracture surface investigation methods, stereomicroscopy and scanning electron microscopy (SEM), a mixed mode failure was determined. An initial fatigue failure occurred followed by a sudden failure of the plate implant as a consequence of patient's fall. The fracture morphology was mostly masked by galling; the fractured components were in a sliding contact. Using information from simulations, the loading was inferred and correlated with fracture site and surface features.

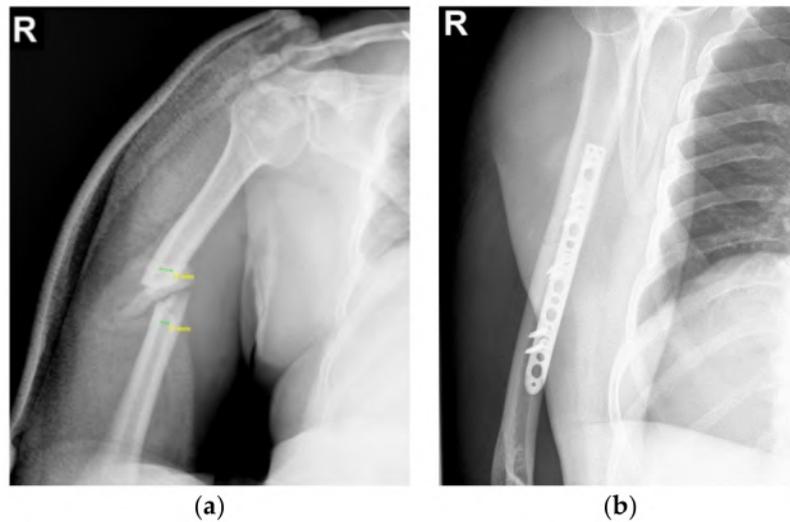
The patient is a 62-year-old male with a documented transverse fracture in the middle third humerus (Figure 1a), which was implanted using an LCP with eight screws. The screw configuration

consists of five locking screws and three compression screws, according to Figure 1b. The patient was advised to follow a standard postoperative program with immobilization (sling) for the first three weeks, followed by three weeks of passive range of motion and a period of active range of motion after that. Nevertheless, two months after surgery he suffered a second injury, leading to an increased mobility of the arm, that produced a second fracture and consequently the plate failure. An X-ray examination revealed that he suffered a complete breakage of the implant, as depicted in Figure 2a.

Figure 1. Clinical details: (a) X-ray comminuted fracture of midshaft humerus; (b) Post-operative X-ray with reduction and osteosynthesis with the locking compression plate (LCP).

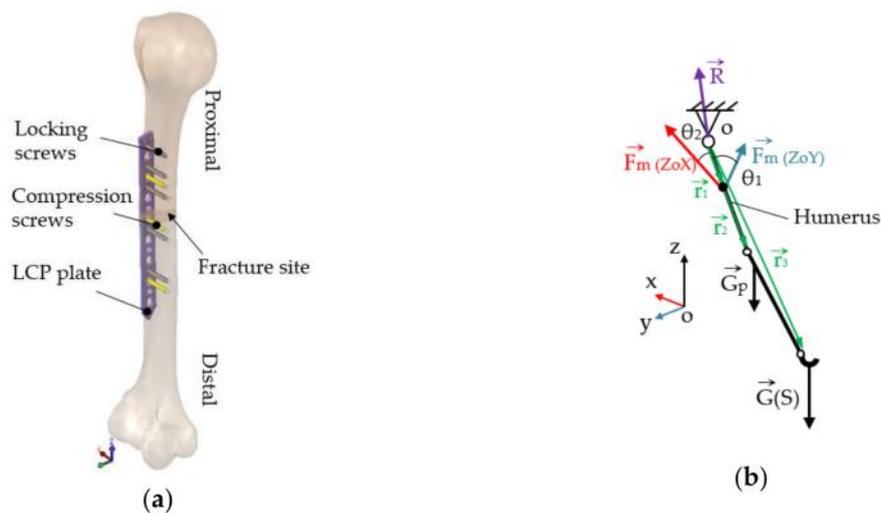
Figure 3. Geometric assembly and simplified static model: (a) Reconstructed humerus and LCP system fixed in place—internal lateral view; (b) Simplified body diagram of the upper limb used for computation of muscle forces.

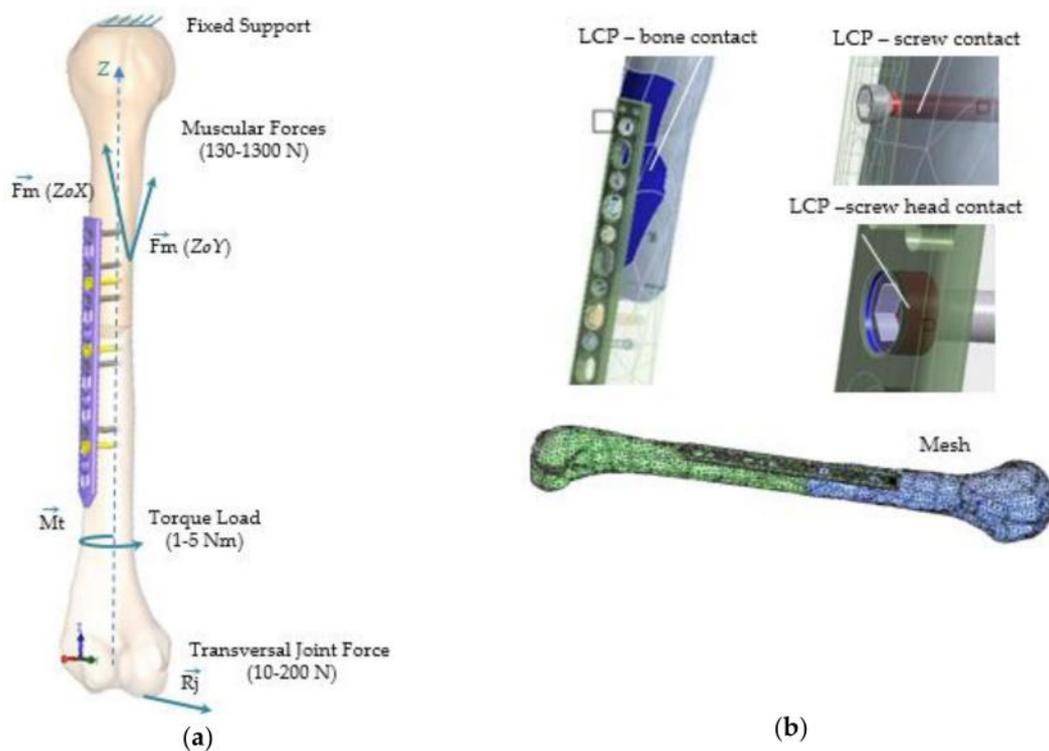
Figure 4. Structure loadings, constrains and contacts applied to the FEA model (all scenarios): (a) Loadings and boundary conditions; (b) Bonded contact definition: bone-plate, screw-plate, and screw-bone.
