# Evaluation of the Fatigue Behavior and Failure Mechanisms of 4340 Steel Coated with WIP-C1 (Ni/CrC) by Cold Spray

**Abstract:** Fatigue behavior of standardized 4340 steel samples uniformly coated with WIP-C1 (Ni/CrC) by cold spray was investigated. In particular, when a crack appeared at the interface between the base material and the coating, the cause of it as well as its shape and size were investigated. Fatigue loading was applied by alternating symmetrical cycles. Scanning electron microscopy was used to study the onset of failure and the subsequent propagation of cracks. The interface between the two materials performed well—in all samples, the initial crack propagation occurred on the surface of the base material, continuing into the coating material and in the interior of the base material. The fatigue durability curve of stress vs. number of cycles (S-N) presented a conventional form for a metallic alloy and the coating material had an influence only on the damage on the surface of the base material.

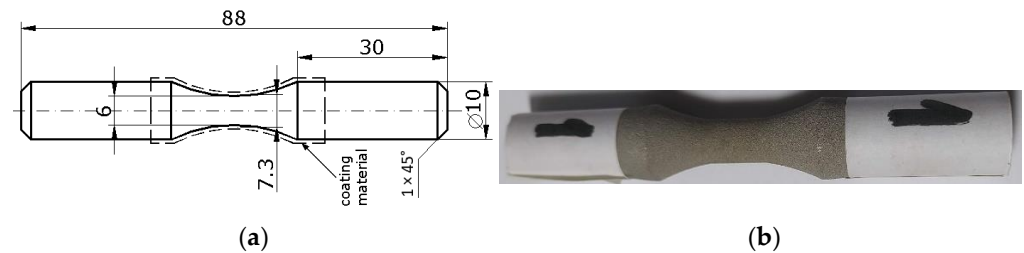
**Figure 1.** Details of tensile test sample: (a) Sample shape and dimensions (mm), (b) coated sample.

The deposition shows no geometric deviation of the deposited layer, and in addition it adheres well to the base material (Figure 1). This figure also shows that the surface area of the base material (AISI 4340 alloy steel) was partially affected by the intrusion of the coating material into base material surface.

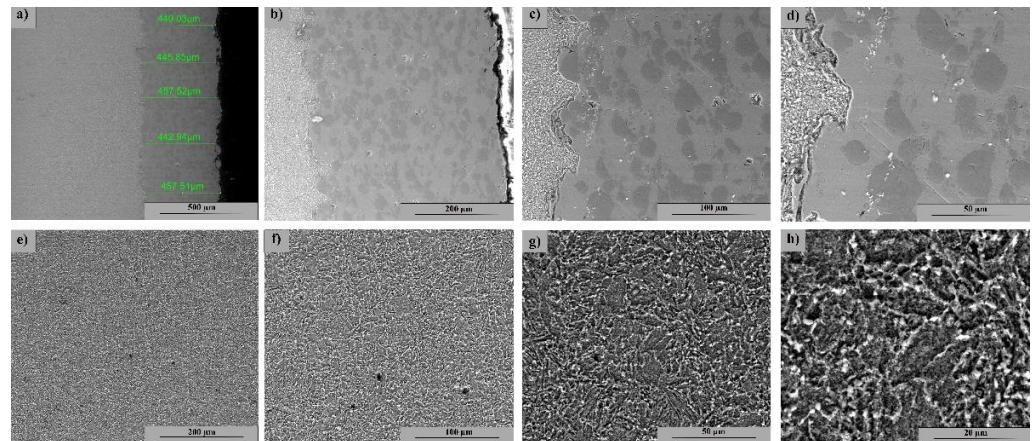
Figure 2 highlights the SEM image of the coated sample section as-coated (not tested). The coating is uniform, with no porosity; it is adherent to the substrate and has an approximate thickness of 450  $\mu\text{m}$ .

**Figure 2.** SEM image of the cross-section at the interface between the base and the coated materials: (a–d): Cold spray Ni/CrC layer—(a) 200 $\times$ ; (b) 500 $\times$ ; (c) 1000 $\times$ ; (d) 2000 $\times$ ; (e–h): 4340 microstructure base material—(e) 500 $\times$ ; (f) 1000 $\times$ ; (g) 2000 $\times$ ; (h) 5000 $\times$ .

Figure 2a–d show the layer deposited by the CS method at various magnifications, where a structural uniformity with coarse grain size and two distinct phases corresponding to the powders used is observed. The base material (Figure 2e–h) shows a uniform ferritic-pearlitic structure with a fine grain size without defects and isolated inclusions.

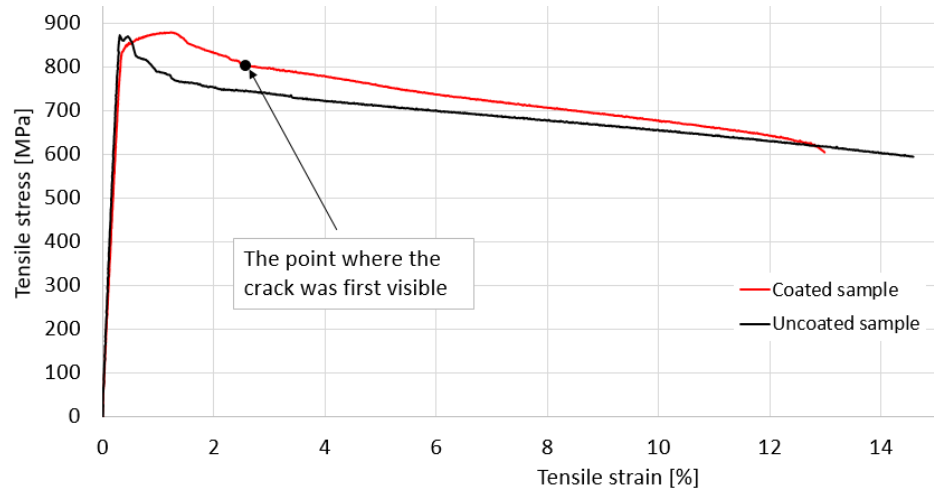
**Figure 4.** Characteristic stress–strain curve, specific to the coated sample and uncoated samples.

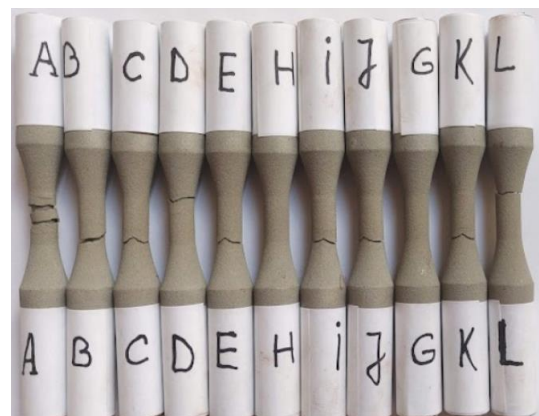
The present work covered analysis of ten samples (Figure 5—B to L), tested for axial-symmetrical tensile fatigue. Only eight of the ten samples were broken—samples H and G did not break even after 5 million cycles. Observations about each sample are presented in detail below. The samples with close values of the maximum loading stress are specified and discussed together.

**Figure 5.** Samples after fatigue testing: A: static tensile sample; B–L: fatigue tested samples.
