Interdisciplinary Research on Medieval Fresco Subjected to Degradation Processes in the Corbii de Piatră Cave Church

Abstract: This paper presents research on the degradation processes of the fresco painting in the cave church of Corbii de Piatră Hermitage under the influence of meteoric infiltration water and environmental factors. The medieval fresco dates from the end of the 13th century and the beginning of the 14th century, being painted on a sandstone wall. The infiltration of meteoric water through this wall, the temperature variations, the environment and the repeated wetting/drying processes determined the degradation of the fresco, resulting in its detachment from large surfaces. This research established correlations between the processes that take place, the structural transformations, the changes in composition and the adhesion of the fresco to the sandstone wall. The results have been made available to conservation and restoration specialists, in order to choose appropriate materials and technologies. This paper presents findings regarding the pictorial material and introduces new analysis techniques in research on the degradation processes of the fresco painting in

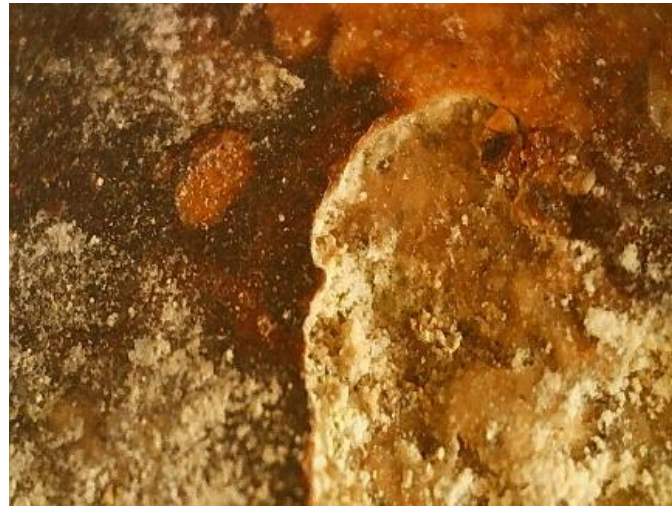
The purpose of the experiments was to determine the average surface roughness of the materials, their 2D and 3D appearance and to identify the use within the materials of a unitary homogeneous aggregate made of a single material or a multi-component one. The appearance of the surface of composite materials covered with a pictorial layer was also observed. The construction material and mortar, under the black painting layer that was investigated by atomic force microscopy is shown in Figure 5.

Figure 5. The mortar material present under the black pictorial layer, analyzed by atomic force microscopy.

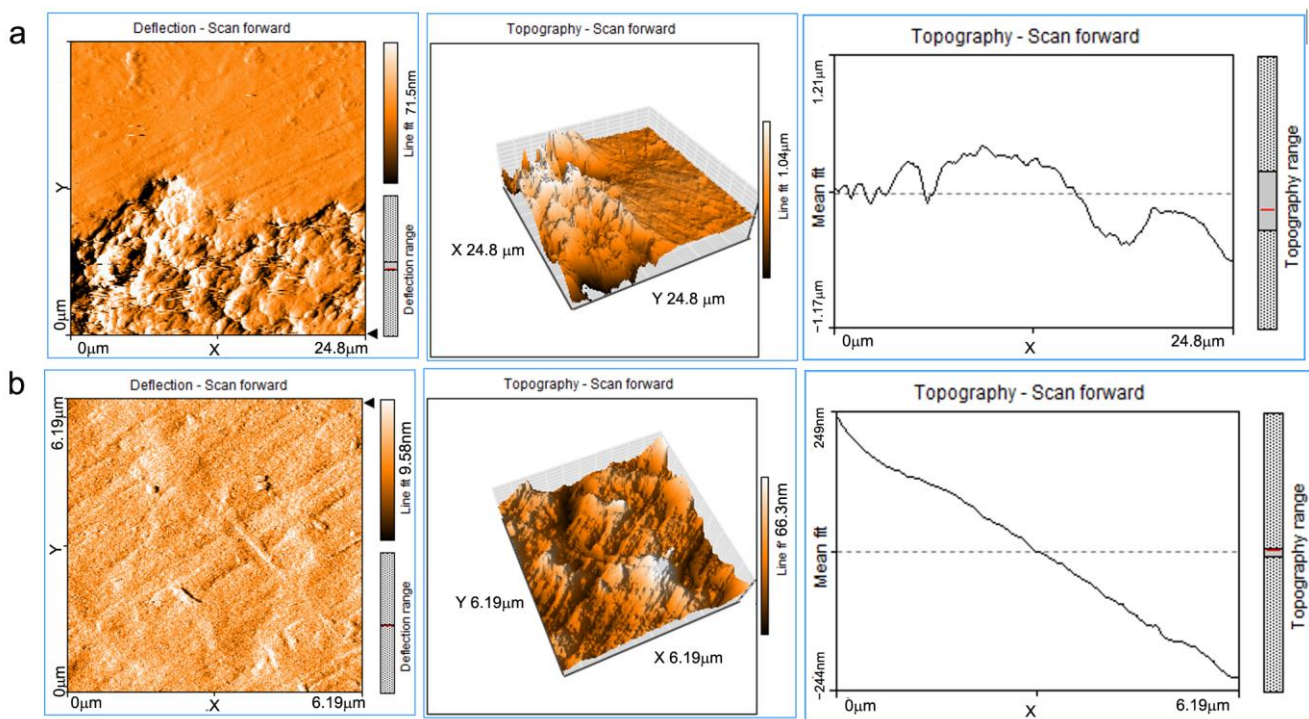
Figure 6 shows two surfaces at 25×25 and $6 \times 6 \mu\text{m}^2$, respectively, on the surface of the material from the side not exposed to light. Figure 6a shows that the sample is made up of at least two types of materials with very different levels of roughness: $\text{Ra} = 27.09 \text{ nm}$ and $\text{Rq} = 31.18 \text{ nm}$; and for the second area: $\text{Ra} = 330 \text{ nm}$ and $\text{Rq} = 409.6 \text{ nm}$.

Figure 6. AFM images of the surface of the material of sample N: (a) on an analysis surface of $25 \times 25 \mu\text{m}^2$ and (b) $6 \times 6 \mu\text{m}^2$.

For the entire surface, the Sa and Sq parameters have values of 135.17 and 215.6 nm, respectively.

For the second surface (Figure 6b), the main parameters of the surface condition are: Sa = 8.09 nm and Sq = 10.44 nm. At the nano metric level, different materials or different structural constituents are not observed, they appear only at the micrometric level. At micrometric scale exists an intimate contact between the component materials of the aggregate without a clear boundary between them, with a good cohesion that supports the good general material properties.

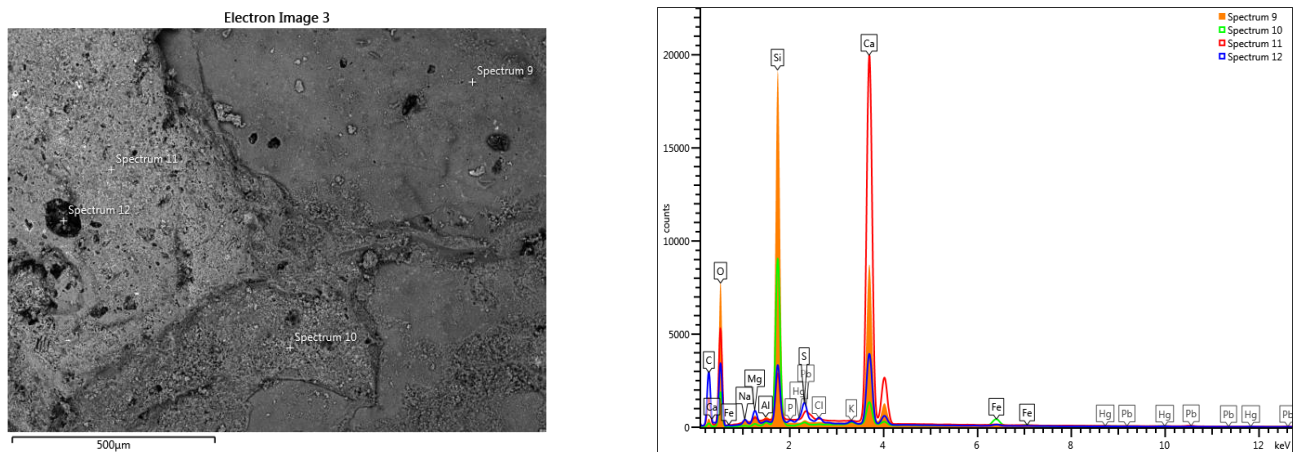
SEM analysis of the surface highlights the pictorial layer with unevenness resulting from biodegradation and impurities [10] (Figures 12–14).

Figure 12. SEM-EDS scan on the surface of the painting layer: Fe, Hg, Pb.

The elemental chemical composition determined in the points in Figures 12 and 13 shows the presence of iron, mercury and lead. For the points in Figure 14, the pictorial layer shows iron (Table 2).

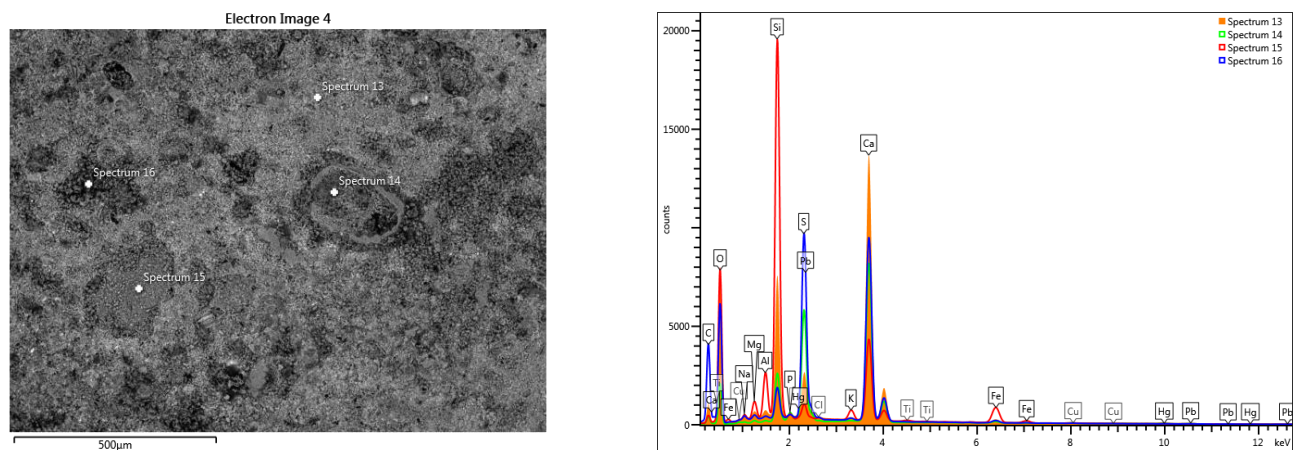
Figure 13. SEM-EDS scan on the surface of the painting layer: Fe, Hg, Pb and Ti traces.

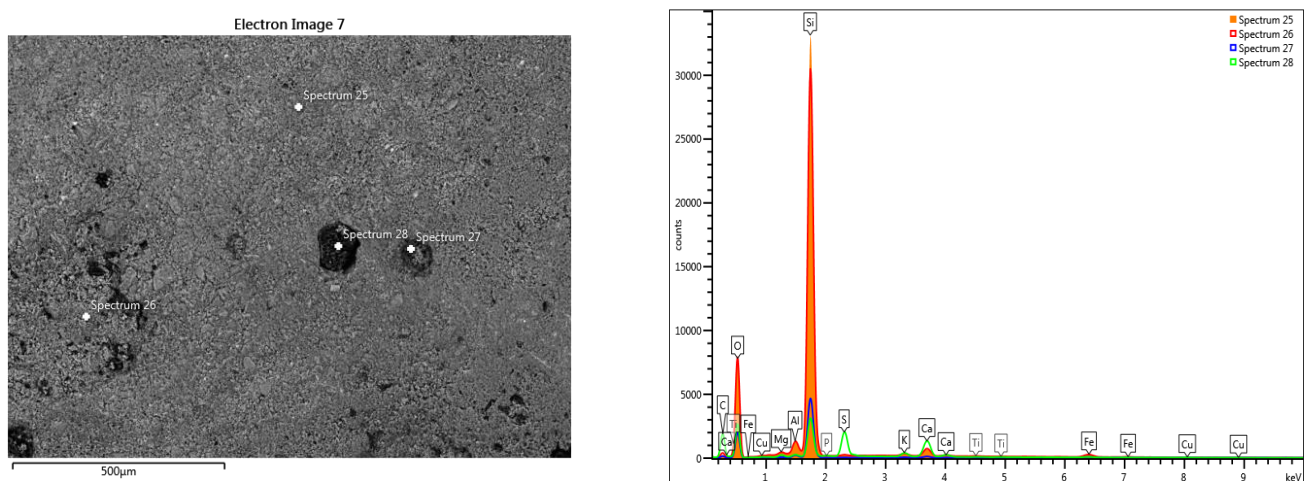
Figure 14. SEM-EDS scan on the surface of the painting layer: Fe, Ti and Cu traces.

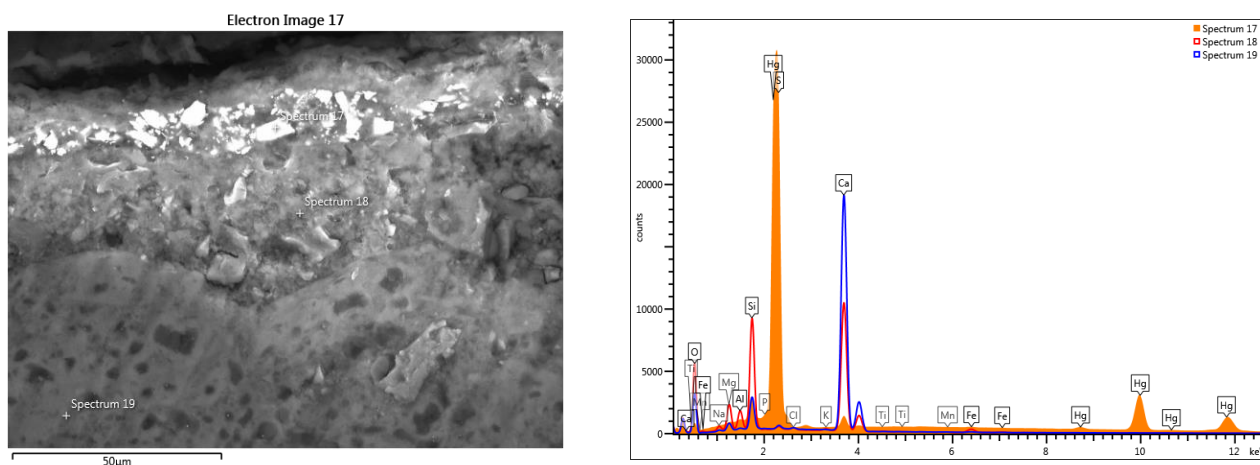
**Figure 15.** SEM-EDS of the red pictorial layer: cross-section scan through the fresco fragment (Hg, Fe).
