Operational and Material Causes of High-Pressure Turbine Disc Damage in the RD-33 Engine

Abstract: This paper presents an analysis of the causes of damage and fragmentation to the high-pressure turbine (HPT) disc of the RD-33 engine mounted in the MiG-29 aircraft. The authors have carried out an analysis of the changes to the structure of the disc material, both in the areas containing cracks and in the undamaged areas. The impact of structural changes on the alterations in the analysed strength properties along the disc radius was assessed. Material tests were correlated with the analysis of the recorded engine parameters, indicating potential causes of the HPT disc fragmentation.

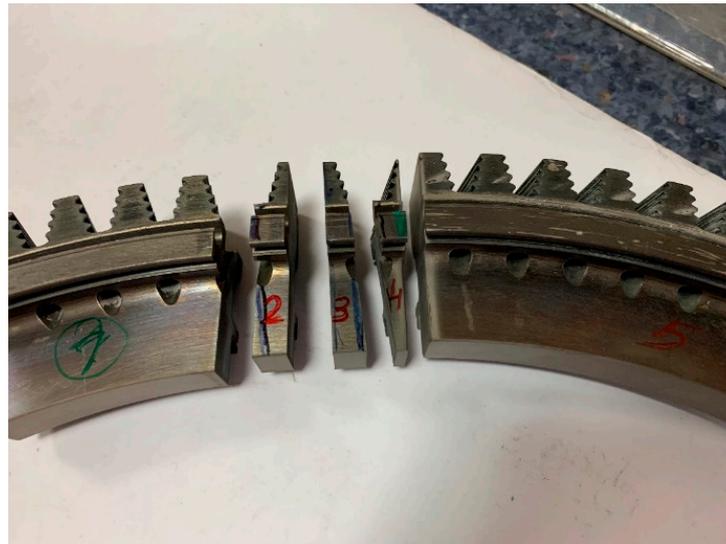
Figure 2. A view of the non-damaged part of the disc cut into pieces with markings of the respective samples.

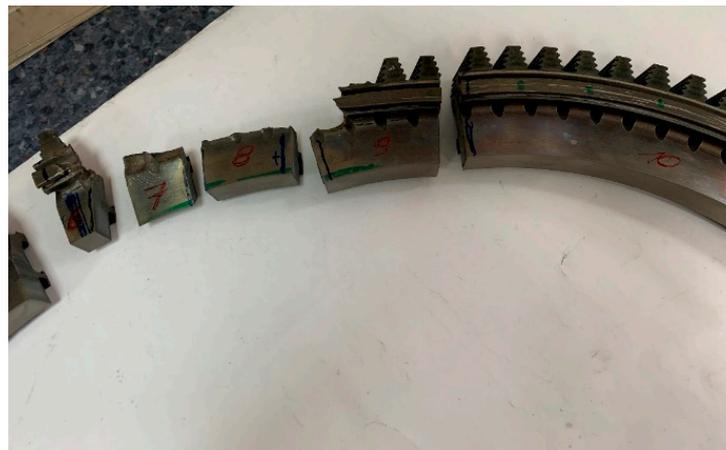
Figure 3. A view of the damaged part of the disc cut into pieces with markings of the respective samples.

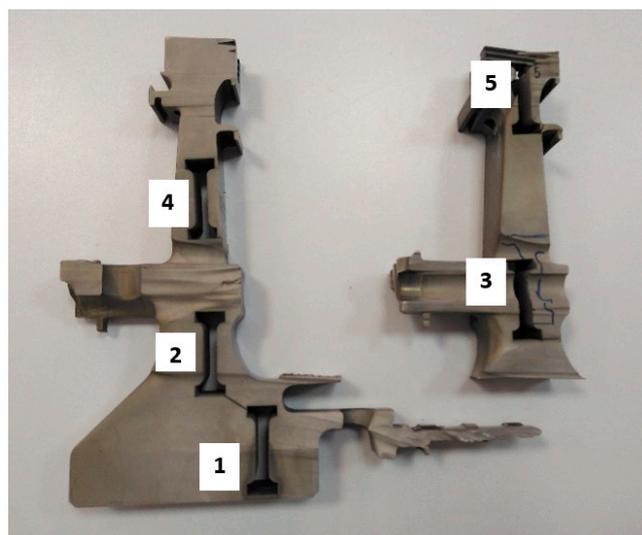
The structural changes of the material observed along the disc radius (Figure 13) should also be reflected in the mechanical properties. In order to determine the basic, static strength parameters in the disc sections (Figure 17), tensile test samples were collected from five areas: one—disc foot plate, two—disc zone between the labyrinth seal and the connecting drum, three—drum zone, four—zone between the blade rim and drum part, and five—retaining ring area. The prepared samples were subjected to tension on an Instron 8501 testing machine using an extensometer with a measuring length of 12.5 mm and TestXpert III v.1.5 software. The tests were carried out in accordance with the requirements of the PN-EN ISO 6892-1:2020-05 standard [23].

Figure 17. The location of sample collection from sections of the turbine disc for the static tensile test. “1–5”—areas of cutting strength samples described in the text.

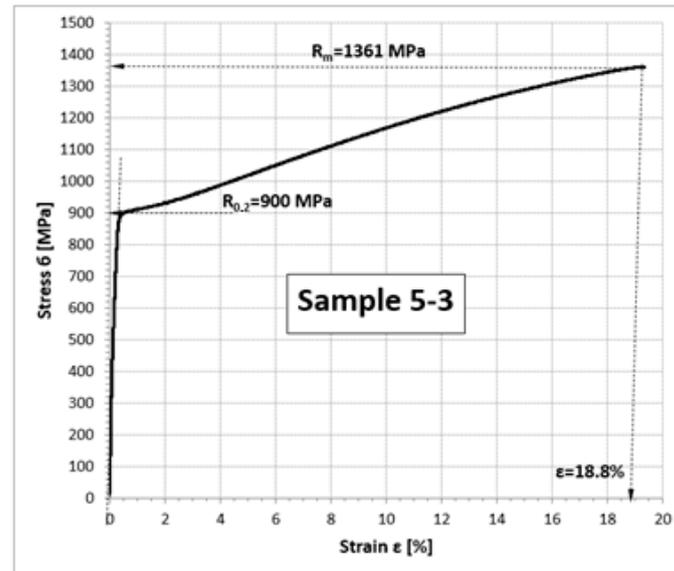
As a result of the test, stress–strain curves (σ - ϵ) (Figure 18) were obtained based on which the basic strength properties of the tested samples were determined, including: yield strength $R_{p0.2}$, tensile strength R_m , and relative elongation A (Table 1).

Figure 18. Sample stress–strain curve obtained for a sample collected from the retaining ring zone.

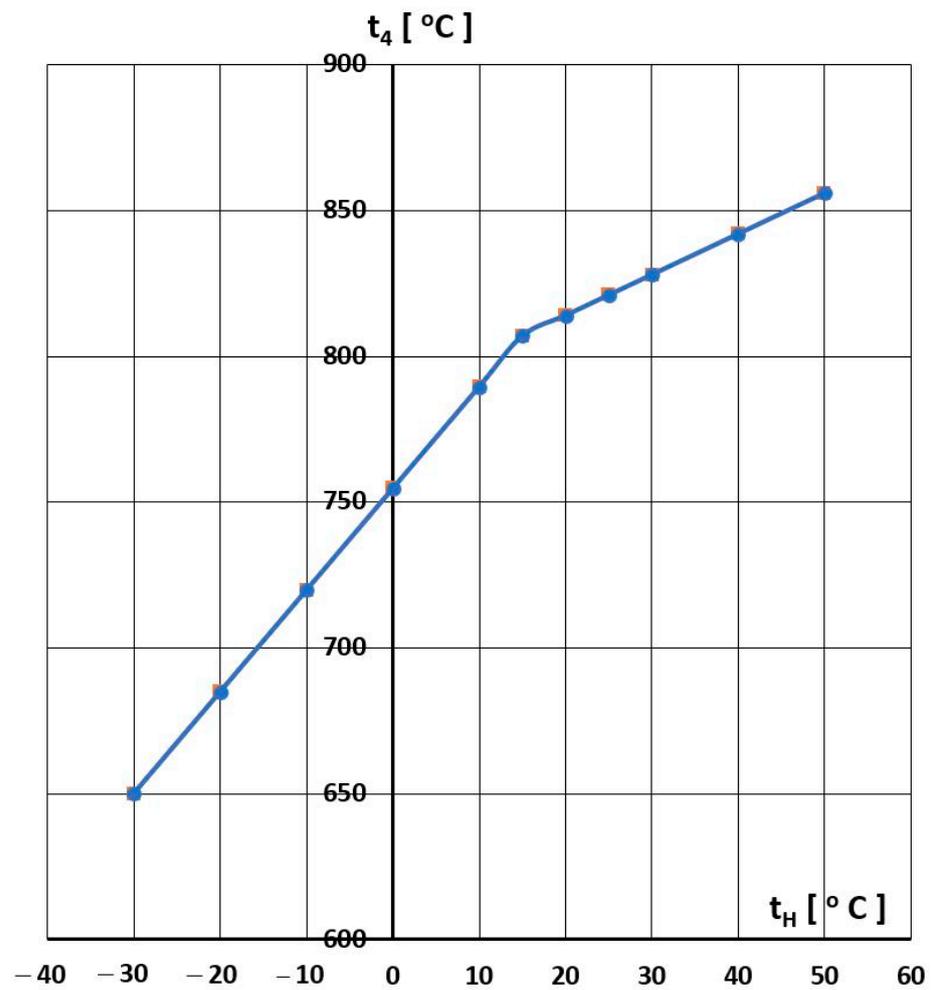
After determining the characteristics $t_4 = f(t_H)$, we analysed the selected flight parameter changes. The temperature t_4 was assessed in terms of the possibility of exceeding the limit values. Sample temperature value differences dt_4 between the permissible value $t_{4,D}$ resulting from the limitations imposed by the manufacturer (Figure 20) and the value recorded in the engine $t_{4,L}$ are shown in Figures 21–23.

Figure 20. Temperature limit curve t_4 for the tested engine.
