# Failure Analysis of Cracked P110 Repaired Tubing Used for Gas Transmission

**Abstract:** With green and low-carbon developments in oil fields, an increasing amount of repaired oil tubing is being used as oil and gas transmission pipelines in China. However, due to differences in manufacturing standards between oil tubing and transmission pipelines, there are inevitably some issues during their use. This paper investigates a case of cracking failure in repaired oil tubing used as a gathering and transportation pipeline. The failure occurred after eight months of operation and was characterized by a circumferential crack at the male thread end of the tubing joint. To determine the root cause of the failure, a series of experiments were conducted on the oil tubing. The experiments included visual inspection, chemical composition analysis, mechanical properties testing, hardness testing, metallographic examination, and microstructure analysis. The results revealed that the thread of the cracked tubing was not tightened to the specified position; the connection between the tubing and the coupling was welded in a circumferential direction; and cracks occurred in the heat-affected zone

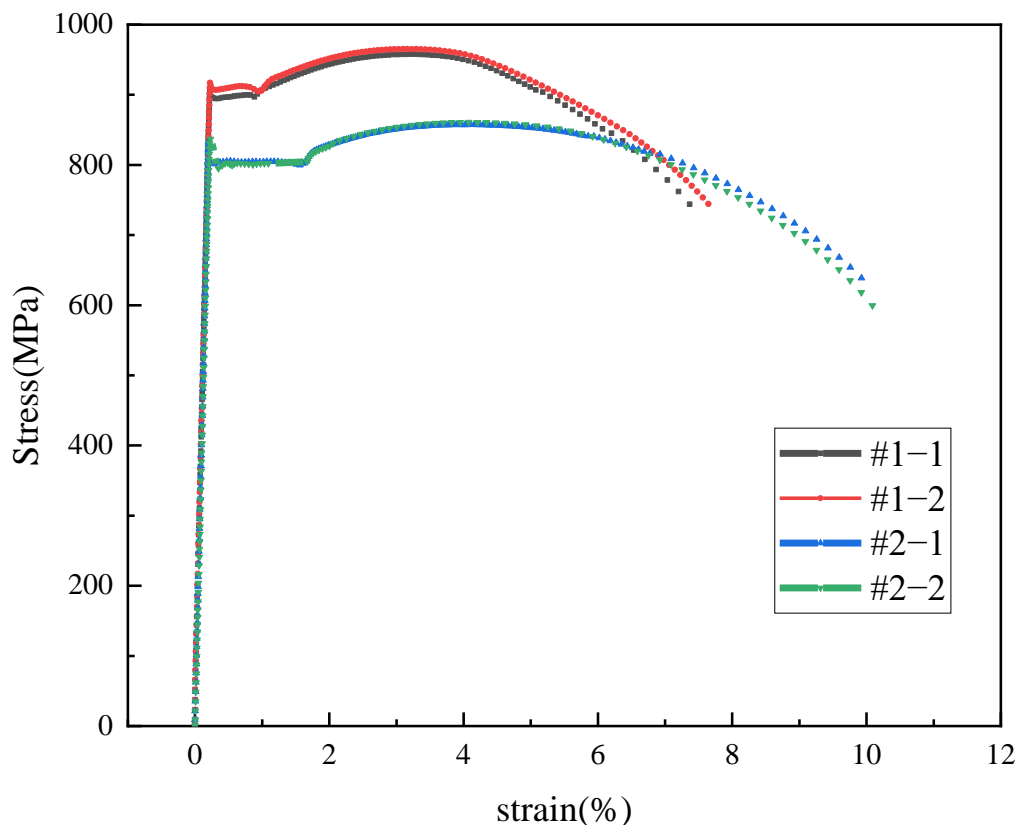
**Figure 3.** The strain–stress curve of the tensile test.

The results of the tensile test are shown in Table 2, and the strain–stress curves are shown in Figure 3. The tensile strength and yield strength of the #1 repaired tubing meet the requirements of the standard API 5CT for P110, and the tensile strength and yield strength of the #2 repaired tubing meet the requirements of the standard API 5CT for C110.

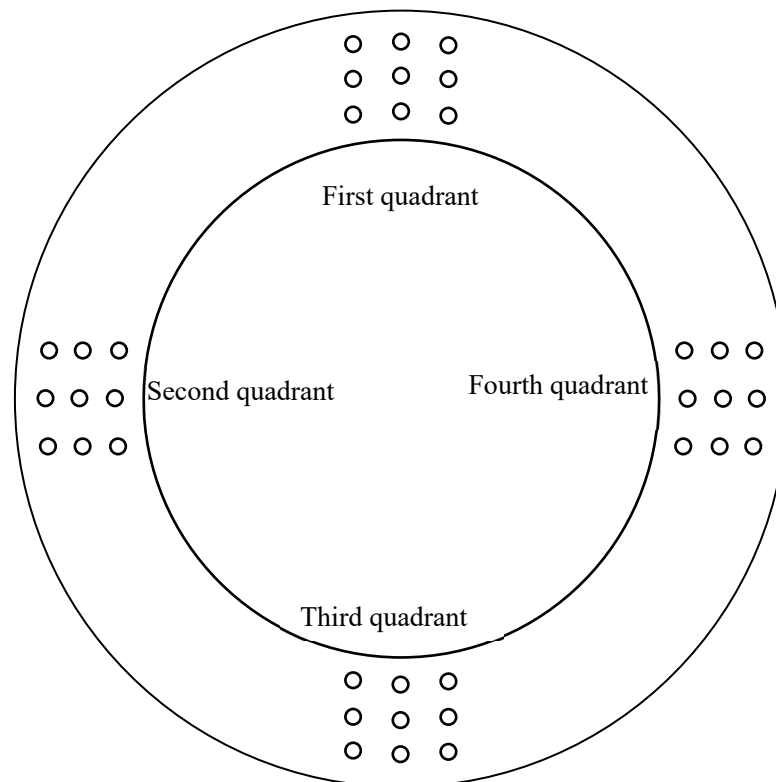
**Figure 4.** The schematic diagram of hardness test on the pipe.

The schematic diagram of the Rockwell hardness test on the pipe shown in Figure 4, and the results of the hardness test are shown in Table 4. The standard API 5CT has no requirement for the hardness of the P110 material of the #1 repaired oil pipe, and the hardness of the #2 repaired oil pipe meets the upper limit of 30HRC required by the standard for the material of C110.

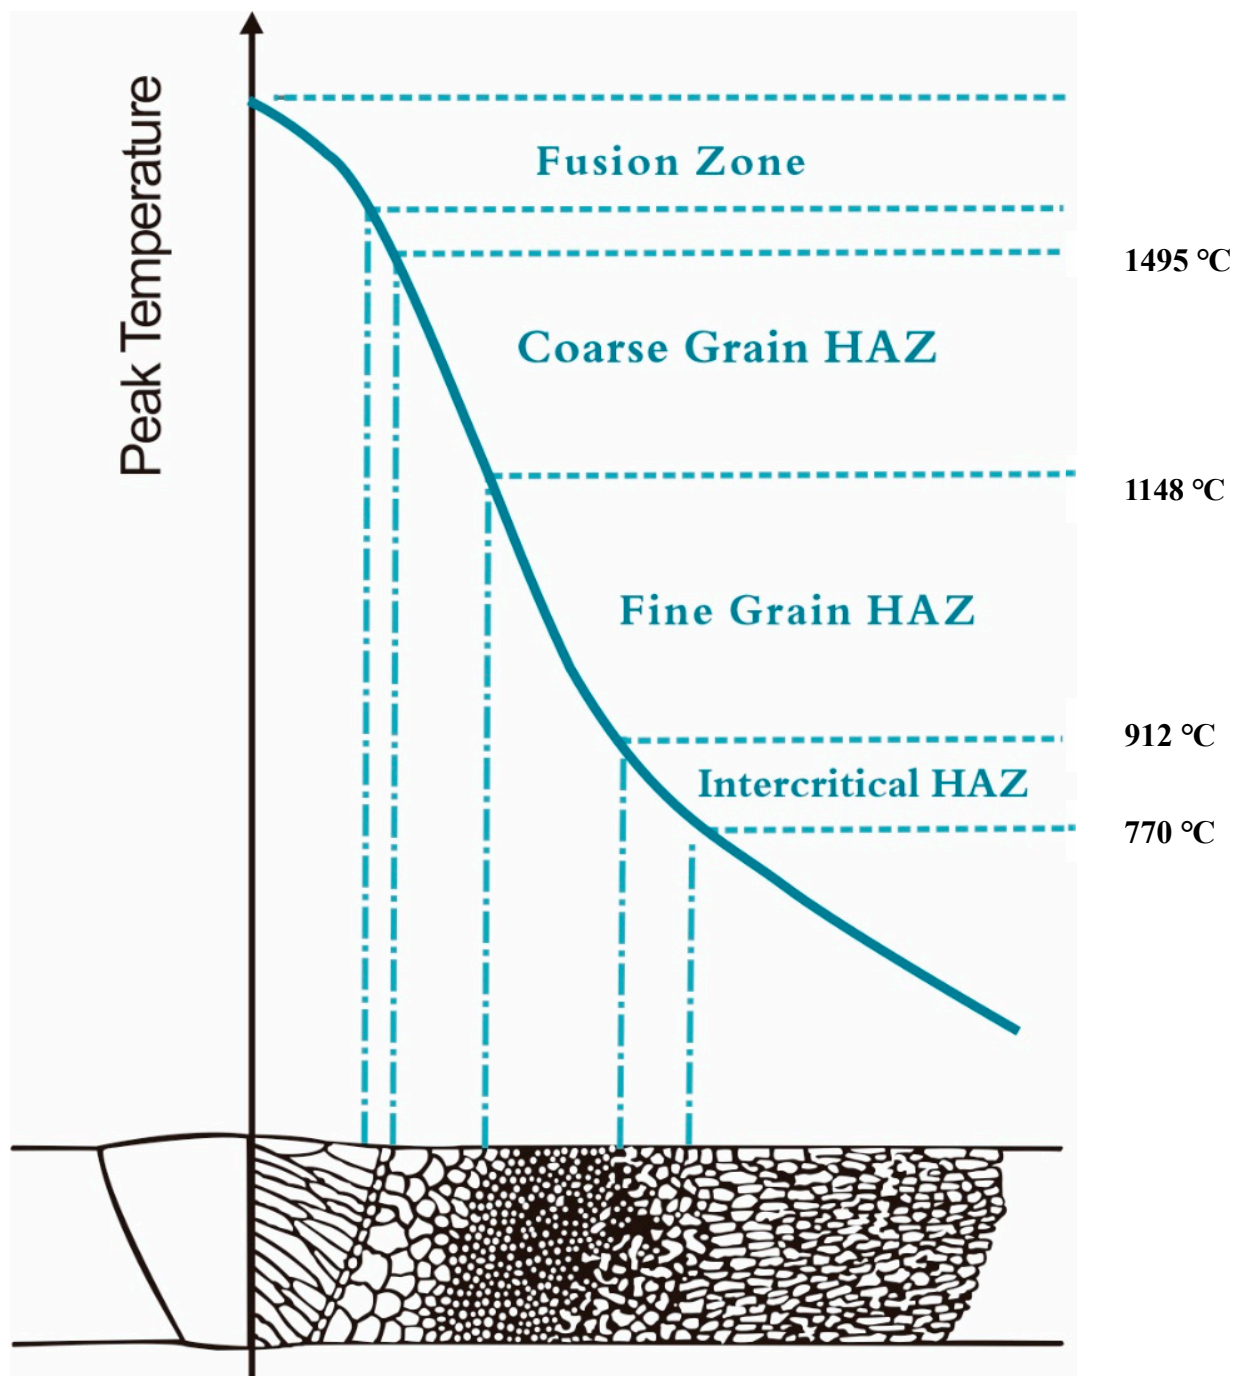
**Figure 11.** Peak temperature corresponding to different weld regions.

The welding thermal simulation involves controlling the peak temperature and cooling rate to replicate the welding thermal cycle process in different heat-affected zones. Based on the peak temperature profiles of different welding regions in carbon steel as shown in Figure 11 [20], we designed heating and subsequent air-cooling processes to simulate the thermal cycles in different welding locations. We selected five peak temperatures: 850 °C, 950 °C, 1050 °C, 1100 °C, and 1200 °C. The 1200 °C temperature represents the coarse-grain heat-affected zone, while 1100 °C, 1050 °C, and 950 °C represent the fine-grain heat-affected zone, and 850 °C represents the intercritical heat-affected zone.

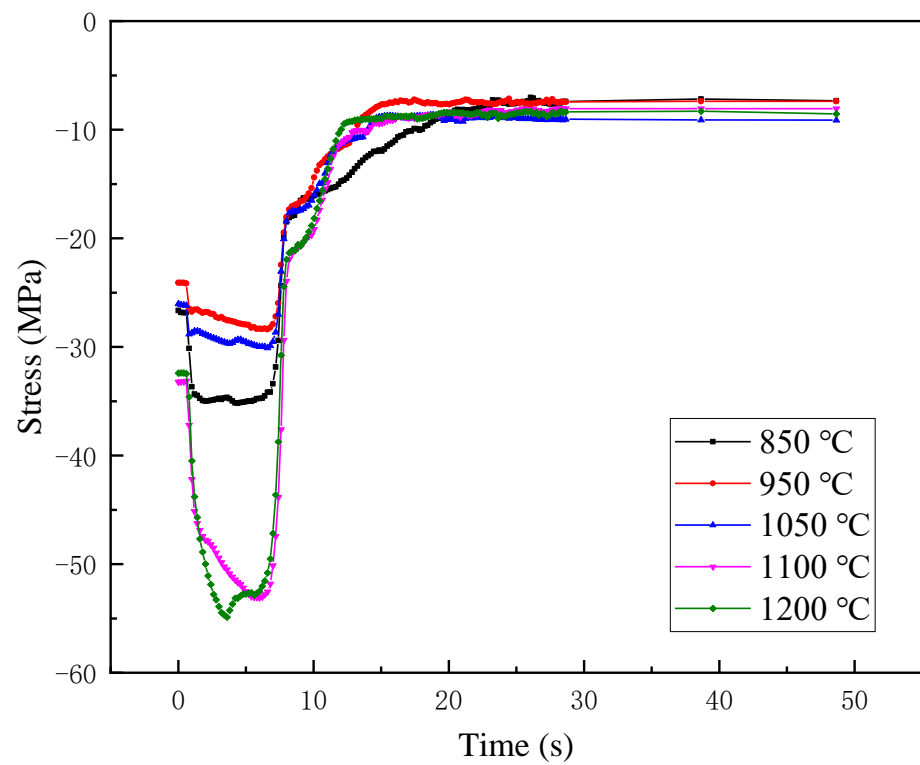
Figure 12. Load variation of base metal of #1 repaired tubing at different simulated peak temperatures.

The thermal simulation test was conducted on the #1 tubing to verify the microstructure of the weld. The two ends of the sample were clamped and were heated to 850 °C, 950 °C, 1050 °C, 1100 °C, and 1200 °C in 10 s intervals, respectively, and then air cooled. The load was recorded during the heating test, and the microstructure and hardness were inspected after the test. Figure 12 shows the load variation when heated to different simulated peak temperatures. The sample is first thermally expanded, and since the two ends are constrained, the sample is subjected to compressive stress, which continues to increase. When air-cooled, the sample shrinks; the sample is subjected to tensile stress; and the load rises in reverse. When heated to 1100 °C and 1200 °C, the maximum compressive stress reaches 55 MPa. After cooling, the maximum stress variation is about 45 MPa.
