# Post-Earthquake Damage Assessment—Case Study of the Educational Building after the Zagreb Earthquake

**Abstract:** In the wake of recent strong earthquakes in Croatia, there is a need for a detailed and more comprehensive post-earthquake damage assessment. Given that masonry structures are highly vulnerable to horizontal actions caused by earthquakes and a majority of the Croatian building stock is made of masonry, this field is particularly important for Croatia. In this paper, a complete assessment of an educational building in Zagreb Lower Town is reported. An extensive program of visual inspection and geometrical surveys has been planned and performed. Additionally, an in situ shear strength test is presented. After extensive fieldwork, collected data and results were input in *3Muri* software for structural modeling. Moreover, a non-linear static (pushover) analysis was performed to individuate the possible failure mechanisms and to compare real-life damage to software results.

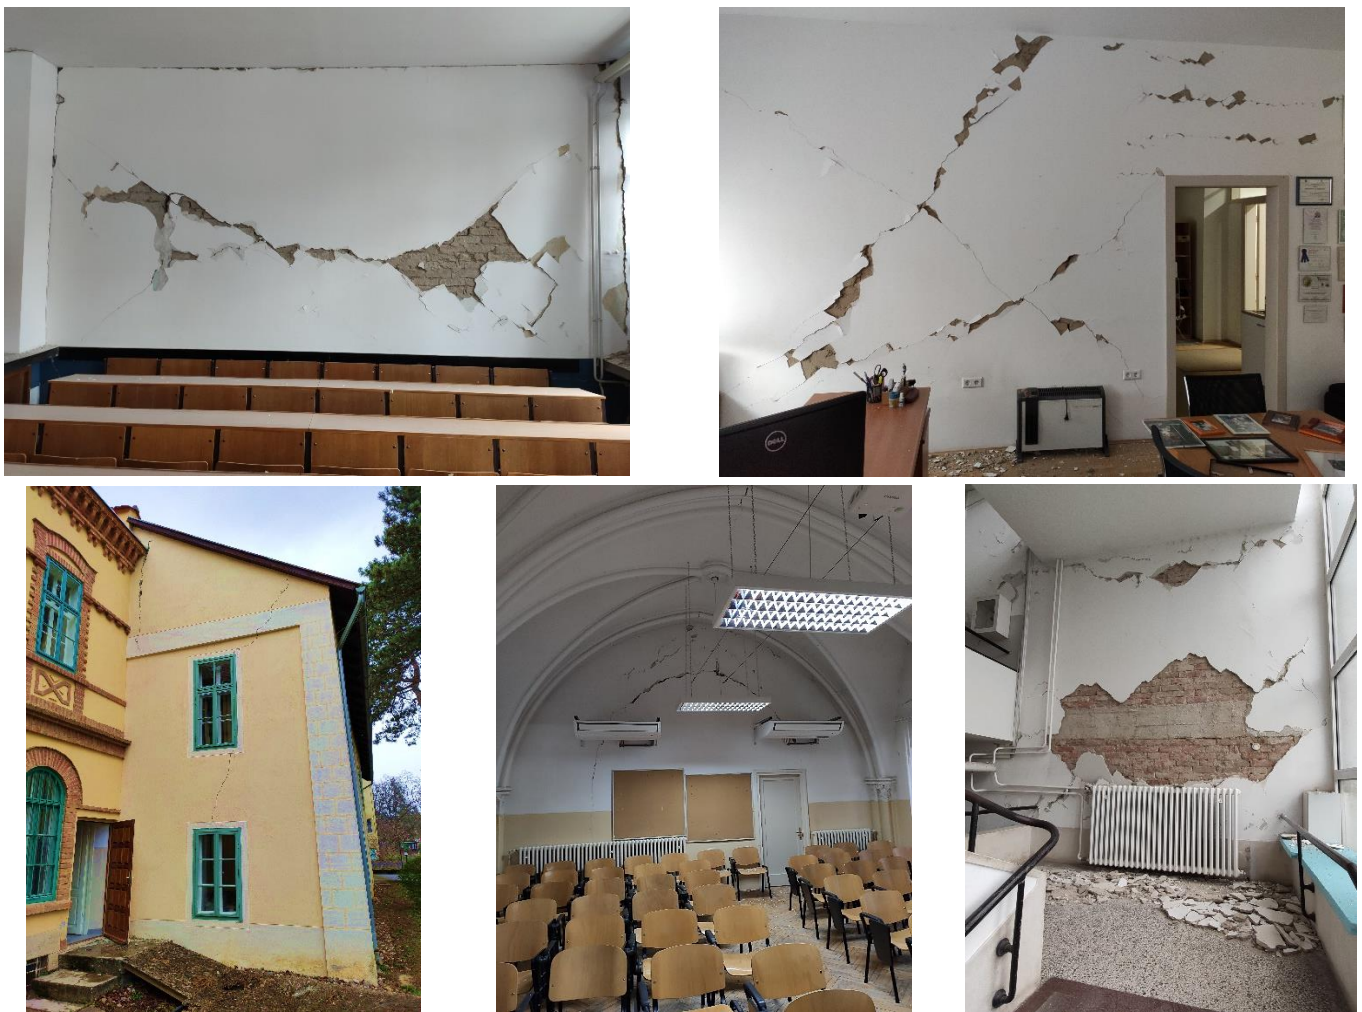
**Figure 1.** Typical damage to educational buildings after the Zagreb earthquake (photo credit: M. Stepinac).

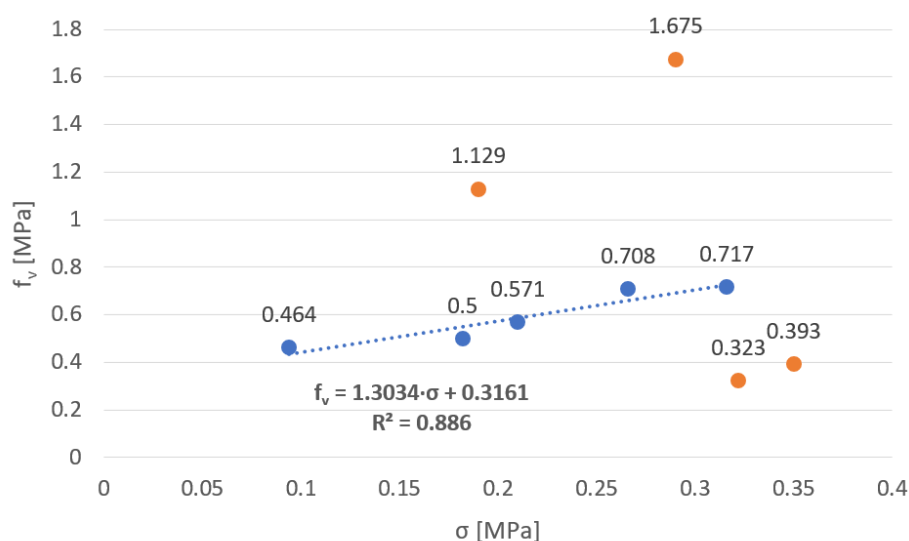
The masonry shear strength test results in the load-bearing walls of the ground floor, 1st floor and 2nd floor are shown in the following Table 1. The values from testing site positions PS-PR-5, PS-1-1, PS-1-2 and PS-2-3 were disregarded because of significant deviations from other results (Figure 20).

Figure 20. f<sub>v</sub>(shear strength)—σ<sub>0</sub> (vertical stress) diagram.

It can be seen from the diagram that the shear strength without vertical pressure is 0.316 MPa and that coefficient of friction is 1.303. Due to the high value in comparison to EC standard recommendation, the friction coefficient was taken as  $\mu = 0.40$  (according to [34]). The obtained shear strength of masonry without vertical pressure, i.e., cohesion, is higher than the one provided by the regulations for the case when there are no tests ( $f_{vm0} = 0.32 \text{ MPa} > 0.10 \text{ MPa}$ ). The results show that the quality of masonry is good in contrast to similar buildings from that period.

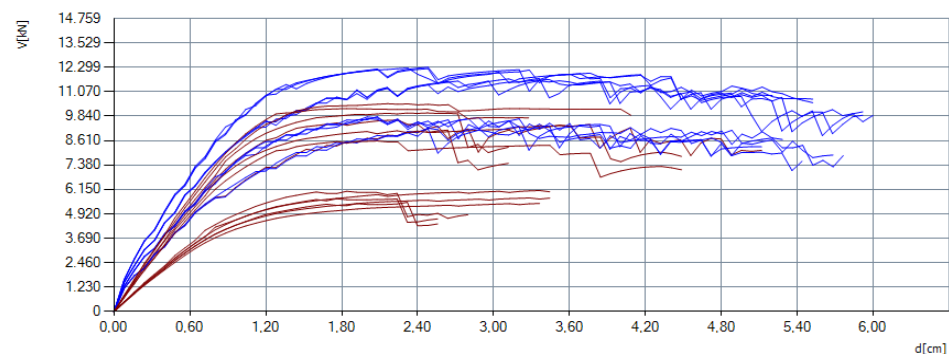
**Figure 24.** Pushover curves for the x- (blue) and y- (red) direction.

For the return period of 475 years, none of the 24 analyses satisfies the limit state of significant damage, while for the return period of 225 years, only 8 of the 24 analyses satisfies the same limit state. For a return period of 95 years, none of the 24 analyses satisfies the limit state of limited damage.

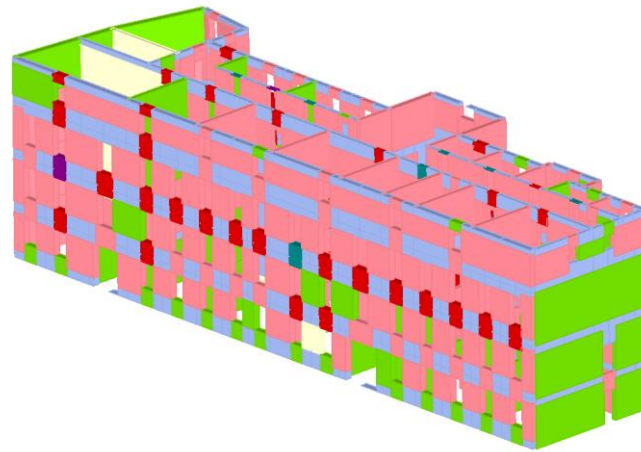
Figures 27 and 28 show the damaged state at the last step of the pushover curves for the x- and y-direction where yellow color represents shear damage, and the red color represents bending damage.

Figure 27. Damage at maximum displacement capacity for pushover in the x-direction.

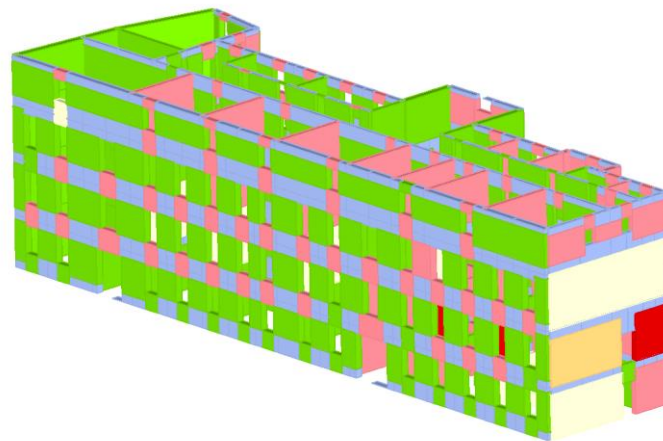
**Figure 28.** Damage at maximum displacement capacity for pushover in the y-direction.

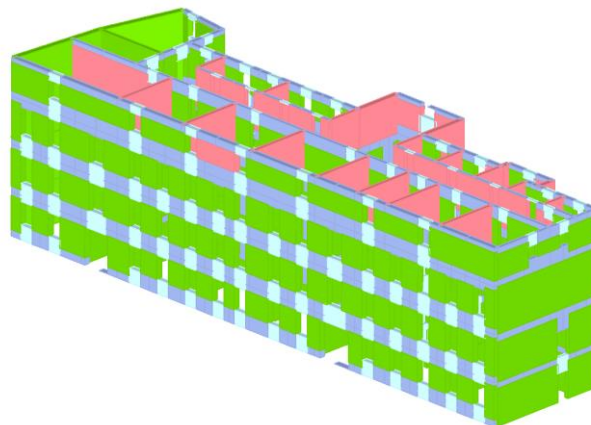
Since 3Muri does not consider the bending failure of walls out-of-plane during the global non-linear static analysis, it is necessary to subsequently perform an analysis of the bending of the walls out-of-plane. This takes into account the seismic action perpendicular to the walls. The analysis is performed for the boundary condition near collapse. A return period of 475 years is used. Walls are considered to have passed the out-of-plane bending check if their  $M_{Rd}/M_{Ed}$  ratio is greater than or equal to 1.0. In Figure 30, walls that did not satisfy the check are colored red.

**Figure 30.** Bending out-of-plane results.
