Multipurpose Retrofitting of a Tower Building in Brescia

Abstract: The paper aims to report a proper low-impact integrated study approach for the energy and seismic retrofitting of a tower building located in the city centre of Brescia (Italy). The building consists of a group of aggregate buildings built in the 1950s, from which emerged an 11-storey tower. It was built with the technology of the time by means of a perimeter and spine framed structure in reinforced concrete, double perimeter infill with a hollow brick air chamber, external cladding on the main fronts with small Botticino marble tiles. The building is registered by the Ministry of Cultural Heritage for its facade and is located in a seismic zone of category two. When work began, the construction was in a class three; thus, the whole project was updated to obtain the new seismic authorisation. The coating showed progressive decay, with dangerous structural instability of the heavy coating. The design team decided to adopt wider corrective action compared to the observed phenomenon, integrating it with a local seismic and global energy improvement through the insertion of a ventilated wall in the building and the rea

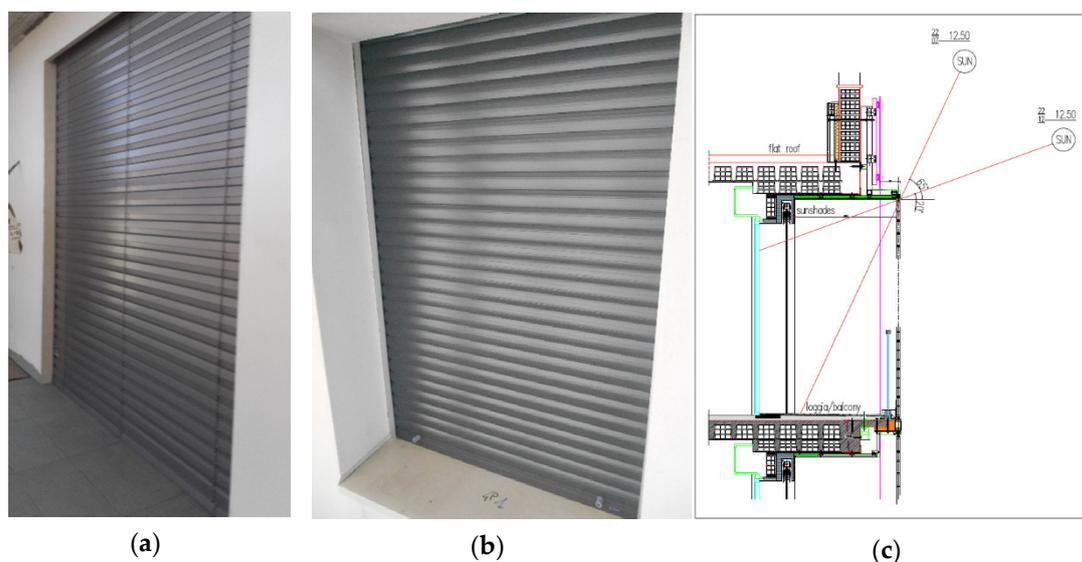
Figure 10. (a) External Venetian blind shading system, (b) roller shutter and (c) solar study scheme to test the effectiveness of loggias in shielding solar radiation in summer (typical summer day: 22 July) and allowing it to penetrate in winter (typical winter day: 22 December).

In addition, in order to limit the energy requirements for summer air conditioning and to contain the internal temperature of the rooms, external screening and shading systems have been installed (sunshades and high-density insulated aluminium roller shutters), which reduce the contribution of heat by radiation through the transparent structures, which currently have a solar factor g of around 0.55–0.60 (Figure 10).

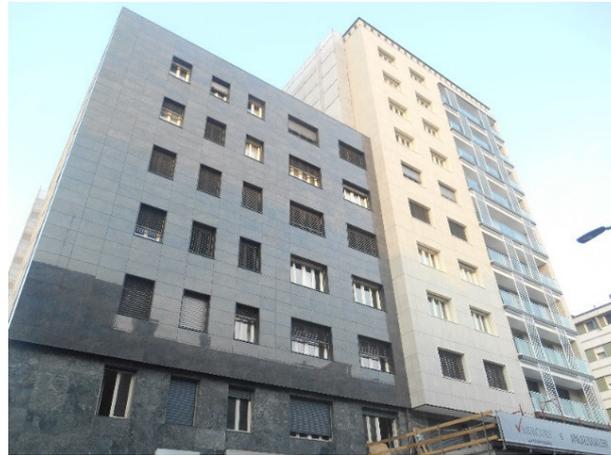
Figure 12. South-facing Block 1: on the left, the insulation and on the right, the ventilated façade are shown.

energy diagnosis process followed has highlighted the feasibility and usefulness of the requirements contained in the GBC Condominiums protocol in terms of energy analysis, which together with the protocol's requirements in terms of structural analysis, allow all those involved in the redevelopment to make informed choices in terms of costs and benefits (Figure 12).

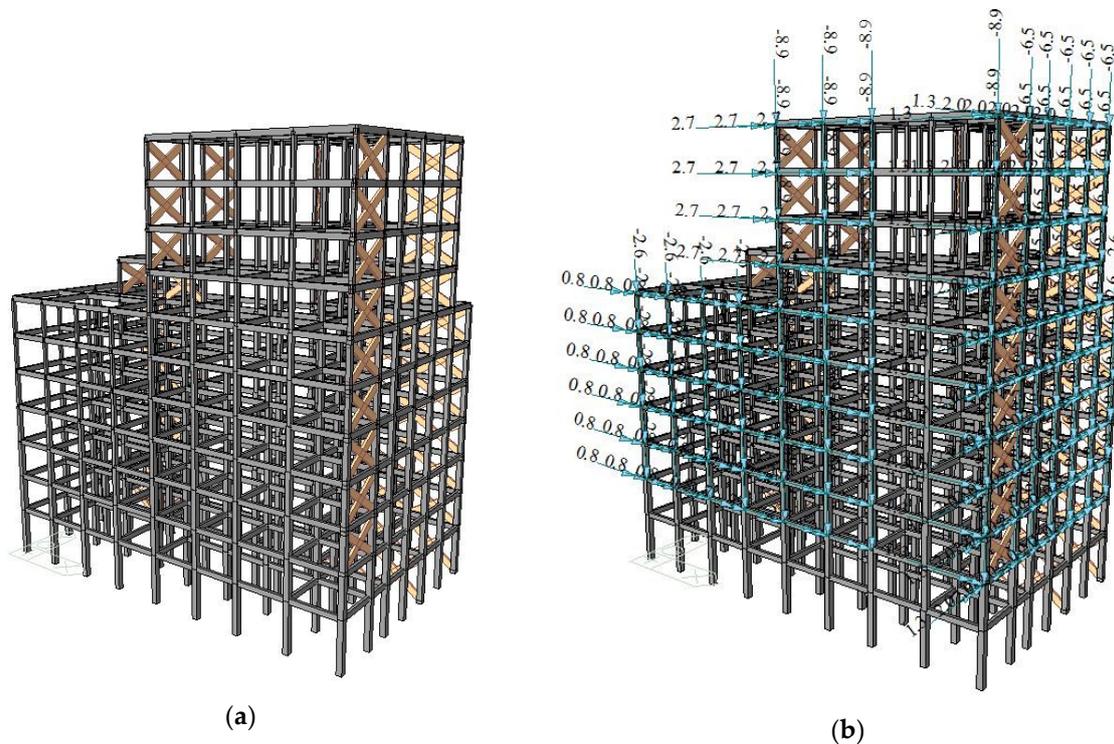
Figure 15. (a) Building model in the state before intervention and (b) building model project status with the nodal loads related to the weight of the new façade equal to 100 kg/m².

The design state calculation model was achieved by implementing the additional facade load on the existing state model by simulating the load of the hanging ventilated facade (Figure 15b). The position of the new ventilated façade is at an angle, so possible distorting effects were sought, which were limited by the new inserted steel structure that

tends to redistribute the eccentric load in a linear manner without distorting effects on the system.

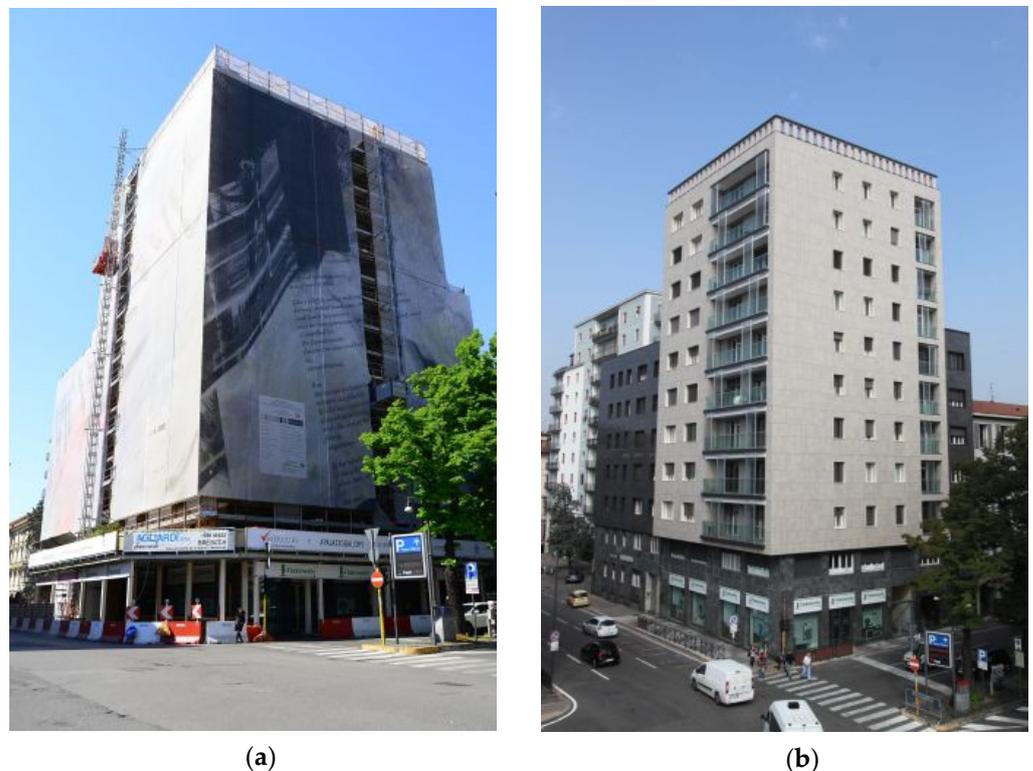
Figure 18. Tower building case study: (a) during the intervention, covered with an artistic sheet and (b) after the intervention.

Finally, the visual impact on the outside was also mitigated with greenery and a protective sheet with artistic decoration (Figure 18). These aspects of sustainable building yard management, implemented for this case study, confirmed that what is required by the GBC Condominiums “Sustainable Construction Site” prerequisite, in the relevant “Connection and Territory” section of the protocol, is applicable and results in a real mitigation of the impact of the construction site on the occupants and the surrounding area.
