Analysis of Water and Mud Inrush in Tunnel Fault Fracture Zone—A Case Study of Yonglian Tunnel

In this paper, water and mud inrush in the F2 fault of Yonglian Tunnel in the Jiangxi Province of China is taken as a typical case project. The process of water and mud inrush in the left and right tunnels during the tunnel's construction is introduced in detail, from aspects of time, scale and the consequences of inrush. Based on this, generation conditions and the evolution mechanism of water and mud inrush in tunnel faults are revealed.

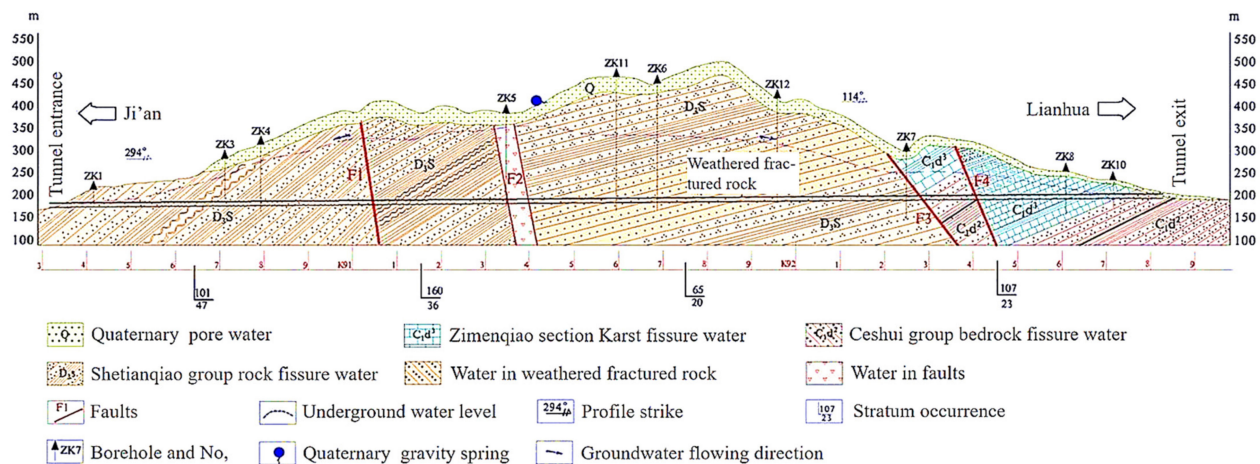
Figure 2. Hydrogeological profile of Yonglian Tunnel.

Under the influence of the regional geological structure, many smaller faults have developed in the tunnel area. According to the results of geophysical exploration and drilling, faults F1, F2, F3, F4 and F5 have developed near the tunnel (see Figure 2). During the excavation of Yonglian tunnel, water and mud inrush disasters all occurred in area of the F2 fault. The F2 fault passes through Yonglian tunnel at K91 + 350 which intersects with

the 45° tunnel axis, with a strike of SSE, dip of E, dip angle of 84°, fault width of 15 m~35 m, and an extension length of 520 m. Rock mass fissures in the F2 fault zone are developed, or well-developed, with rock mass broken or extremely broken; the core recovery rate is 55~65%, RQD < 10. The uniaxial compressive strength of the rock is 400 kPa.

The main types of groundwater in the tunnel area are the Quaternary pore water, bedrock fissure water and Karst water. The hydrogeological profile of the tunnel is shown in Figure 2.

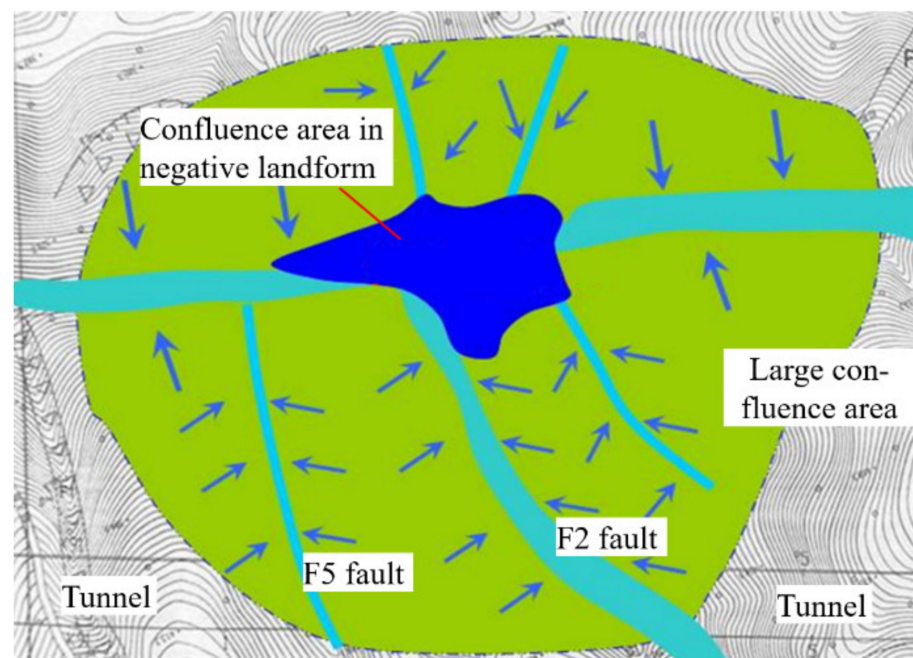
Figure 11. Confluence area of F2 and F5 fault zone.

Several structural valleys converge into a certain range of a confluence area of negative landforms (as shown in Figure 11). Multiple confluence valleys, along which the water flows, are connected with a confluence area, forming another larger confluence area. The F2 fault and the F5 fault are connected with the confluence area and cut across the tunnel. Especially, rock mass in the F2 fault zone is extremely broken, rich in water and high in water conductivity. A water injection test was carried out on the SK2 borehole exposing the F2 fault, which found that the water level was only raised by about 1.2 m after injecting water into the borehole with a flow rate of 4 m³/h for 2 h. The water level recovered only 3 min after the water injection was stopped. The water injection test indicated that the F2 fault had good water conductivity. In addition, a rhodamine tracer test was carried out on the SK2 borehole, and the tracer was detected at entrance of the tunnel for 7 days, which directly indicated that the F2 fault was a water diversion fault and that groundwater migration was relatively smooth.

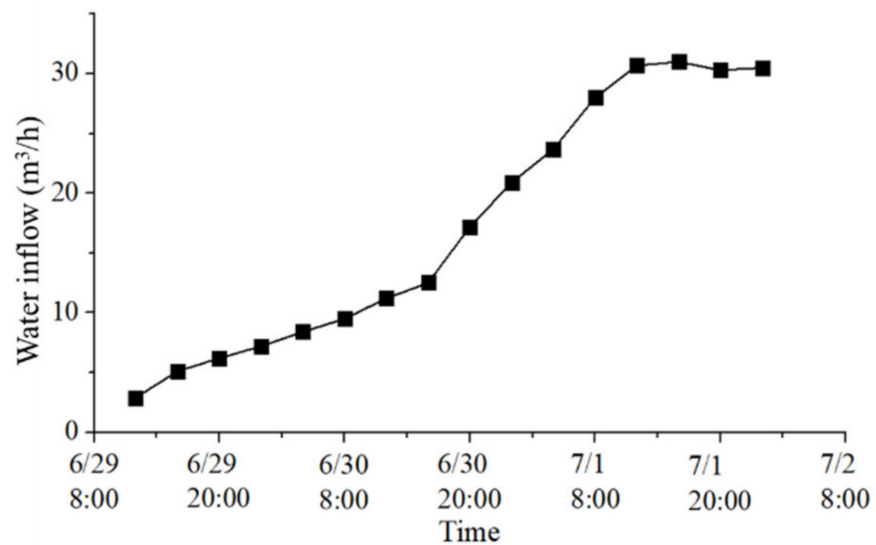
Figure 13. Curve of water inflow during the generation stage.

Based on the water and mud inrush in the left tunnel of the entrance to Yonglian Tunnel, the changes of water inflow in the left tunnel (as shown in Figures 12 and 13) during tunnel excavation in this stage were as follows:

At 10:00 a.m. on 30 June, an excavation operation reached the mileage of ZK91 + 314, and a grid steel frame was changed to ZK91 + 313 mileage. The seeping water gathered into the channel on the back of the initial supports and gushed out at ZK91 + 313 mileage;

At 10:00 p.m. on 30 June, the excavation operation reached ZK91+315 mileage, and the grid steel frame was changed to ZK91+314 mileage. The construction team concentrated the gushing water at the ZK91 + 313 arch shoulder (as shown in Figure 12a); at this time water flow rate increased to $20.5 \text{ m}^3/\text{h}$. During the process of water gushing, there was gravel constantly being flushed out with water, and the diameter of the water passage outlet hole continuously expanded.

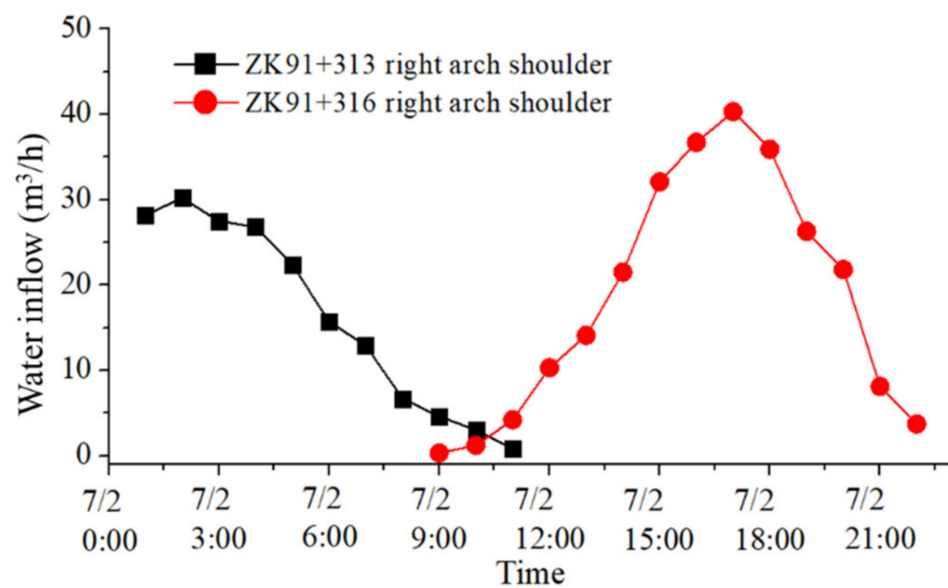
Figure 14. Curve of water inflow during the development stage.

At 3:00 a.m. on 2 July 2012, water flow at the diversion point of the ZK91 + 313 arch shoulder began to decrease gradually, and there was almost no water at the outlet point at about 10:00 a.m. Simultaneously, the gushing point gradually shifted to the tunnel face. At 8:00 a.m. on 2 July, when the grid steel frame was replaced at the ZK91 + 316 mileage (at the tunnel face), groundwater transferred to the right arch shoulder at the tunnel face. Water flow gradually increased and a large amount of yellow mud and stones were brought out by the gushing water. At 4:00 p.m., the water output flow rate increased to $40 \text{ m}^3/\text{h}$. Subsequently, water flow began to decrease again and, at about 10:00 p.m., the water output flow rate was almost reduced to 0. The variation curve of water flow from the outlet point of the tunnel during this stage is shown in Figure 14.
