Watch Out for the Tailings Pond, a Sharp Edge Hanging over Our Heads: Lessons Learned and Perceptions from the Brumadinho Tailings Dam Failure Disaster

Deqiang Cheng ¹, Yifei Cui ^{2,*}, Zhenhong Li ^{3,4,5} and Javed Iqbal ^{6,7,8}

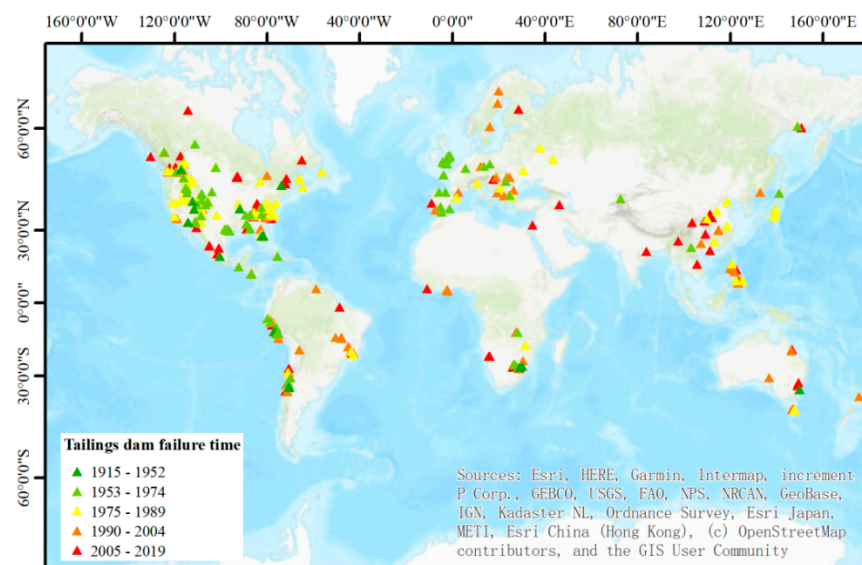
There are about 3500 active tailings ponds in the world, among which 2000 experience about two to five known “major” failures, and 35 “minor” failures annually [30]. During the period from 2007 to 2017, there were at least 10 very serious mine tailings dam failures involving multiple loss of life, with approximately 20 lives per incident, a release of at least 1 million cubic meters of waste each time, and a travel of 20 km or longer every waste movement [31]. Based on the world mine tailings failure data with more than 300 records during the period from 1915 to 2019 [14], a global spatial geographic database of tailings dam failure was made using ArcGIS. Using the “Natural Break” classification method, the tailings dam failure records could be divided into five categories (Figure 4).

**Figure 4.** Tailings dam failures (1915–2019) with their occurrence times.

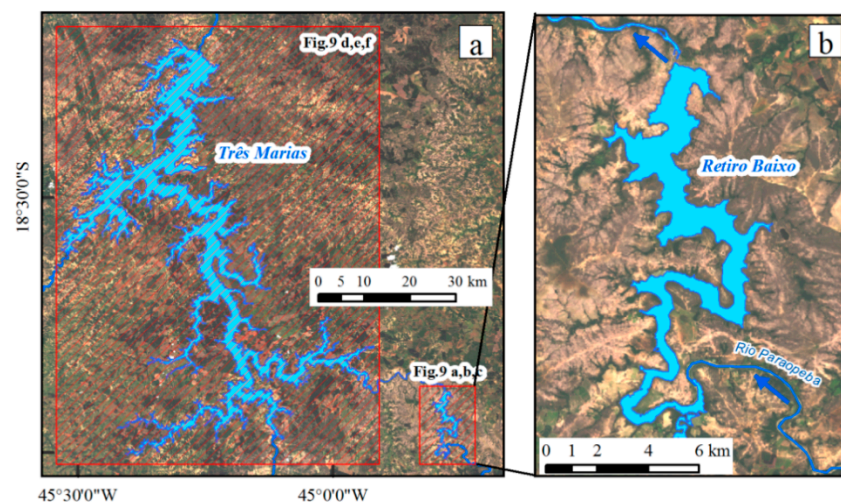
Using the Atmospheric Correction Module, it can be accurately compensated for atmospheric effects. In this study, the atmospheric correction using the FLAASH model [34,35,68] was performed and Landsat 8 images were fused using the Gram—Schmidt Pan Sharpening method [69–72]. After calculating the NDWI using the images after atmospheric correction and image fusion, zero was used as the segmentation threshold to extract the water body, and the manual editing was used to complete the extracted water body boundaries in the ArcGIS software. Figure 9 shows the boundaries of two reservoirs, Retiro Baixo and Três Marias.

Figure 9. (a) Retiro Baixo and Três Marias reservoirs. The larger reservoir on the left is Três Marias, and the smaller one in the lower right corner is Retiro Baixo (b).

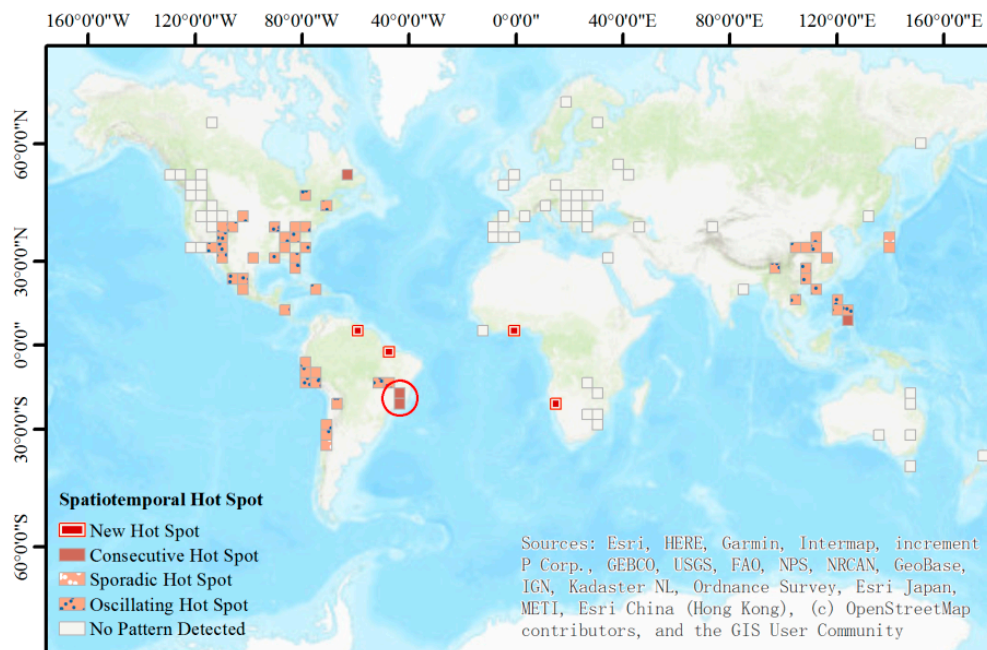
Using the emerging spatiotemporal hot spot analysis method, it can be found that the Brumadinho dam disaster in Brazil belongs to the Consecutive Hot Spot area (Figure 11). This disaster happened 3 years and 2 months after the Mariana dam disaster (5 November 2015), which was considered the worst environmental disaster in Brazil [74,75]. The Brumadinho and Mariana dam disasters both occurred in Minas Gerais, Brazil, and the two dams were both owned by Vale, a Brazilian multinational corporation engaged in metals and mining. Furthermore, based on the world mine tailings failure records [14], tailings dam failures have been recorded several times in this area. As a result, this area belongs to the Consecutive Hot Spot area, and the risk of tailings dam failure in this area would be relatively high if the necessary pond's management and the engineering safety measures were not carried out.

Figure 11. Spatiotemporal hot spot analysis of tailings dam failures. The location of Brumadinho dam disaster is marked with red circles.

According to Figure 11, New Hot Spots appear in Africa and South America which belong to developing regions, where the mining industry has been an important economic pillar in recent years [76,77]. Consecutive Hot Spots mainly lie in Eastern South America and Western Pacific islands where there are a lot of tailings left by mining, but due to poor management, tailings failure is easy to occur. The Sporadic Hot Spot is in Southwest South America and Oscillating Hot Spots mainly lie in Asia and America. China has many Oscillating Hot Spots and there have been some particularly serious tailings failure disasters, such as the 8 September 2008 dam break accident in Shanxi [78]. Different hot spots have different characteristics of disaster occurrences. These characteristics can be influenced by the mining history, mining features (e.g., man-made or natural), etc. [79–81]. The recommendation is that different hot spots should be treated differently. The areas of New Hot Spots and Consecutive Hot Spots are the ones that deserve the most attention. Local governments should adopt appropriate risk management strategies to monitor and change the trend. The risk assessment and monitoring of tailings reservoirs should be adopted and implemented. In this regard, some risk assessment and monitoring methods of mountain disasters can be used as references [82–85].
