# A Comprehensive Investigation on Abnormal Impoundment of Reservoirs—A Case Study of Qionglin Reservoir in Kinmen Island

**Abstract:** Leakage is the most serious problem in reservoir operation, because heavy leakage influences reservoir impoundment efficiency and even leads to a complete loss of reservoir functions. Since its completion in 1982, Qionglin Reservoir has never been fully filled with water except in the spring of 1983 when there was heavy rain. The reservoir management unit suspected that its side slopes, bottom or dam might leak and carried out a number of leakage prevention and improvement works, but all of them failed to fulfill the impoundment function of the reservoir. Hence, this study attempts to find out the reasons why the reservoir cannot impound water. A series of tests and investigations are carried out in this study, including electrical resistivity tomography of dam, tracer test, geological drilling test, reservoir water level observation, investigation of reservoir catchment area and field investigation of dam. The test results and investigation results show that no leakage path and leakage are found. According to the analysis, there is no serious lea

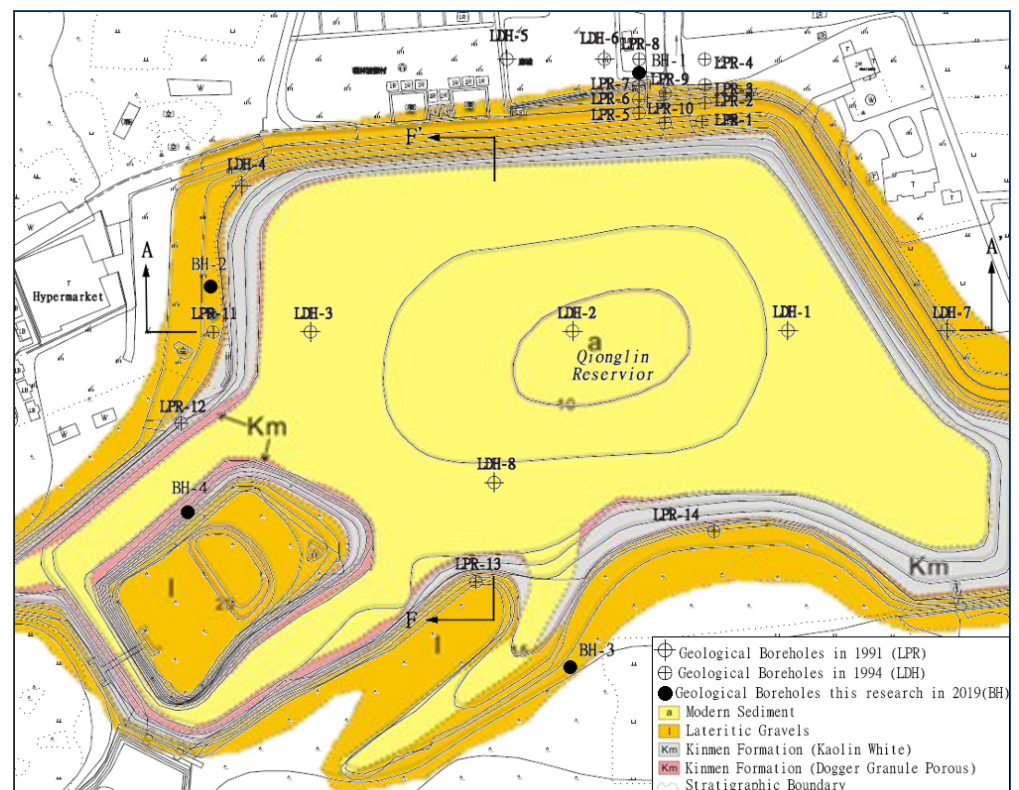
**Figure 2.** Geological map of Qionglin Reservoir/Drilling locations of Qionglin Reservoir over the years.

In order to investigate the causes of reservoir leakage, the reservoir management unit in the dam, bottom and surrounding area of the reservoir, drilled 14 holes in 1992 and 8 holes in 1995. The drilling locations over the years are shown in Figure 2. Figure 3 is the geologic cross-section of the dam site drawn after drilling data collection. As shown in Figure 3, the geology of the dam site is mainly red sandy clay (CL), grayish-yellow clayey coarse sand (SC), red and grayish-yellow argillaceous coarse sand (SM) and yellow argillaceous coarse sand (SM SC). According to the investigation results, the SM materials at the bottom, soil slope and in the front of the dam to the northwest of the inundated area were permeable, and the inundated area could easily leak water. Field tests were carried out to understand the soil density of the dam and the bottom of the reservoir, and the results showed that the Relative Compaction (RC) of the dam was about 93% and the Relative Compaction (RC) of the bottom of reservoir was about 89–92%, indicating that the density of the soil layer at the bottom of reservoir was quite consistent. In order to obtain the permeability of the shallow soil in the whole region, the reservoir management unit conducted a 17 hole field permeability test at the bottom of the reservoir, and the results showed that the permeability coefficient of the reservoir area was between  $10^{-5}$  cm/s and

8 holes in 1995. During the execution of this study, Qionglin Reservoir was kept at a low water level, making it impossible to carry out geological drilling at the bottom and surface excavation. Hence, in this study, a total of 4 places at the lower reaches of the dam, the northwest around the reservoir and the upper reaches were selected for drilling, and the data of the 4 holes were analyzed and compared with the drilling data in literature. The detailed locations are shown in Figure 2.

The field drilling was adopted for the base investigation, and a total of 4 holes numbered BH-1 to BH-4 were drilled, with a total drilling depth of 60 m, as shown in Figure 2 drilling locations of Qionglin Reservoir over the years. The field standard penetration test was carried out to all holes to calculate the blow counts (SPT-N value) penetrating into the strata, and the field permeability test was conducted. Split spoons and thin wall tubes were provided for laboratory test.

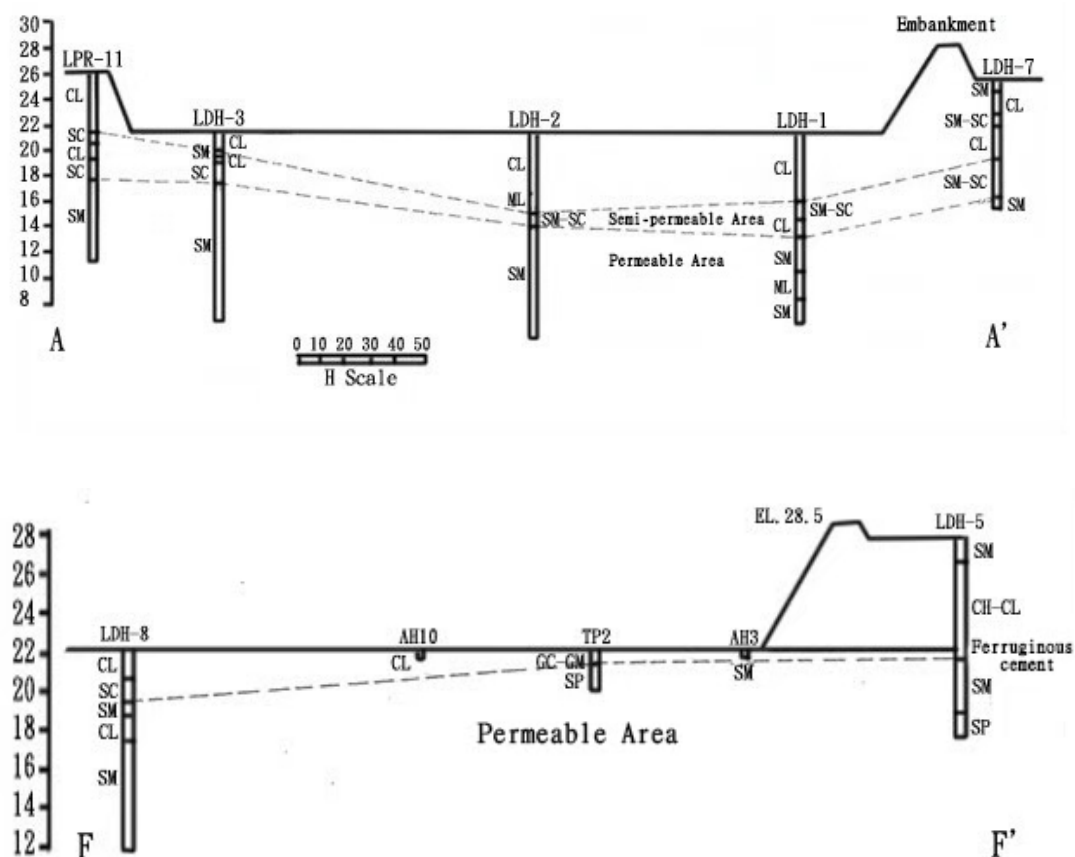
Figure 3. A-A' and F-F' geologic cross-section of the dam of Qionglin Reservoir.

The submerged area of the Qionglin Reservoir dam is placed on the soil foundation (multi-layer, CL). The drilling data in Section 4.3 and Figure 3 show that there is still a thin layer in front of the dam, which may cause leakage. Therefore, this article discusses the leakage analysis of the dam and the leakage analysis of the head difference (hydraulic gradient) caused by the groundwater level:

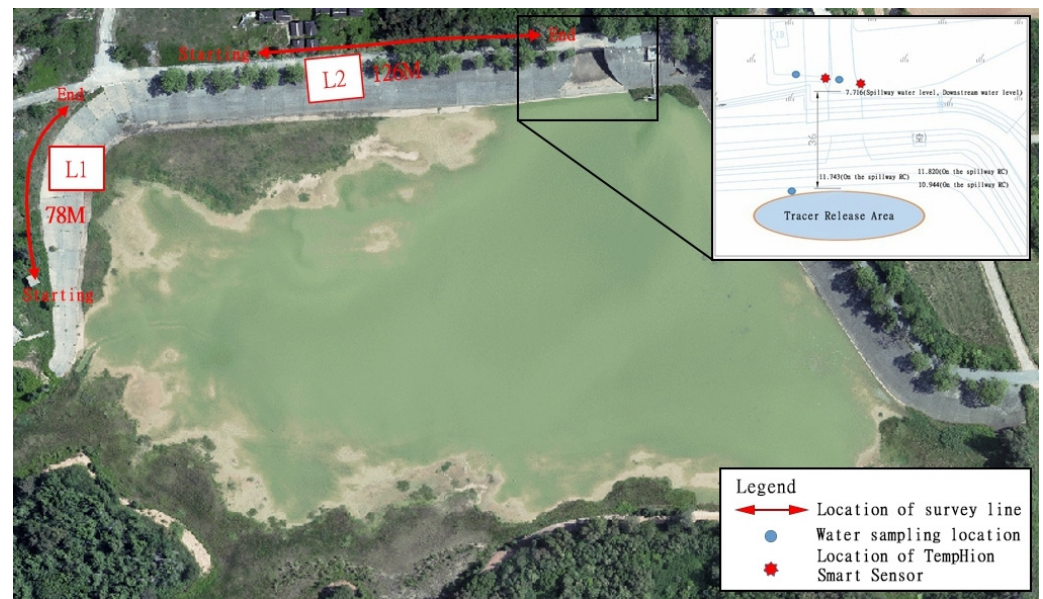
**Figure 4.** Diagram of electrical resistivity tomography survey line layout. /Tracer application area, sampling points and TempHion smart sensor setting points.

In this study, 2 testing lines were laid out around Qionglin Reservoir, as shown in Figure 4. Of the 2 testing lines, L1 was on the west side of the dam, with a length of 78 m and the electrode spacing of 3 m, and L2 was on the north side of the dam, with a length of 126 m and the electrode spacing of 3 m. The Wenner–Shlumberger array was adopted in field measurement for data collection.

In this study, sodium bromide was mainly used as the tracer, and placed near the spillway above the stilling basin of the reservoir in the form of a solution. Then, the sensor was placed on the left bank (the stilling basin outside the reservoir) and the right bank (inside the reservoir area) of the stilling basin to detect the changes of sodium bromide ion concentration. In addition, water samples were respectively collected in the reservoir and stilling basin for the ion chromatography (IC) to analyze the common ions, so as to confirm the test results again. Figure 4 shows the tracer application area and sampling points and the points of sensors.
