Characterization of In Vivo Damage on Retrieved Total Shoulder Glenoid Liners

Abstract: An attempt was made to retrieve glenoid liners from revision surgery to undertake a retrospective study to measure the resulting in vivo damage. Since the glenoid liners are circumferential, the curvature changes at every point in the component, an “assisting arm” was designed to hold the liner firmly, thus allowing accurate microscopic measurements. We characterized the damage in terms of pitting, embedded debris, complete fracture, abrasion, deformation, delamination, burnishing, grooving, and scratching that took place mutually exclusively. This study of 26 liners showed embedded debris was the most underrated damage mode found on the liners, followed by pitting and abrasion, representing 65.2% and 52.2% of the liners, respectively. The prevalence of pitting in over half the samples examined is indicative of free-radical oxidation, resulting in a decrease in physical strength from morphological changes in the microstructure. These may initiate from different pathways, however, they may interact with other processes in which other damage initiates and grows, resulting in higher damage causing

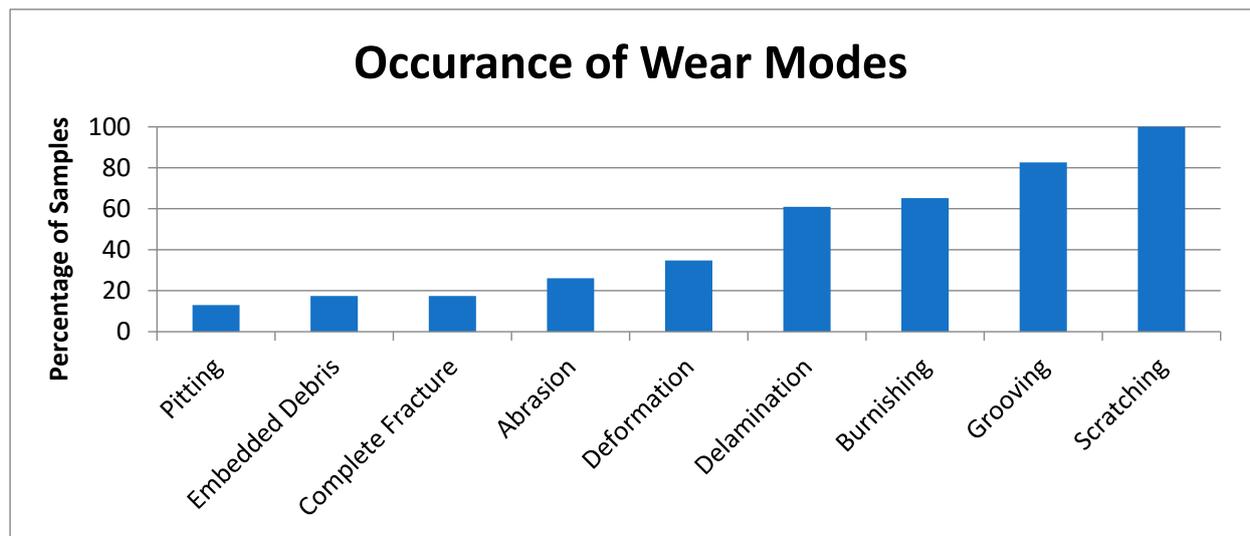
Deformation is defined as exaggerated wear changing the shape of the overall material. Although deformation can occur from a high-stress event, constant wear can cause material deformity and lead to absolute failure of a liner. Deformation was present in 8 liners or 34.7% of cases examined. Figure 1f shows deformation from excessive wear.

Grooving is a more aggressive form of scratching that occurs when a floating or fixed foreign particle is dragged across or caught in the articulating surface. The motion of the shoulder joint can accelerate the wear leading to deep grooves throughout the articular surface. With the addition of fatigue/sliding loading over time, these grooves have the potential to propagate into a fatigue crack over time. There were 20 liners that exhibited grooving, representing 86.9% of the samples examined.

Mutually exclusive percent wear mode occurrences in the liners are presented in Figure 2.

Figure 2. Percentage Occurrence of Particular Wear Modes for Each of the Liners Examined.

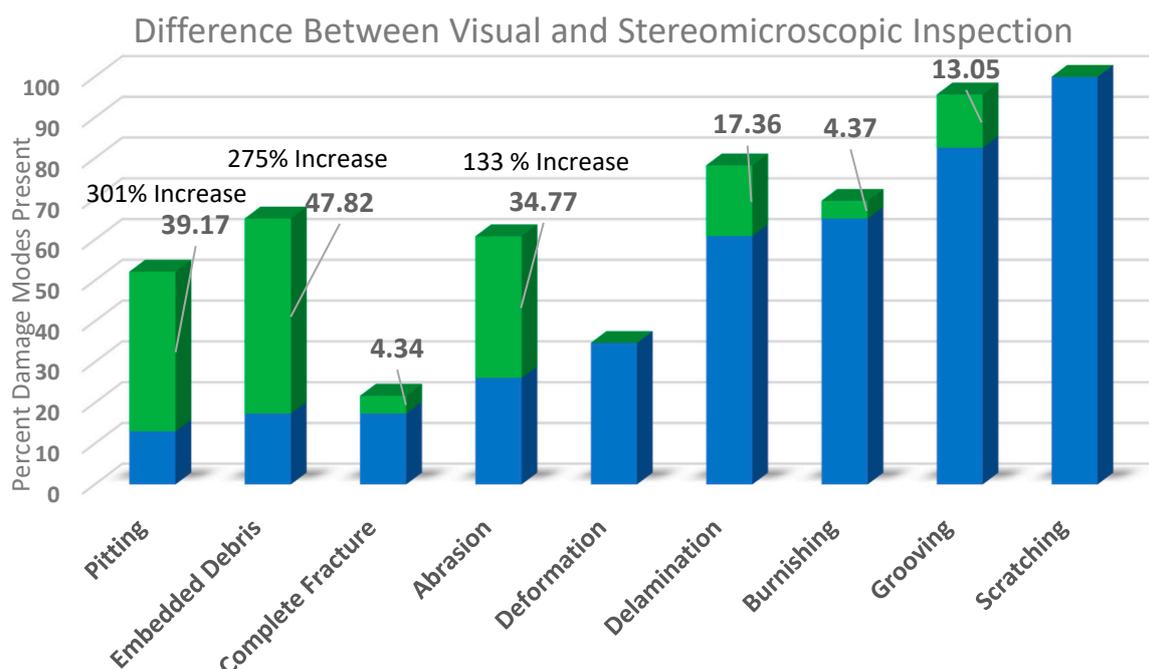
Nearly all wear modes were underrated during visual examination, and it was clear that microdamage was present throughout the articular surface that was not otherwise apparent in visual exam. Pitting was the most underrated form of damage physically occurring in 52.2% of the liners, followed by embedded debris occurring in 65.2% of the liners. The prevalence of pitting in over half the samples examined is indicative of free-radical oxidation, resulting in a decrease in physical strength from morphological changes in the microstructure. Similar results were obtained [7], where 75 liners were examined and it was found that a majority of the liners had pitting present with an average damage score of 7.4, using evaluation methods defined by Hood et al. [1,2,5,10]. The corrected increase in embedded debris gives an origin to the amount of grooving and scratching present. Particles enter between the articulating surfaces of the joint and are dragged between the ball and liner in randomized motion as the joint is subjected to tension and compression. These particles can range from bone cement, liberated PMMA fragments, or metal fragments from the ball [11].

In this research, we were able to compare the visually observed damage features with those of stereomicroscopy. Figure 6 shows the corrected change in the tabulated wear data from the visual examination to stereomicroscopy. The percentage increase between examination methods is shown, as well as the physical percentage of liners where the damage was previously overlooked in Figure 6.

Figure 6. Results from Microscopic Inspection.

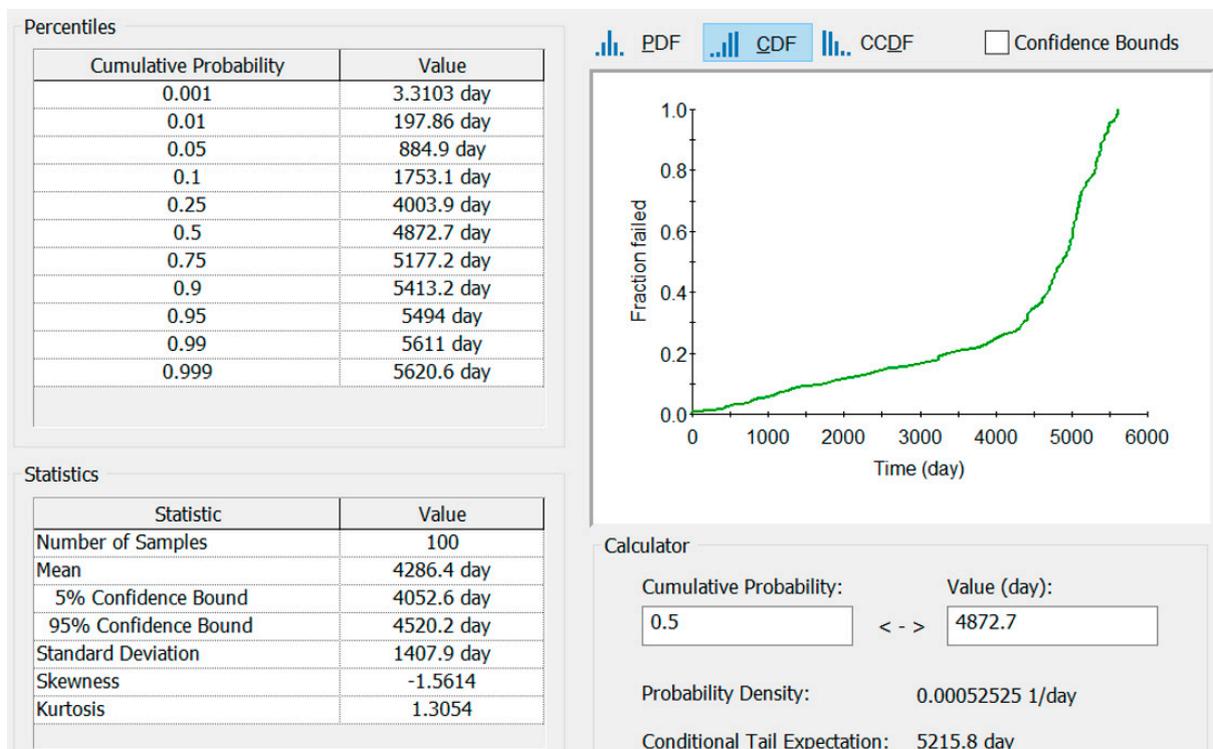
Figure 10. Graph Representing Fraction of Failed Liners Versus Time as a Cumulative Distribution and Mean Liner Life.

From these results, it was inferred that the mean time to failure increased linearly as scratching and grooving occurred within the liner. After the scratching and grooving were complimented with third-body particles, the rate of failure increased exponentially as additional wear modes manifested. This tended to mirror the trends of the 23 liners damaged in this study despite there being no in-situ duration information available. Since we did not know the time at which the revision occurred, Kaplan–Maier survivability for the glenoid liner was not possible. However, such data may be recorded to plot the behavior.

A probabilistic analysis was found to predict the time to replace liners using Monte Carlo simulations. The Monte Carlo simulations predicted the mean time to implant failure was roughly 12 years based on damage mode factors alone and could provide a useful tool to schedule the revision surgery.

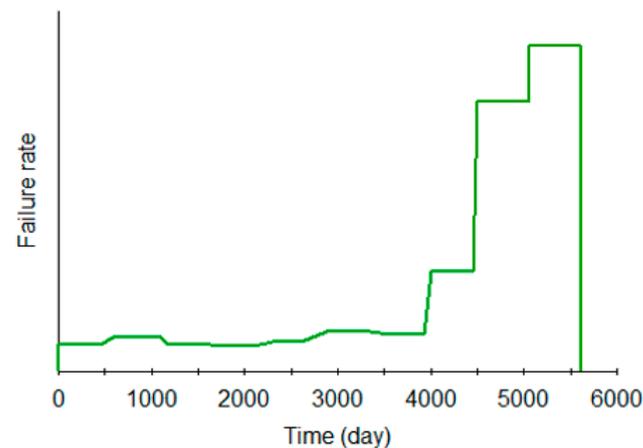
**Figure 11.** The Rate of Failure Shown as a Probability Density Function.

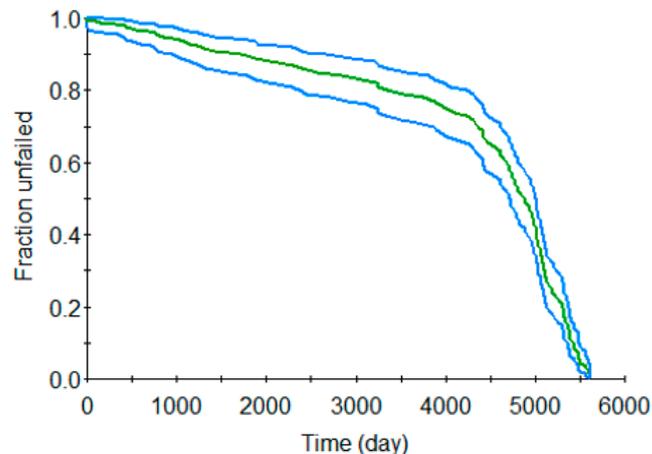
**Figure 12.** The survival function of Liners as a Complimentary Cumulative Probability Distribution Constrained by a 95% Confidence Interval showing mean, upper and lower bound trends.
