Investigation on Multiphase Erosion–Corrosion of Elbow in LPG Desulfurization Unit

Abstract: Severe leakages of the elbow occur in the regeneration tower return pipeline of the LPG desulfurization unit, leading to the unplanned shutdown of the unit frequently over the period of four months. It is forced to apply additional steel plates to prevent the leakage. Elusively, it is found that the first wall contact with the fluid is fully eroded away in the vicinity of the bend, however, the walls of additional steel plates are intact. The clarification of this problem is required to ensure safe production. This strange phenomenon can be investigated by failure analysis and computational fluid dynamics (CFD) simulation. The failure analysis showed that the gas–liquid two-phase erosion–corrosion was the main cause of elbow leakage. The simulation shows that droplet erosion plays a dominant role in the erosion–corrosion process, and the elbow will leak in 4.3 months, which matches the actual situation very well. Furthermore, multiphase erosion–corrosion behavior was thoroughly investigated to expose the feature of the mentioned strange phenomenon. It was shown that when the corrosion hole

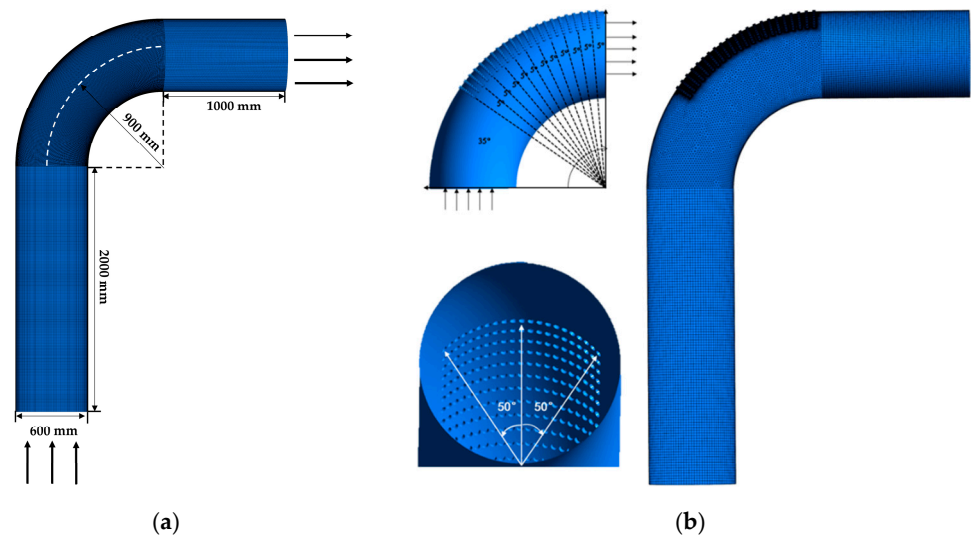
The geometric model of the elbow is shown in Figure 5. The size of the elbow is shown in Figure 5a. The geometric model of the elbow with corrosion holes is shown in Figure 5b, where the area of severe erosion–corrosion is covered with corrosion holes. After the field measurement, the number of holes with a 19 mm diameter was the highest. Therefore, the diameter of the holes was set to 19 mm and the depth of the hole was 10 mm.

Figure 5. Geometric models: (a) elbow; (b) elbow with holes.

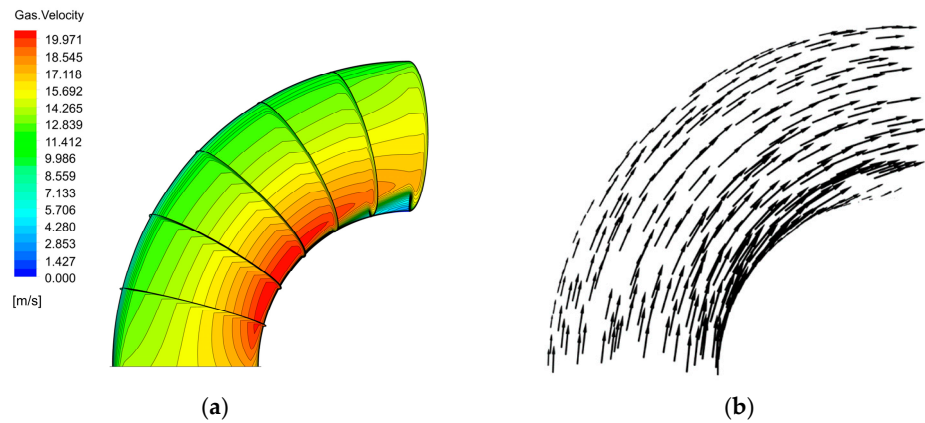
The velocity distribution of the gas–liquid two-phase in the elbow is shown in Figures 9 and 10. The velocity distribution of the gas phase in the elbow is uniform. The gas phase had the maximum velocity on the inside of the elbow and the minimum velocity on the outside, and the velocity decreased from the inside of the elbow to the outside. The velocity distribution of the liquid phase in the elbow was more complex. A small part of the droplets flowed along the inner wall and separated near the inner wall and flow out of the elbow. Most of the droplets collided with the outer wall of the elbow at a certain velocity and angle and flow out of the elbow at a lower velocity after the collision. In addition, the droplet and the wall collision area were mainly concentrated in the axial angle of $0\text{--}75^\circ$. When the droplet collides with the wall, the droplet will gather in the collision area, so the liquid phase fraction in the collision area will be larger. The volume fraction of droplets at different axial angles is shown in Figure 11. The liquid phase was mainly concentrated in the axial angle between 30 and 75° , indicating that the collision between droplets and the wall was focused on this area. It can be assumed that the erosion–corrosion of the wall in this area was more serious.

Figure 9. Velocity distribution and streamline of the gas phase: (a) contour; (b) vector.

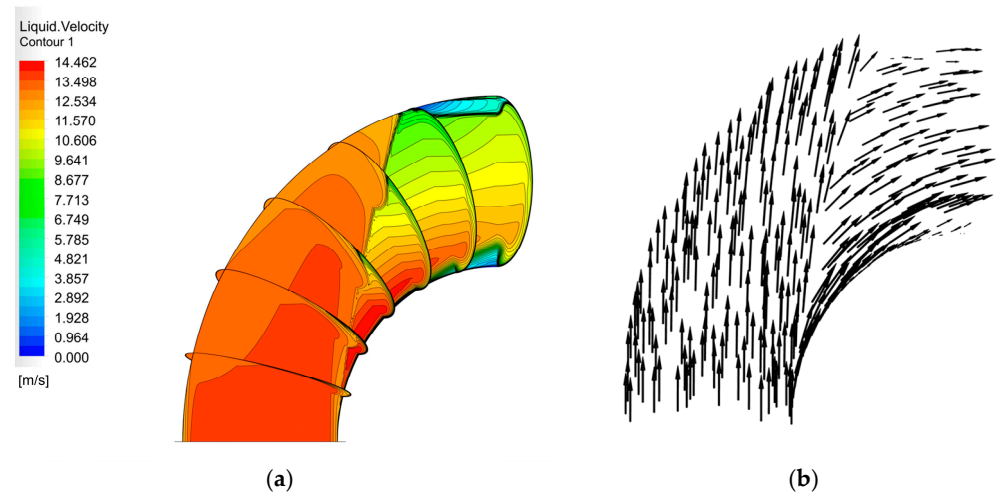
Figure 10. Velocity distribution and streamline of the liquid phase: (a) contour; (b) vector.

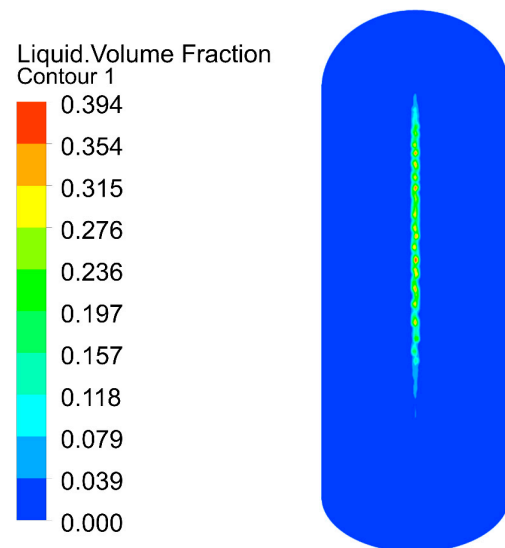
Figure 11. Distribution of the volume fraction of the liquid phase.

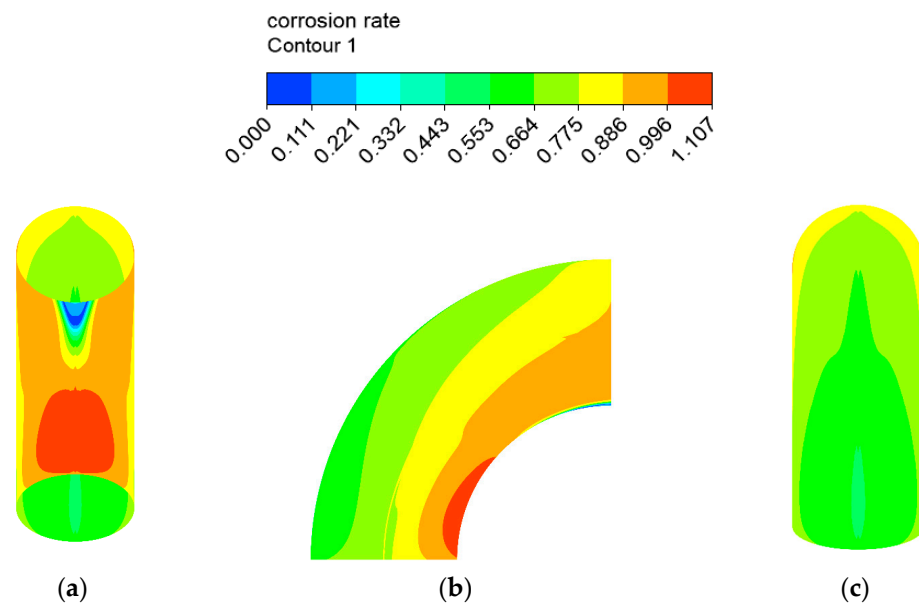
The erosion–corrosion rate calculated by the mathematical model is shown in Figures 12 and 13. The inner wall of the elbow was subjected to the maximum electrochemical corrosion rate of 1.107 mm/y, and the electrochemical corrosion rate gradually decreased from the inner wall to the outer wall of the elbow. The droplet erosion was

mainly concentrated in the elbow outer wall surface, and the maximum erosion rate was 26.766 mm/y.

Figure 12. Distribution of the corrosion rate: (a) view from +Y; (b) view from +X; (c) view from −Y of the elbow.

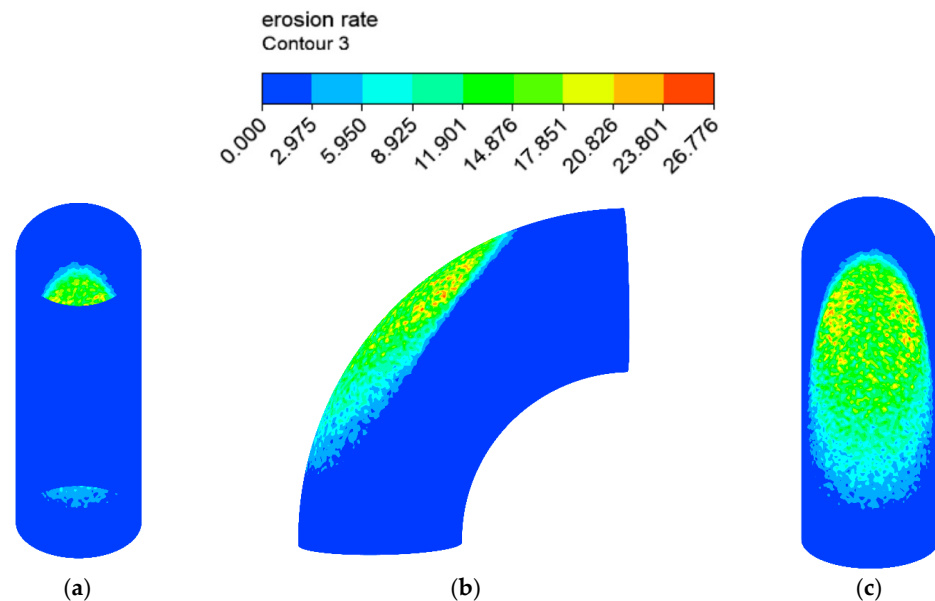
Figure 13. Distribution of the erosion rate: (a) view from +Y; (b) view from +X; (c) view from −Y (1).

- (2) The severe erosion area obtained by numerical simulation and the actual severe wall thinning area matched. The max erosion rate was 26.766 mm/y and the max corrosion rate was 1.107 mm/y, which indicates that droplet erosion was the main cause of elbow wall thinning.

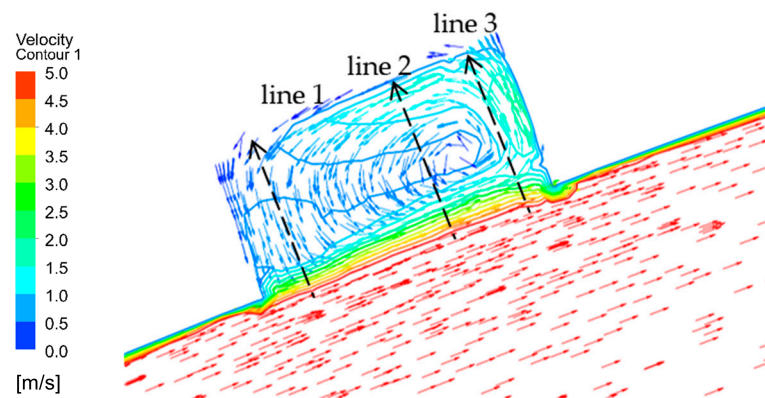
Figure 16. Gas vortex in the holes.

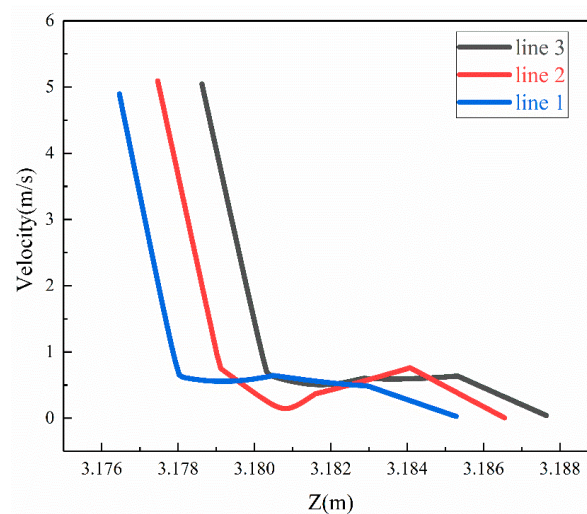
Figure 17. Velocity of gas of the three lines.

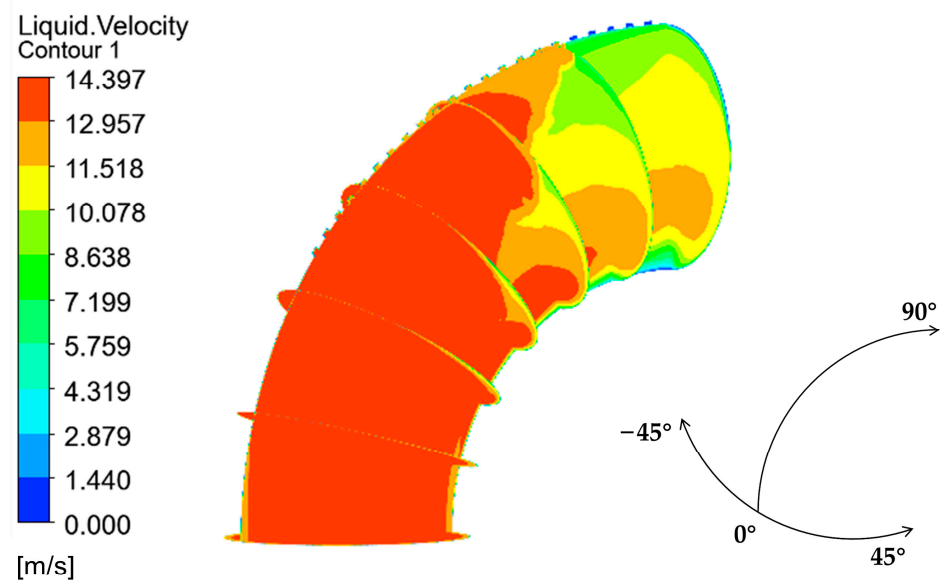
The flow of droplets in the elbow with holes was mainly similar to the elbow, but was different in the holes, as shown in Figures 18 and 19. When the droplets entered into the holes, the velocity at different locations appeared at different degrees of decline. To better describe the movement of droplets in the holes, four cross-sections of holes were chosen: location 1 (0° , 30°), location 2 (0° , 45°), location 3 (0° , 60°), and location 4 (0° , 60°) according to Figure 18, and the holes were divided into two by the diagonal of the hole cross-section. It can be seen that the velocity was larger in the area below the line, and the closer to the diagonal, the smaller the velocity, while the velocity was relatively small in the area above the line, where the closer to the diagonal, the larger the velocity. Combined with the flow of droplets in the hole, droplets flowed into the hole from the area below the diagonal, and the velocity direction of the gas and droplet was the same, so the gas on the droplet obstruction was relatively small, and the overall velocity was larger in the area. The closer the region is to the diagonal, the longer the droplet trajectory in this region and the greater the buffering effect of the gas on the droplet, resulting in a decrease in velocity near the diagonal region. When the droplet collides with the wall, the kinetic energy loss is larger after bouncing into the area above the line. At the same time, the gas in this area moves in the opposite direction to the droplet. These two reasons together led to a smaller droplet velocity in the area above the diagonal line. It can be presumed that the collision between the droplet and the hole wall is mainly concentrated in the area below the line. The presumption was proven by the volume fraction of the liquid shown in Figure 20. Therefore, it was presumed that the erosion–corrosion of the hole was concentrated in the hole wall in the area below the line. The erosion–corrosion in the area above the line was small.

Figure 18. Velocity distribution and streamline of the liquid phase.

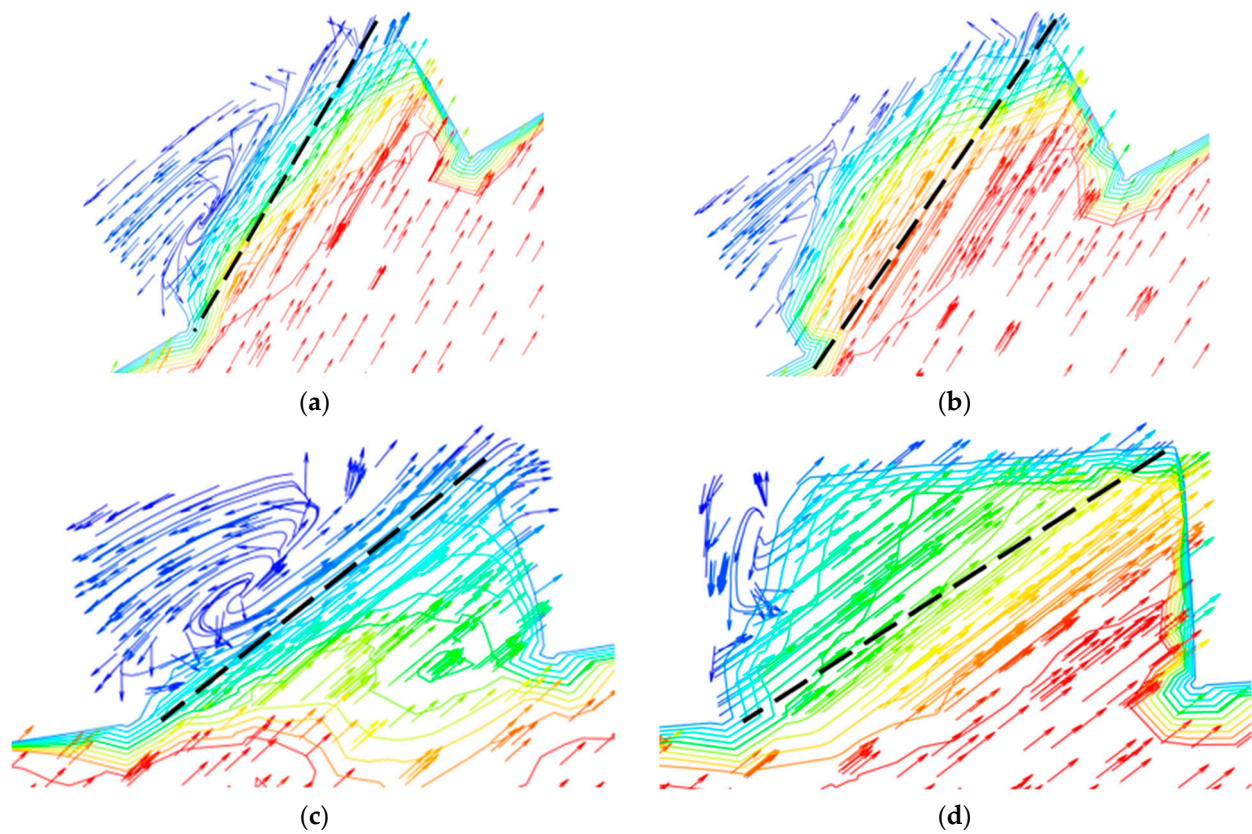
Figure 19. Velocity distribution and streamline of the liquid phase in the holes: (a) location 1; (b) location 2; (c) location 3; (d) location 4.

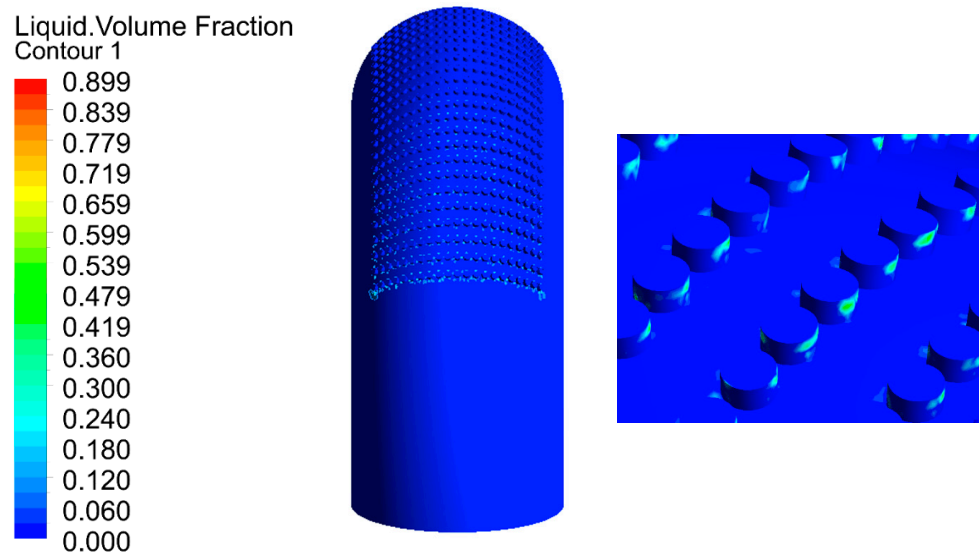
Figure 20. Distribution of the liquid volume fraction.

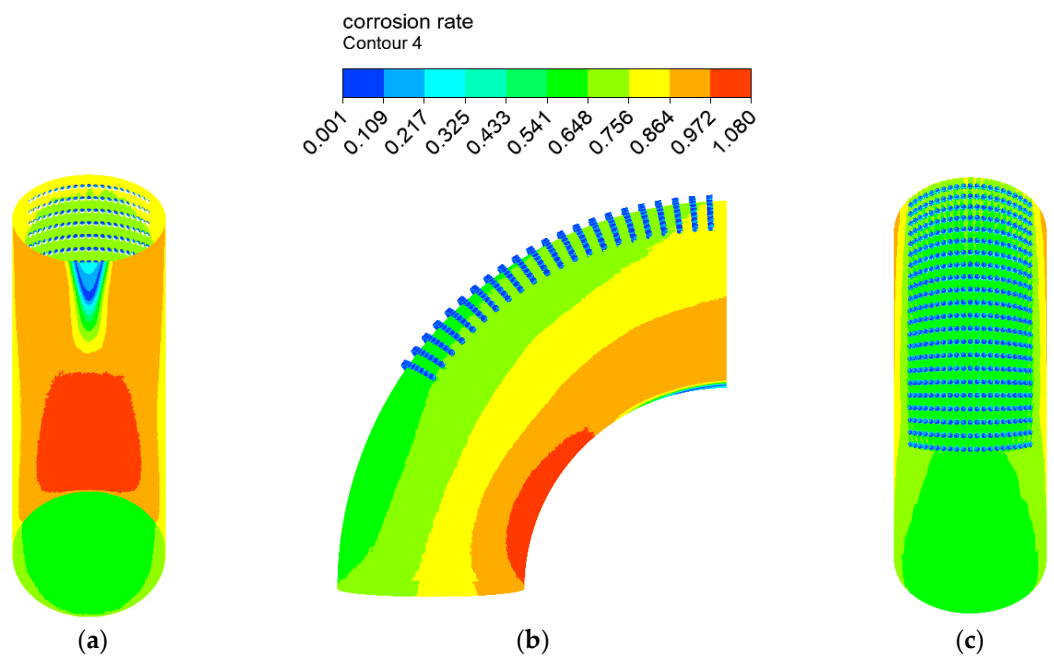
The distribution of the erosion–corrosion rate on the elbow wall with the corrosion holes is shown in Figures 21–23. The distribution and value of the erosion–corrosion are similar to those before. When the corrosion holes formed, the max erosion rate on the wall of holes was 15.832 mm/y, which decreased by 39.2% compared to the outer wall. The reduction in the erosion rate may be related to the formation of vortices in the holes.

Figure 21. Distribution of the corrosion rate: (a) view from +Y; (b) view from +X; (c) view from −Y.

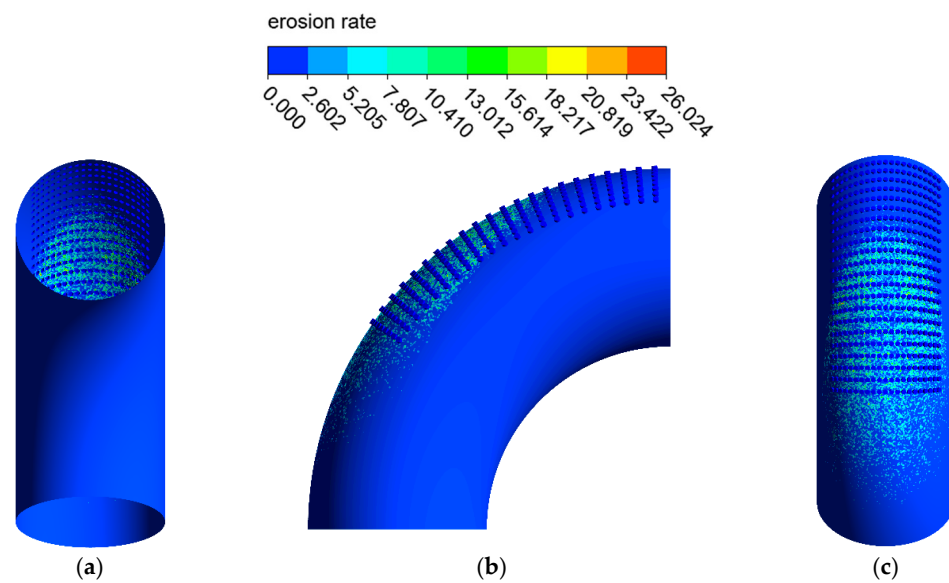
Figure 22. Distribution of the erosion rate: (a) view from +Y; (b) view from +X; (c) view from $-Y$ (2).

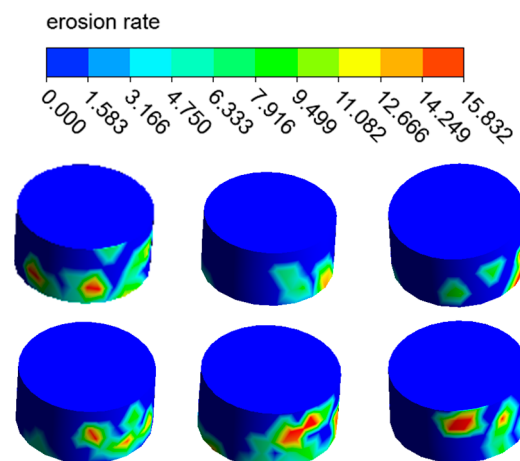
Figure 23. Distribution of the erosion rate on the holes.

- (3) Compared to the erosion–corrosion behaviors on the elbow, the erosion rate on the outer wall of the elbow was the same while the max erosion rate on the wall of holes was 15.832 mm/y, which decreased by 39.2% compared to the outer wall when the corrosion holes formed in the outer wall of the elbow. The formation of the gas film played a buffering role in the collision between the droplet and the wall, changing the mechanism of action between the droplet and the wall, thus creating the protection of the additional plate.

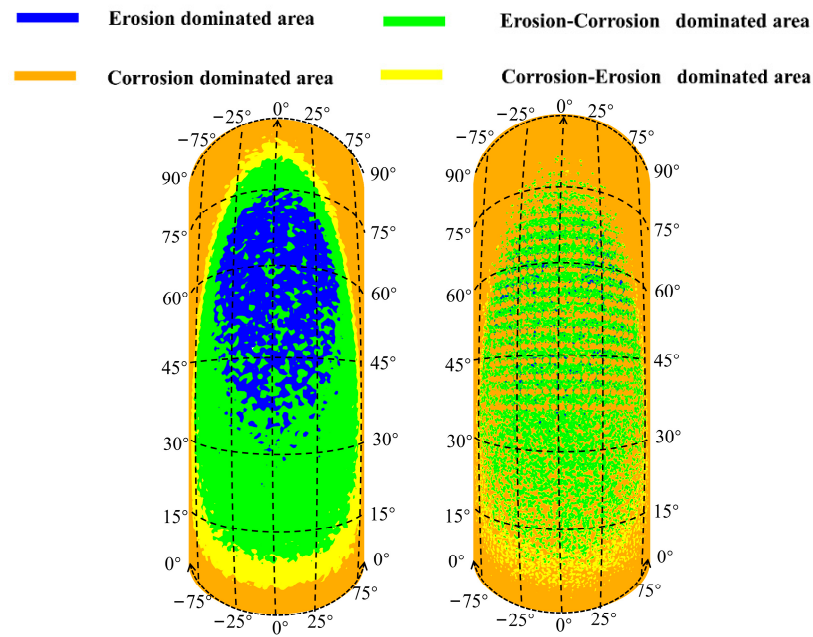
In accordance with the erosion–corrosion behavior with the formation of corrosion holes, the elbow can be divided into the erosion-dominated region, erosion–corrosion dominated region, corrosion–erosion dominated region, and corrosion-dominated region by calculating the ratio of erosion rate to corrosion rate [35], as shown in Figure 24. The erosion dominant region of the elbow is elliptical in shape, mainly located between $30\text{--}75^\circ$ axially and $-25\text{--}25^\circ$ circumferentially. With the erosion-dominated area as the center, the area from the inside to the outside are erosion–corrosion-dominated regions, corrosion–erosion-dominated regions, and corrosion-dominated regions. When the corrosion holes formed, the erosion-dominated region was mainly concentrated in the wall of the corrosion holes. Compared to the elbow, the reduction in the area of erosion dominated area can be observed, which indicates a substantial mitigation of the erosion effect of the droplets on the wall. The changes in the other regions after the formation of corrosion holes were not noticeable.

Figure 24. Erosion–corrosion map for the outer wall.

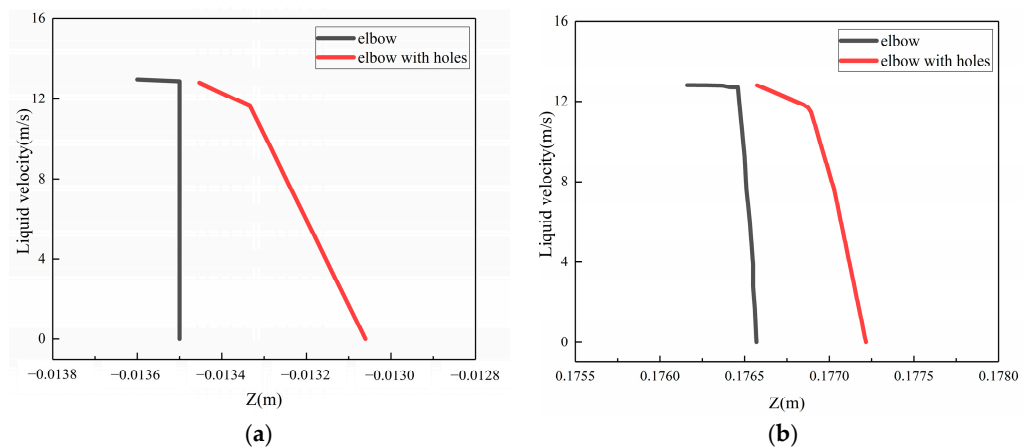
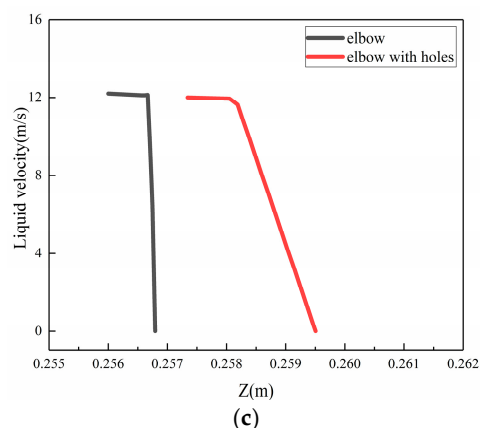
To investigate the phenomenon of the buffer effect on the droplet erosion on the elbow after the formation of corrosion holes, three locations, which were location 1 ($0^\circ, 70^\circ$), location 2 ($-5^\circ, 50^\circ$), location 3 ($5^\circ, 60^\circ$), according to the Figure 24, were selected from the severe erosion–corrosion area and the droplet velocity near the wall was extracted for comparative analysis, as shown in Figure 25. The results show that when the droplets collided with the wall, the velocity rapidly decreased to 0 to the wall of the elbow. When the corrosion holes formed on the elbow, the droplet velocity first showed a slight decrease compared to the elbow and then rapidly decreased to 0. Combined with the distribution of the gas in the hole, the droplets first make contact with the gas vortex inside the hole, where the gas vortex is equivalent to a dynamic gas film, so the droplet velocity hitting the wall decreases, thus having a buffer effect on the droplet erosion.

Figure 25. The velocity near the wall: (a) location 1; (b) location 2; (c) location 3.
