Tribological Properties of Plough Shares Made of Pearlitic and Martensitic Steels

Abstract: Tribological properties of ploughshares made of pearlitic and martensitic steels were compared in field tests. Sectional ploughshares consisting of separate share-points and trapezoidal parts were subjected to examinations. Contours of the examined parts were similar, but the thickness of the parts made of pearlitic steel was 1 to 3 mm greater for the share-points and 0.5 to 2 mm greater for the trapezoidal parts. Within the tests, sandy loams, loams, and loamy sands with circa (ca.) 13% humidity were cultivated. A greater intensity of thickness reduction and mass wear of the parts made of pearlitic steel was found, which indicates a lower resistance of this steel to wear in soil. However, contour changes of the share-points and the trapezoidal parts made of pearlitic and martensitic steels were comparable, which was probably influenced by the greater thickness of the parts made of pearlitic steel. The roughness of the rake faces of the parts made of pearlitic steel was greater than that for the parts made of martensitic steel, which can be attributed to lower hardness of the former. The la

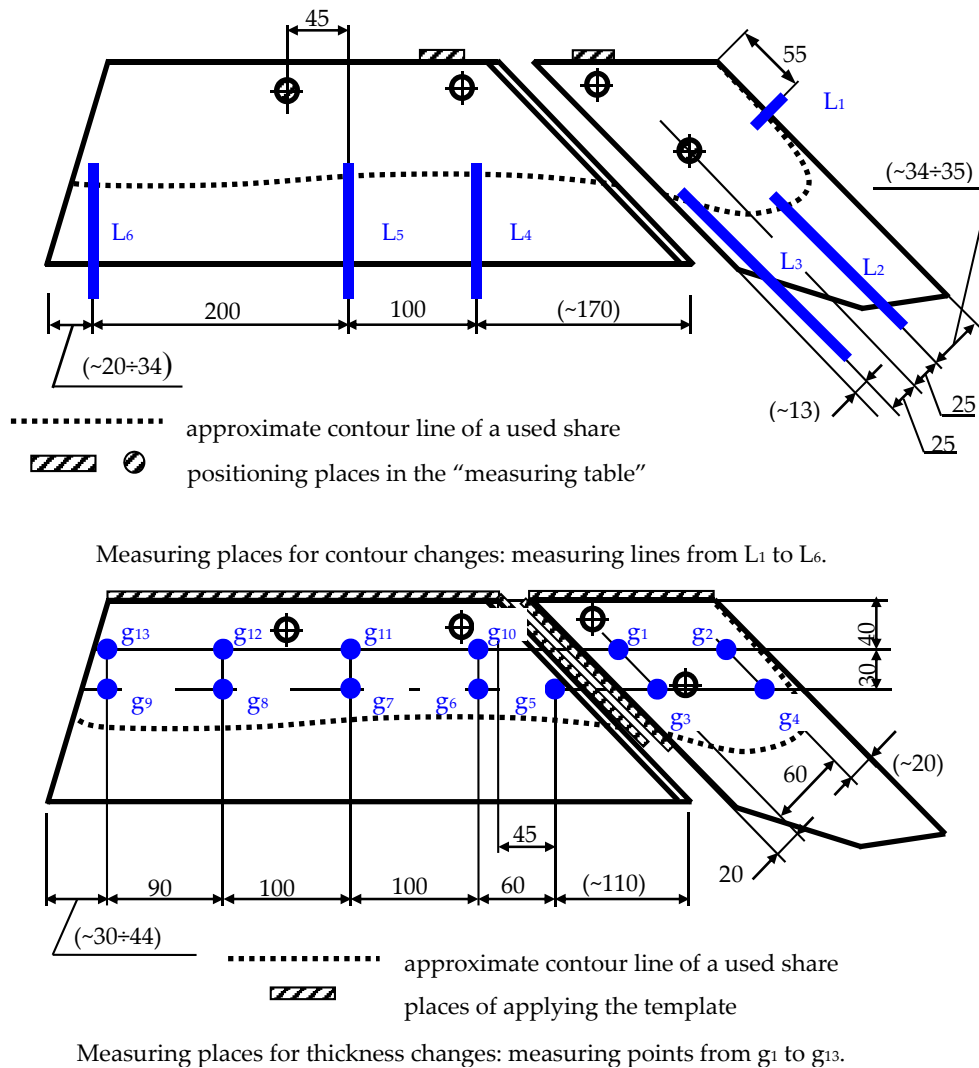
The width of wear bands formed on the flank faces of the parts as a result of the abrasive action of soil from the furrow bottom was also measured. Measurements of this parameter were taken at Lines L₂ and L₃ at the share-points and Lines L₄, L₅ and L₆ at the trapezoidal parts, see Figure 3. The measurements were made with a slide caliper in the direction perpendicular to the blade lines of the parts.

Figure 3. Measuring places for geometry changes of the examined shares, all results are in mm.

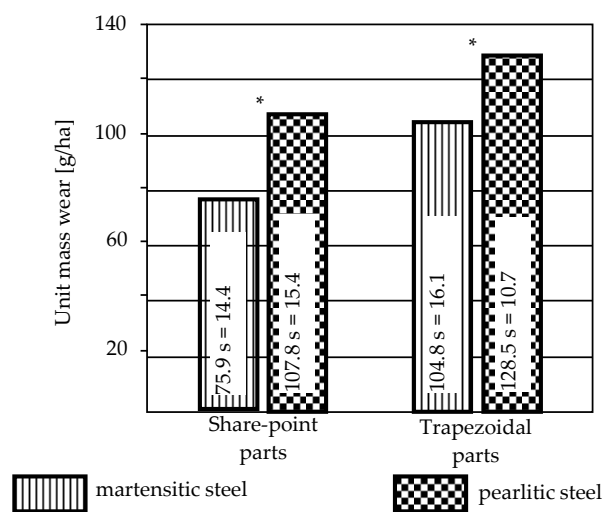
Figure 6 shows values of the unit mass wear of the examined shares. Significant differences between these values for the two used steels (at intensity levels of respectively $p = 0.00025$ and 0.007 for the share-points and trapezoidal parts; statistically significant differences are marked by asterisks in the figures). In both share-points and trapezoidal parts made of pearlitic steel, more intensive wear was observed compared to the parts made of martensitic steel: ca. 1.42 times more for the share-points and ca. 1.23 times more for the trapezoidal parts.

The trapezoidal parts were characterized by a greater unit mass wear than the share-points: ca. 1.2 times greater for the parts made of pearlitic steel and ca. 1.4 times greater for the parts made of martensitic steel. This can be explained by a ca. 2.4 times larger rake face area in the trapezoidal parts, while it is obvious that material loss occurred also from the sides of the flank faces and field edges of the ploughshares.

Figure 6. Unit mass wear of share-points and trapezoidal parts of the examined ploughshares (s —standard deviation, *—statistically significant differences).

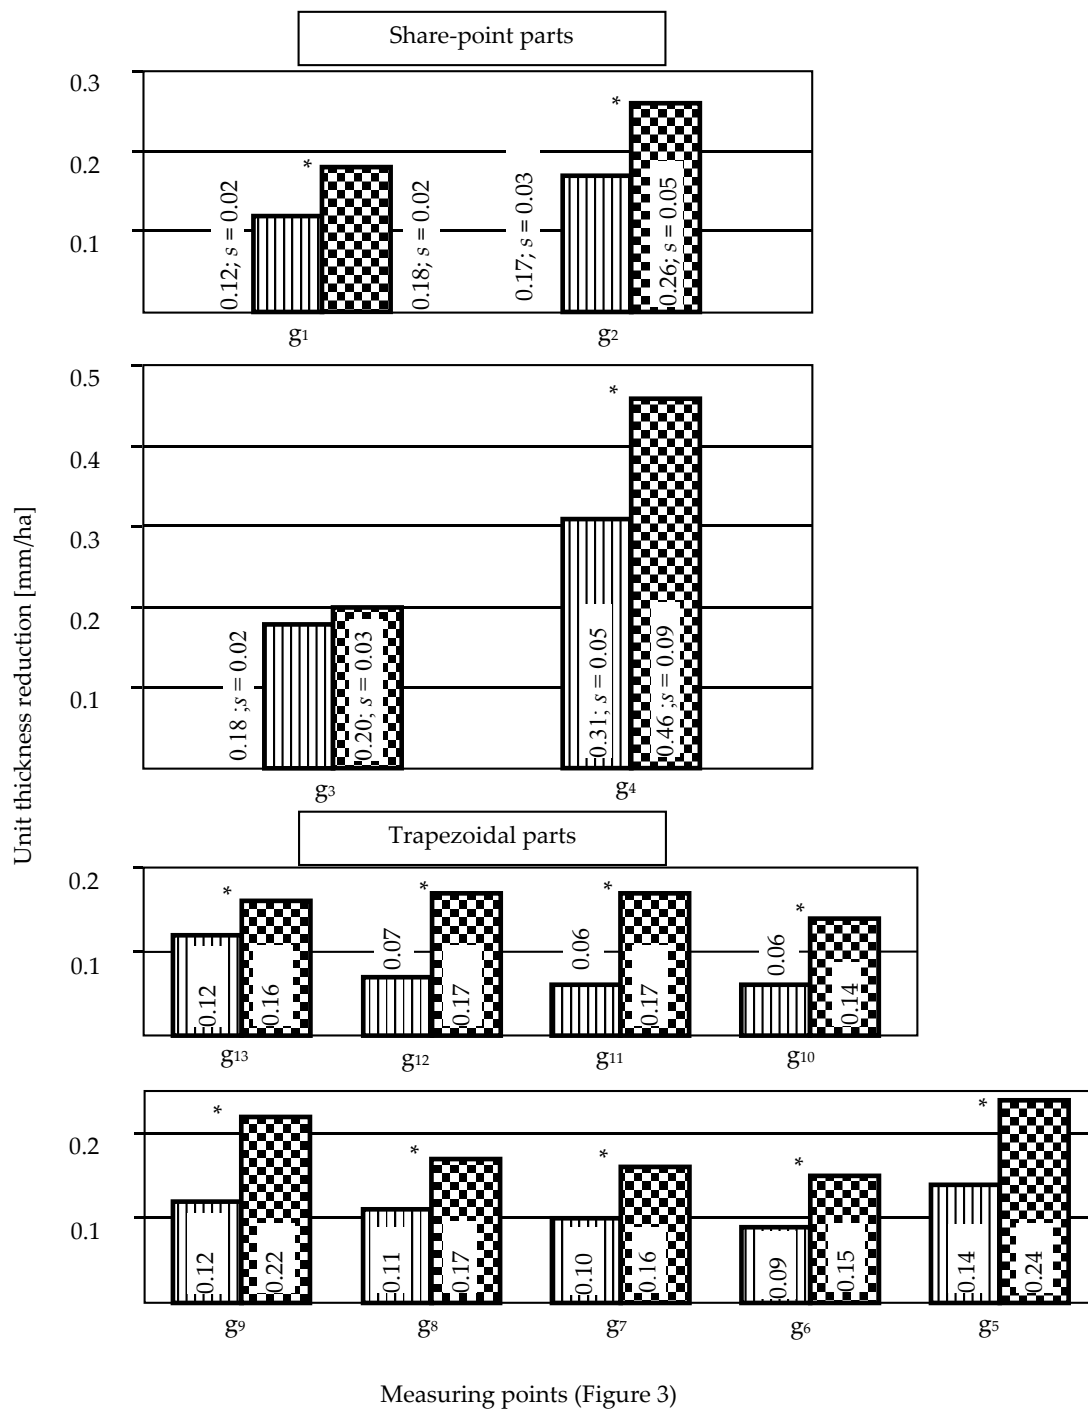
The measurement results of the unit thickness reduction of the share-points and trapezoidal parts of the ploughshares are shown in Figure 7. At each measuring point, the values found in the parts made of pearlitic steel were higher than those found in the parts made of martensitic steel: from 0.02 to 0.15 mm/ha for the share-points and from 0.04 to 0.11 mm/ha for the trapezoidal parts. In the share-points, statistically different values were found in three measuring points: g_1 ($p = 0.001$), g_2 ($p = 0.002$), and g_4 ($p = 0.003$), see Figure 3. In the trapezoidal parts, statistically different values of unit thickness reduction were found in all the measuring points ($p = 0.0000005$ – 0.0042).

Unit thickness reduction of the parts was greater in the places located in the lower measuring line (measuring points from g_3 to g_9). The share-points were subjected to the most intensive wear in the area adjacent to the field edge and the nearest to the blade (measuring point g_4), which can be related to the highest pressure exerted by the soil on that surface fragment. In the case of the trapezoidal parts, these areas were extreme measuring points located at the lower measuring line (measuring points g_5 and g_9).

Figure 7. Unit thickness reduction of share-point parts and trapezoidal parts of the examined ploughshares-standard deviation for trapezoidal parts: $s = 0.01\text{--}0.03$ mm/ha. (*—statistically significant differences).

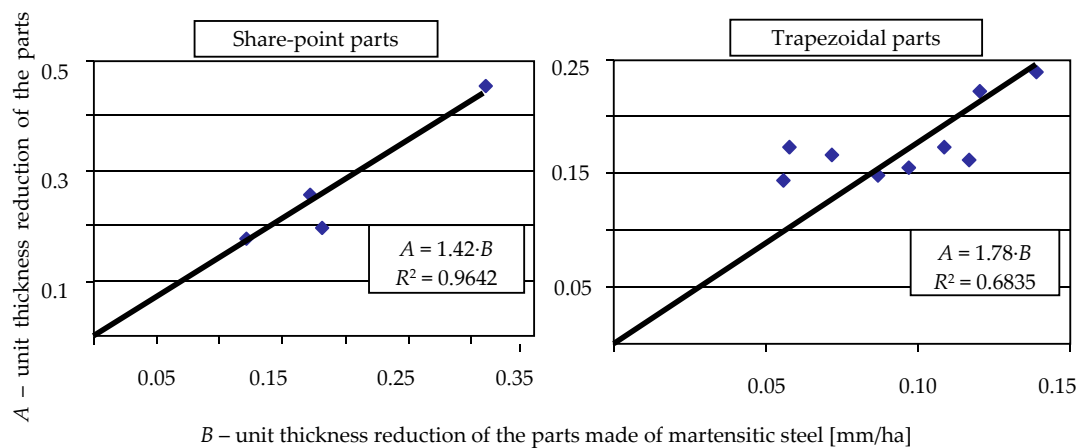
For unit thickness reduction, linear regression analysis was performed in order to find a correlation between the values for the parts made of pearlitic and of martensitic steel. Obvious boundary conditions were accepted for this regression: zero thickness reduction of the parts made of martensitic steel corresponds to zero thickness reduction of the parts made of pearlitic steel. Results of the analysis are shown in Figure 8.

A very strong correlation was found between the unit thickness reduction of the parts made of pearlitic and that made of martensitic steel, indicating a more intensive wear of pearlitic parts: ca. 1.4 times for the share-points and 1.8 times for the trapezoidal parts.

Figure 8. Relation between unit thickness reduction of the parts made of pearlitic and of martensitic steel (R^2 —coefficient of determination).

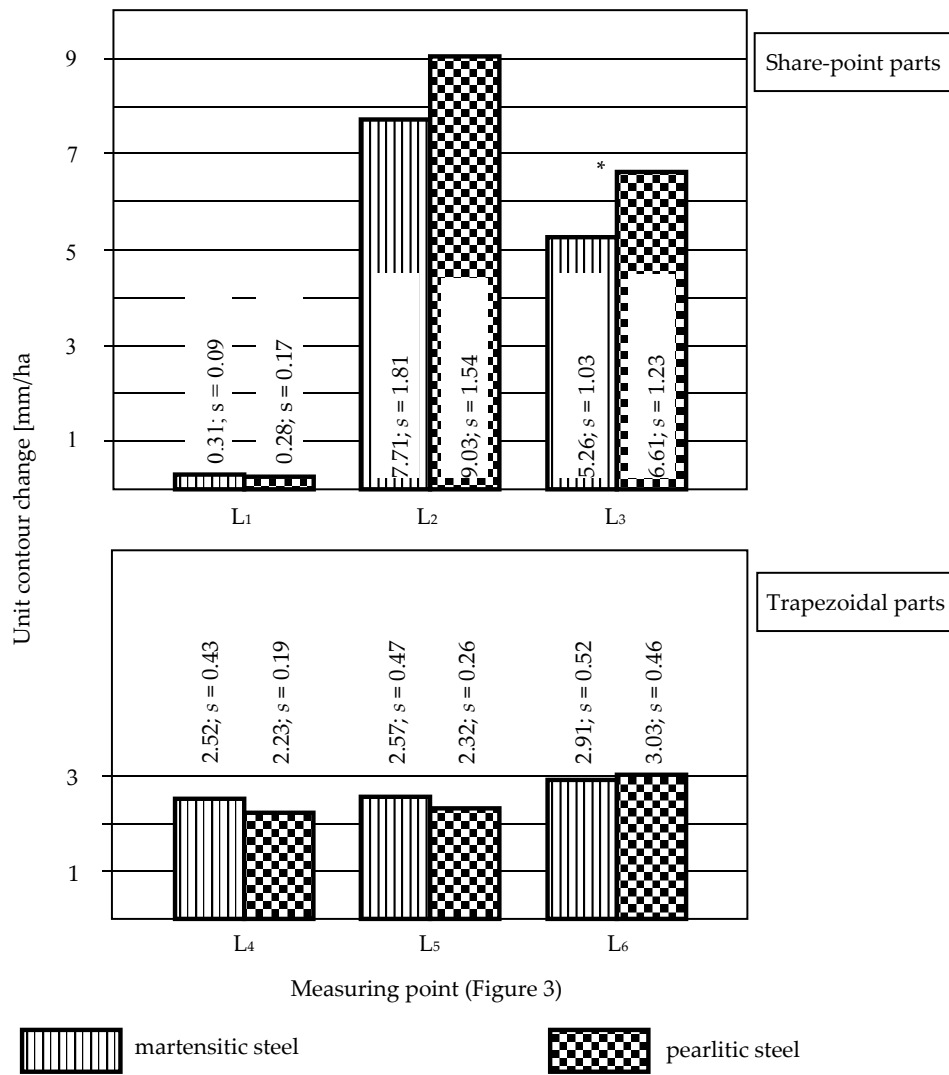
Figure 9 shows the values of the unit contour change of the examined parts. At most of the measuring lines, no statistically significant differences were found for the parts made of pearlitic and of martensitic steel. Such a significant difference occurred only at Line L_3 , used in the share-points.

For the share-points, unit contour changes were much greater than those for the trapezoidal parts, of course in addition to the wear at Measuring Line L_1 . A slight tendency for the wear intensity of the trapezoidal parts to increase with increasing distance from the share-points was also observed (increasing parameter values in Lines L_4 , L_5 , and L_6).

On the grounds of unit contour change of the elements, it is possible to evaluate their durability. It was found that absolute length reduction of the share-points measured at Line L_2 (corresponding to limit wear condition) was 96.6 mm, and the width reduction of the trapezoidal parts measured at Line L_4 was 63.7 mm. Utilization of the parts beyond the accepted limit wear condition in Lines L_2 and L_4 (Figure 3) would result in abrasion of the bolts and nuts located under the parts (Figure 10) which, with regard to operation of the plough, should be considered as unacceptable. At durability evaluation, the simplifying assumption was accepted: the intensity of contour changes of the parts at Measuring Lines L_2 and L_4 does not depend on the cultivated area.

Since no statistically significant differences were found between unit contour changes at Lines L_2 and L_4 , the averaged value of this parameter (determined for the parts made of both martensitic and pearlitic steel) was accepted in the calculations. The so evaluated durability was ca. 11.5 ha for the share-points and 26.8 ha for the trapezoidal parts. Thus, in the testing conditions, the share-points showed a ca. 2.3-fold lower durability compared to that of the trapezoidal parts. It should be noted that the evaluated durability of the share-points made of pearlitic steel concerns the parts that would not be bent or would be bent “backwards”.

Figure 9. Unit contour change of share-points and trapezoidal parts of the examined ploughshares (s—standard deviation, *—statistically significant differences).

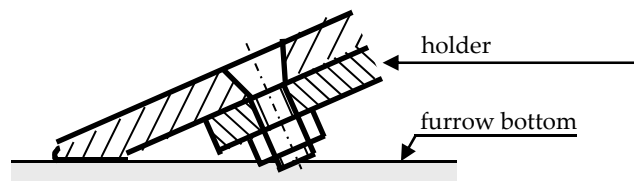
Figure 10. Limit wear condition of ploughshares resulting from the contour change.

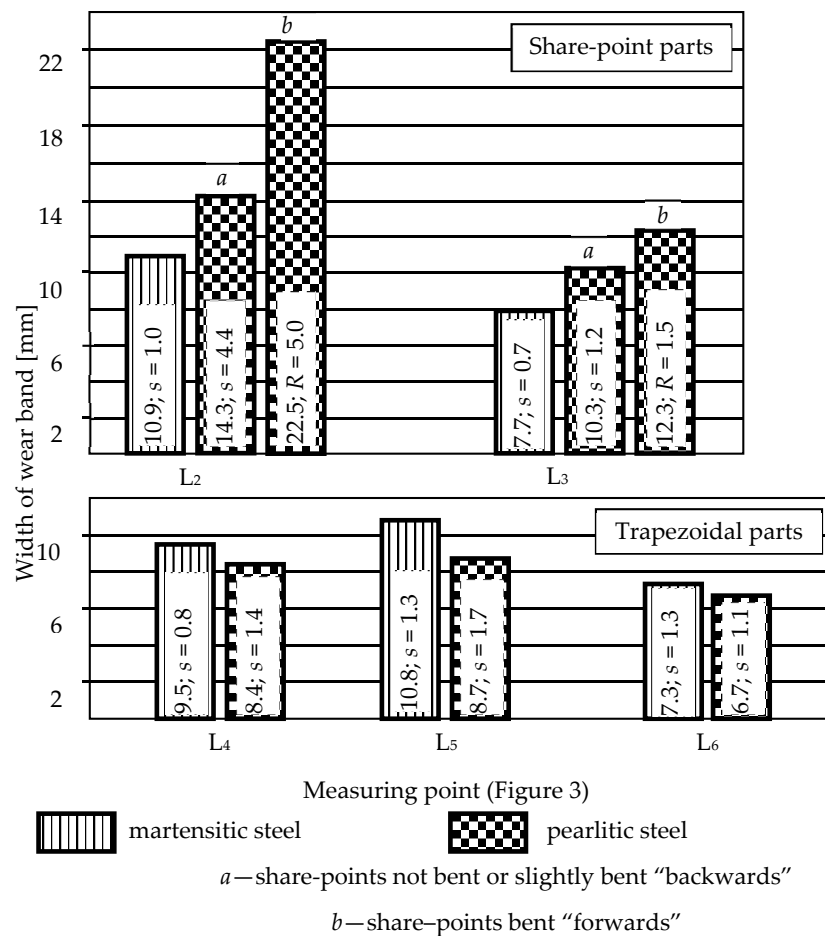
Bending of the share-points made of pearlitic steel resulted in various widths of the wear band formed on the flank faces of the parts, see Figures 11 and 12. This parameter is important insofar as, at the wide wear band, difficulties can happen in sinking the plough or in maintaining its set working depth. Bending the share-points “forward” resulted in a ca. 1.6–1.2-fold wider wear band at Measuring Lines L₂ and L₃, respectively.

Figure 11. Width of the wear band created on the flank faces of the share-points and trapezoidal parts after the tillage test: 8.43–12.29 and 20.93 ha/body, respectively. s —standard deviation, R —range. No significance test was performed for this parameter.

The width of the wear bands in the share-points made of pearlitic steel, which were not bent “forward”, was ca. 1.3 times greater than that in the parts made of martensitic steel. However, the width of the wear bands in the trapezoidal parts made of pearlitic steel was ca. 1.1–1.2 times smaller (Figure 11), which can be related to their clearly greater thickness reduction, see Figure 5.

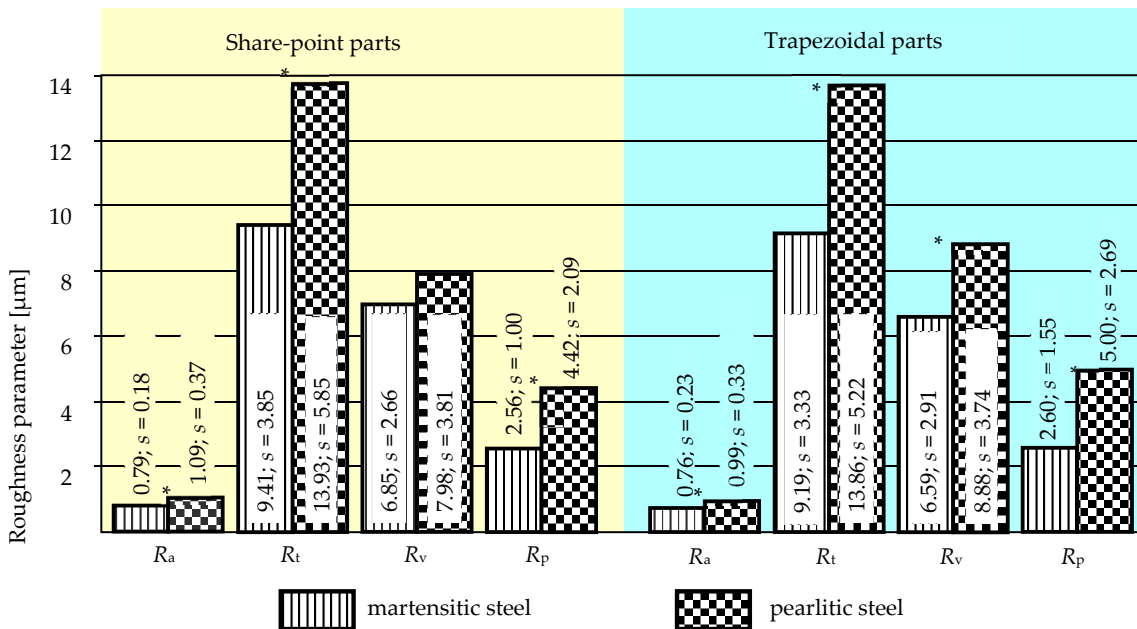
Figure 14. The roughness of the rake faces of the examined ploughshares: R_a —arithmetical mean deviation of the roughness profile, R_t —total height of the roughness profile, R_v —maximum valley depth of the roughness profile, R_p —maximum peak height of the roughness profile (s—standard deviation, *—statistically significant differences).

Statistically significant differences were found in the share-points for the parameters R_a ($p = 0.0003$), R_t ($p = 0.0006$), and R_p ($p = 0.0001$), and in the trapezoidal parts—for the parameters R_a ($p = 0.0048$), R_t ($p = 0.0003$), R_v ($p = 0.0130$), and R_p ($p = 0.0002$).

Larger roughness found on the rake faces of the parts made of pearlitic steel (Figure 14) can be related to lower mechanical properties of this steel and, especially, with ca. 1.8 times lower hardness than that of martensitic steel, see Table 2. Higher roughness values indicate a more intensive course of wear of pearlitic steel. The maximum peak height of the roughness profile values (R_p) on the share-points and trapezoidal parts made of pearlitic steel were respectively ca. 1.7 and 1.9 times greater than those for the parts made of martensitic steel. Thus, in the course of the wear process of pearlitic steel, the material was subjected to more intensive plastic deformation, characteristic of ridging, which was confirmed by SEM observations and former literature data [30–33].

It is also interesting that values of the parameters R_a , R_t , R_v , and R_p determined for the share-points and trapezoidal parts made of the same material slightly differ from each other, see Figure 14. Generally, the values found on the trapezoidal parts were a bit lower, but the differences did not exceed 14% of the parameter value. In this case, the performed roughness measurements did not show any statistically significant differences. This advocates a similar interaction of elementary wear processes occurring on rake faces of the share-points and trapezoidal parts. Therefore, considering a more intensive unit thickness reduction of the share-points in comparison to that of trapezoidal parts, it can be assumed that the more intensive wear of the share-points resulted from a greater intensity of the occurring wear processes.
