# Investigation of Stress-Oriented Hydrogen-Induced Cracking (SOHIC) in an Amine Absorber Column of an Oil Refinery

**Abstract:** Stress-oriented hydrogen-induced cracking (SOHIC) of an amine absorber column made of a Hydrogen Induced Cracking (HIC) resistant steel and operating under wet H<sub>2</sub>S service was investigated. SOHIC was not related to welds in the column and evolved in two steps: initiation of HIC cracks in the rolling plane and through-thickness linking of the HIC cracks. Both the original HIC cracks as well as the linking cracks propagated with a cleavage mechanism. The key factors identified were periods with high hydrogen charging conditions, manifested by high H<sub>2</sub>S/amine ratio, and stress triaxiality, imposed by the relatively large thickness of the plate. In addition, the mechanical properties of the steel away from cracked regions were unaffected, indicating the localized nature of SOHIC.

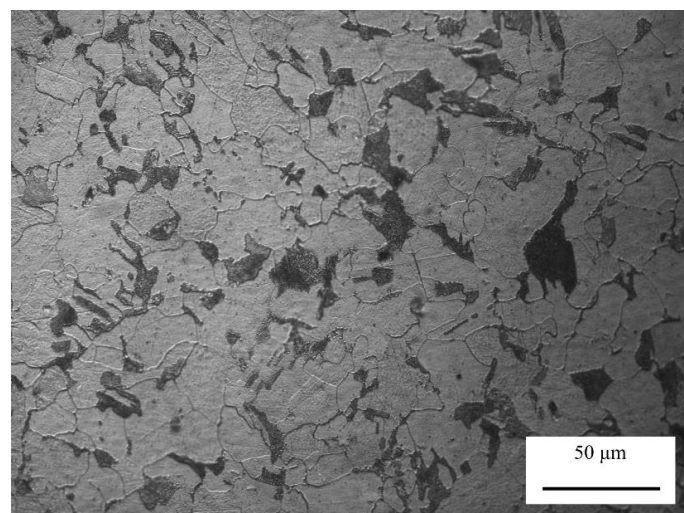
The microstructure of the steel is depicted in the micrograph of Figure 6, indicating that the microstructure consists of ferrite and pearlite. The metallographic section at location 604 is shown in Figure 7, which is an assembly of micrographs starting from the inside diameter (ID) of the

Figure 6. Ferrite–pearlite microstructure of the investigated steel.
