Seismic Retrofitting of Dual Structural Systems—A Case Study of an Educational Building in Croatia

Abstract: On 29 December 2020, a devastating Mw6.4 earthquake struck near the town of Petrinja, Croatia. The main earthquake was preceded by a Mw4.9 foreshock the day before. The earthquakes caused extensive damage to buildings, especially historic buildings made of unreinforced masonry but also to buildings of other typologies and to critical infrastructure. Today, recovery efforts in Croatia focus primarily on reconstruction and seismic retrofitting. Family homes and public, cultural, educational, and other facilities are top priorities. In this paper, a comprehensive study of existing building in the educational sector is presented as a case study. The seismic performance of the building is evaluated using numerical methods, first for the as-built condition and then for the retrofitted building. For each condition, the collapse mechanisms of the building were determined and critical structural elements were identified. The presented retrofit strategy of the dual structural system consisting of RC frame system and masonry walls aims to reduce the displacements of the RC frame syste

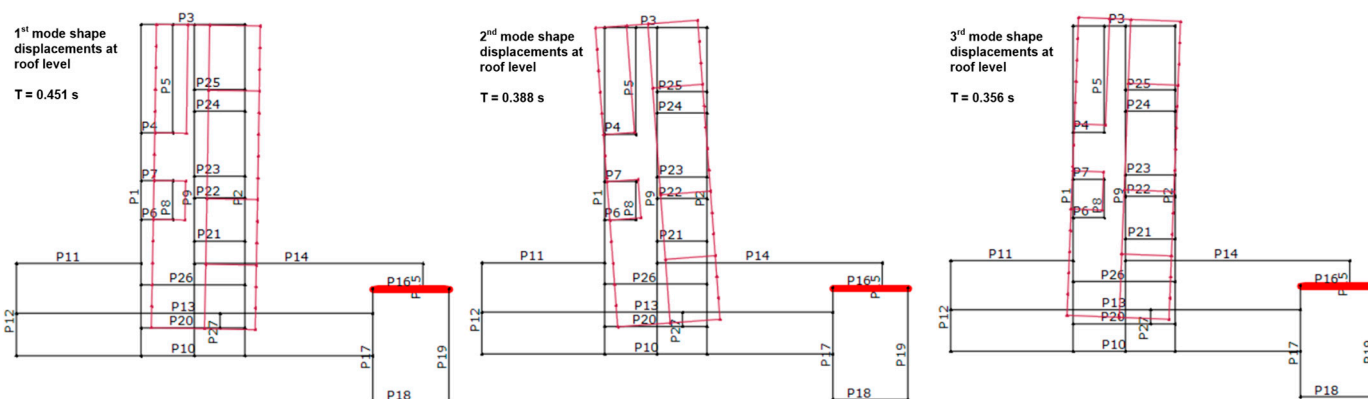
The second model was created with the program 3Muri [39], as mentioned before. First, the eigenmodes and the corresponding periods are determined for the structure, taking into account the crack state of the elements (Table 3 and Figure 19). The first period of the structure is 0.45 s and corresponds to the translation in the X direction, activating 62.5% of the total mass, while the translation mode in the Y direction with a period value

Figure 19. Relevant mode shapes obtained by EFM.

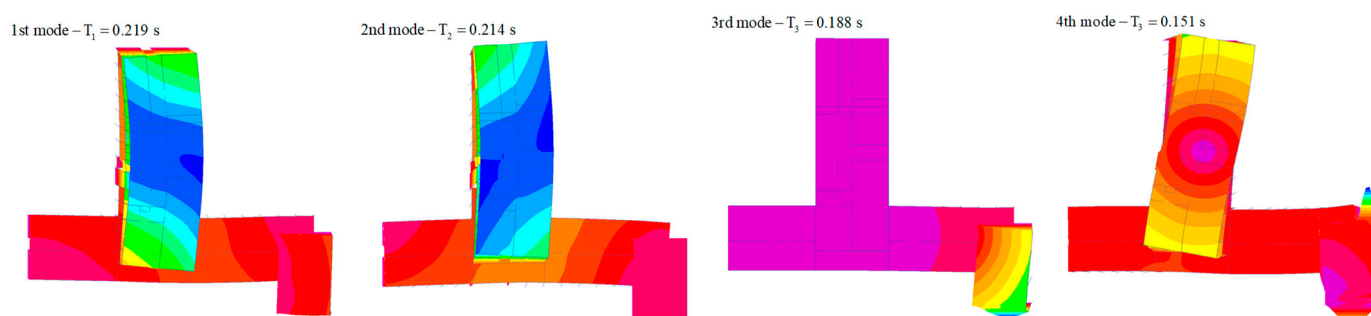
Due to the presence of new and strengthened elements the dynamic properties of the building have changed, i.e., the period values have reduced notably which is the result of significant increase of structural stiffness mainly due to addition of new RC walls. The Figure 23 shows relevant modes, and it is noticeable that coupling of mode shapes is evident what can be even more emphasized since relevant mode shapes all have near values of periods.

Figure 23. Eigenmodes and corresponding periods values for cracked sections of the retrofitted building.

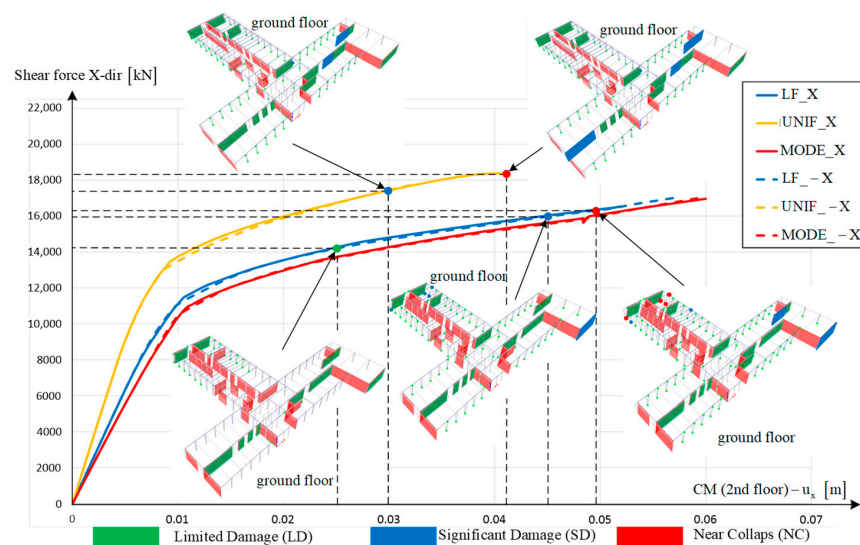
The main results of the pushover analysis for strengthened structure obtained by modelling with ETABS are given below. The limit states of the critical elements and the development of the failure mechanisms are marked on the curves. In Figure 24, it can be seen that some elements of the structure reach a state of limited damage, which is reflected on the curve as a decrease in stiffness, i.e., the slope at a force of 11,000 kN (B.S. = 32%) and a displacement of 9 mm. In addition, there is the initial opening of cracks and a reduction in the stiffness of the individual elements in all floors. These elements still did not utilize bearing capacity and continue to deform. The beginning of the failure of the structural elements occurs at a force of 15,000 kN (B.S. = 44%) and a displacement of 40 mm. The columns on the ground floor on the north side reach the SD limit state due to the exceeding of the shear force capacity. Since such a fracture of the columns is non-ductile, exceeding their ultimate capacity means failure very soon. The walls of the large hall on the ground floor are also in an SD limit state. The next important stage is the failure of these columns (NC limit state) at a force of 16,000 kN and a displacement of 50 mm. At this stage, it can be said that the load-bearing capacity of this part of the building is utilized and a partial failure of the building takes place. As a result, the local failure of the floor slab may occur. It can already be said that the building is in a NC limit state and can be classified as having

the highest degree of damage. However, even in the case of local failure, it is unlikely that the rest of the structure will collapse at this load level. The walls and columns of the 1st and 2nd floors are not critical for action in the X-dir and have not reached the SD limit state.

Figure 24. Pushover curves in X-dir for retrofitted structure.

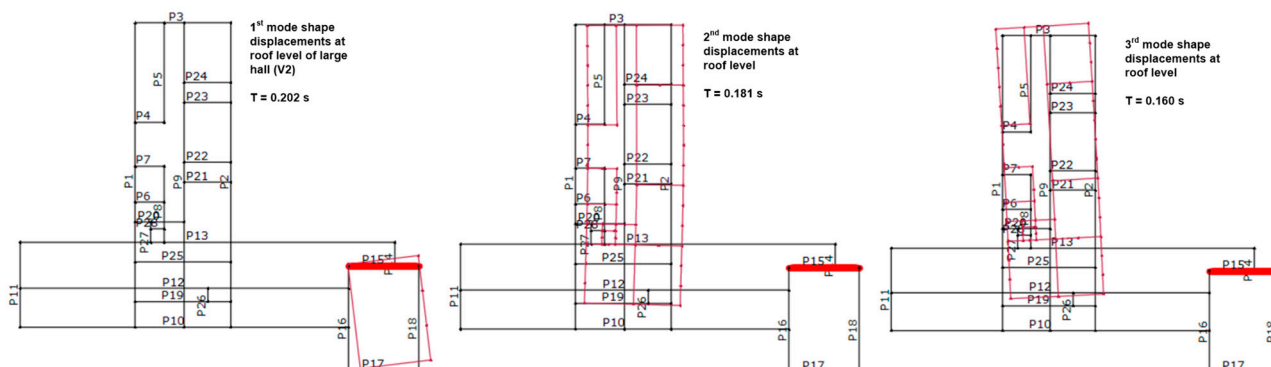
The results of the EFM with the program 3Muri also demonstrate that the reinforcements caused a significant change in the dynamic properties of the structure, which is a consequence of the stiffening of the structural system (Table 4). In this model for the state of cracked sections (Figure 28), the first mode of vibration with a period of 0.204 s is a local one and affects the deformation of the elements of the large hall with a participation of 2.1% of the mass in the Y-dir and a visible torsional influence. The translation mode in the X-dir appears in the second period with a value of 0.181 s and a mass participation of 70.2%, while the translation in the Y-dir direction maintains the influence of torsion and has a period value of 0.16 s with a mass participation of 58.5%. In the fourth oscillation mode, the torsion is noticeable, and the value of the period is 0.145 s.

Figure 28. Relevant mode shapes obtained by EFM for the retrofitted structure.
