The Assessment and Retrofitting of Cultural Heritage—A Case Study of a Residential Building in Glina

Karlo Ožić¹, Ivan Markić², Antonela Moretić^{1,*} and Luka Lulić¹

Keywords: earthquake; structural strengthening; cultural heritage; nonlinear static analysis; in situ tests

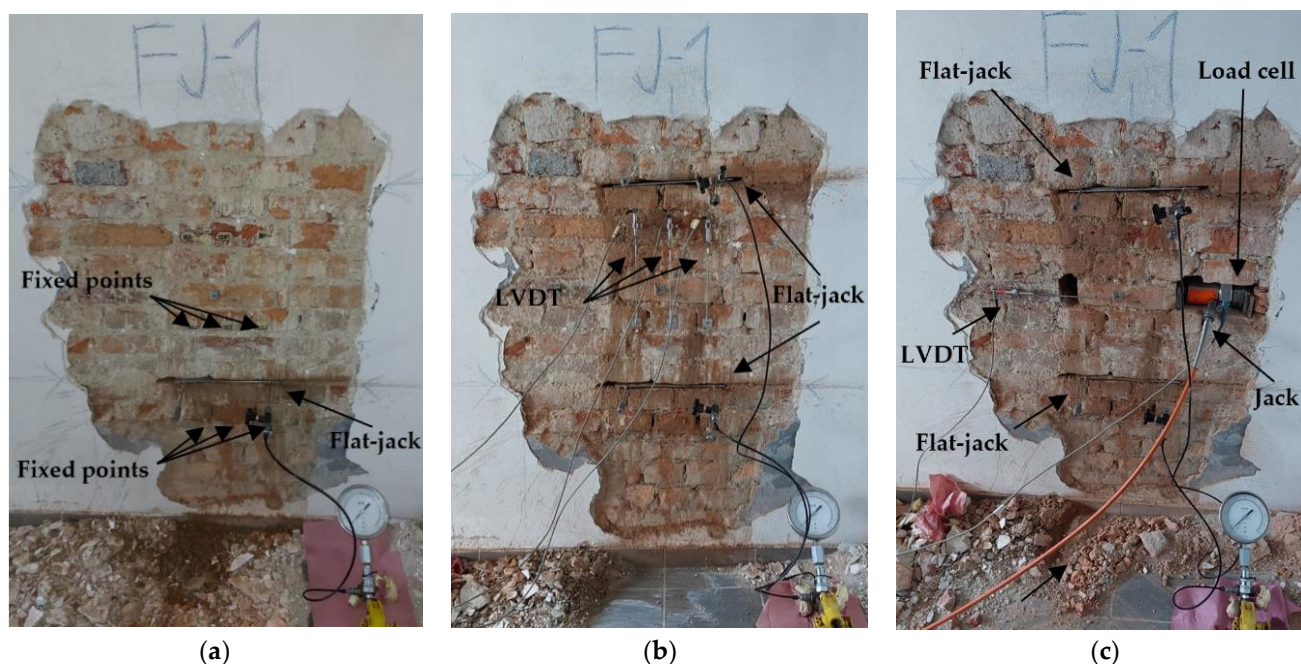
Figure 12. Flat-jack method: (a) single flat-jack test, (b) double flat-jack test, and (c) shear test.

The principle of the single flat-jack test is to partially relieve the compressive stress in the wall by removing the mortar from the horizontal bed joint. This is achieved by making the opening with an eccentric circular saw. The stress is then compensated by means of a flat-jack inserted in the opening. The stress is gradually increased until the original stress and strain state is established, which is verified by measuring the displacements perpendicular to the opening. Measurements are made with a portable extensometer, and fixed measurement points glued to the bricks can be seen in Figure 12a. The results of the single flat-jack tests are shown in Table 1.

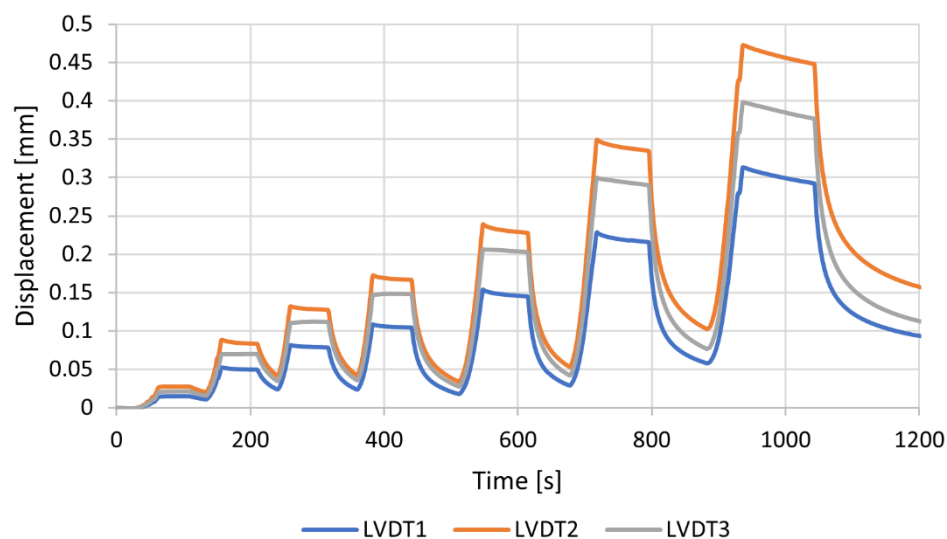
To determine the stress–strain behavior of masonry in compression and the modulus of elasticity of masonry, it is necessary to use another flat-jack placed above the first one (a double flat-jack test). Flat-jacks are inserted into parallel horizontal openings and pressure is applied gradually. In this phase, the displacement gauges (LVDTs) are placed vertically between the flat-jacks, as in Figure 12b. Simultaneously with the application of vertical pressure with the flat-jacks, the displacement is measured (Figure 13), which allows the stress–strain behavior and modulus of elasticity to be determined. For reference, see [27]. The resulting values for the double flat-jack tests are listed in Table 2.

Figure 13. Measured displacement during double flat-jack test.

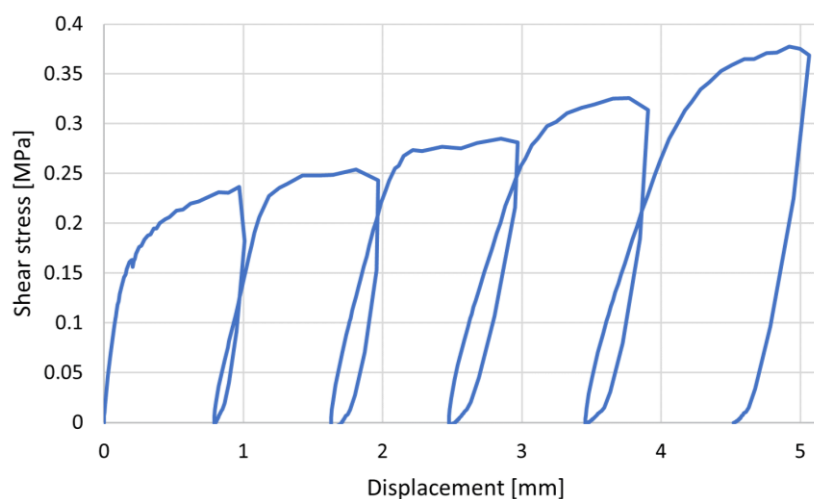
After the double flat-jack test, the shear (shove) test follows in the same location. Both flat-jacks with an additional horizontal hydraulic jack are used for this test (Figure 12c). The displacement gauges used in the previous phases are removed and a horizontal displacement gauge is mounted. In this phase, a horizontal brick (oriented so that a mayor dimension of the brick is parallel to the wall) is pushed until failure, that is, until it slips. This process is repeated for several vertical stress levels (Figure 14). Flat-jacks allow the control of the vertical stress at the test location. As a result, this provides the relationship between the shear stress and the vertical compressive stress. From this relationship, a best-fitting line can be drawn. The angle of this line represents the coefficient of friction, while the intersection with the vertical axis represents the initial shear strength of the masonry. The results of this test phase are shown in Table 3.

Figure 14. Change in shear stress during the test (blue line).

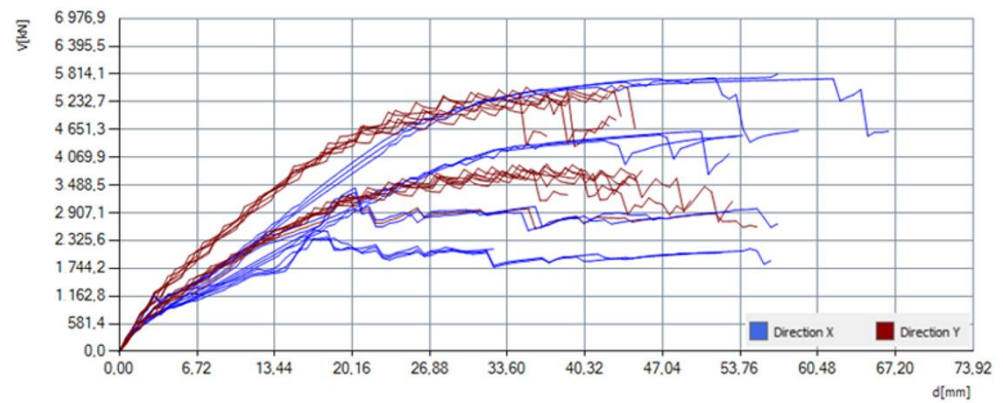
The pushover curves are shown in Figure 15. It is noted that the pushover curves vary within the same direction. The asymmetry of the building (both in plan and height) causes a higher shear capacity for the $-X$ (negative) orientation versus the X (positive) orientation. Additionally, it is noted a higher shear capacity is accomplished for the uniform load distribution, in both the X and Y direction.

Figure 15. Pushover curves of the existing structure in the current condition.

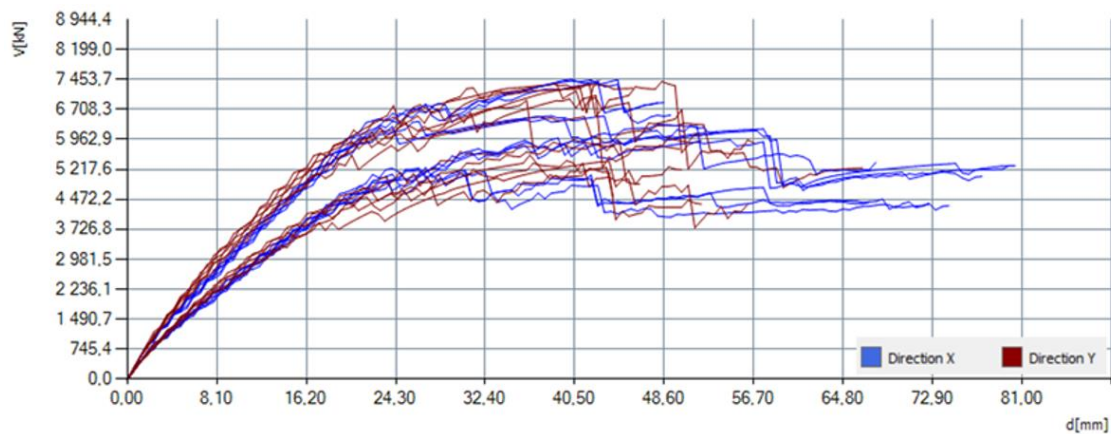
The results are shown in terms of risk indices, pushover curves and capacity curves (Table 8, Figures 21 and 22). In total, 24 analyses were performed. The base shear value

varies depending on the pushover analysis (load distribution, eccentricity load direction, and orientation). The discrepancies are high due to the plan and height irregularities. The aim was to satisfy 24 analyses, so the increase in the capacity also varies. The average increase for the X direction is 23–53%, while for the Y direction, it is 33–40%. The suggested solution caused the increase in seismic capacity to satisfy the level 3, $\alpha_{225} > 1.0$. The significant increase in shear capacity in the X direction was noted; this was expected, since the FRCM system was mainly applied to the walls set in the longitudinal X direction. Both displacement capacity and ductility in the X direction increased. The displacement capacity increased in the Y direction, but the ductility remained the same.

Figure 21. Pushover curves of the strengthened structure.

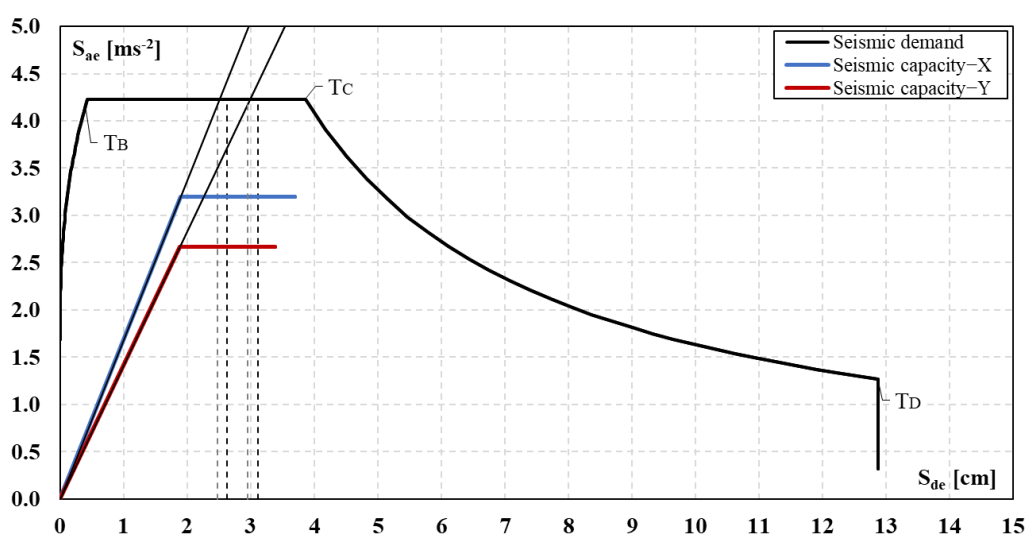
Figure 22. Seismic demand and capacity of the strengthened structure.

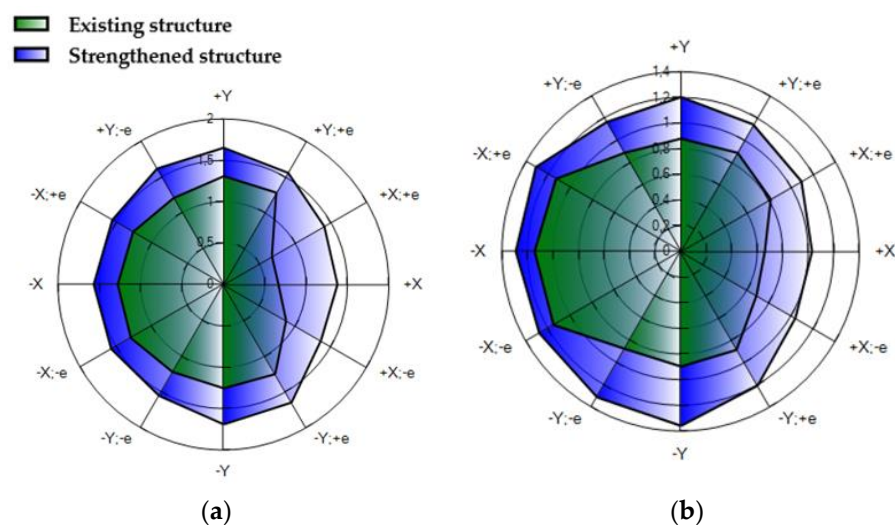
Risk indices vary for each direction, which is displayed in Figure 23. It shows the comparison of risk indices for the limit state “Significant damage”, and the return period of 225 years for the existing and strengthened structures. It is visible that the capacity of the strengthened structure increased overall, regardless of the direction, orientation, and distribution of the forces.

Figure 23. Comparison of the risk indices of the models of the existing structure and the structure strengthened using FRM: (a) uniform distribution; (b) distribution proportionate to the static forces.
