Reflections from the 2019 Durrës Earthquakes: An Earthquake Engineering Evaluation for Masonry Typologies

Abstract: Two earthquakes struck the NW region of Albanian territory on 21 September 2019 ($M_w = 5.6$) and on 26 November 2019 ($M_w = 6.4$). The epicenters of the seismic activity were located offshore NW Durrës, one of Albania's most populated cities, located 30 km from the capital Tirana. Various aftershocks followed subsequently. While there were no reported injuries, a number of buildings sustained significant damage near the epicenter following the initial event. Subsequently, during the second event, there was loss of life and extensive damage to civilian structures, resulting in multiple collapses. This study focuses on the earthquake damages observed in residential and public buildings in the earthquake-affected region. The earthquakes predominantly affected low-rise masonry buildings, while the newly constructed RC structures built according to the latest seismic rules were almost unaffected. The commonly encountered building typologies in the region, together with photos showing the amount of destruction are presented here. As observed by the authors during the rec

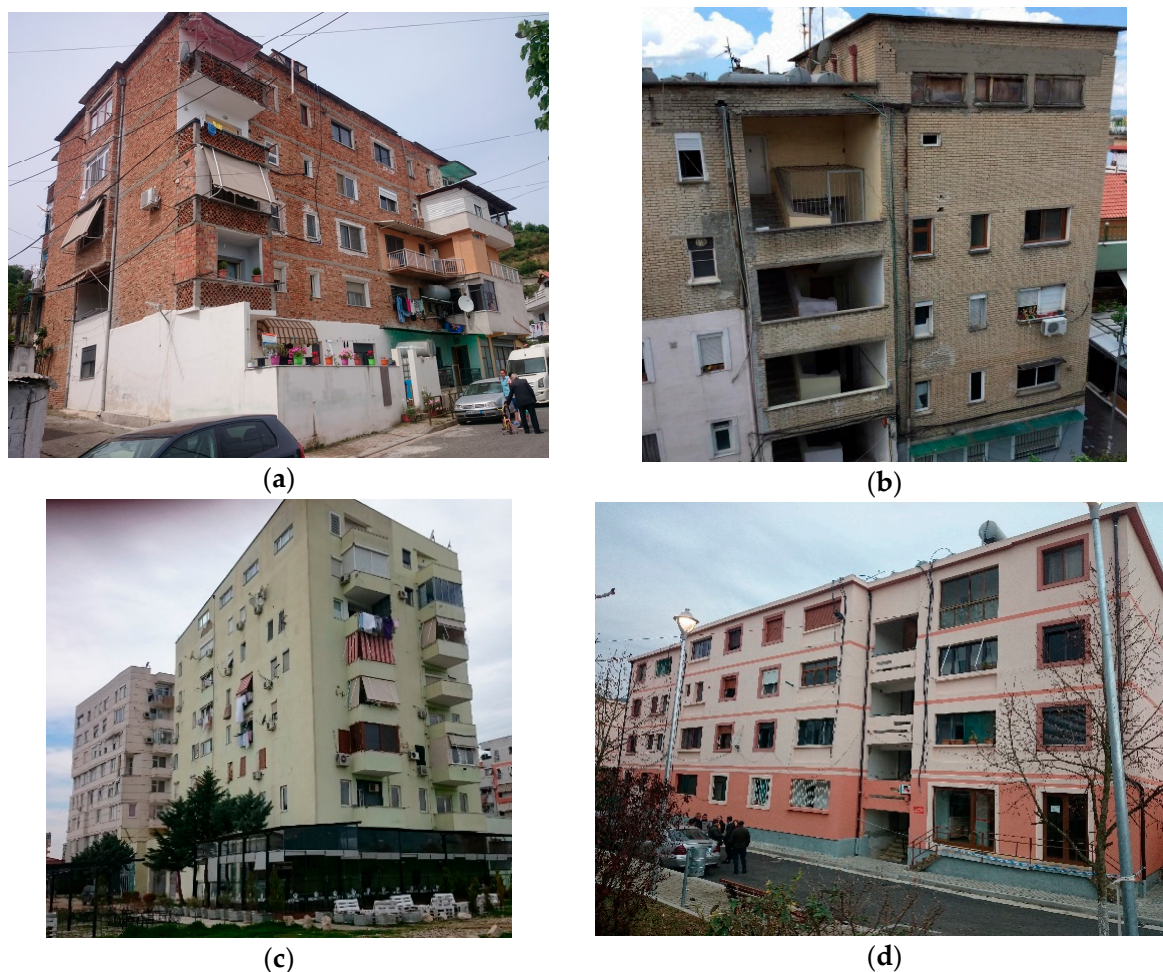
Figure 3 provides an illustration of the usual multi-story housing buildings found in Albania. The most common types include unreinforced masonry (URM) and construction using clay or calcium silicate bricks (Figure 3a,b), as well as reinforced concrete (RC) structures with masonry infills (Figure 3c). Furthermore, prefabricated large-panel buildings (as shown in Figure 3d), which fall under the ‘prefabricated’ category in the 2001 census, are also widespread and form a significant part of the building stock in Albania. The roofs of these multi-story buildings are primarily constructed using flat reinforced concrete (RC) slabs. Also, it should be noted that all buildings taller than six stories are typically built using RC frames.

Figure 3. Commonly encountered typologies for multi-story buildings in Albanian building stock: (a) Unreinforced masonry built by clay bricks; (b) Confined masonry made of silicate bricks; (c) newly constructed RC buildings; (d) Large panel Prefabricated buildings.

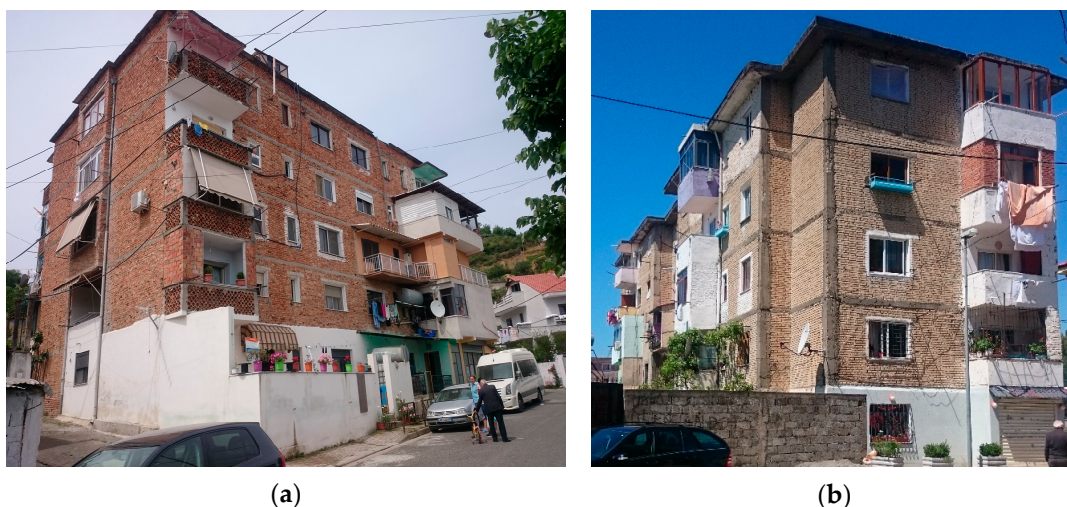
Masonry buildings and RC buildings continue to be in use and represent a significant portion of the dwellings in Albania. These buildings can be categorized into two primary typologies: (1) unreinforced masonry (URM) buildings with load-bearing walls, as illustrated in Figure 8a, and (2) confined masonry (CM) buildings with load-bearing walls reinforced using RC tie-elements, as depicted in Figure 8b.

Figure 8. Typical masonry buildings (a) URM; (b) Confined masonry.

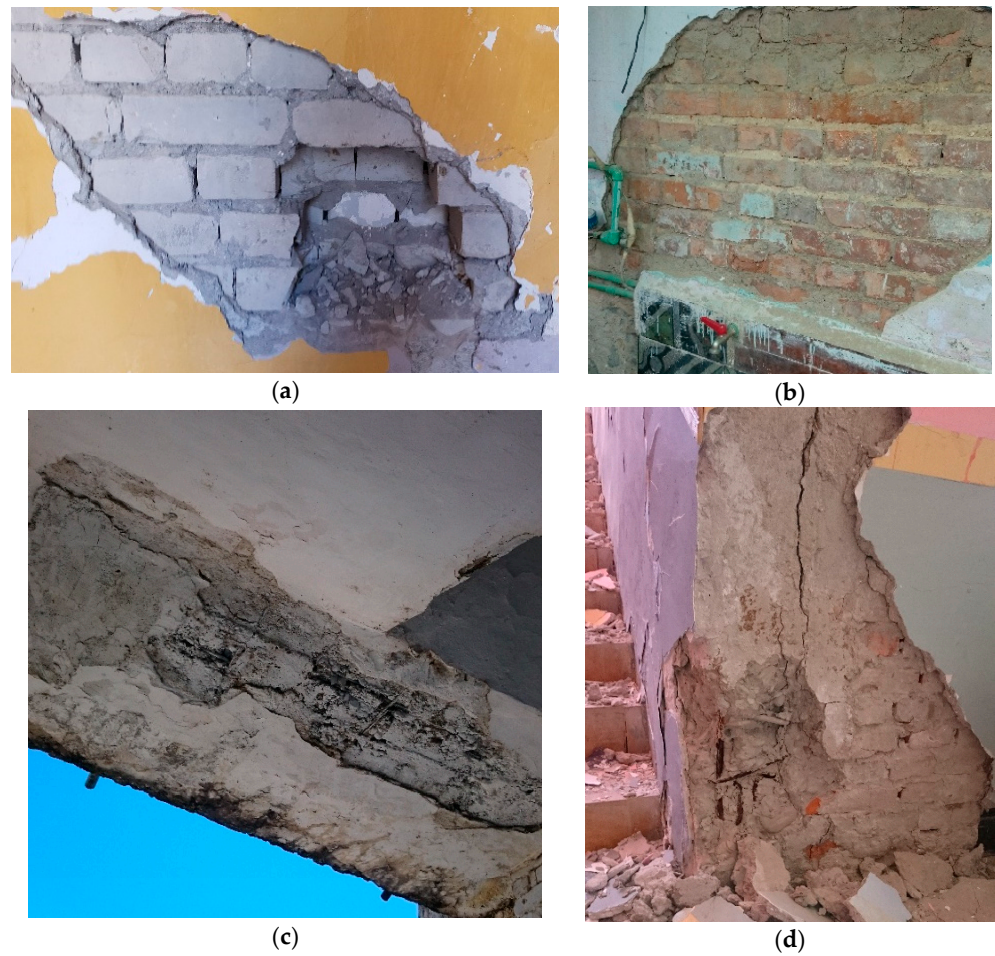
In CM buildings (as shown in Figure 9c,d), tie elements are utilized. These tie elements include reinforced concrete (RC) columns with a typical cross-section size of $38 \times 38 \text{ cm}^2$, as well as RC beams with a depth of either 25 cm or 38 cm. The choice of beam depth depends on the thickness of the walls at their respective locations. The concrete used in these tie elements is generally of class C16 or lower. Similarly, the steel grade typically employed in these buildings is S220, as reported [27].

Figure 9. Typical solid bricks and details of the confinement elements used for masonry walls: (a) Silicate bricks; (b) Red clay bricks; (c,d) RC beams and column reinforcements.
