Underwater Inspection of Submerged Elements in Masonry Bridges and Other Old Civil Structures Using Drones

Rubén Rodríguez Elizalde

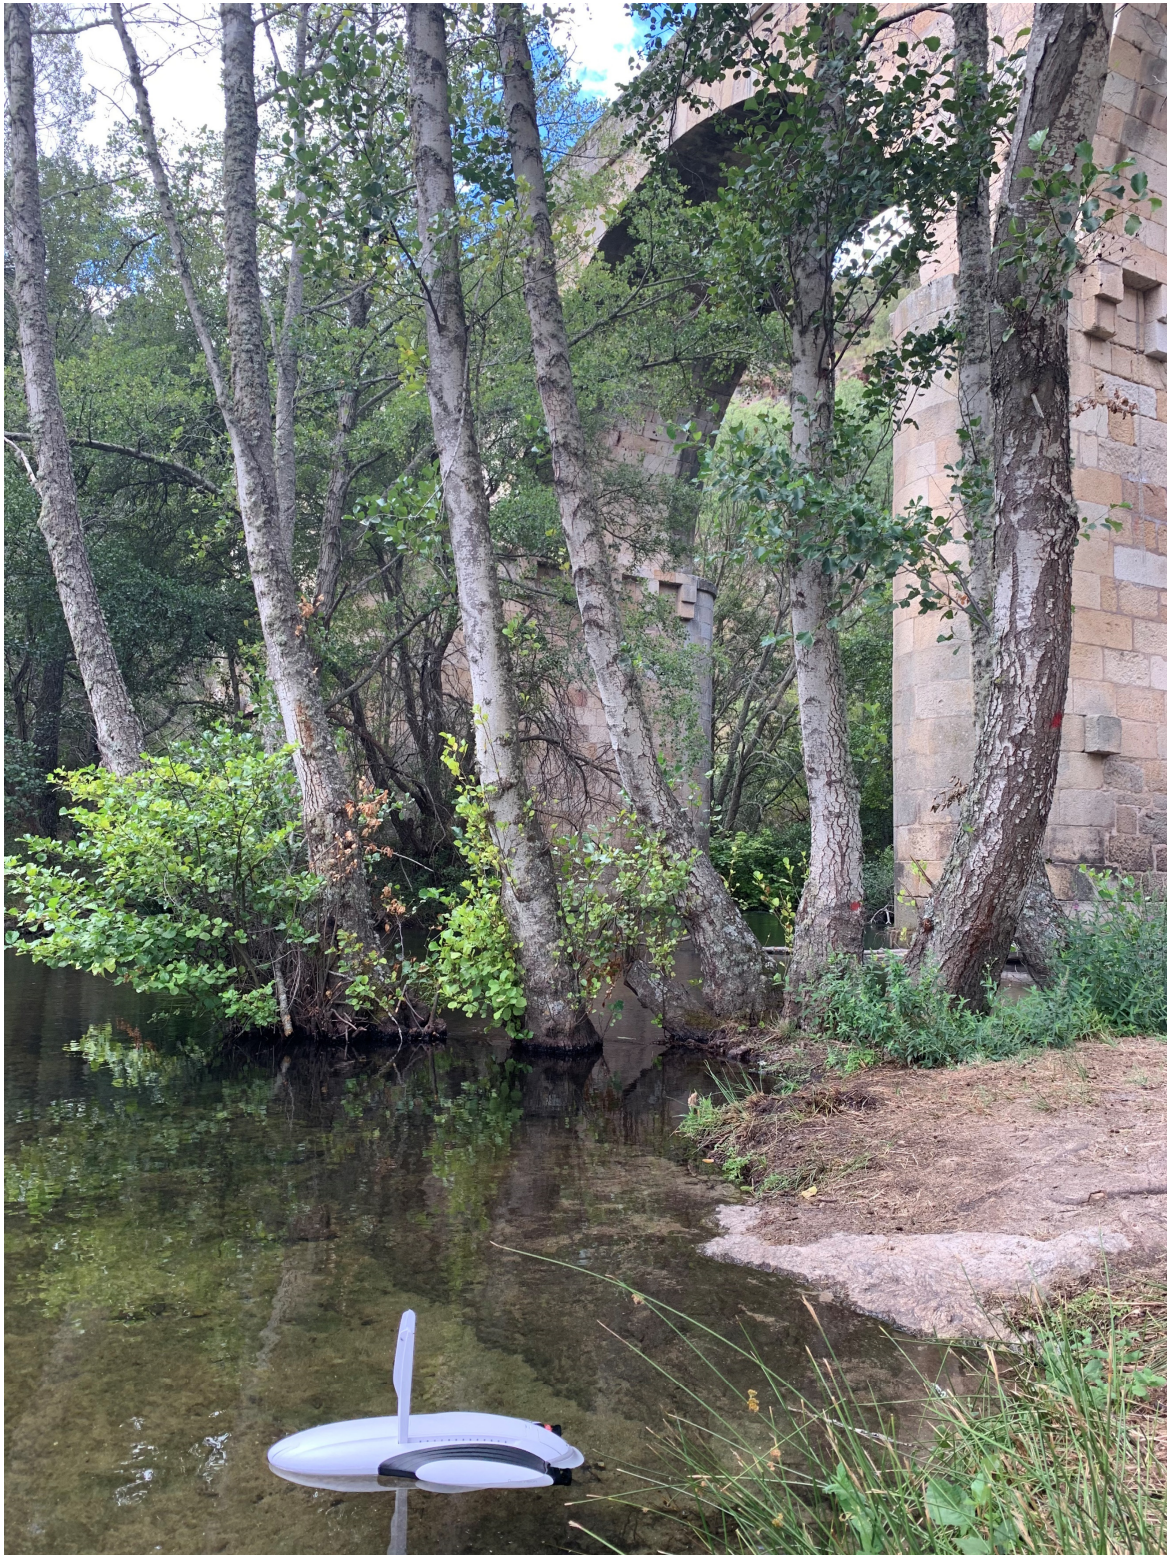
Figure 1. General view of the underwater drone used to inspect the San Lorenzo Bridge. At the time of the photo, the device was being launched towards the submerged elements of the structure for reasons of accessibility (photo by the author).

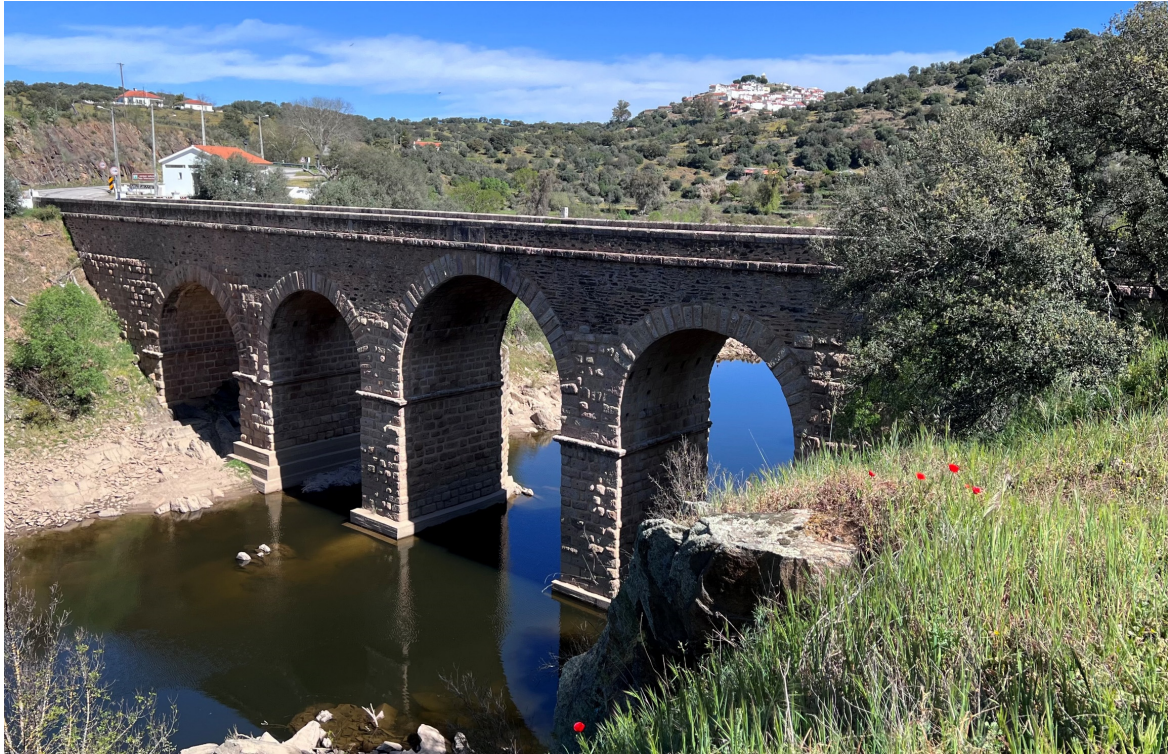
Figure 4. General view of the southern (downstream) side of the Segura Bridge, showing that it is a Roman masonry bridge with five arches, the central one being the largest (photo by the author).

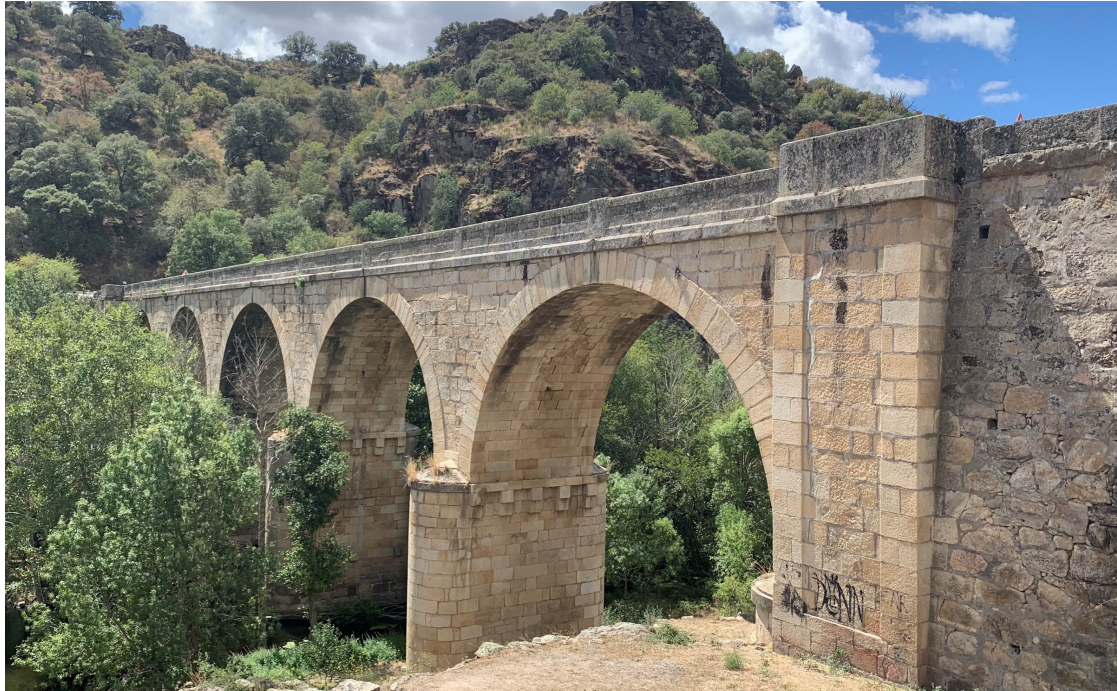
Figure 10. Image taken from the northern abutment, on the Zamora side, of the San Lorenzo Bridge (photo by the author).

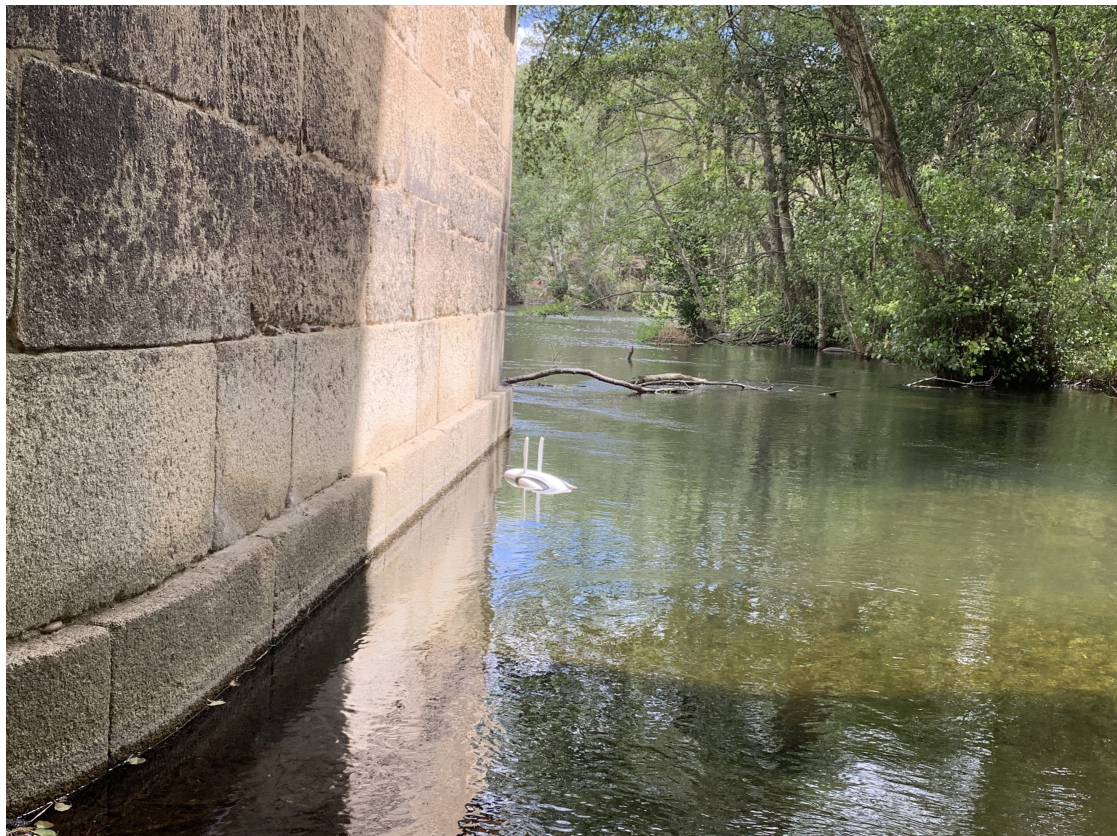
Figure 11. Underwater drone approaching one of the central piers of the San Lorenzo Bridge from downstream to allow observation of the submerged elements (photo by the author).

The underwater drone inspection of the submerged parts confirmed the correct state of the elements underwater: there were no missing granite ashlars, and the granite forming the submerged ashlars was in an adequate state of preservation. The presence of stone slabs in various joints between the ashlars and their appropriate location (Figure 14) appeared to help maintain the position of the ashlars by mutual friction against the erosive action of the river. This would have prevented the need to use grouting mortar, which inevitably tends to dissolve or be lost over time due to the washing action of the flowing water.

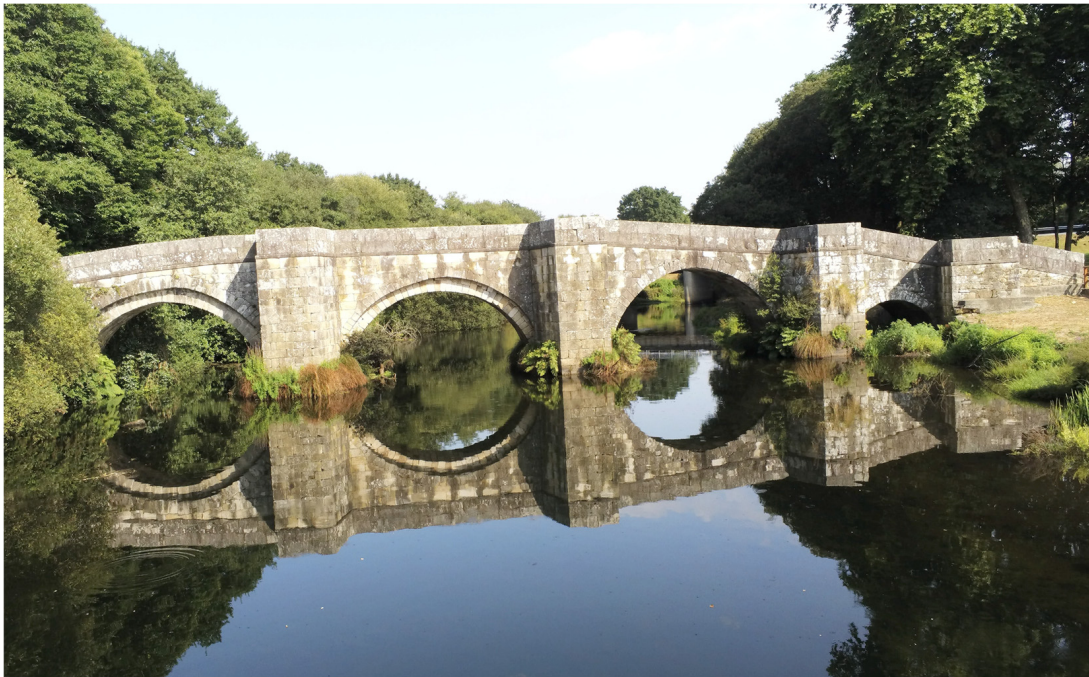
Figure 16. General view of the downstream elevation of the Brandomil Bridge, in an image captured by a quadcopter drone (photo by the author).

Prior to the underwater drone inspection, the bridge underwent a complete and meticulous inspection of its visible parts using a quadcopter drone [29]. This inspection made it possible to check that there were no defects in the various visible elements that would indicate that the foundation was not functioning properly.

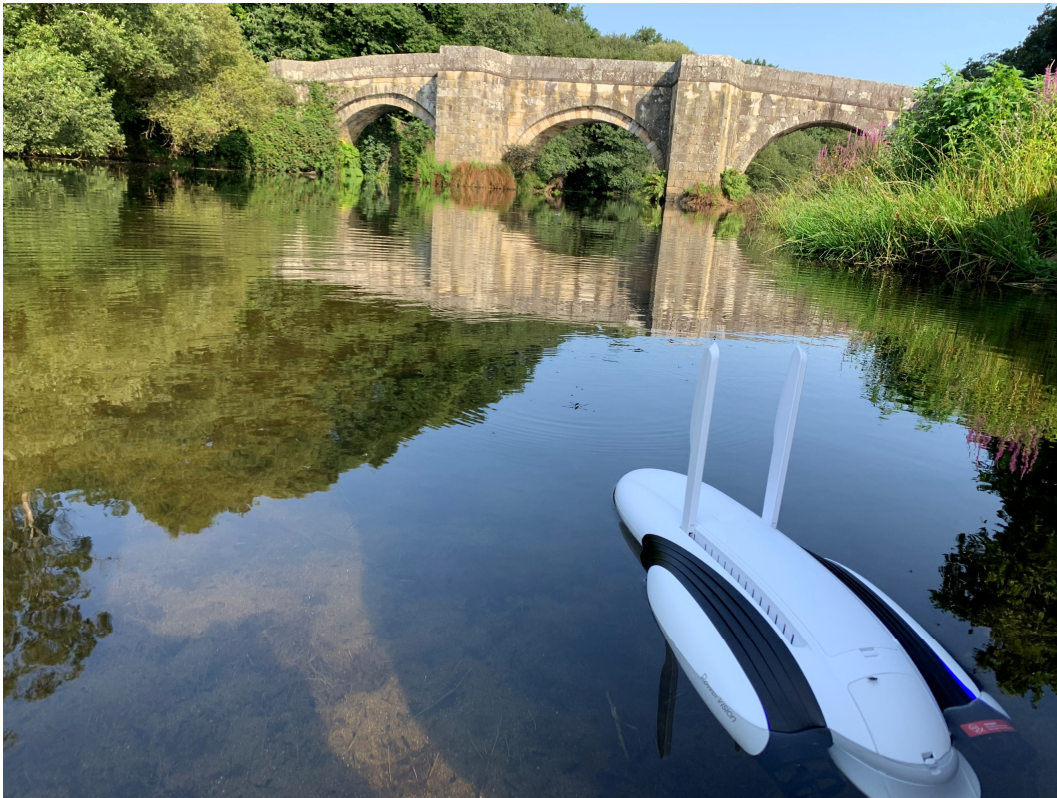
Thanks to the drone, it was possible to rule out the existence of any degradation phenomena in the material making up the submerged elements, as well as the presence of any signs of poor performance of the soil-pile assembly due to the actions to which this assembly is exposed. It was therefore concluded that the foundation was in good working order.

Figure 17. Underwater drone moving along the Xallas River, approaching the downstream side of the Brandomil Bridge (photo by the author).
