Assessing Structural Damage after a Severe Wildfire: A Case Study

Angeliki Papalou * and Dimitrios K. Baros

Department of Civil Engineering, University of Peloponnese; 26334 Patras, Greece

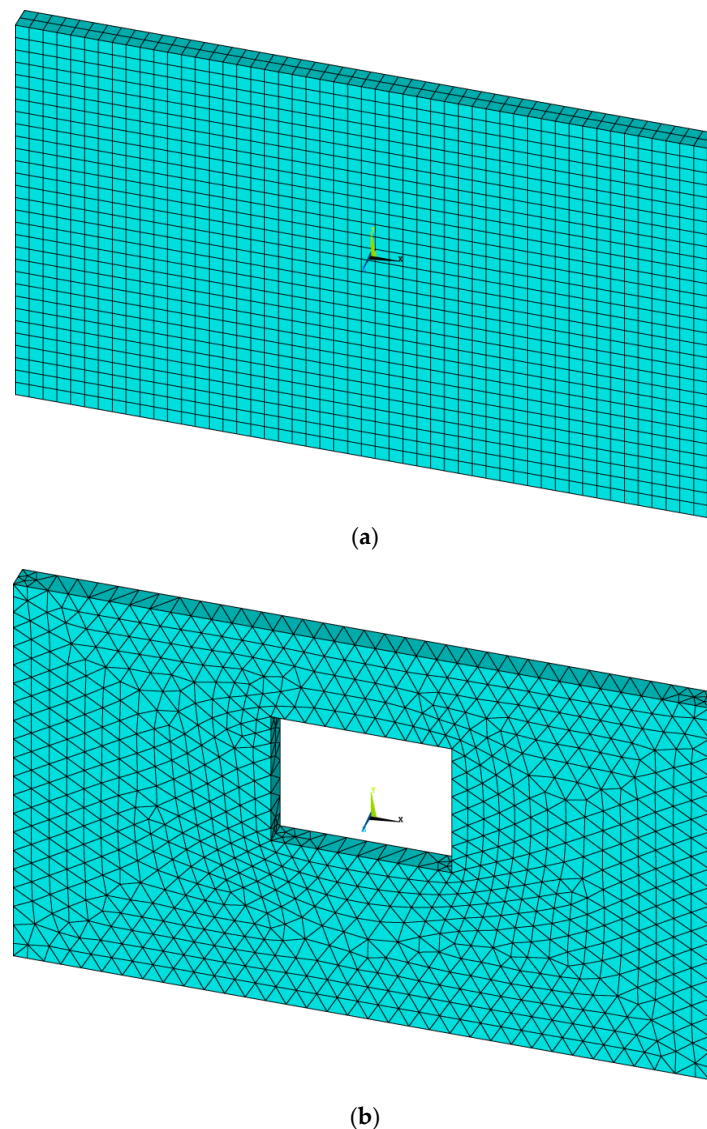
Figure 11. Model layout: (a) W1A; (b) W1B wall specimens.

Moreover, the effect of openings was also included in our numerical investigation, given the fact that structural damage patterns on walls appear to be connected with their presence (or absence). Thus, two different models of 0.20-m-thick wall panels were used in the analysis: W1A represented a “continuous” wall without openings, and W1B represented a window opening of dimensions 1.3 m in length and 1 m in height located at the center of a panel (Figure 11).

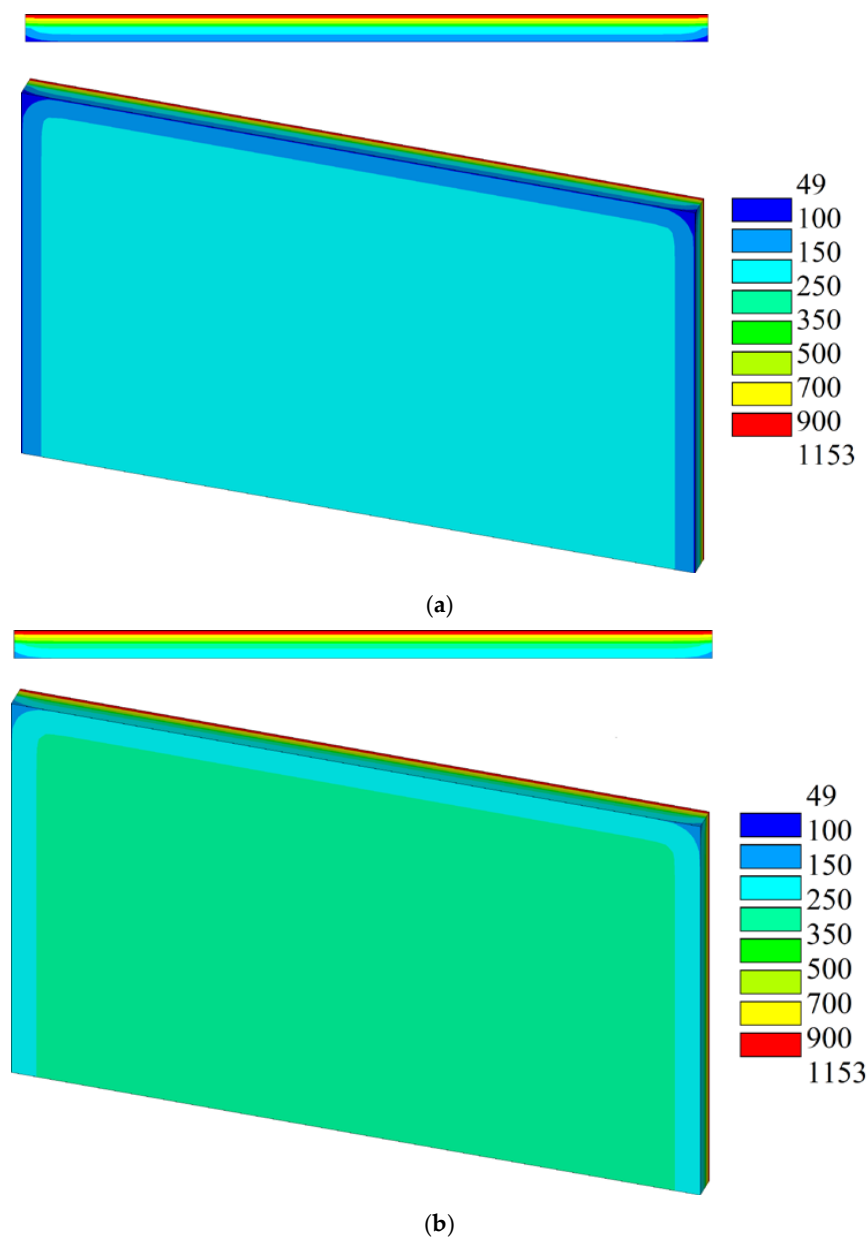
Figure 12. Analysis results for the W1A specimen and two values of material thermal conductivity: (a) 0.50 W/m K; (b) 1 W/m K.

The temperature gradients on the nonexposed face and a section of the wall for the W1A and W1B models are presented in Figures 12 and 13, respectively.

As can be seen in both figures, the use of the lower value of λ_c led to relatively low temperature values (< 200 °C) on the nonexposed face. This was not consistent with the in situ observations of extensive coloration and structural damage related to high temperature values on both exposed and nonexposed faces of walls. The use of $\lambda_c = 1.00$ W/m K significantly improved the results, leading to temperatures up to about 400 °C on the nonexposed face of the model. Thus, we may conclude that the latter value of thermal conductivity was more appropriate for the numerical investigation of the problem. The previous observations were consistent with results found in similar research efforts (e.g., References [22–25]). However, as shown in Figure 13, both numerical models appeared to misinterpret the effect of openings. Lower temperatures were calculated in their immediate areas, which would indicate that openings are actually “stress relief” zones, and as a result, no significant structural damage should be expected close to them. Obviously this contradicted the previously discussed field observations (e.g., Figure 6e).

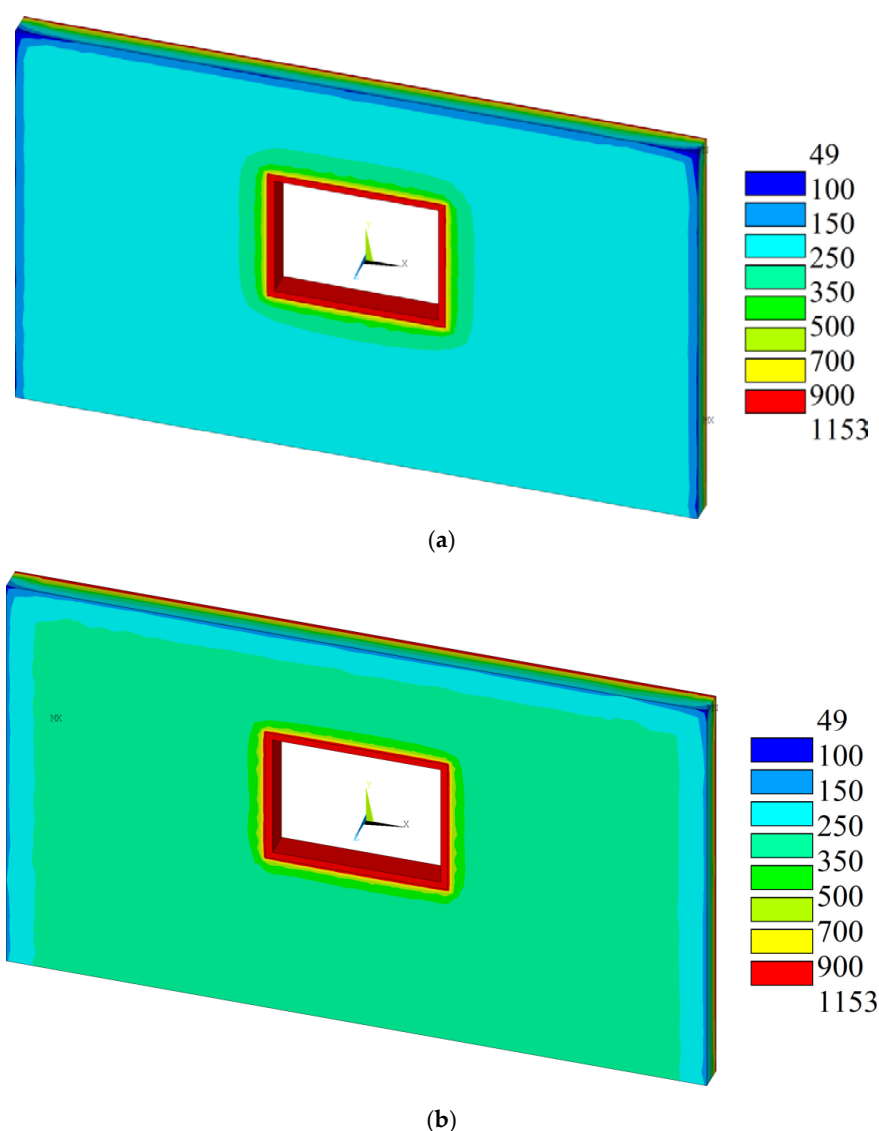
Figure 14. Analysis results for the W1B specimen, including an aluminum window frame, and considering (a) 120 min and (b) 240 min of exposure.

Window frames were included in the numerical model as a separate volume that was subsequently meshed to respective 3-D FEs with properties representative of the frame material ($\lambda_c = 200$ W/m K). The heat transfer between the separate volumes was achieved by using proper nodal constraints for the frame–masonry interfaces. Indicative results from the analysis of the more detailed model, including the window frame, are presented in Figure 14.

The numerical results indicated that the model identified the effect of openings, as it properly calculated the variation and higher values of temperature that may lead to concentrated structural damage in the immediate area of wall openings, as was observed in the field.

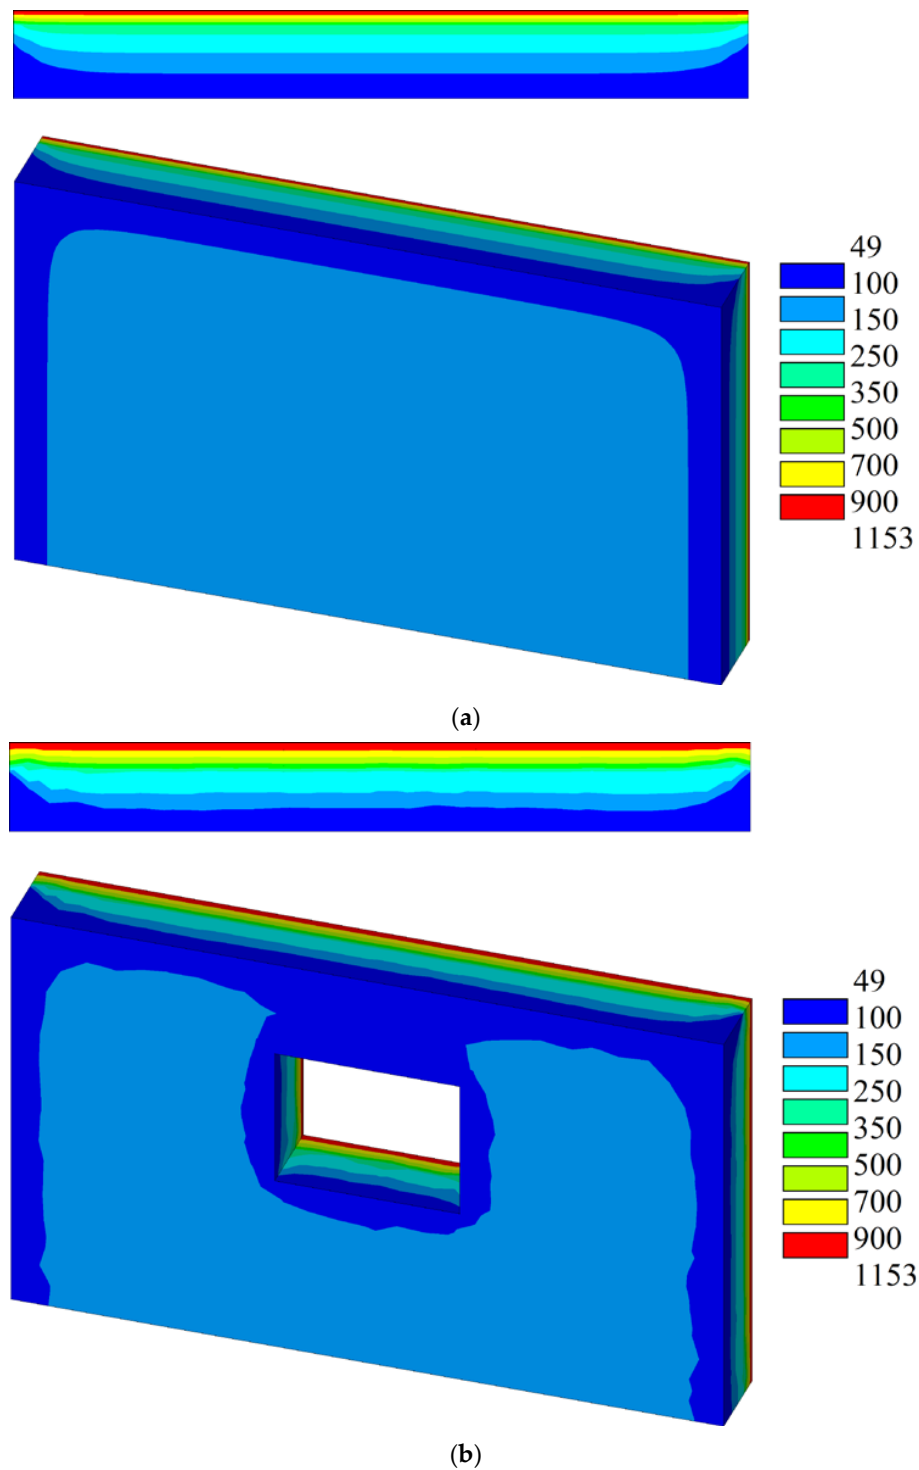
Figure 15. Analysis results for (a) W2A and (b) W2B specimens (material thermal conductivity 1 W/m K).

Finally, Figure 15 presents the results for W2A and W2B models. These were similar to W1A and W1B, respectively, with the wall thickness increased to 0.50 m.

Thermal conductivity was considered equal to 1.00 W/m K in both cases. The analysis results indicated that even in the extreme temperature scenario that was applied, relatively low values of temperature ($< 150\text{ }^{\circ}\text{C}$) were expected in the nonexposed wall face. This may be possible in cases of very thick stone masonry. The results were improved when the window frame was properly modeled, as shown in Figure 16.

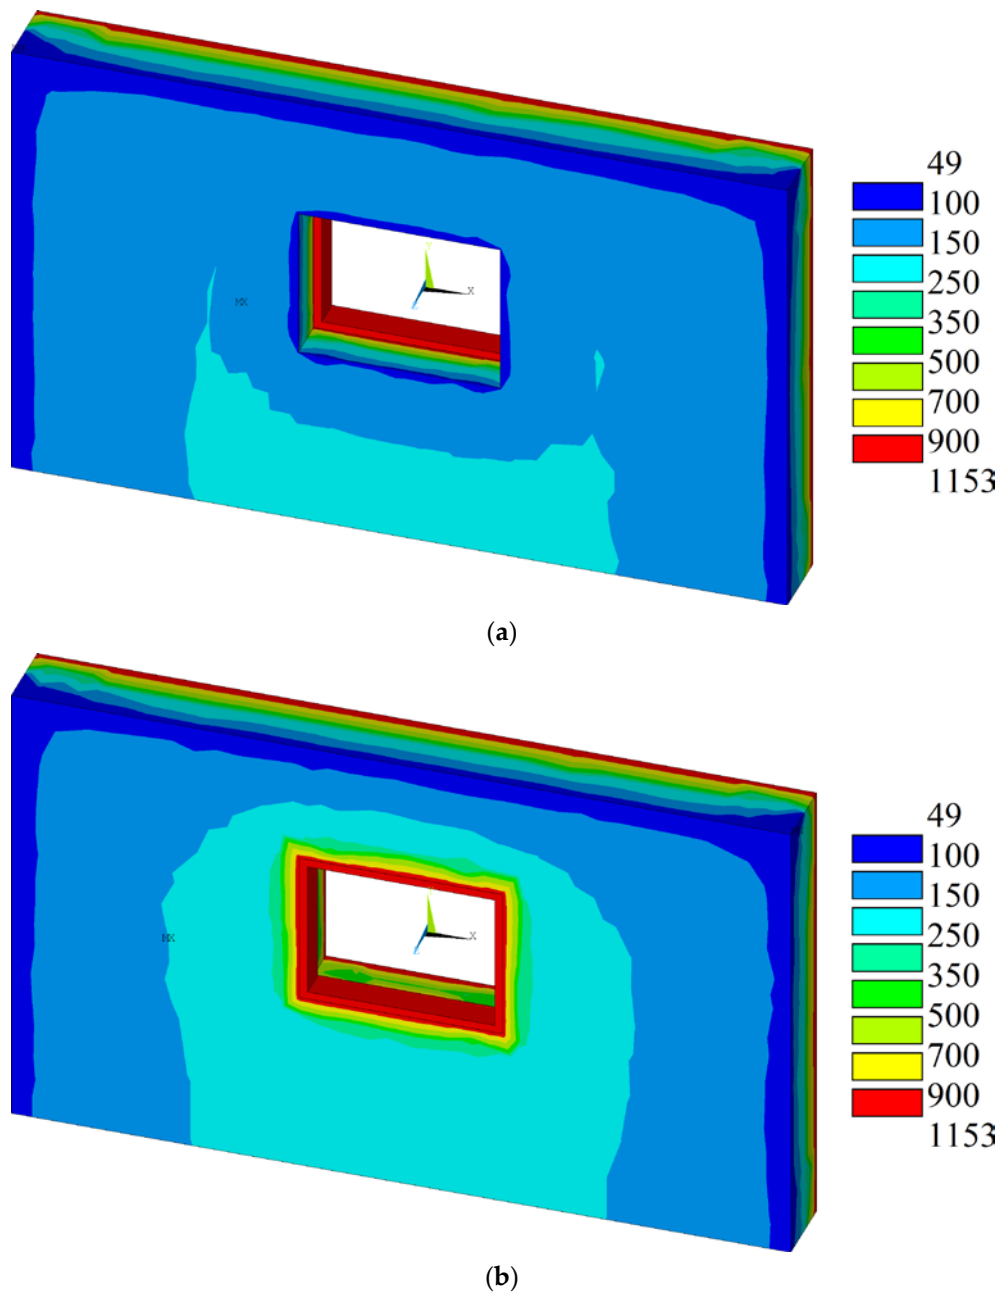
Figure 16. Analysis results for the W2B specimen, including an aluminum window frame, close to (a) the exposed and (b) nonexposed face and considering 240 min of exposure.

In this case, the numerical findings suggested that the location of the window frame may also affect the temperature distribution and, as a result, the expected structural damage. As shown in Figure 16b, when the window frame was closer to the nonexposed face and the fire reached it, a higher temperature in its immediate area was possible, leading to extensive structural damage on the nonexposed face of thick masonry. This was consistent with some of the field observations discussed in the previous sections of the present article.
